1928 Differential Rebuild, May 2016

by Tom Endy

This 1928 rear axle assembly was removed from a 1929 roadster pick up for rebuild; the owner is a member of the Santa Anita A's. A complete disassembly took place while the owner was present.

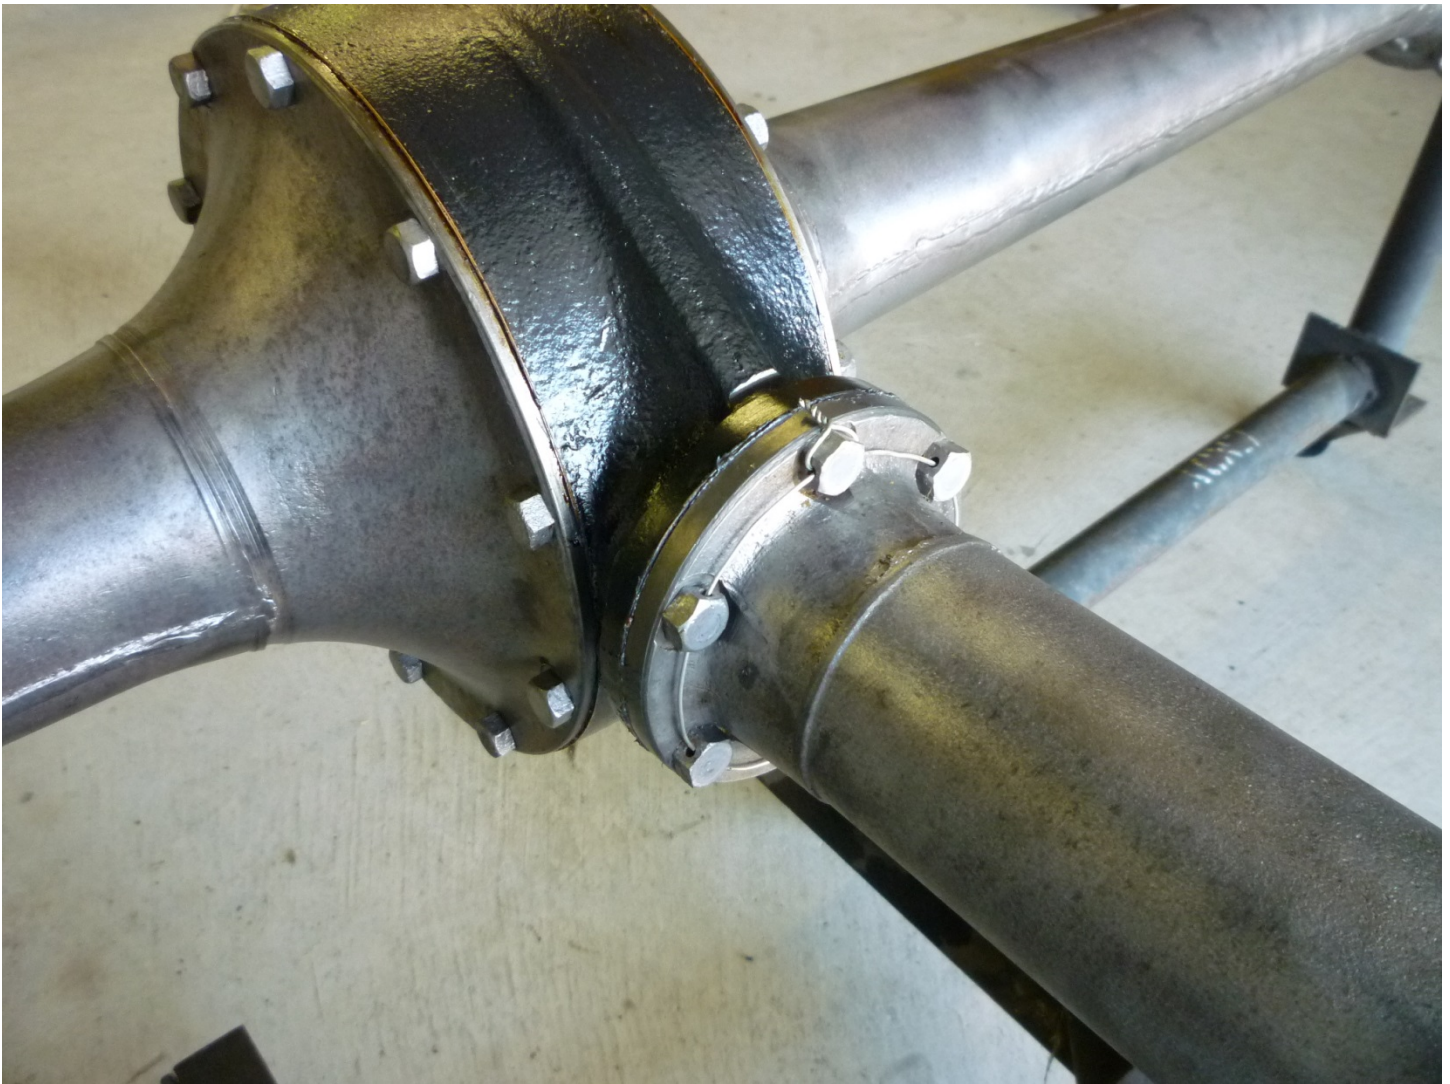
The torque tube bolts are torqued to 35 ft. lbs. and safety wired. The axle housings for a 1928 rear axle assembly have the weld seams on the side and should be oriented such that they face forward.

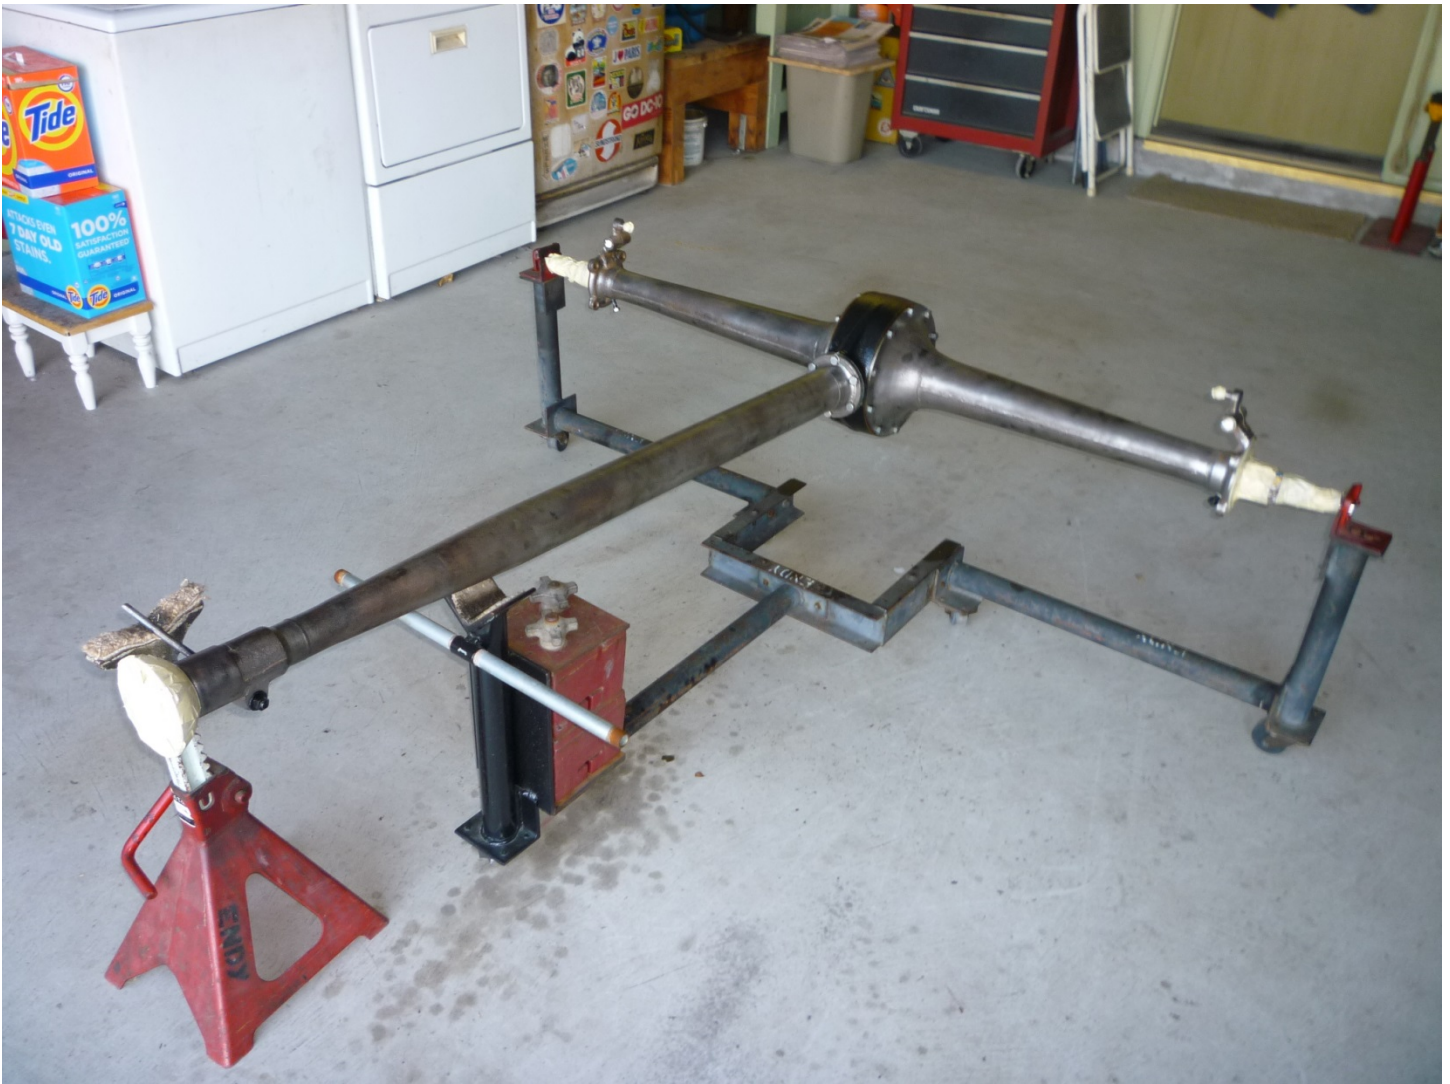
The fully assembled rear axle assembly has been masked off for painting. The bell end that attaches to the U-joint housing is masked. The area where the two rear backing plates bolt up to the axle housings is also masked. The ball perch for the shocks is masked. Paper toweling has been stuffed into the shackle bushings, and threaded stock has been inserted into the grease fittings for the rear wheel bearings. A length of threaded stock has been inserted into the bolt hole for the rear radius rods. This will allow the assembly to be lifted off the cradle at the front and rested on a jack stand so that both the top and the underside can be painted at the same time by pivoting the assembly at the rear of the stand.

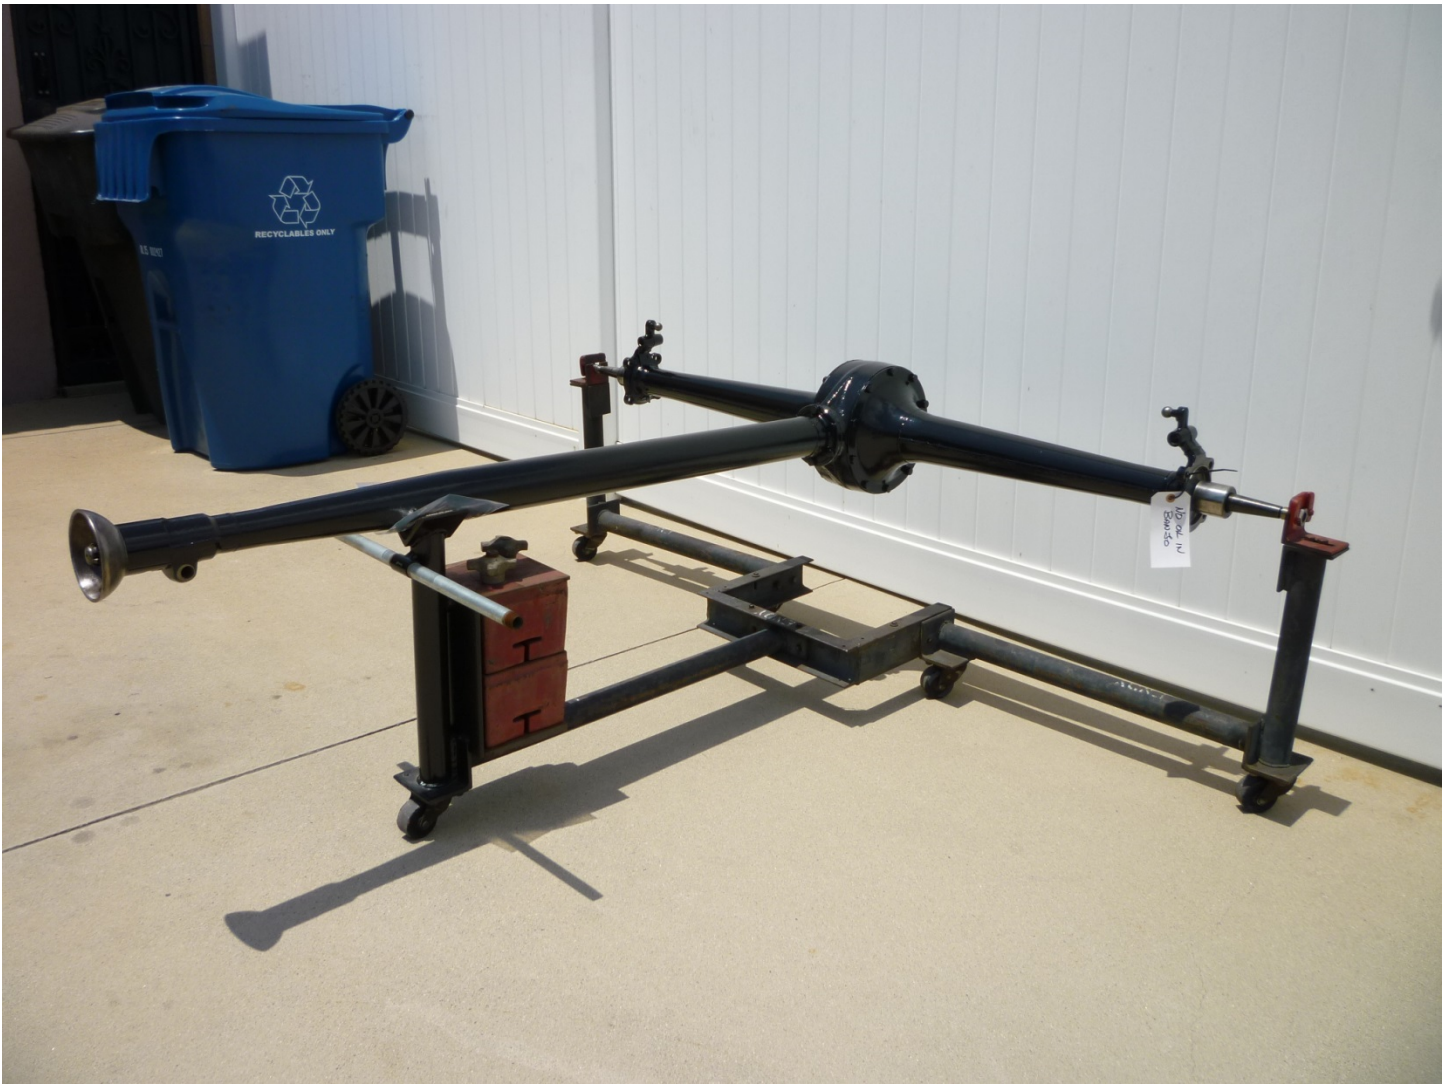
The rear axle assembly is painted and ready for return to the customer. Note the tag attached: “no oil in banjo”. Best to leave it in place until the assembly has been oil serviced.
