# Oil Pump Change

by Tom Endy

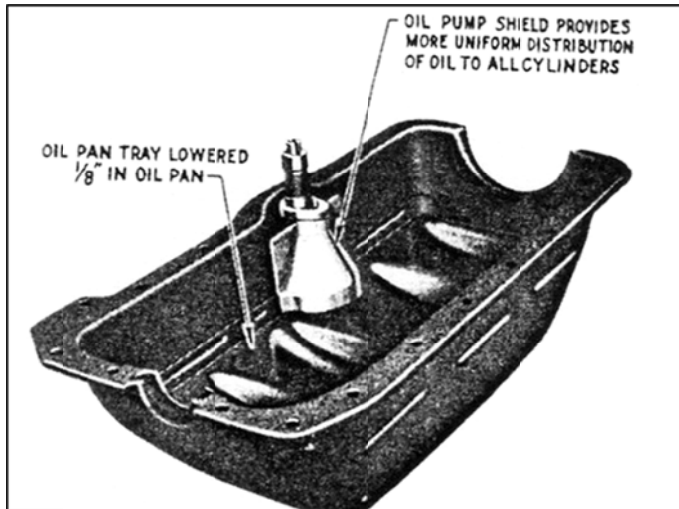
Ford made a change to the oil pump and the dipper tray in late summer of 1931. According to the service bulletin the reason was to lessen oil consumption.

**“An Improvement to lessen oil consumption: A shield is provided that fits around the oil pump and assures a more even distribution of oil to all the cylinders. The oil pan tray has also been lowered by 1\8” and is accomplished by raising the bead in the oil pan tray.”**
