# Rear Axle Assembly Rebuild Pictorial 2015

by Tom Endy

The following series of photos were taken during the rebuild of a Model A rear axle assembly.

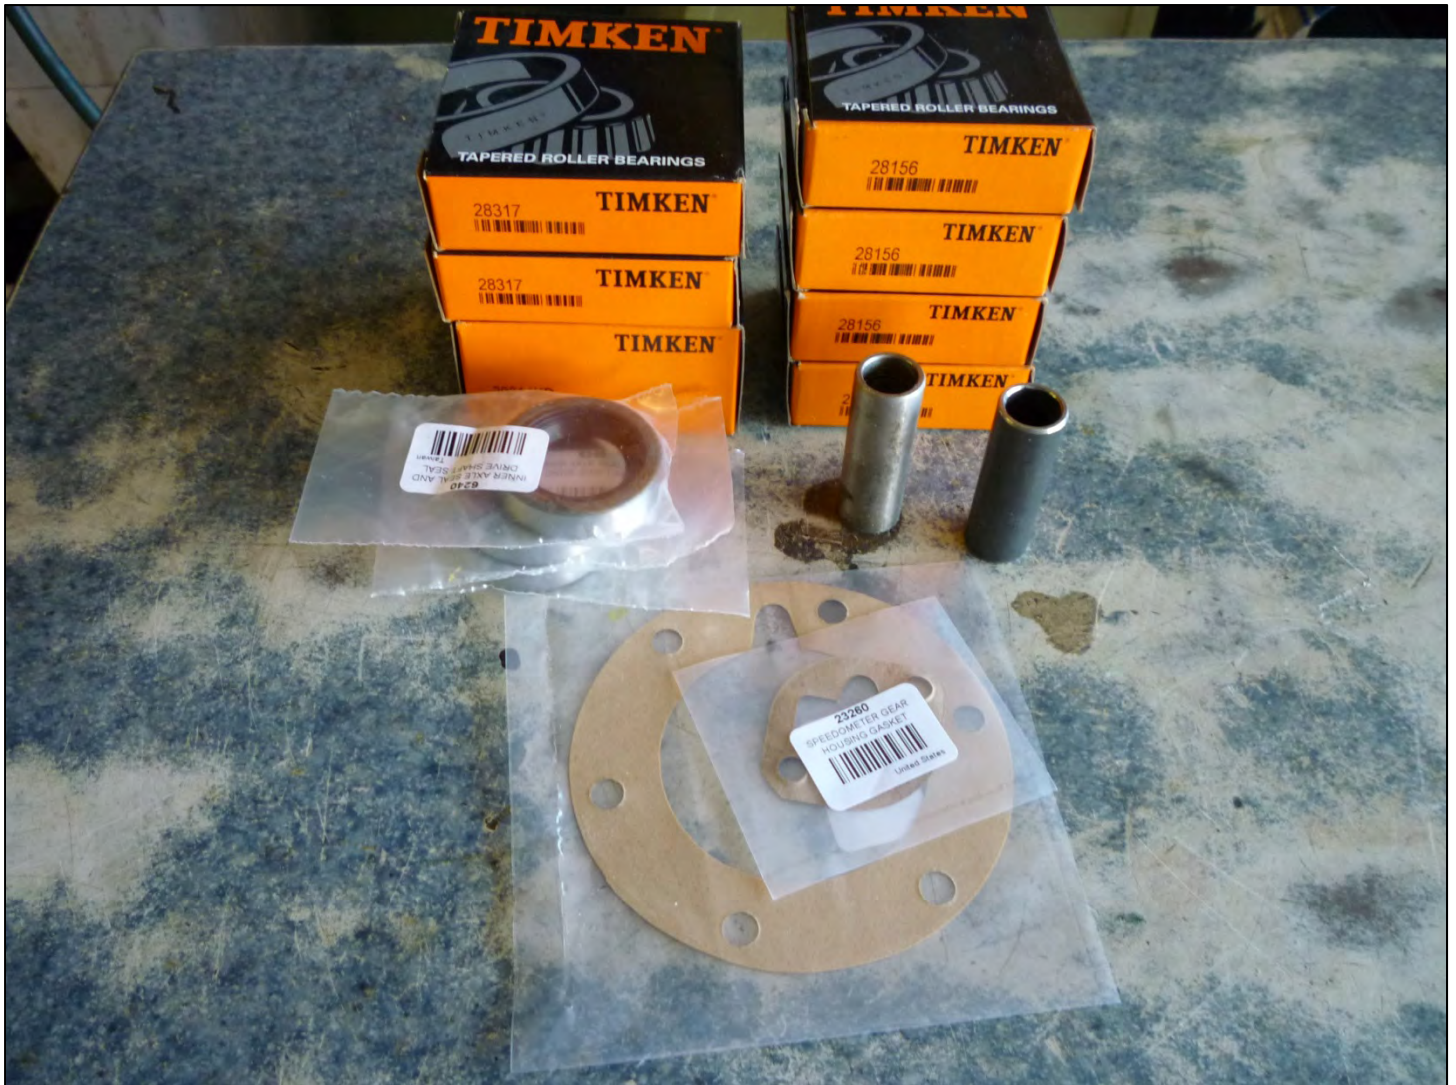
Bearings, races, seals, gaskets and new shackle bushings are ready for installation in a rear axle assembly rebuild.

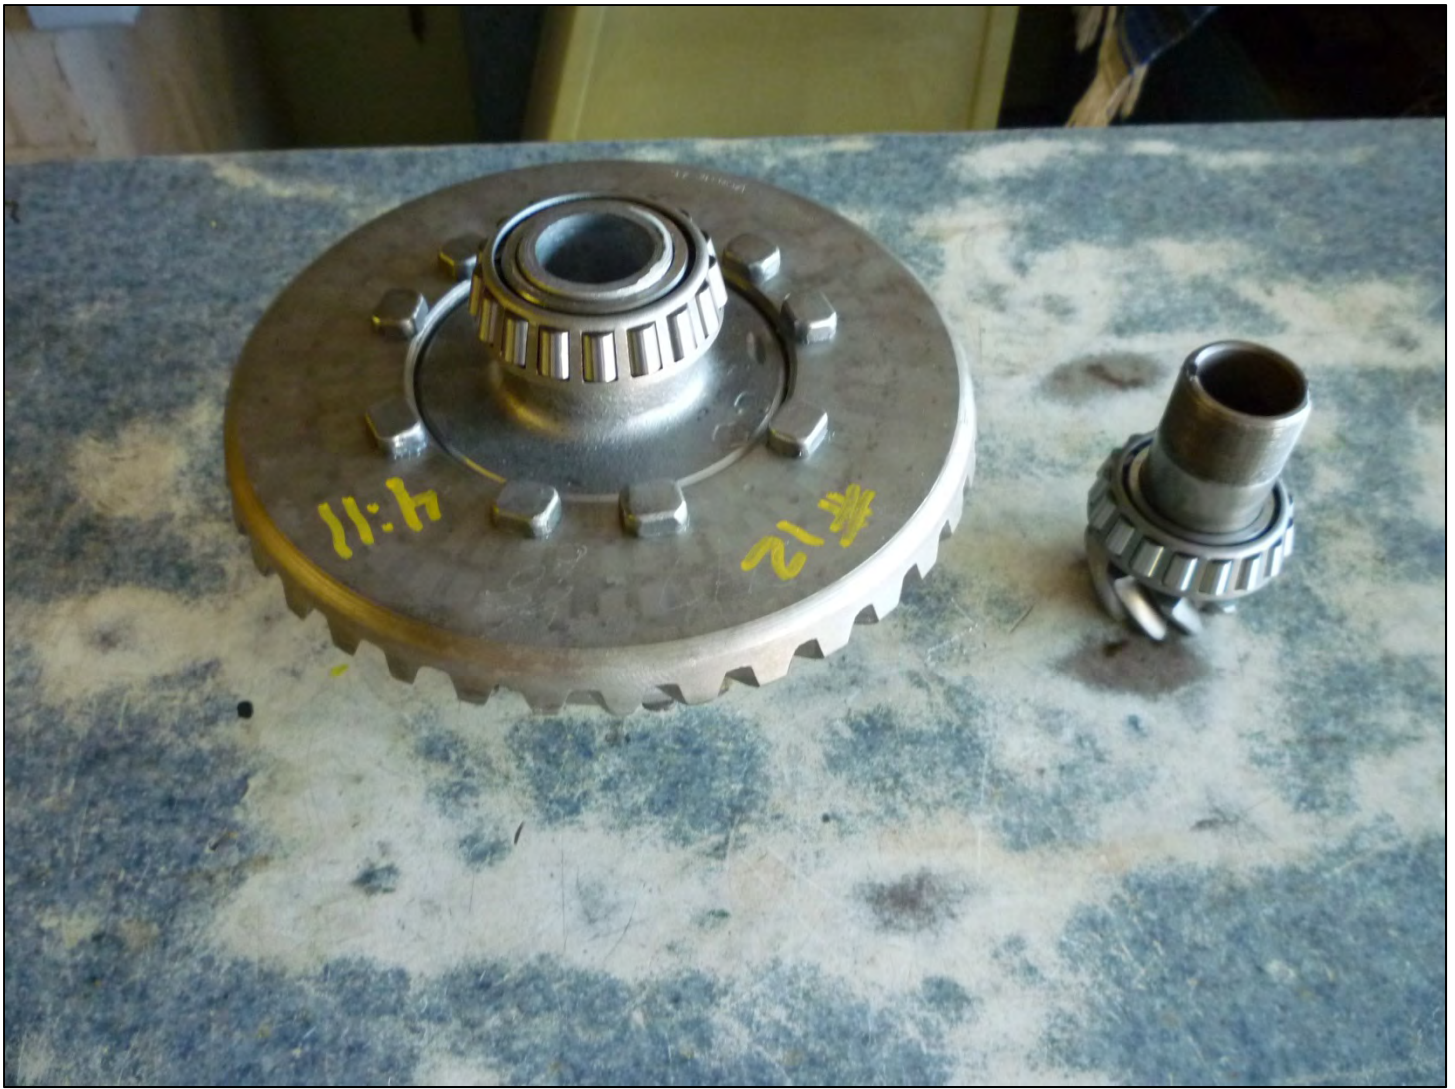
**Another view of the 411 ring and pinion gear set. This is an original Henry Ford gear set. The first pinion bearing should seat with an interference press fit just behind the gear. The second bearing when installed should press on snugly, but not overly tight. On an original pinion gear sleeve there is a difference in diameter of .0015 where the two bearings mount. The reason is to allow the second bearing to be moved fore and aft to achieve the pinion bearing pre-load adjustment.**

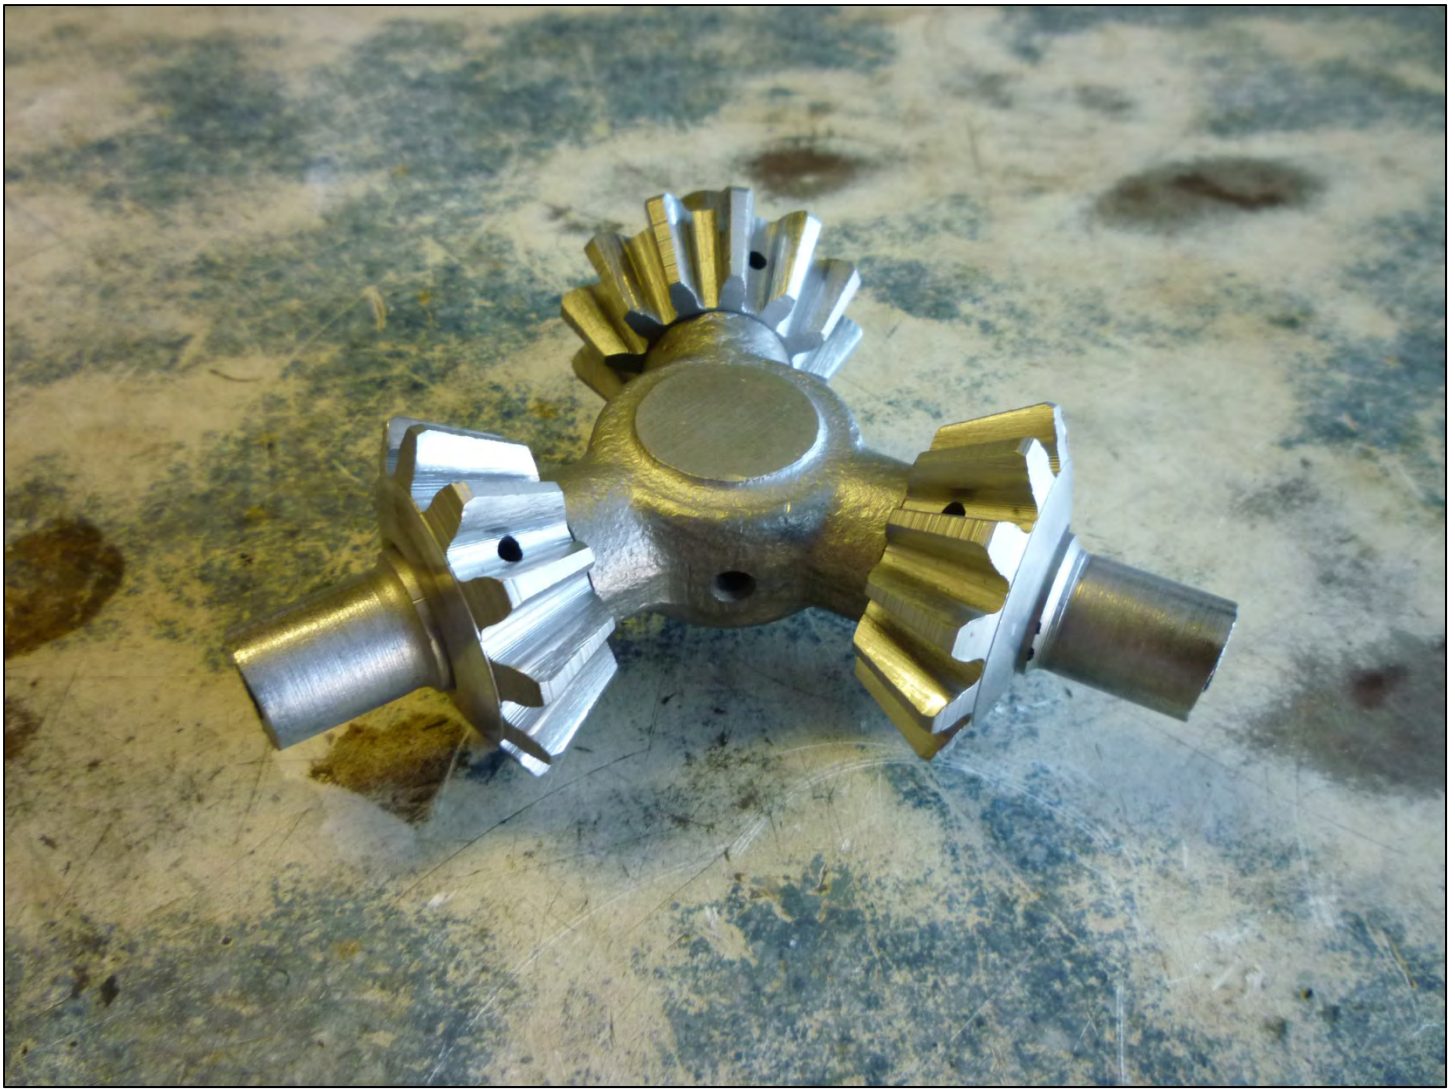
**The spider gear assembly has been cleaned, inspected, and bead blasted. This particular set is a 1931 gear assembly with oil holes drilled into the three spider gears. The three spider gears normally turn loosely on the shafts. This spider gear assembly will be set aside until final assembly when it will be installed.**

**The modified spider yoke that was installed in the carrier to measure the pre-load has a hole bored through the center and is threaded to accept a long threaded rod. By turning the rod with a dial indicator torque wrench the pre-load value (nominal 20 in. lbs.) can be read from the dial. The three spider gears are left off for this procedure.**

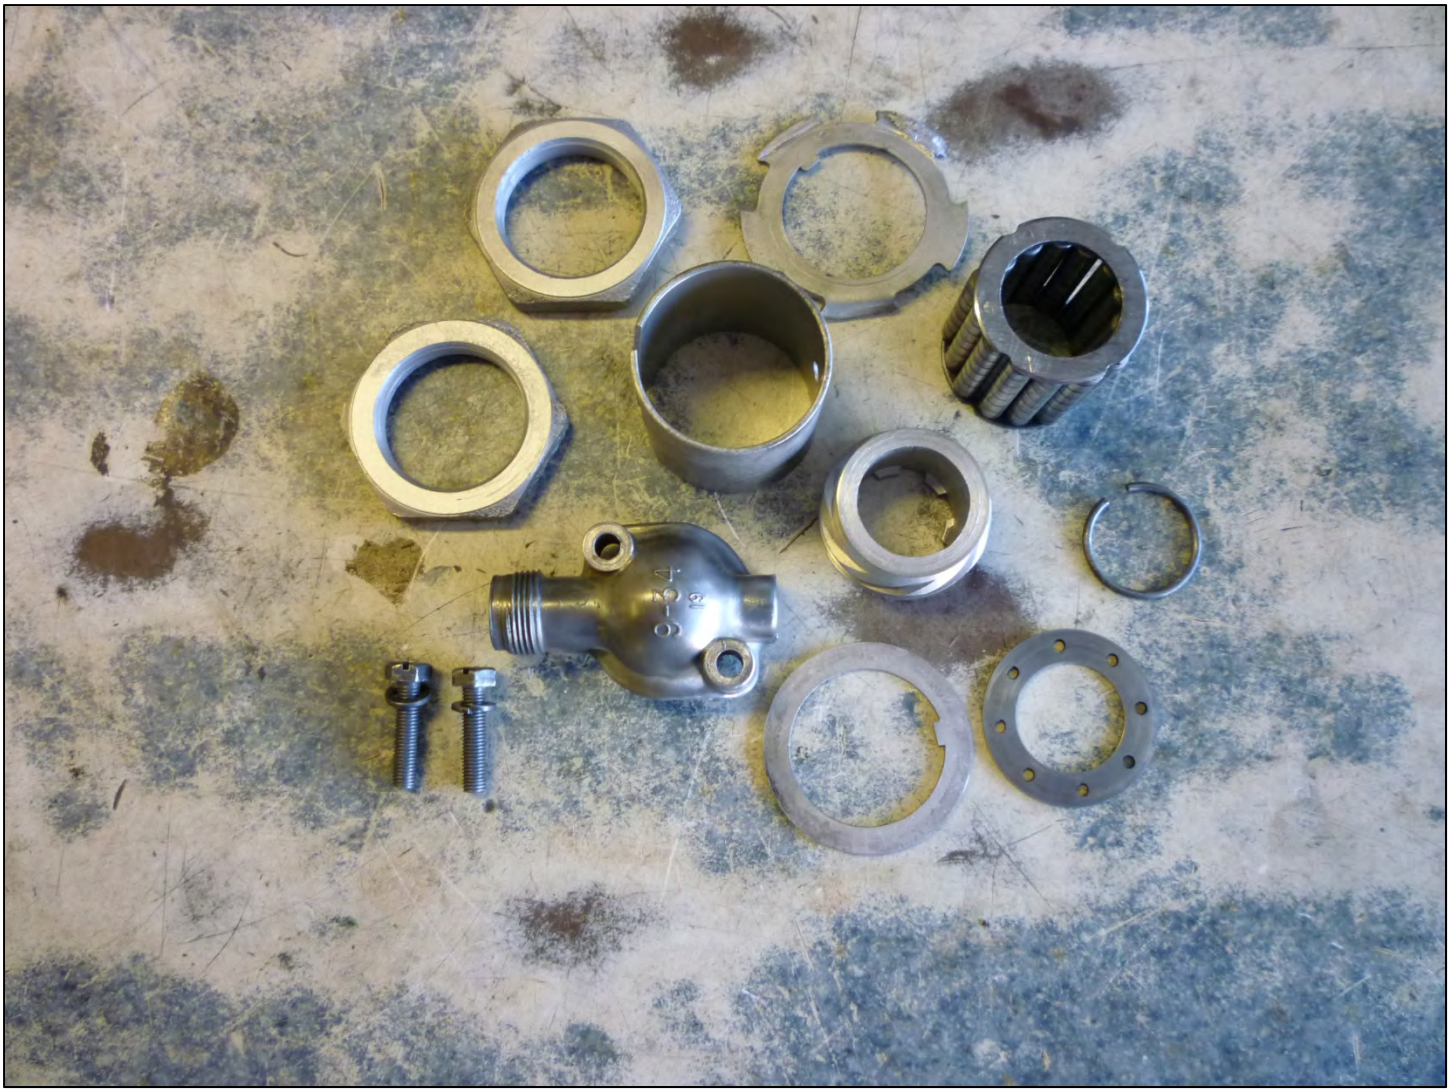
**The miscellaneous hardware for the front of the torque tube has been cleaned and bead blasted along with the hardware for the pinion gear sleeve.**

**Note the flat thrust washer on the right with the holes around the circumference. This washer is positioned between the roller bearing and the speedo drive gear. The purpose is to allow grease pumped into the U-joint housing to reach the roller bearing.**

**A new grease seal will be installed in the neck of the torque tube just behind the roller bearing and race sleeve to prevent grease from migrating down the drive shaft.**

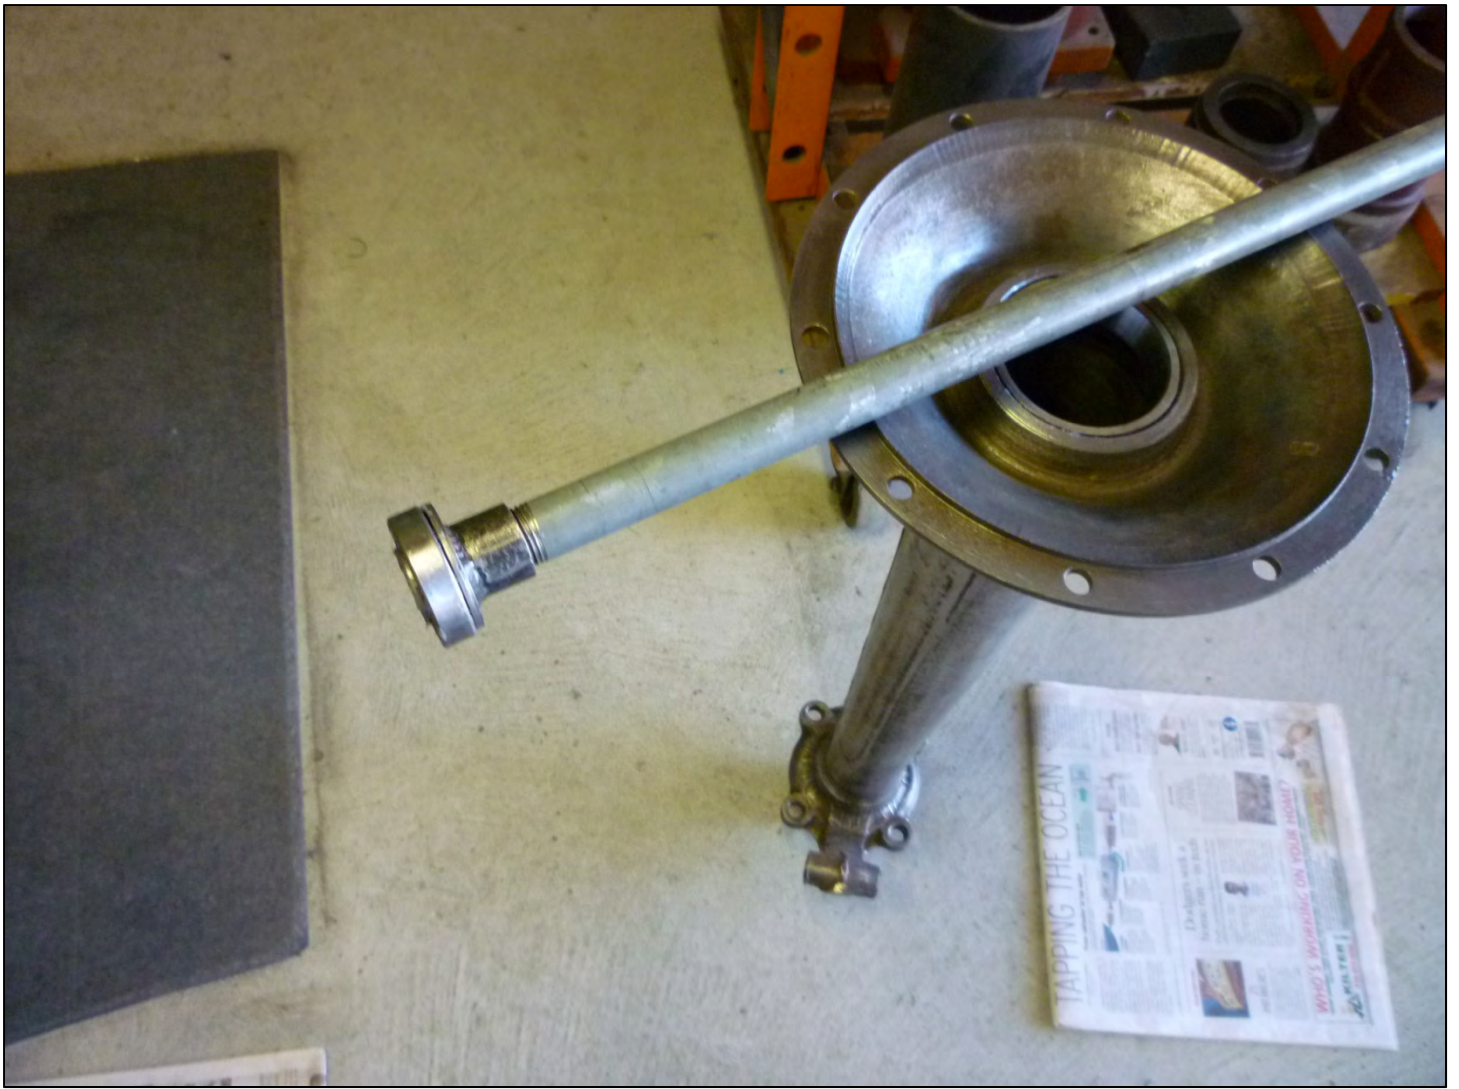
**A new grease seal is hammered into place using a long insertion tool. The area where the seal will seat must be thoroughly cleaned before the seal is hammered into place. The seal is shown positioned onto the end of the insertion tool.**

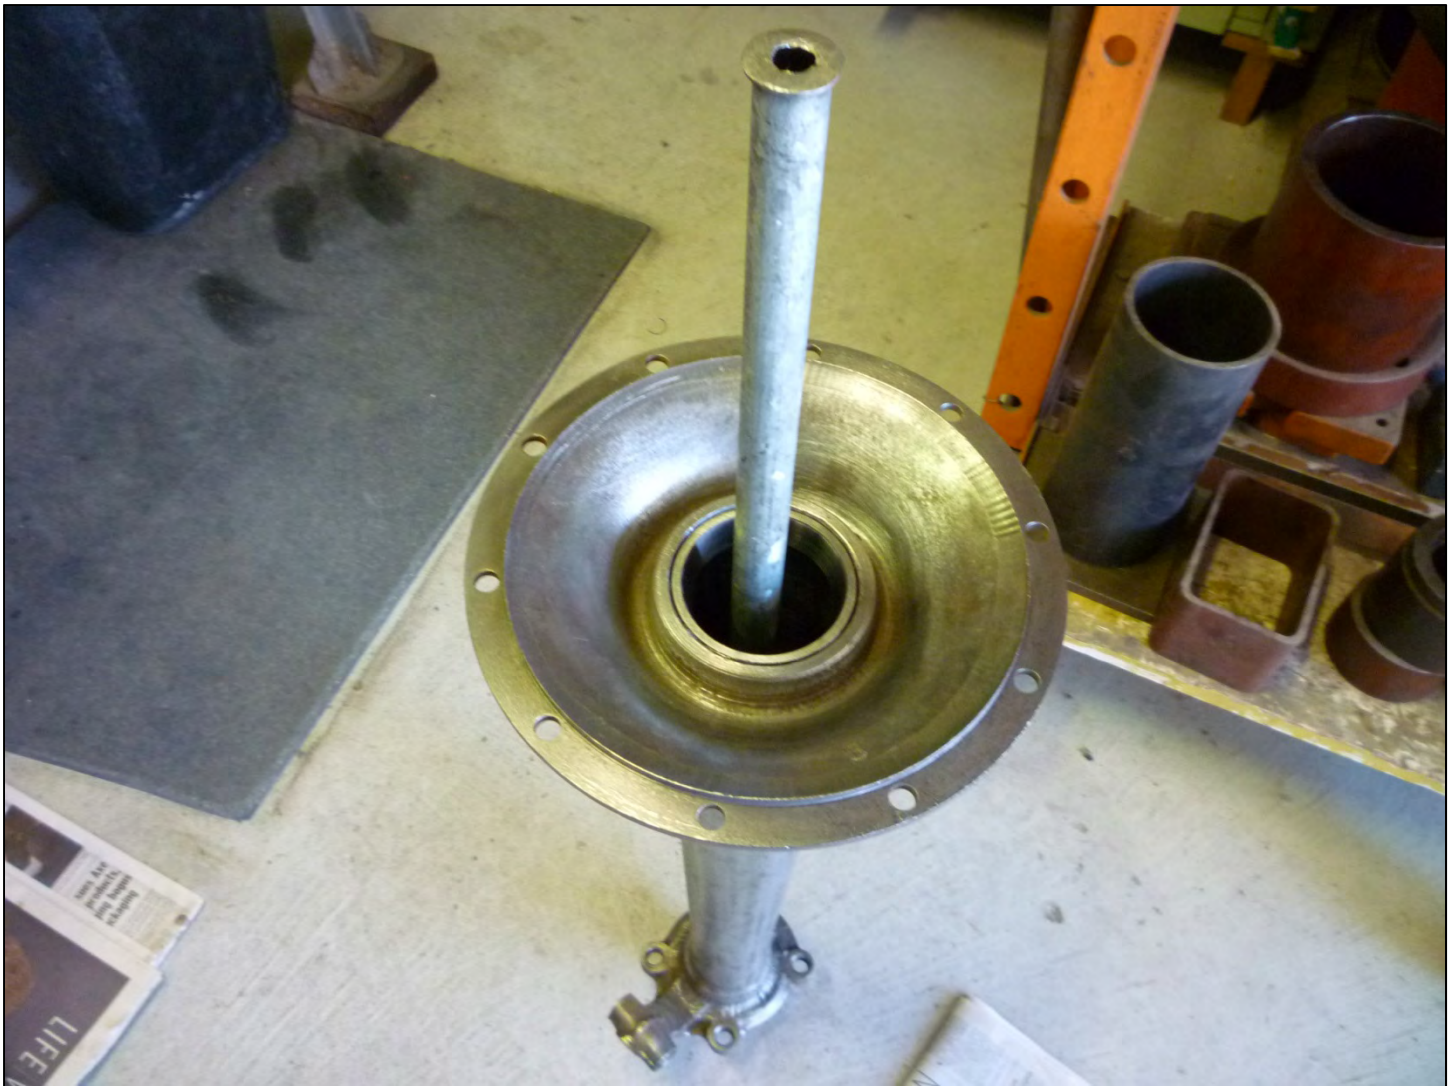
**The grease seal is hammered into place by standing the axle housing upright and using a long insertion tool. It takes about 4 to 5 hammer blows to seat the seal into place. When the seal seats the hammer blow sound will change from a dull thud to a ringing sound. Check that the seal is fully seated by running your finger around the circumference at the other end of the housing.**

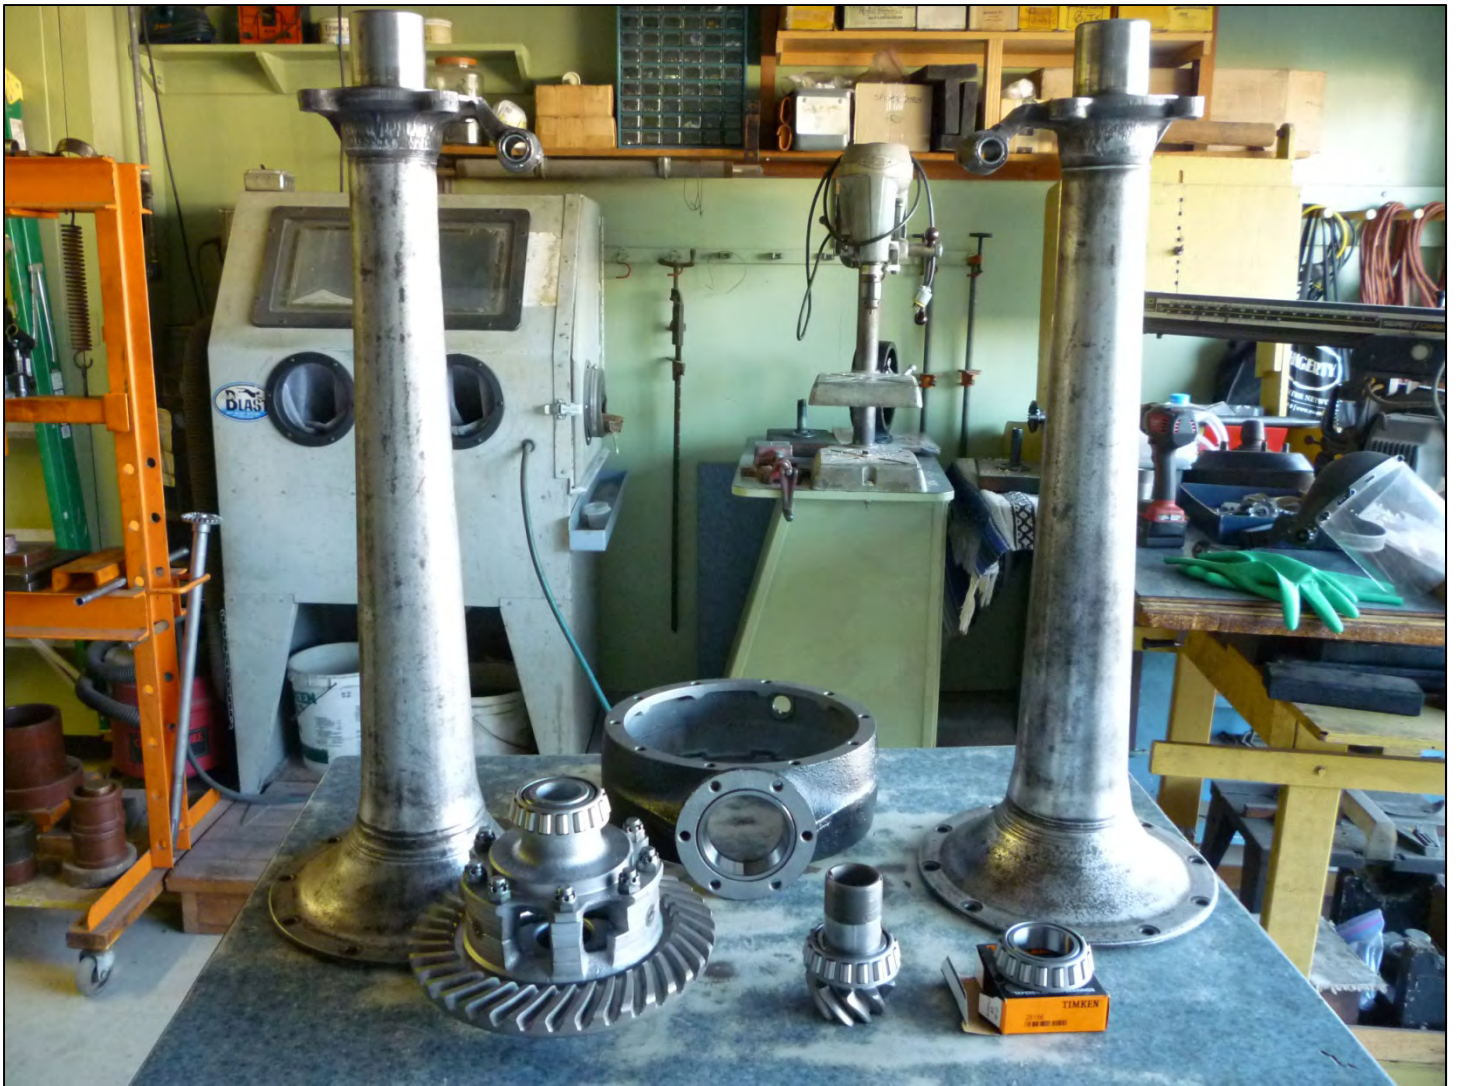
**This photo shows the two axle housings, the banjo, the pinion gear, and the carrier ready for assembly for a trial and error effort to determine the carrier pre-load. Both axle housings have new races and seals installed. The carrier assembly has new bearings installed and the modified spider yoke tool installed. The axle housings have been wire wheeled and sanded down. New shackle bushings have also been installed.**

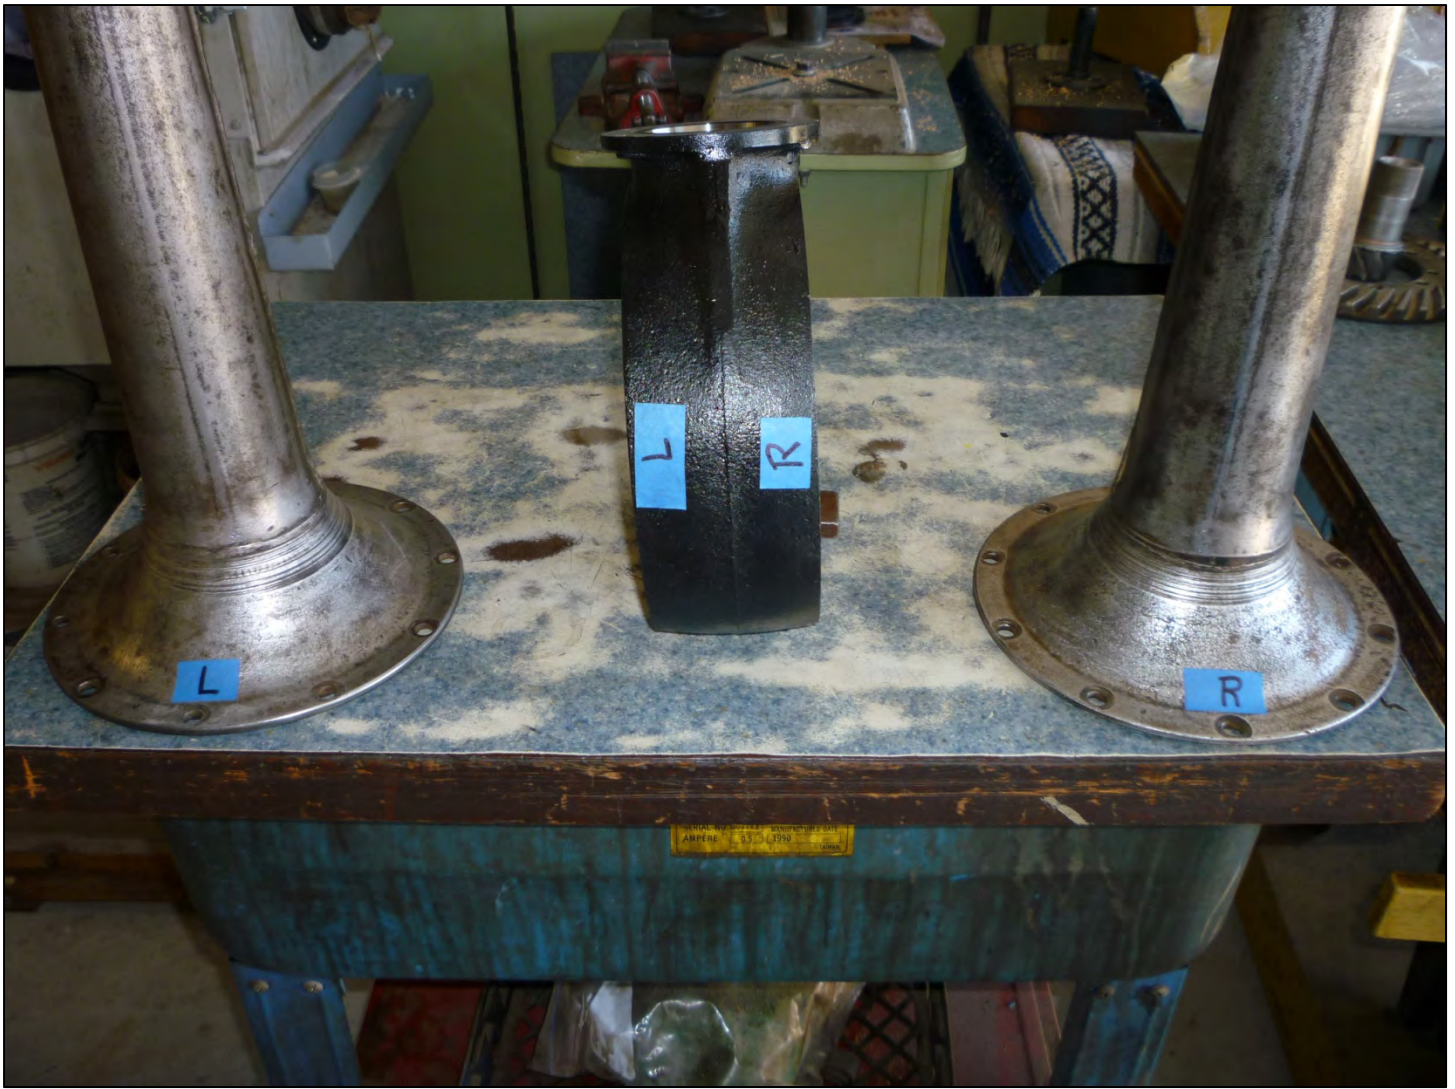
**Before beginning assembly it is suggested that the two axle housings and the banjo have left-right markers placed to indicate the proper mating. Since the assembly will be taken apart several times it is easy to assemble the housings to the wrong orientation.**

**Note that this assembly is a hybrid, in that the banjo is from a 1931 vintage car that has offset fill and drain holes. The two axle housings are from a 1928 vintage car that has the axle weld seams oriented along the length and face forward on the car. All Model A rear axle housings are functionally interchangeable, the only consideration being the Judging Standards for a show car.**

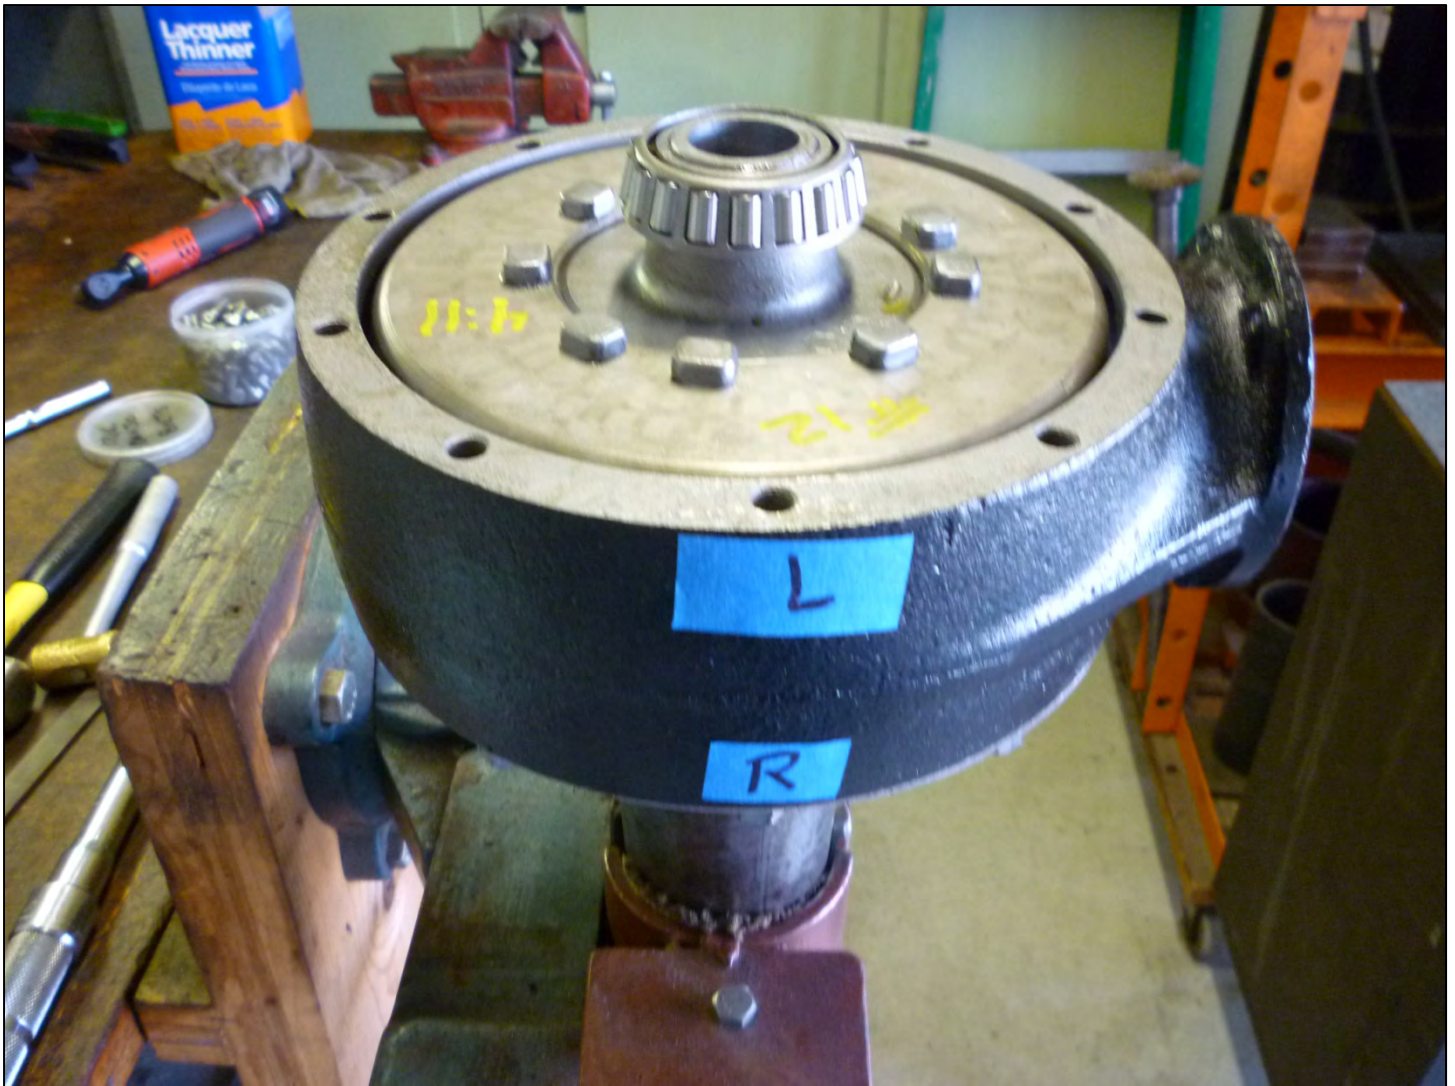
**The right axle housing is shown mounted into the vertical work stand. The banjo has been bolted to the right axle housing with the ten banjo bolts and torqued to 35 ft. lbs. There are no gaskets between the banjo and the right axle housing. The carrier assembly, minus spider gears and the two axles is set down into the right axle housing with the flat side of the ring gear facing up.**

**When the left axle housing is bolted into place, also without any gaskets, the ability to lock up the ring gear should be noted. As the ten banjo bolts are pulled down on the left axle housing reach in through the opening where the pinion assembly installs and turn the ring gear with your fingers. The ring gear should lock up before the 35 ft. lbs. of torque is reached.**

**If the ring gear does not lock up the assembly will have to be taken apart, one or more of the carrier bearings removed, and shims placed under either or both of the bearings. This will increase the width of the carrier assembly and provide the means to lock up the ring gear. There must be an ability to lock up the ring gear with no gaskets installed before proceeding with the preload adjustment, which will be accomplished by adding banjo gaskets.**

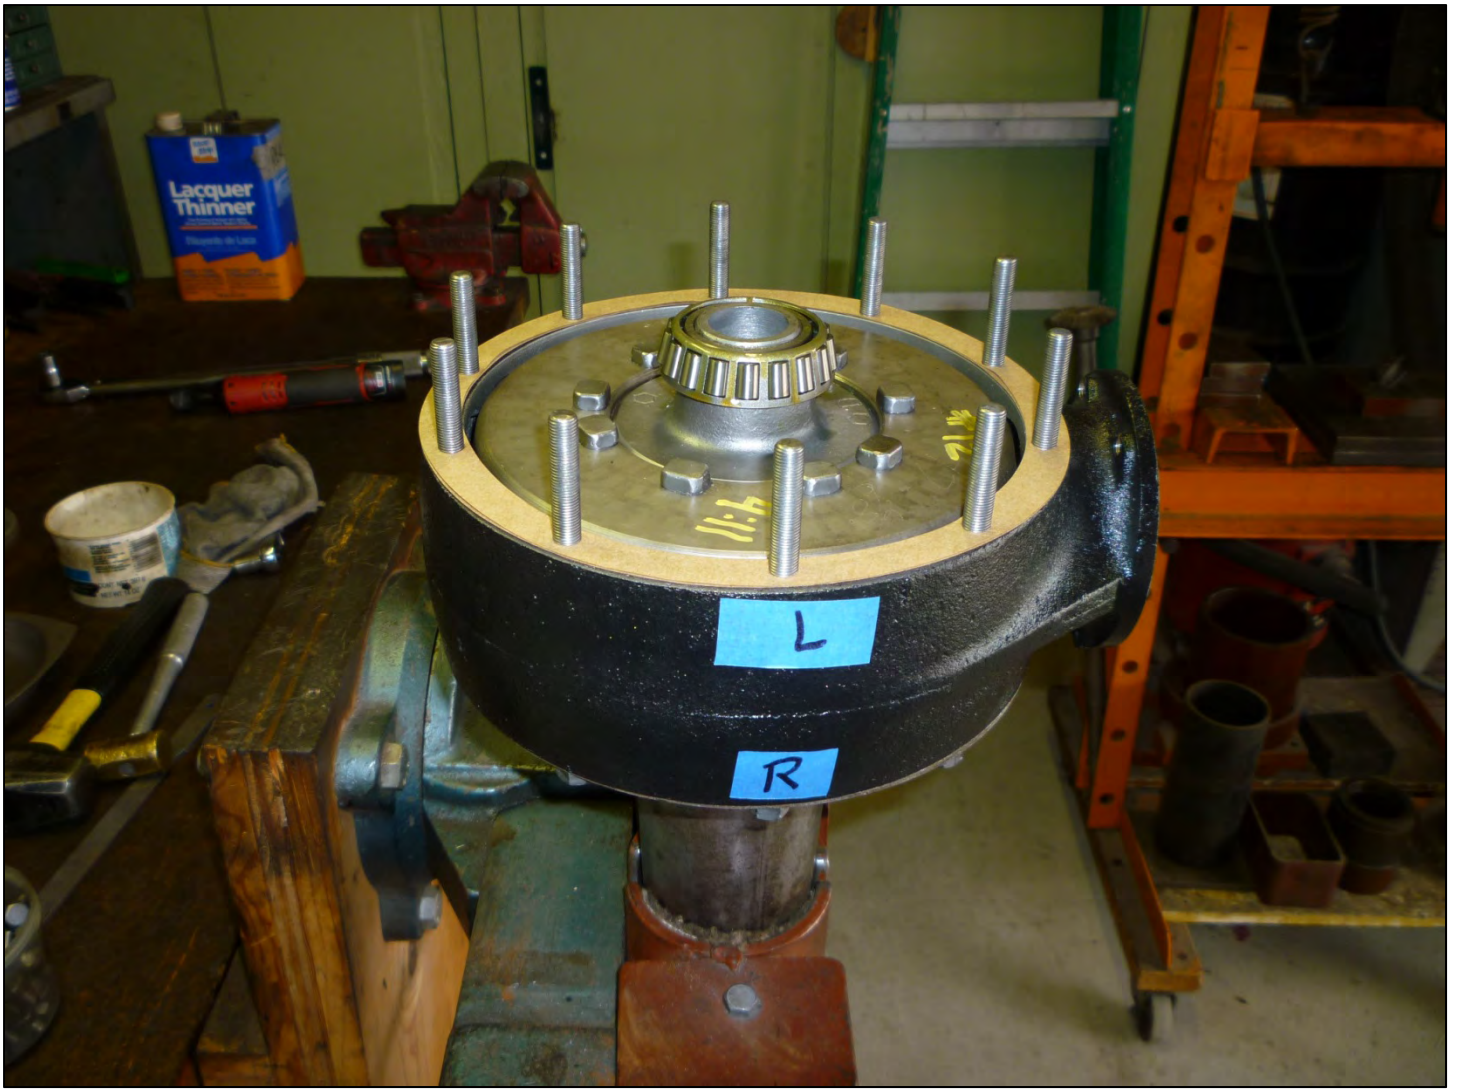
**The next step was to install two paper .010 paper gaskets to the left side of the banjo. Short threaded studs are used to properly align the holes in the gaskets with the holes in the banjo. Two .010 gaskets are the minimum that should be used to create a good oil seal.**

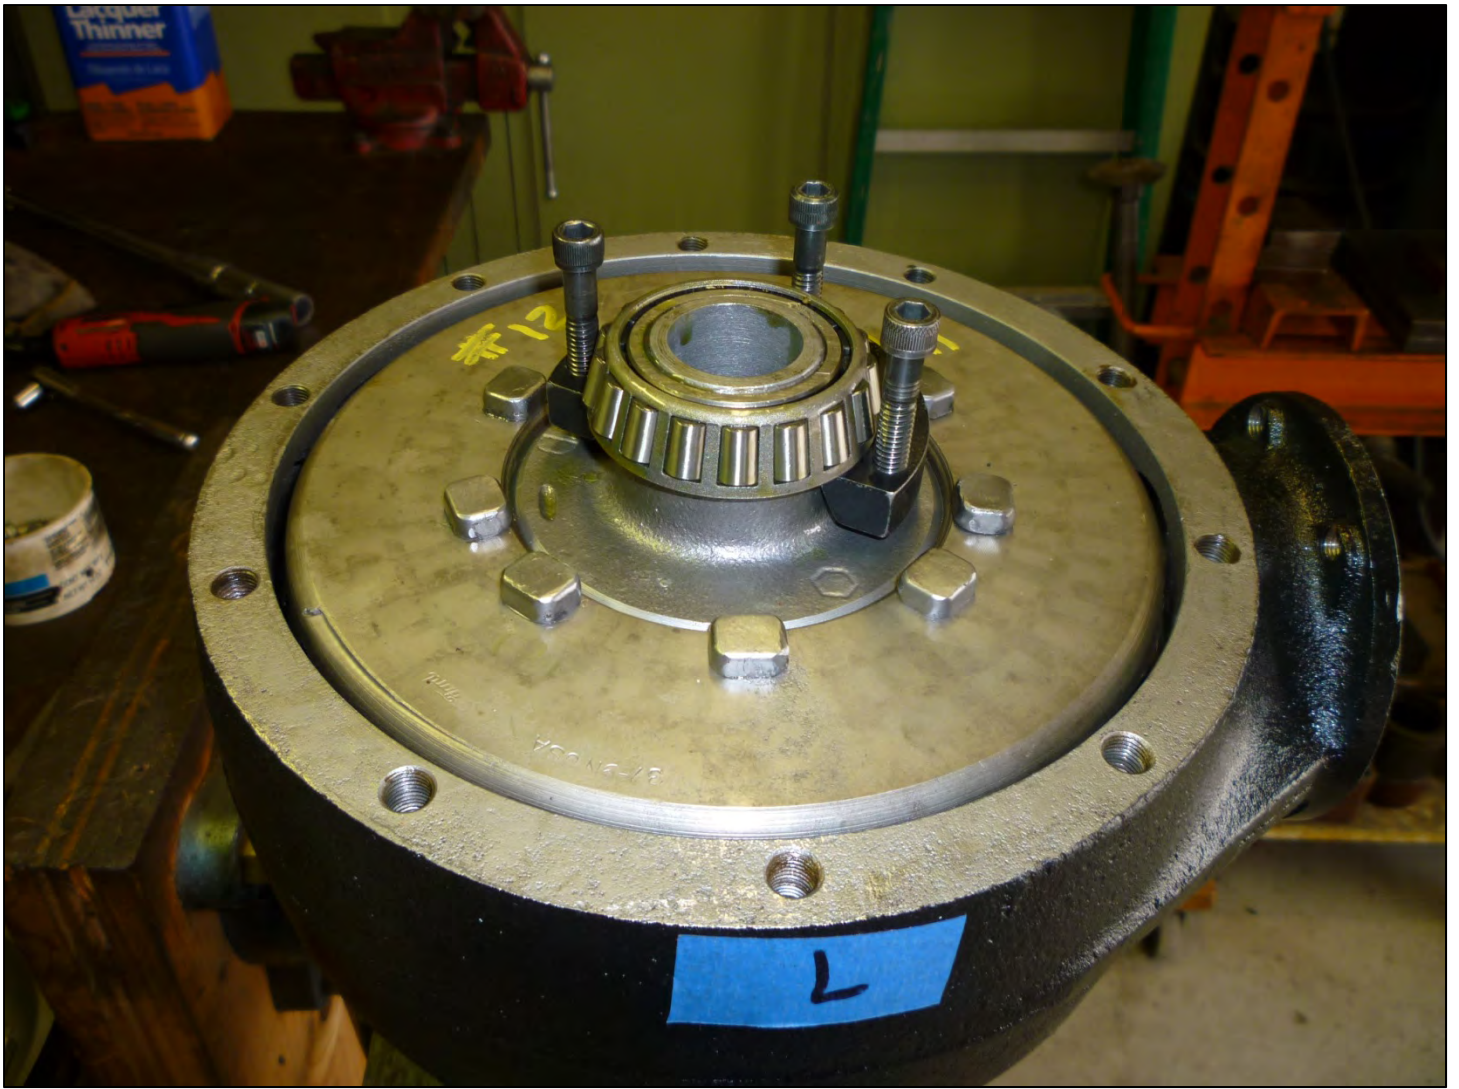
**The left carrier bearing is being removed from the carrier hub using a specially made tool that will grip the underside of the bearing and remove it without damaging the skirt.**

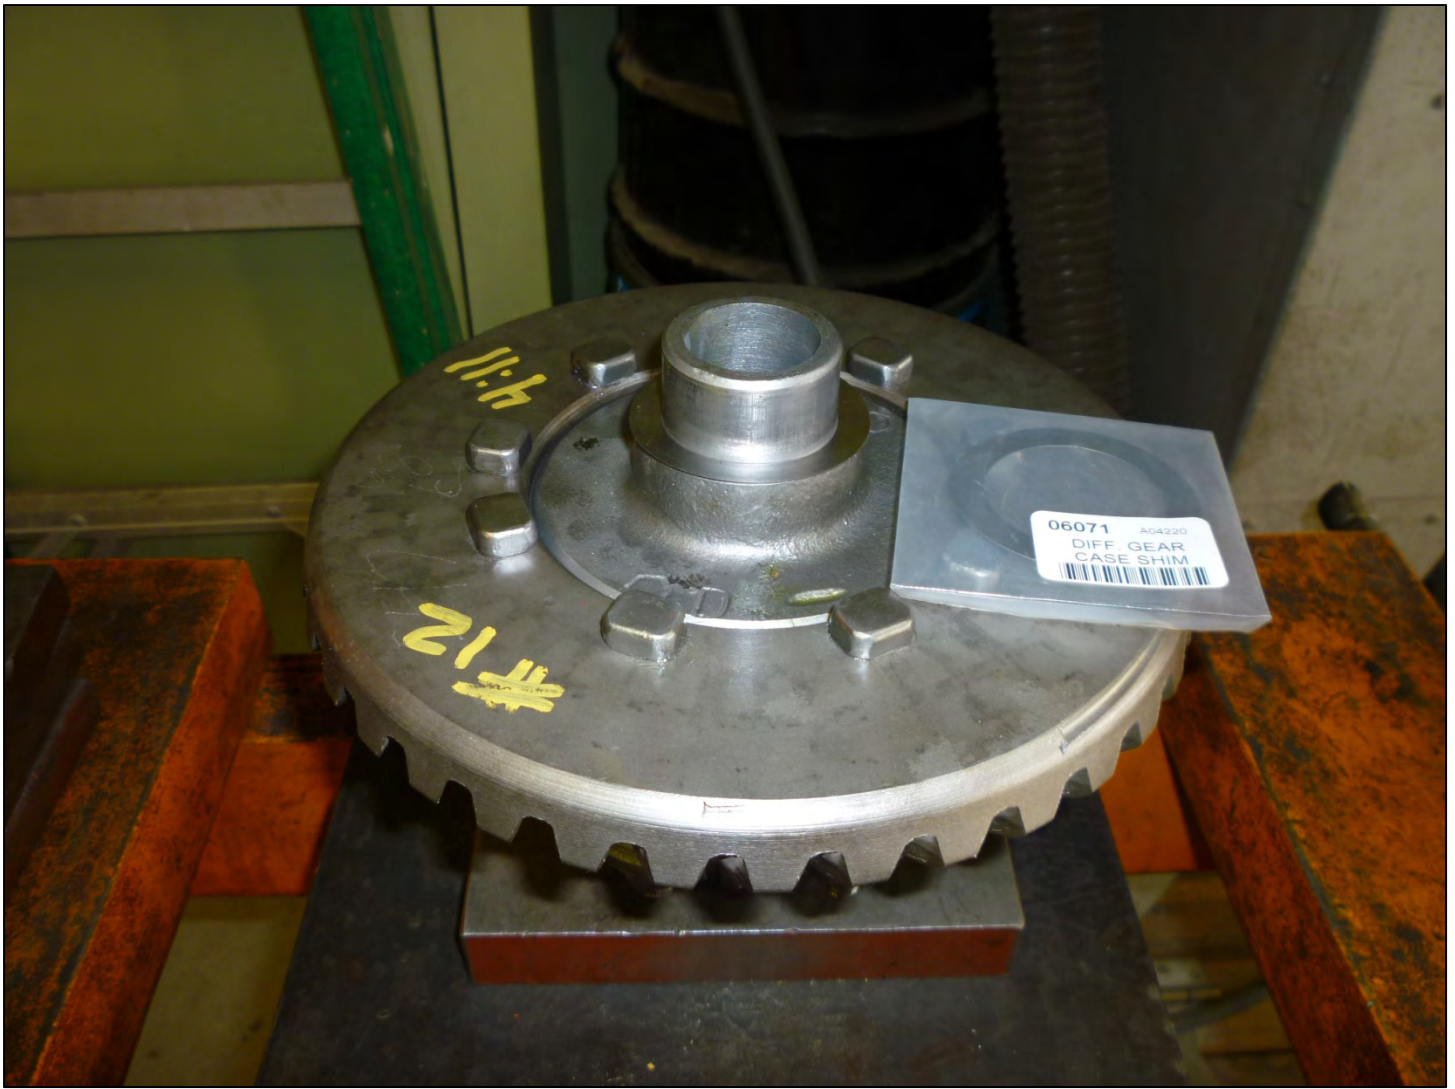
**The carrier assembly is placed on a press with a .005 metal shim installed on the bearing hub on the left side of the carrier. Shims can be purchased from Bratton's. Each is .005 thick. Shims can be stacked if additional shimming is needed.**

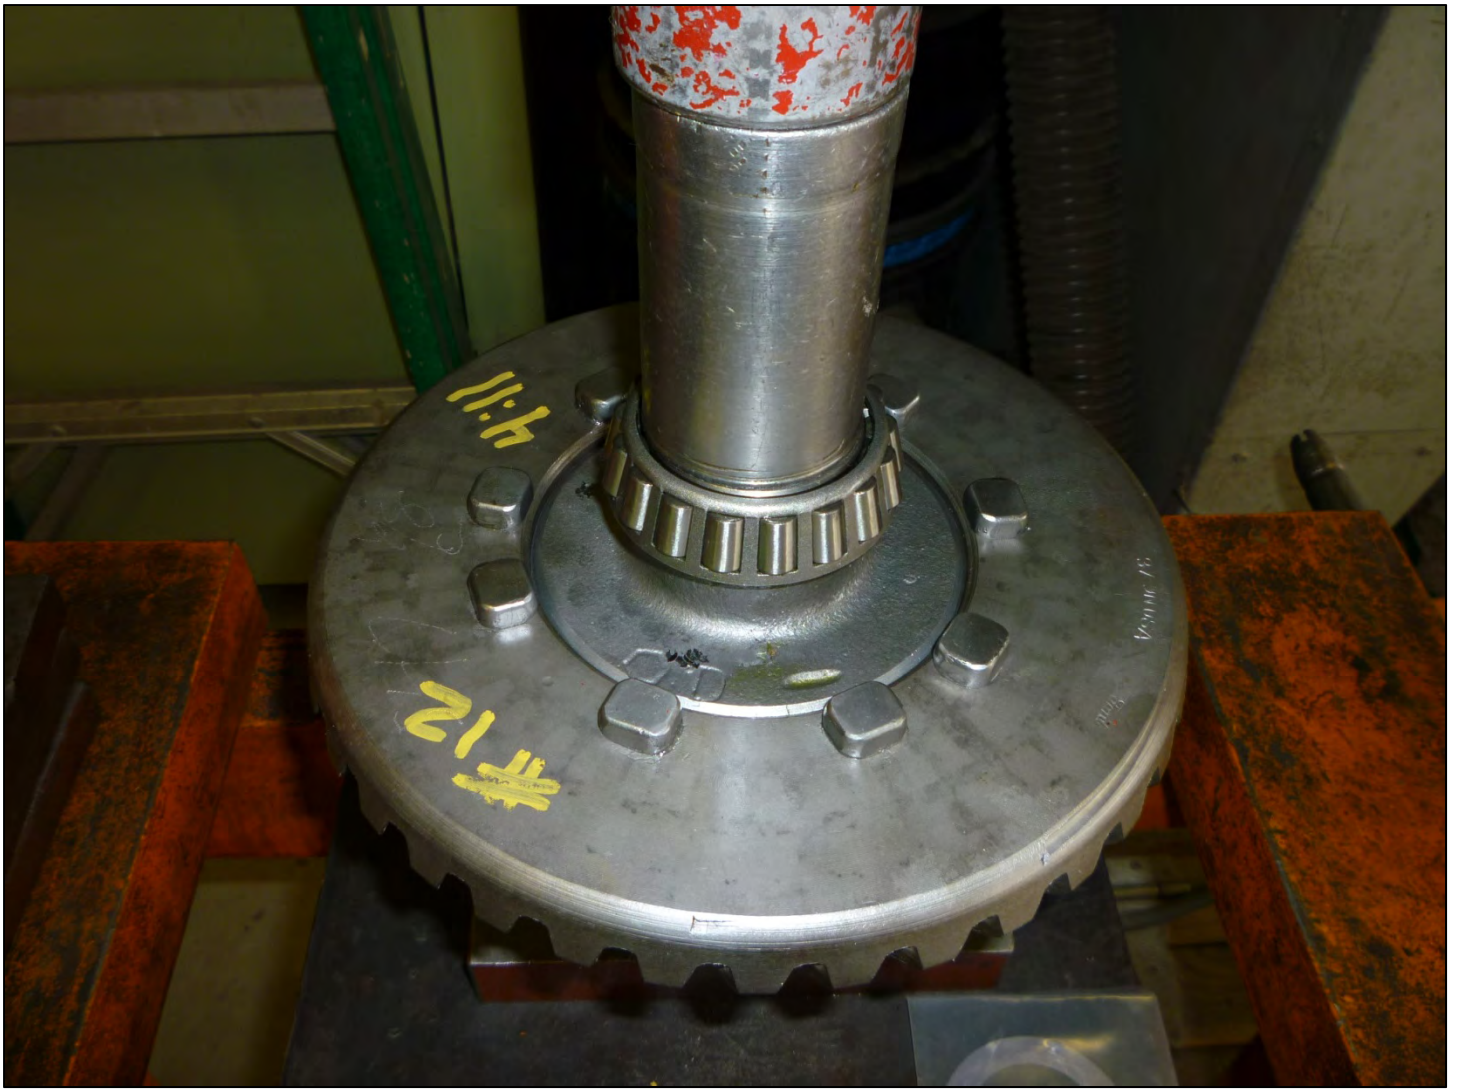
**The carrier bearing for the left side is pressed back onto the hub with a .005 metal shim under it.**
