# Rear Axle Assembly Rebuild Pictorial 2015

by Tom Endy

The following series of photos were taken during the rebuild of a Model A rear axle assembly.

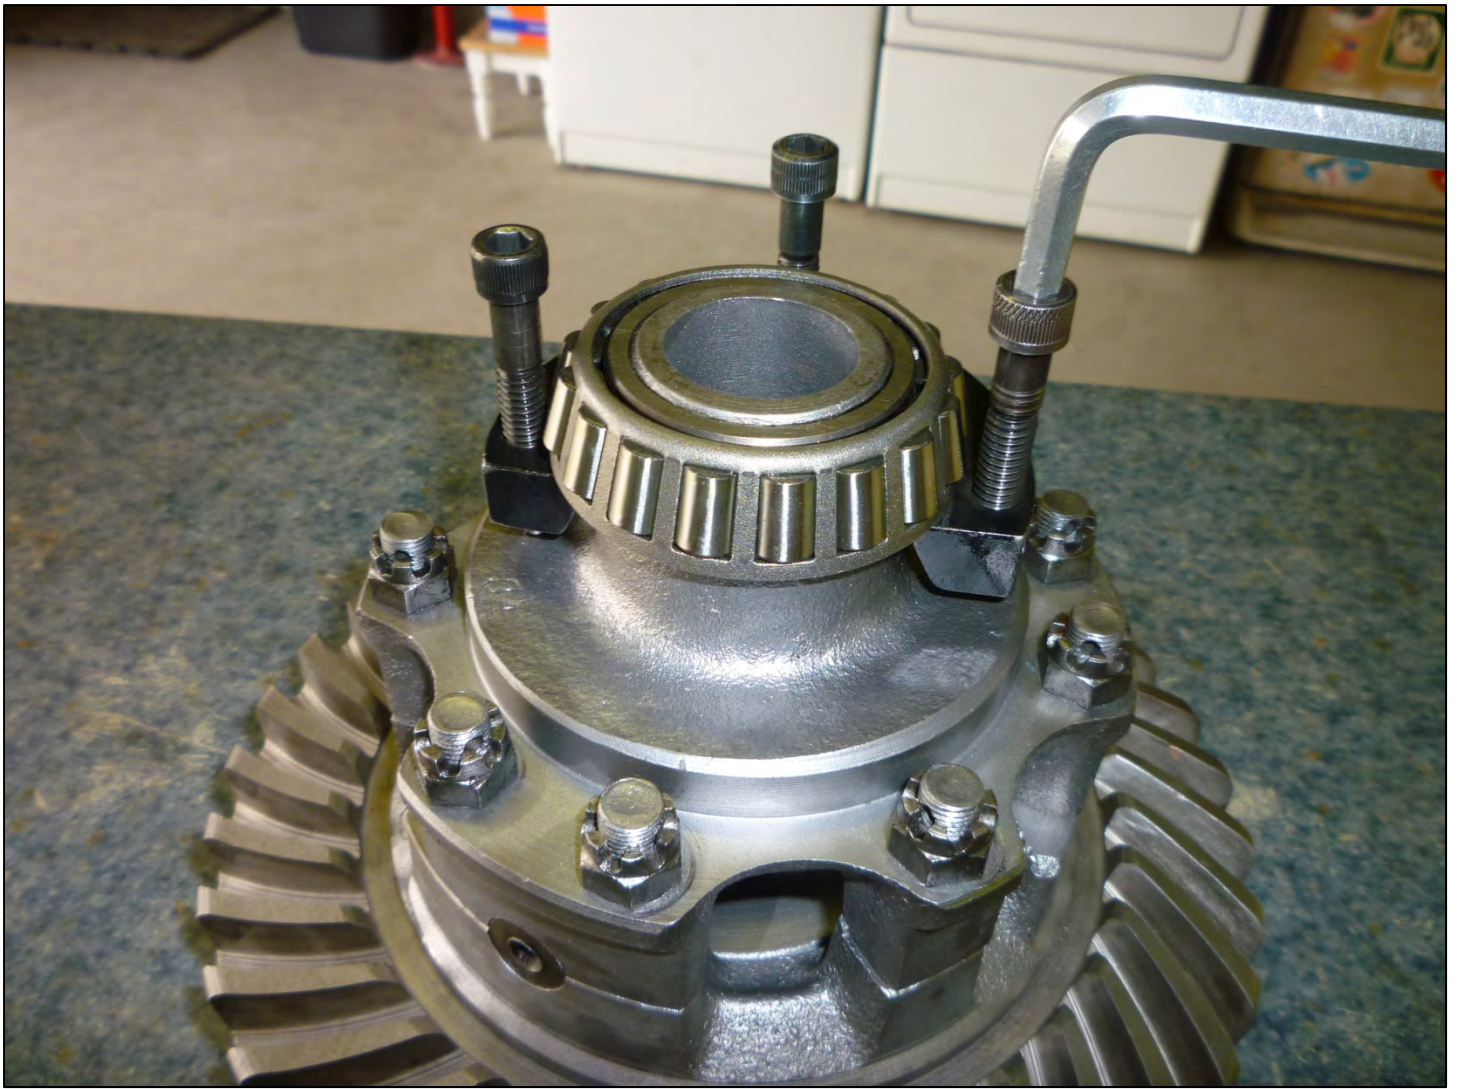
**The carrier bearing on the right side is removed using the same special bearing removal tool.**

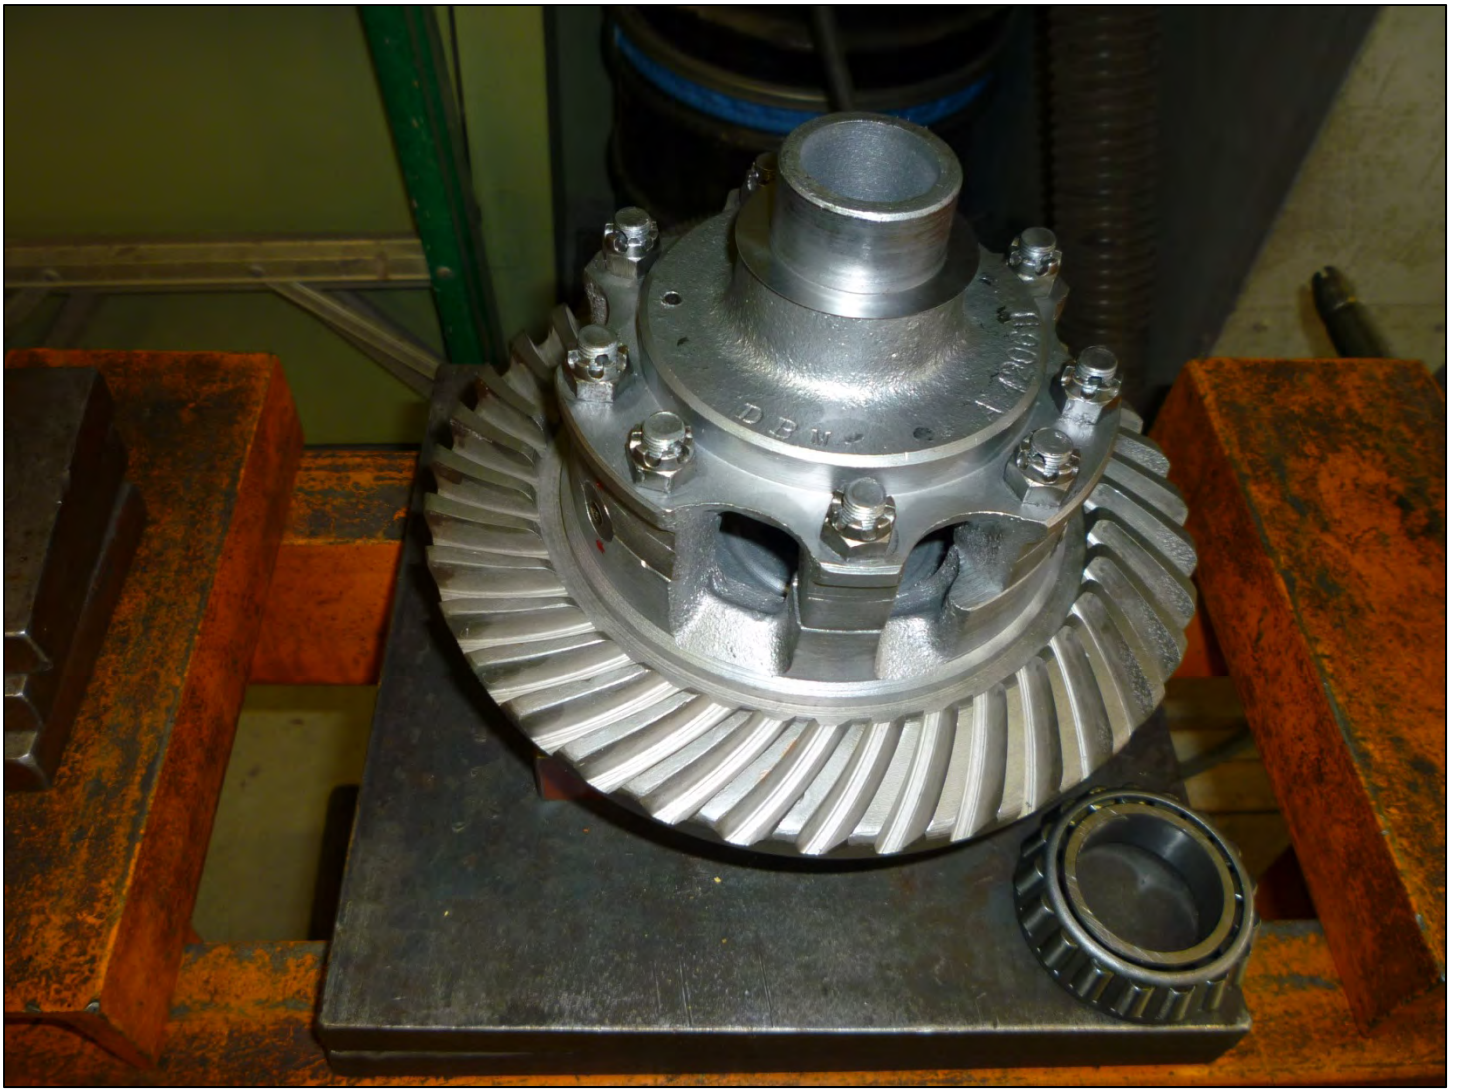
**The carrier is placed back on the press and a .005 metal shim installed under the bearing.**

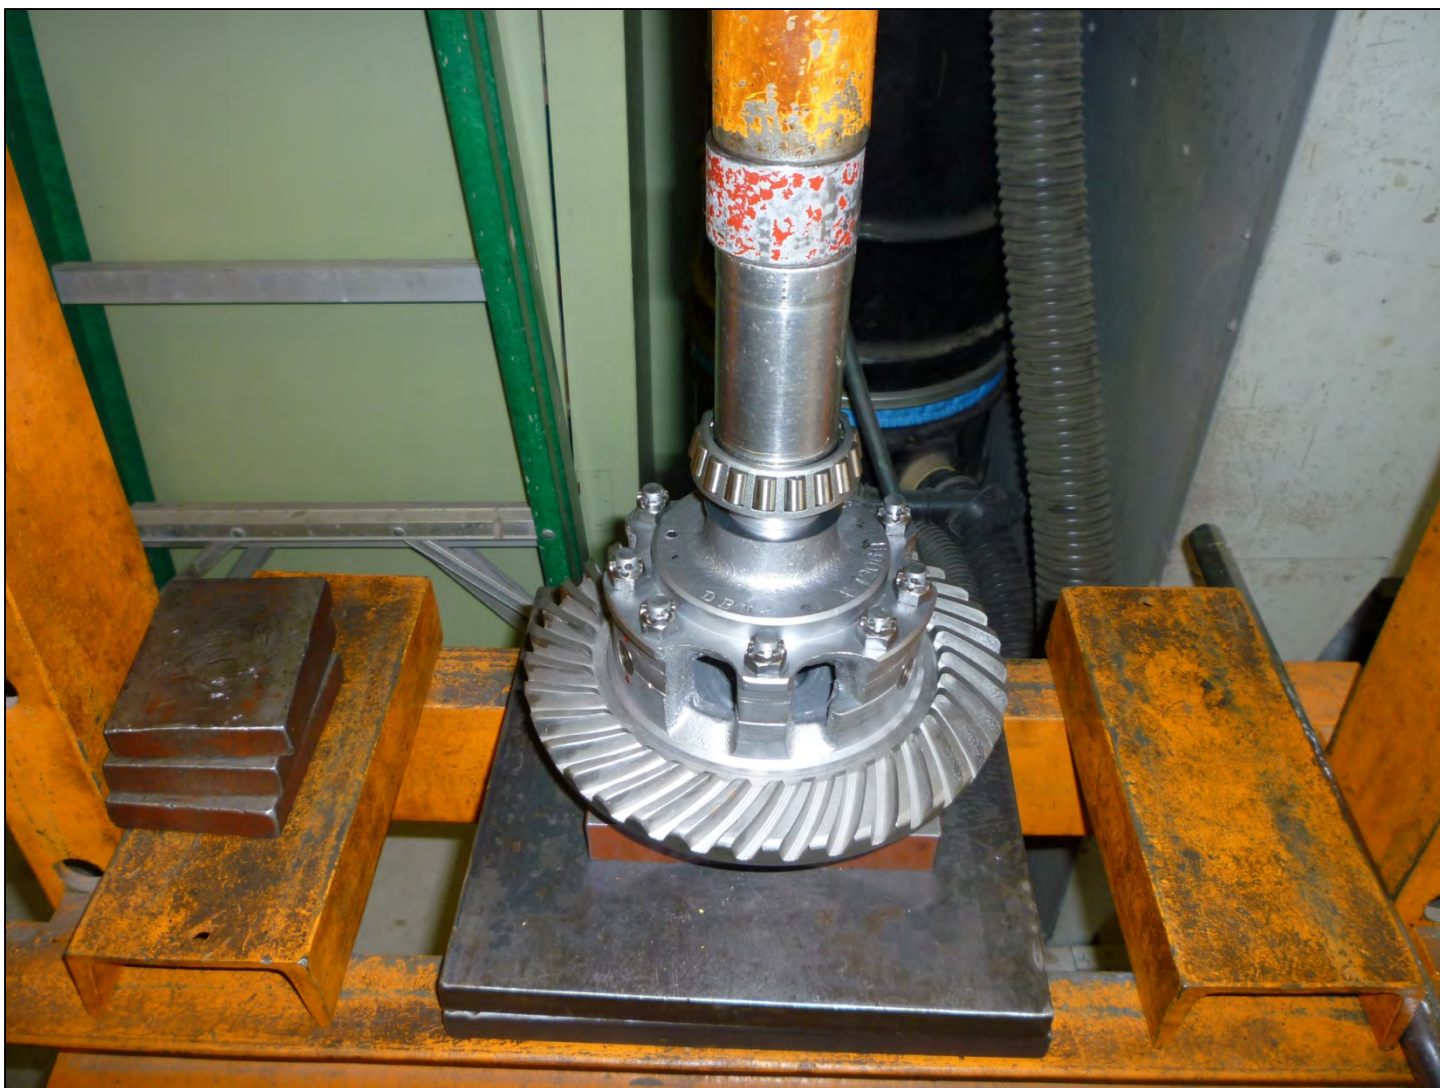
**The carrier bearing for the right side is pressed back on with a .005 metal shim under it. The carrier is then installed back into the banjo and the right axle housing as before. The left axle housing is reinstalled with the same two .010 paper banjo gaskets.**

**When all was back together the ring gear was again rotated by finger and it was found that the ring gear by feel was hard to rotate which indicated it had too much pre-load on it.**

**The left axle housing was once again removed and a .006 paper banjo gasket was added to the two .010 paper banjo gaskets.**

**The left axle housing was once again reinstalled and torqued down. The ring gear was rotated by finger and this time the pre-load by feel seemed to be reasonably close to the desired 20 in. lbs.**

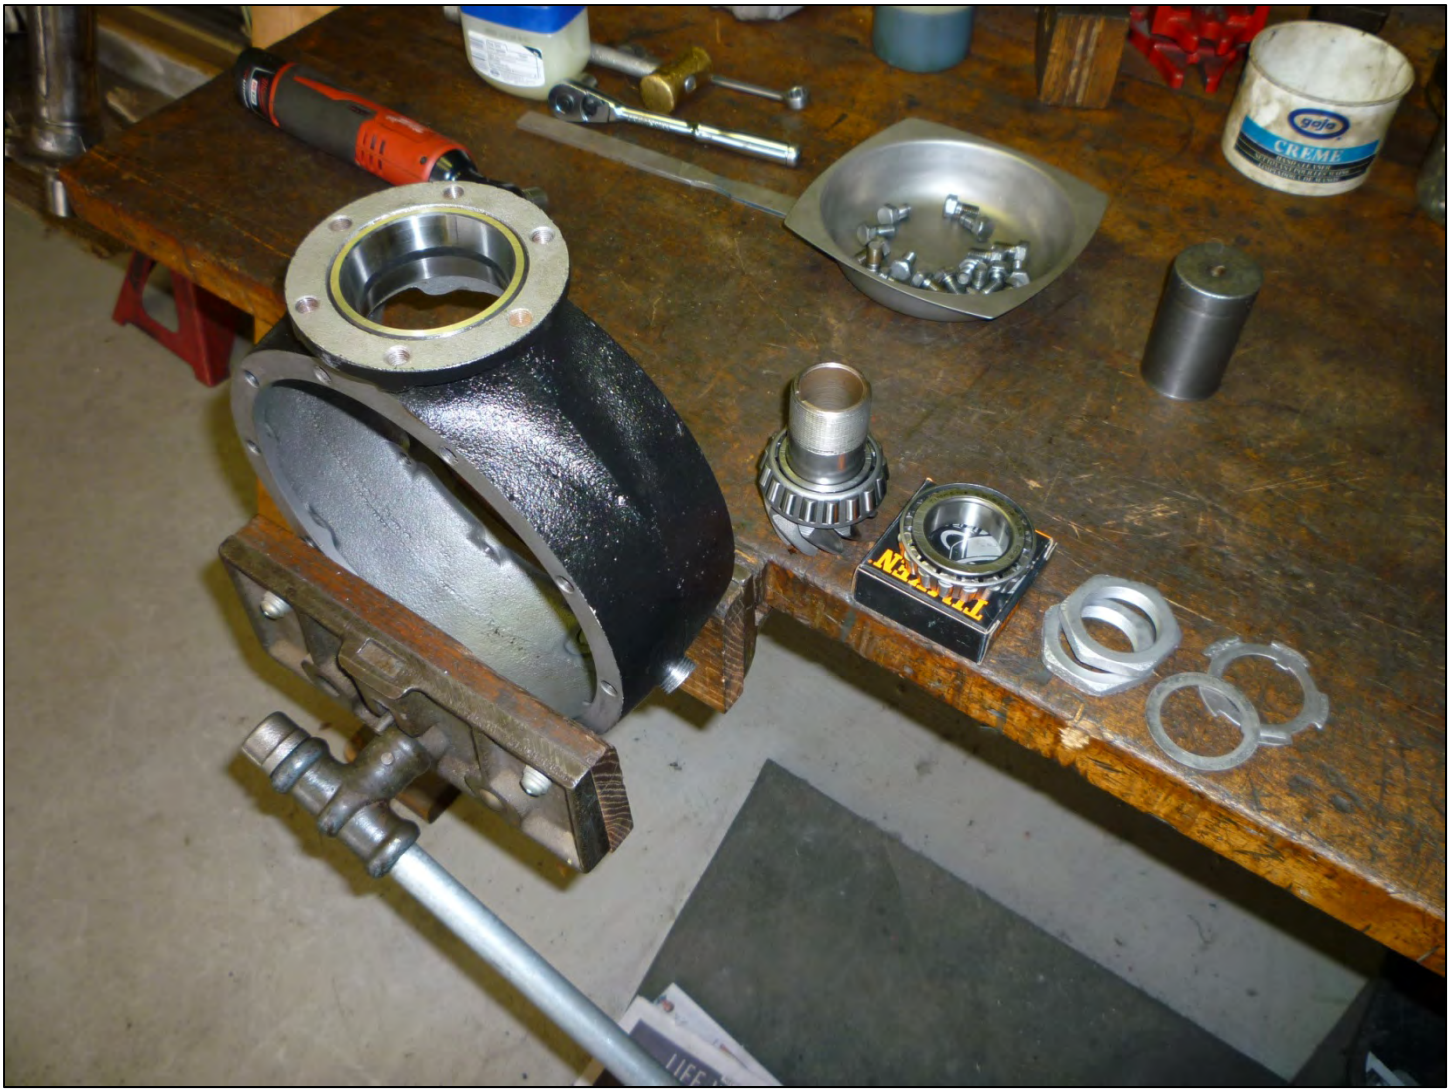
**The next effort is to install the pinion gear assembly in the banjo and set the pre-load on the two pinion bearings.**

**In the photo the pinion gear assembly is ready to install in the banjo. It is best to use an original locking washer as some of the reproductions are made incorrectly and they will rub the inside of the torque tube and create noise unless all the ears are bent over. Flatten it out under a press and reuse it.**

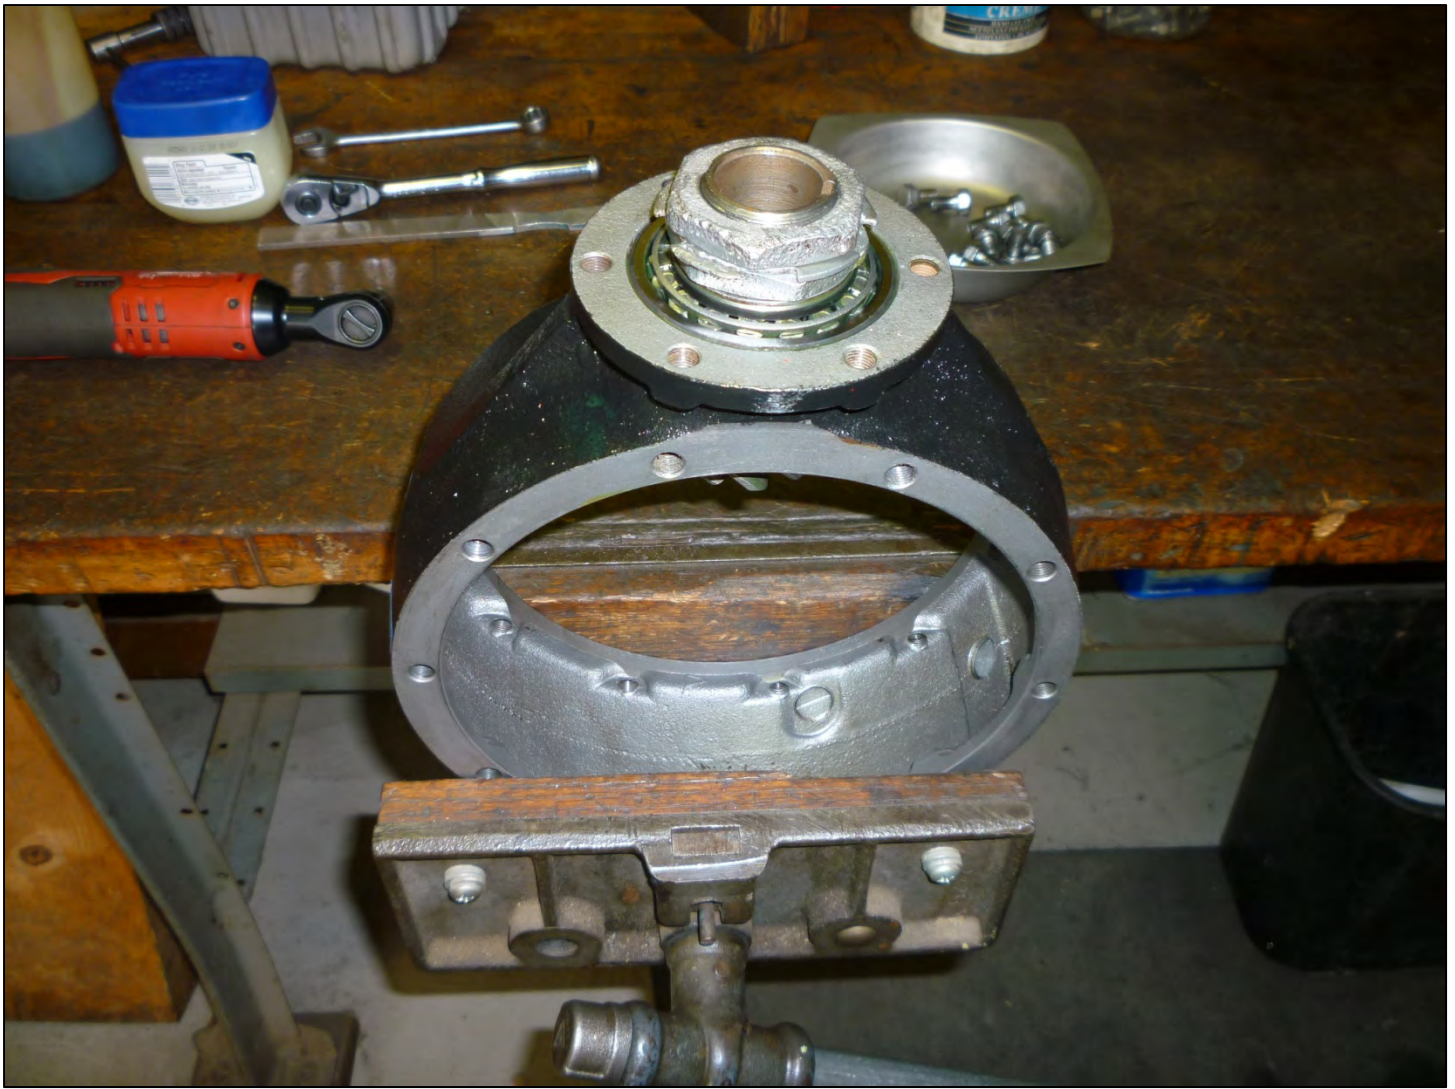
**The pinion assembly has been installed. The second pinion bearing installed with ease and has the ability to move back and forth with little effort to facilitate the pre-load adjustment. The next step will be to rotate the banjo in the vice to a horizontal position for the installation of the drive shaft and torquing of the shaft nut down to a nominal 100 ft. lbs. before attempting to set the pre-load on the pinion bearings.**

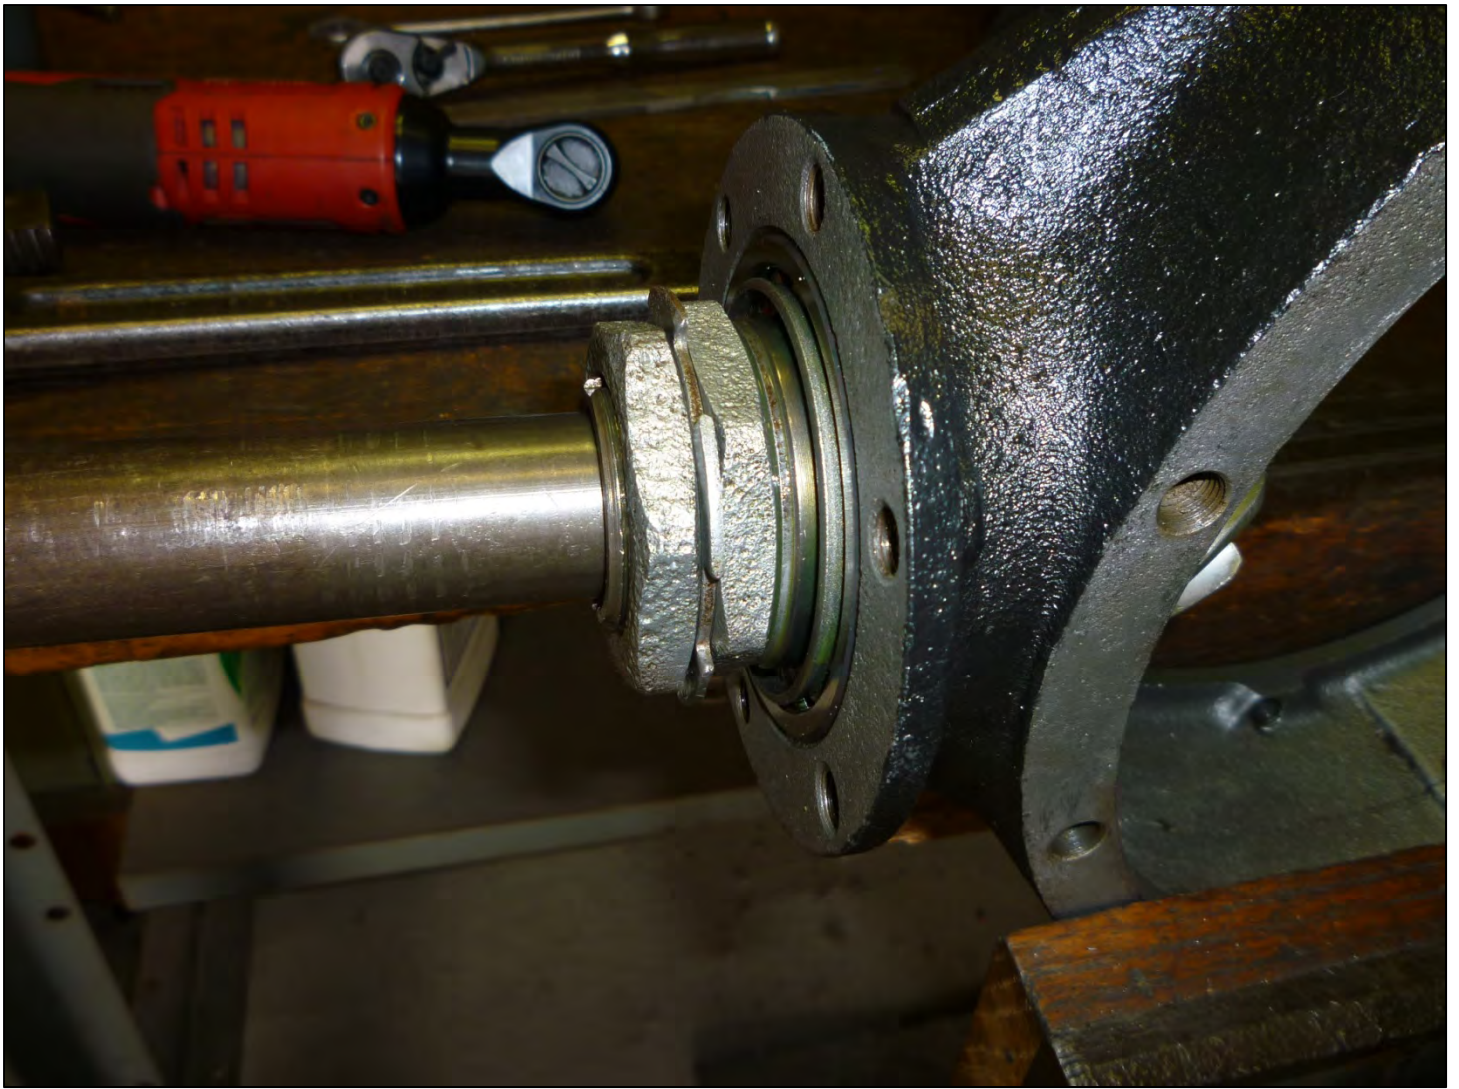
**With the banjo in a horizontal position in a wood vice the drive shaft with locking key is inserted into the pinion gear sleeve. I always coat the taper on the drive shaft with anti-seize compound. Note that the two pinion nuts show signs of severe pitting from rust. This is acceptable as long as the flat mating surfaces are smooth. They should also be lubricated during assembly. Quite often you find chisel marks on these nuts where a mechanic of yester year adjusted the pinion bearing pre-load with a hammer and a chisel instead of using the proper wrenches. Both of these nuts have been bead blasted to remove all the rust.**

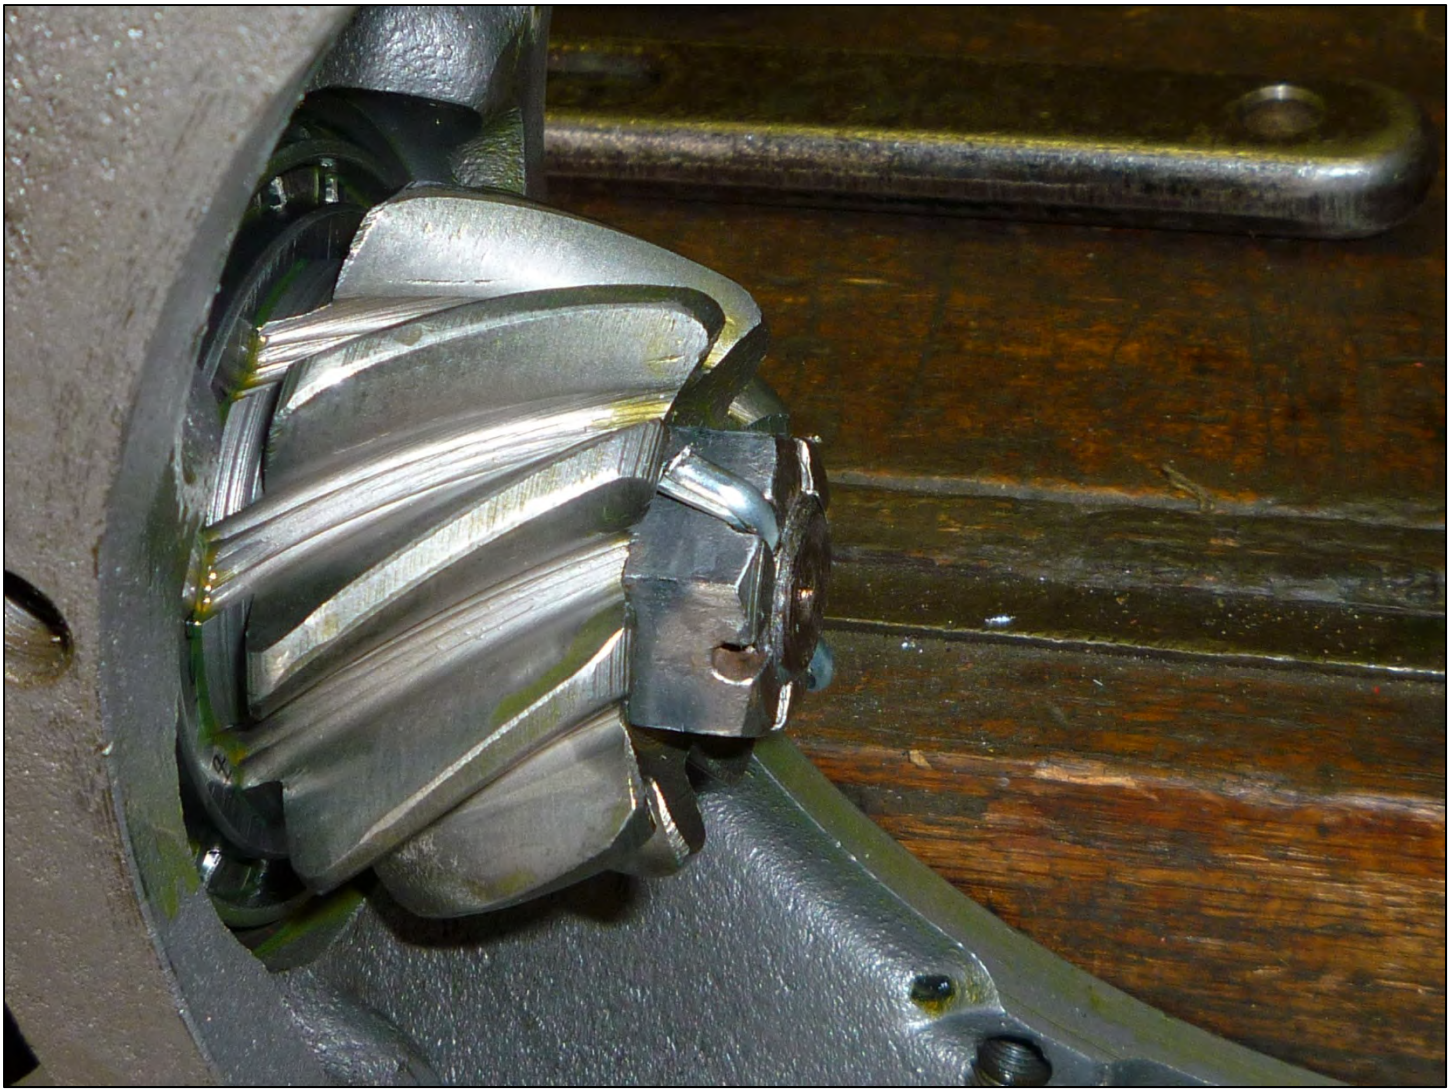
**The nut on the end of the drive shaft is torqued to a nominal 100 ft. lbs. My procedure is to set the torque wrench to 90 ft. lbs., tighten and then look to see where the cotter pin hole is. I then tighten more until the hole is in a window of the castle nut. The end torque value will be between 90 and 120 ft. lbs.**

**The cotter pin is installed as shown with the two cotter legs bent down alongside the nut. Do not bend it over the end of the drive shaft as it may contact the rotating carrier. Care should be taken when installing a cotter pin so that it has a low profile and does not interfere with the gears.**

**Quite often the cotter pin cannot be inserted through the hole in the drive shaft because a mechanic of yester year hammered on the end of the dive shaft in an attempt to remove it and made the hole oblong. When encountering this situation I carefully run a drill bit of the proper size through the hole.**

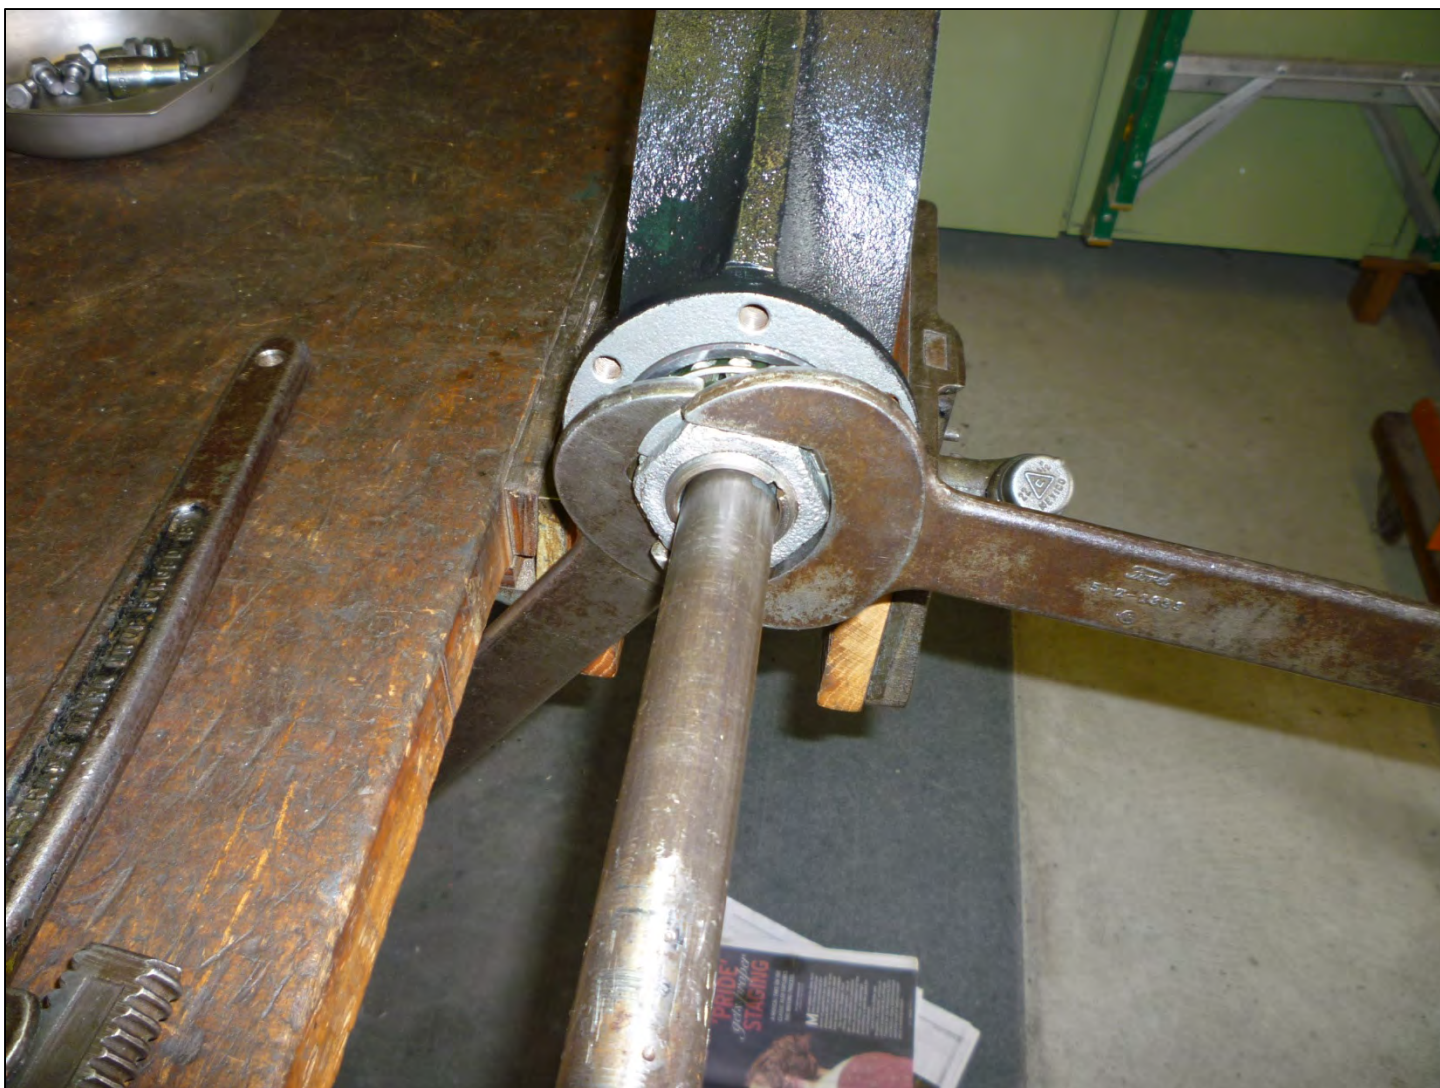
**The next step is to adjust the proper pre-load on the two pinion bearings. The pre-load should be set to the same value as the carrier bearings, a nominal 20 ft. lbs. The photos show Ford factory wrenches being used to turn the two nuts. The wrench on the left is locked against the bottom of the work bench. The wrench on right is turned by hand to tighten. The other hand is used to hold the drive shaft stationary with a pipe wrench.**

**Most literature instructs to tighten the first nut such to obtain the 20 in. lbs. of pre-load and then tighten the second nut down to lock the first in place.**

**It does not work quite like that. If you tighten the first nut down to the full pre-load, when the second nut is tightened it will increase the pre-load past the desired value. My method is to adjust to about half the pre-load, then tighten the second nut down.**

**The end result is you want the pre-load set to the proper value and both nuts extremely tight. Ford recommends you actually hammer on the Ford factory wrenches to get them extremely tight. This is a tedious and time consuming task, but it must be done correctly.**

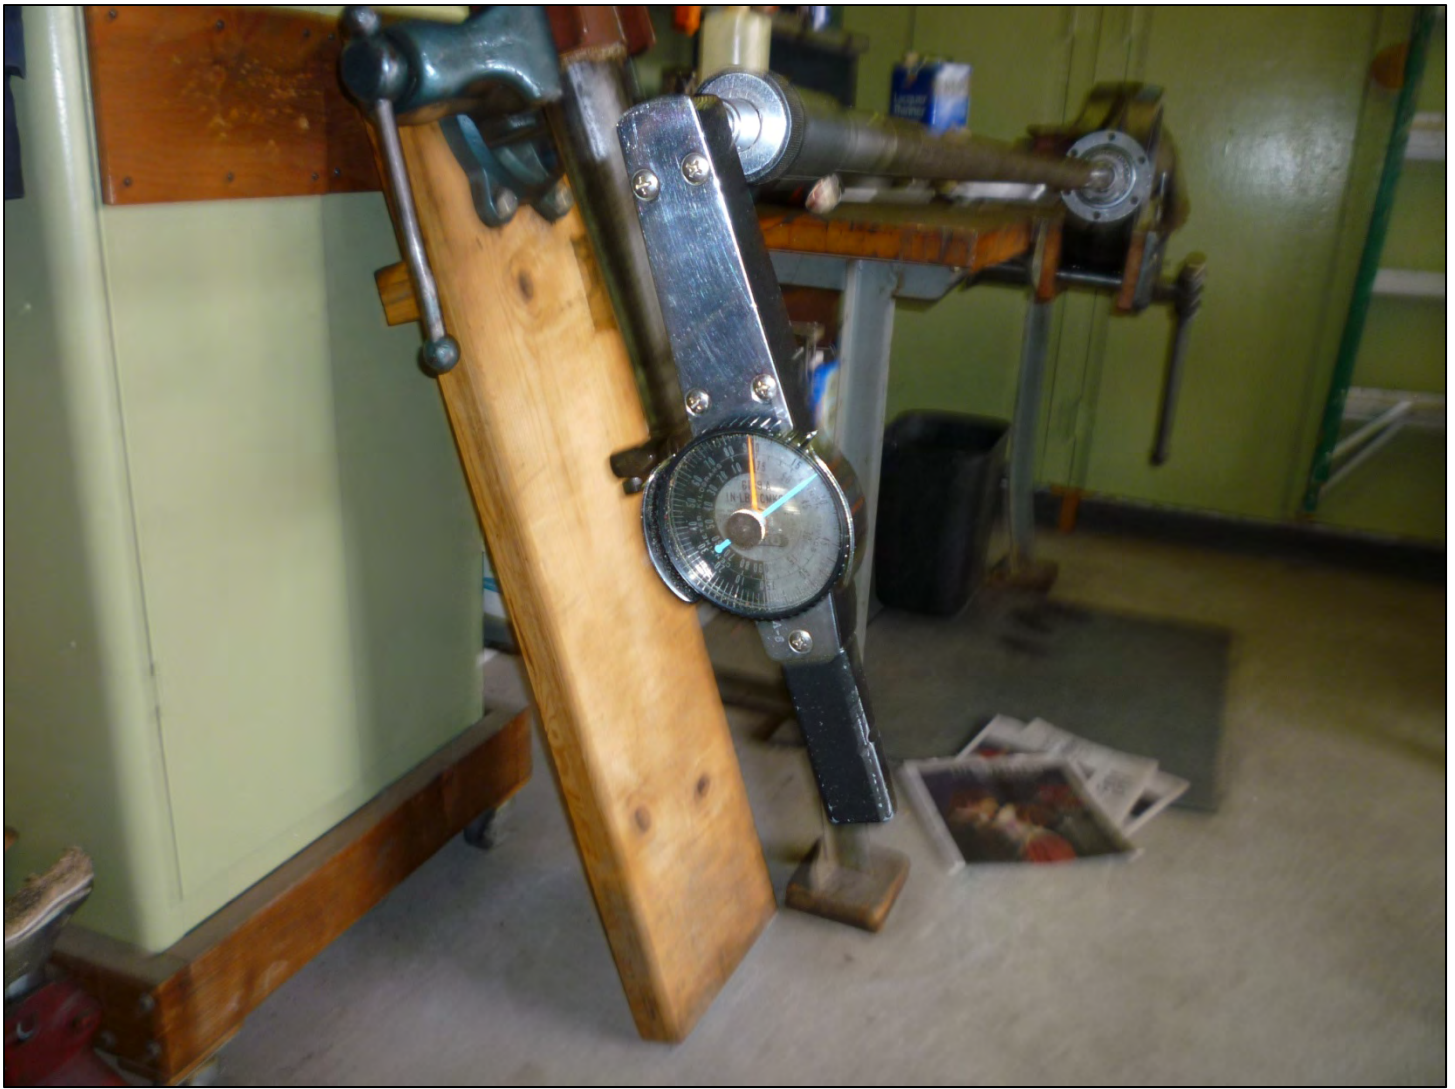
**The pinion pre-load is read from a dial indicator inch pound torque wrench. A one and a sixteenth inch six point deep socket will fit directly onto the spline end of a Model A drive shaft. The photo shows the socket in place and being turned with the dial indicator torque wrench.**

**When making the pinion pre-load adjustment it is often necessary to loosen the two nuts and start over again. For this reason the back, or second pinion bearing, must have the ability to be repositioned with little effort. If it is on with a press fit it makes the task difficult if not impossible. This is the reason original pinion gear sleeves have two dimensions on the sleeve with a difference of .0015. Not all reproduction pinion gear sleeves are machined correctly. Some have the sleeve machined to one dimension (a press fit for both). These will definitely cause you grief.**

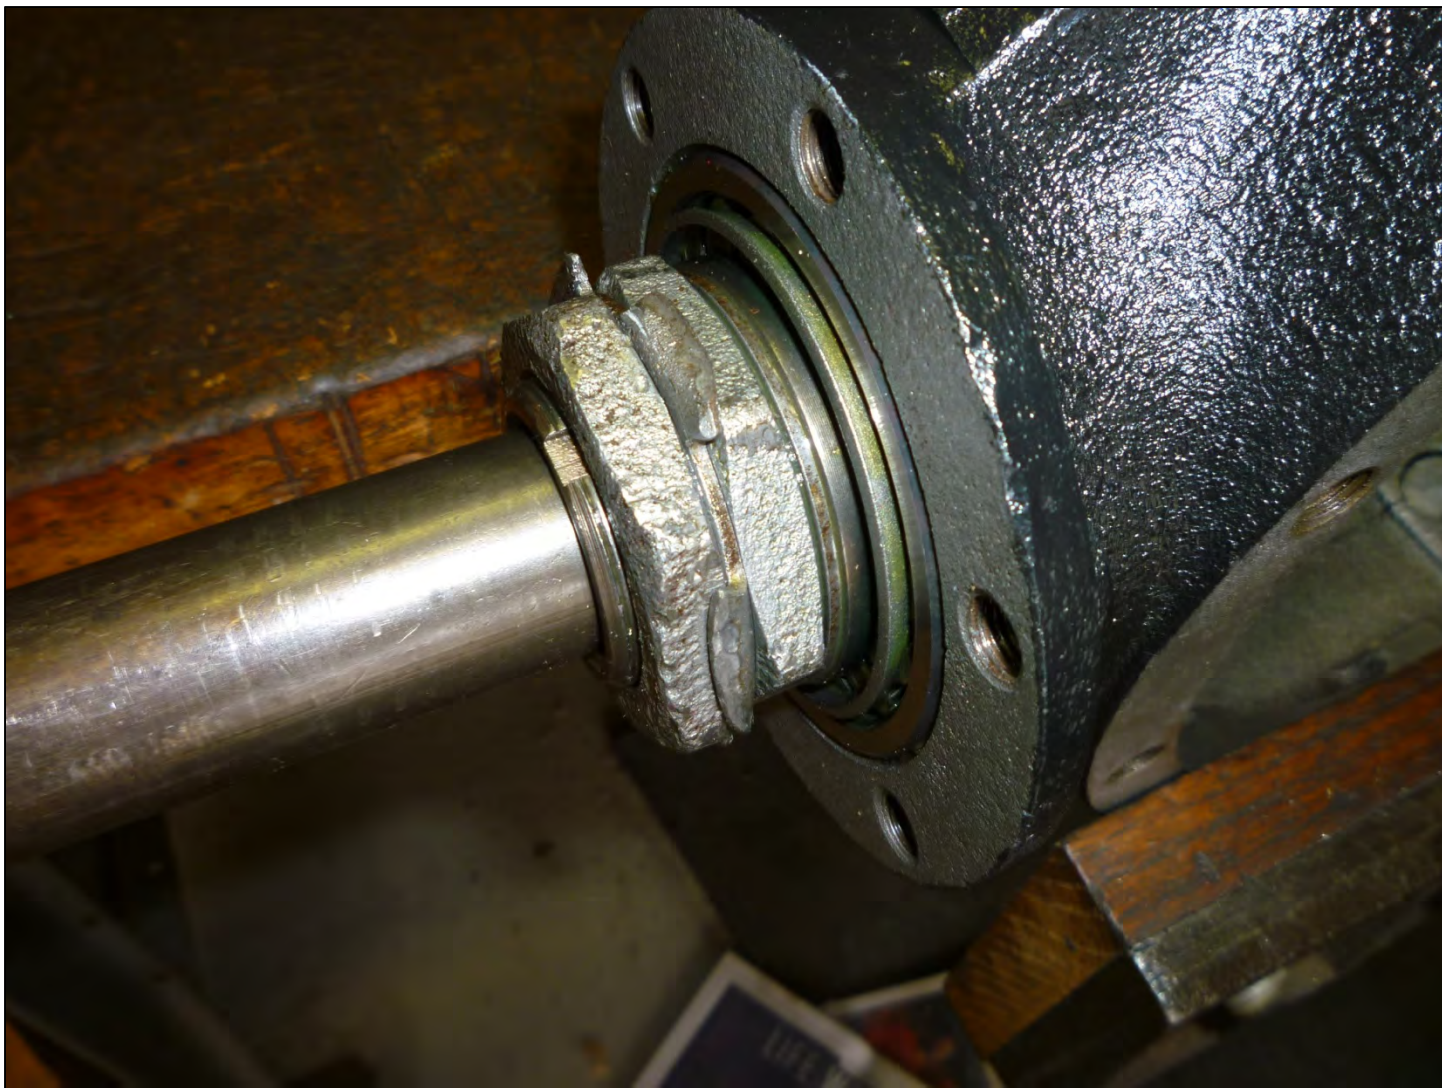
**Once the pre-load adjustment has been achieved and both nuts are tight against each other two of the locking washer ears are bent over to lock the nuts in place. One is bent forward, the other is bent aft. The photo shows the two ears bent over.**

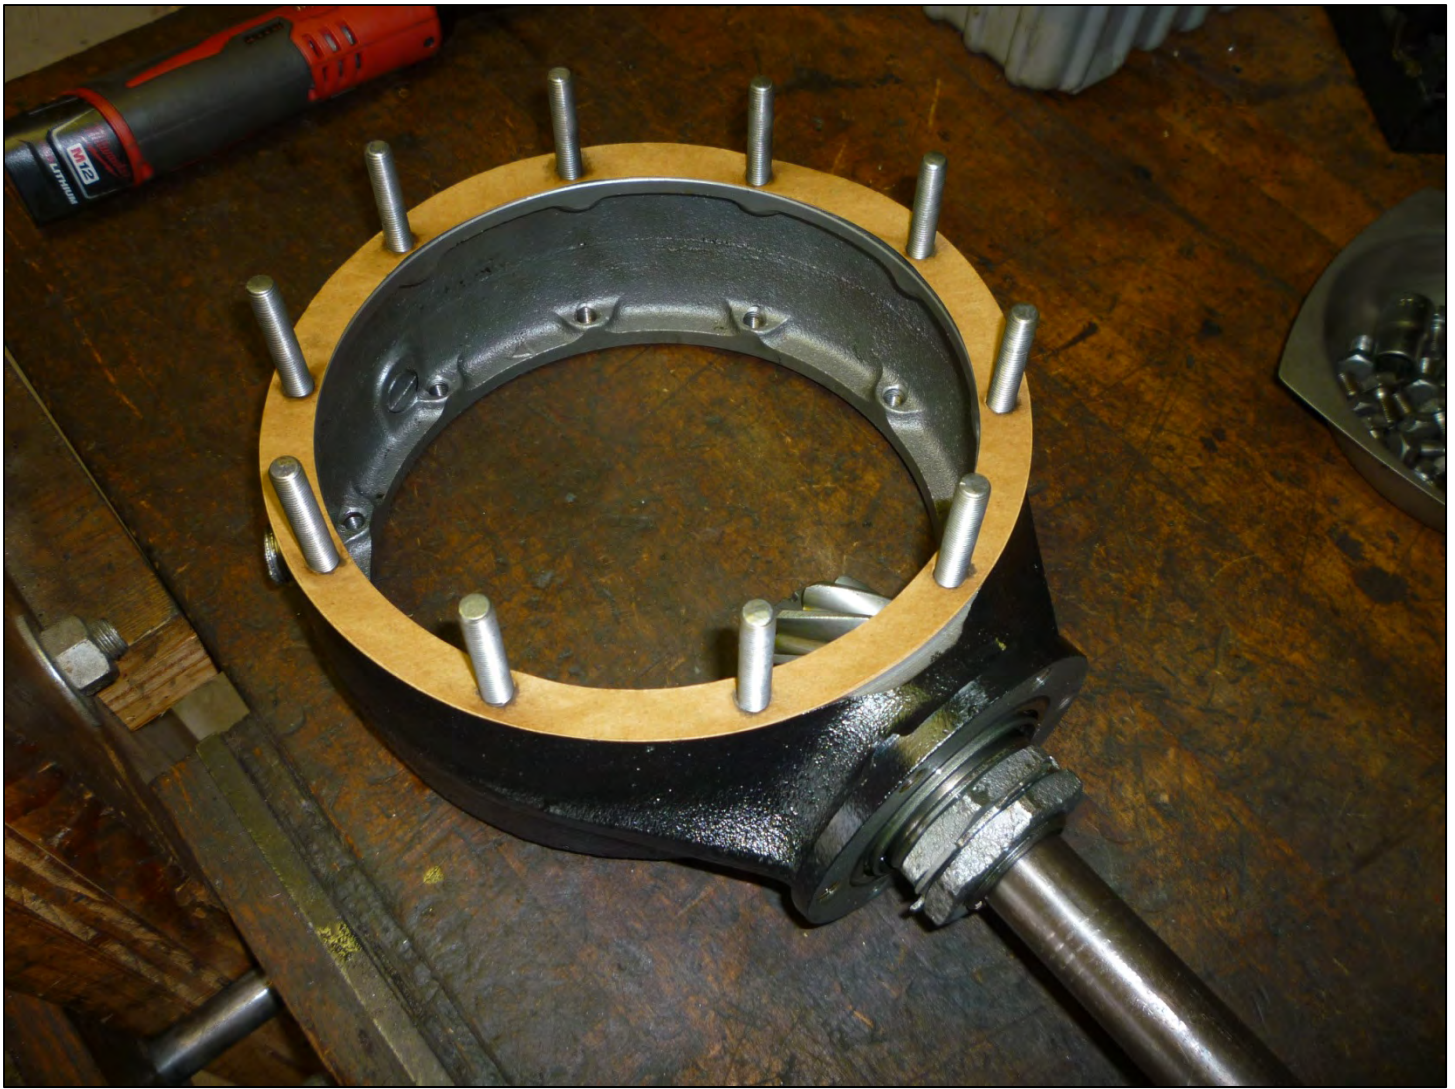
**The next step is to establish the backlash by reassembling both axle housings onto the banjo with an educated guess as to which side to install the previously selected banjo gaskets.**

**In this particular rebuild it was determined that carrier pre-load was established by installing a .005 metal shim under each carrier bearing and adding two .010 gaskets and one .006 gasket to the left side of the banjo.**

**The photo shows gaskets being installed on the right side of the banjo using the threaded studs. One .010 and one .006 gasket was installed. Since in this case the only choice was which side of the banjo the .006 gasket would be installed on, the choice was to install it on the right side to minimize the backlash.**

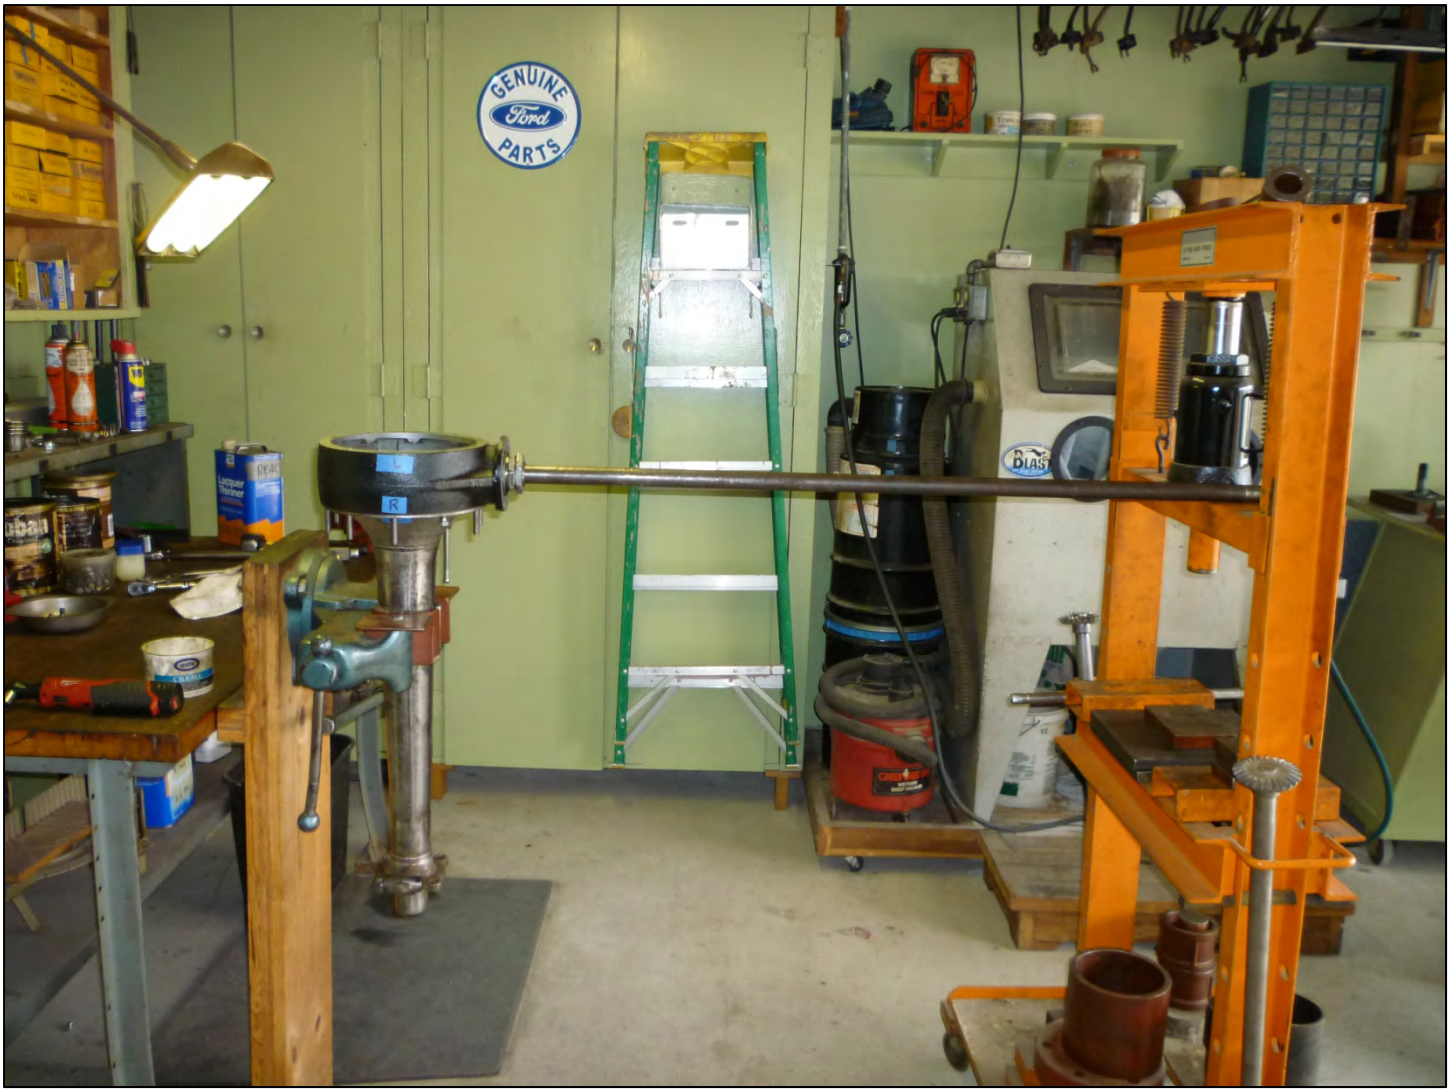
**The banjo with the drive shaft and pinion gear assembly installed it set on top of the right axle housing with the front end supported by a shop press.**

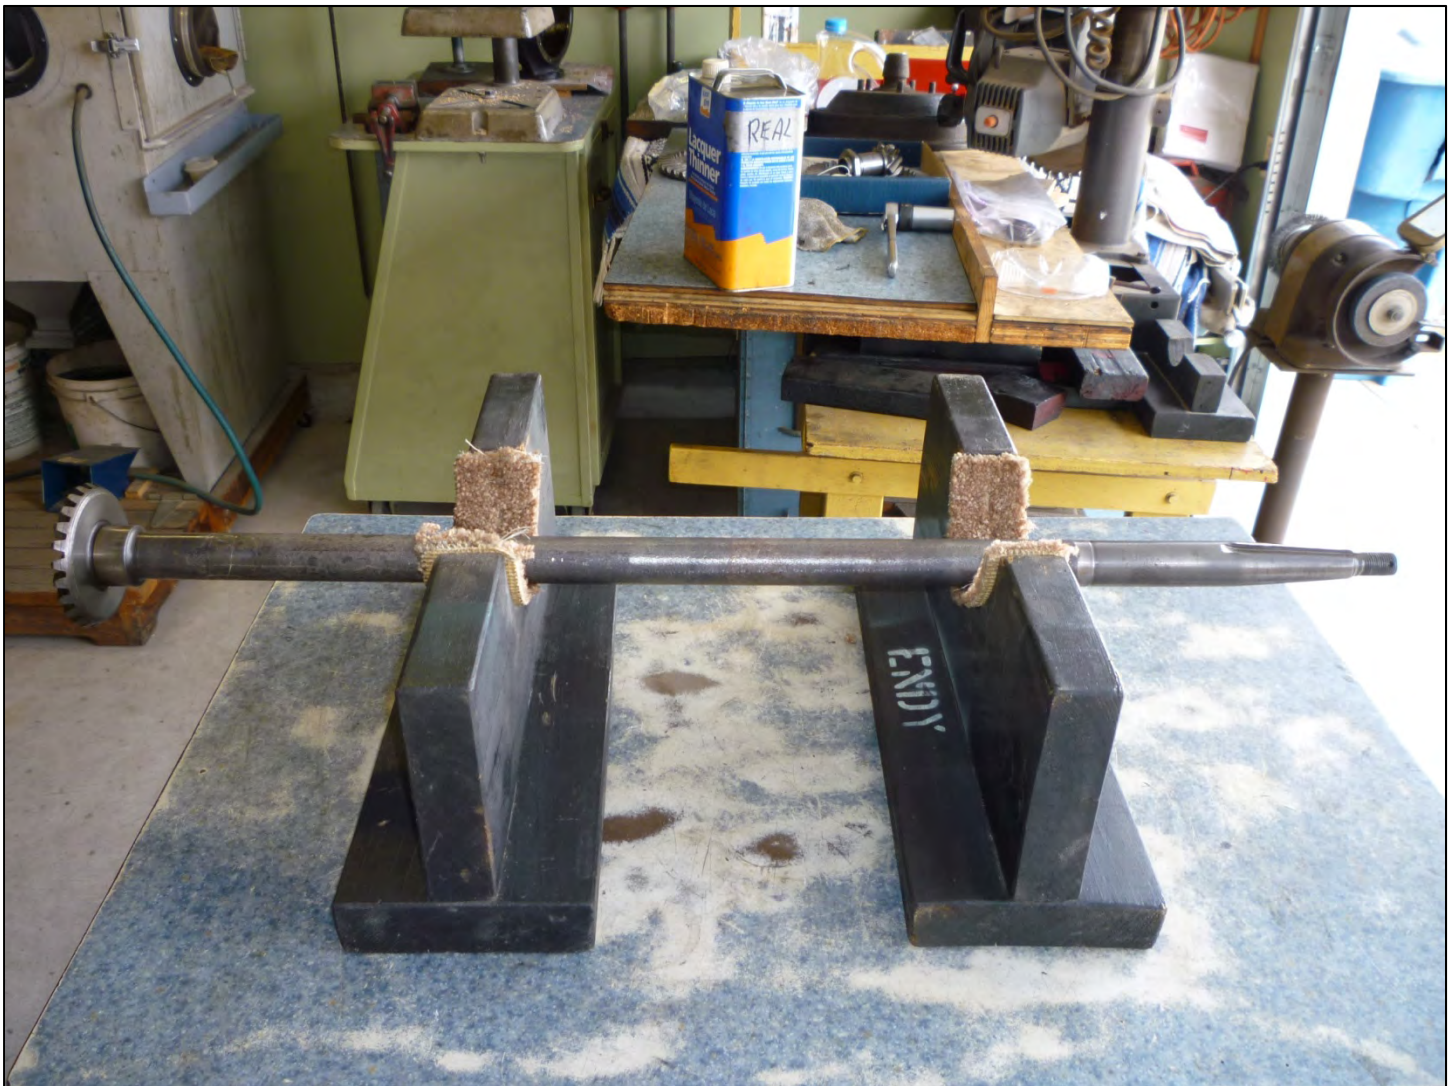
**With both the carrier and pinion pre-loads determined and the backlash determined, the next effort is to prepare for the final assembly. The axle housings are once more disassembled.**
