# Rear Axle Assembly Rebuild Pictorial 2015

by Tom Endy

The following series of photos were taken during the rebuild of a Model A rear axle assembly.

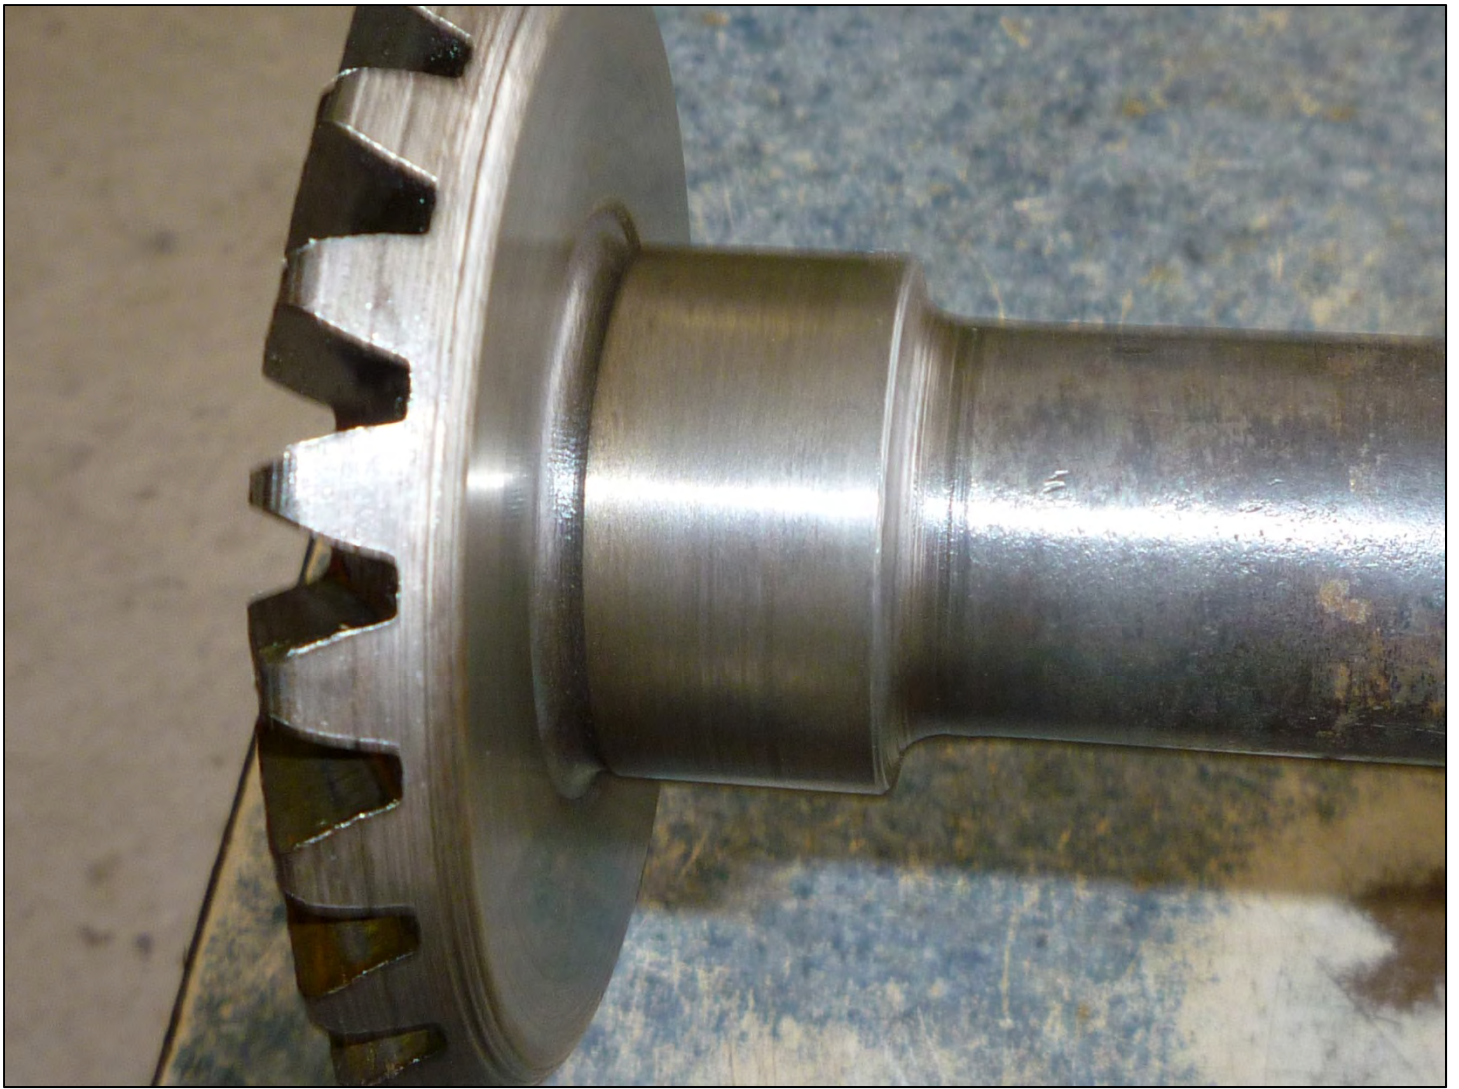
**The two axle shafts are cleaned and inspected. Particular attention should be paid to the key slot and the threads. The gear end is not critical as long as teeth are not broken off or hopelessly pitted by heavy rust.**

**The key slot should be inspected for a crack at the inboard end. A crack will usually start in this area and eventually work its way around the circumference of the axle shaft, and then break off. The key slot should also be inspected for wallowing. This is caused when the axle nut was not torqued down to a nominal 100 ft. lbs. This allows movement of the brake drum against the locking key and in time will wallow out the slot. Some repair can be made by placing the axle on an anvil and with a heavy hammer pound the edges of the key slot back. An axle shaft with an excessively wallowed key slot should be discarded in favor of a better one.**

**Check the threads carefully. If they appear somewhat compromised a dye can be run over them. However, excessively damaged threads are cause for rejection of the axle shaft.**

**The axle shaft should be wire wheeled or bead blasted if rusted. The gear end of the axle shaft should be in good shape where it rides inside the carrier.**

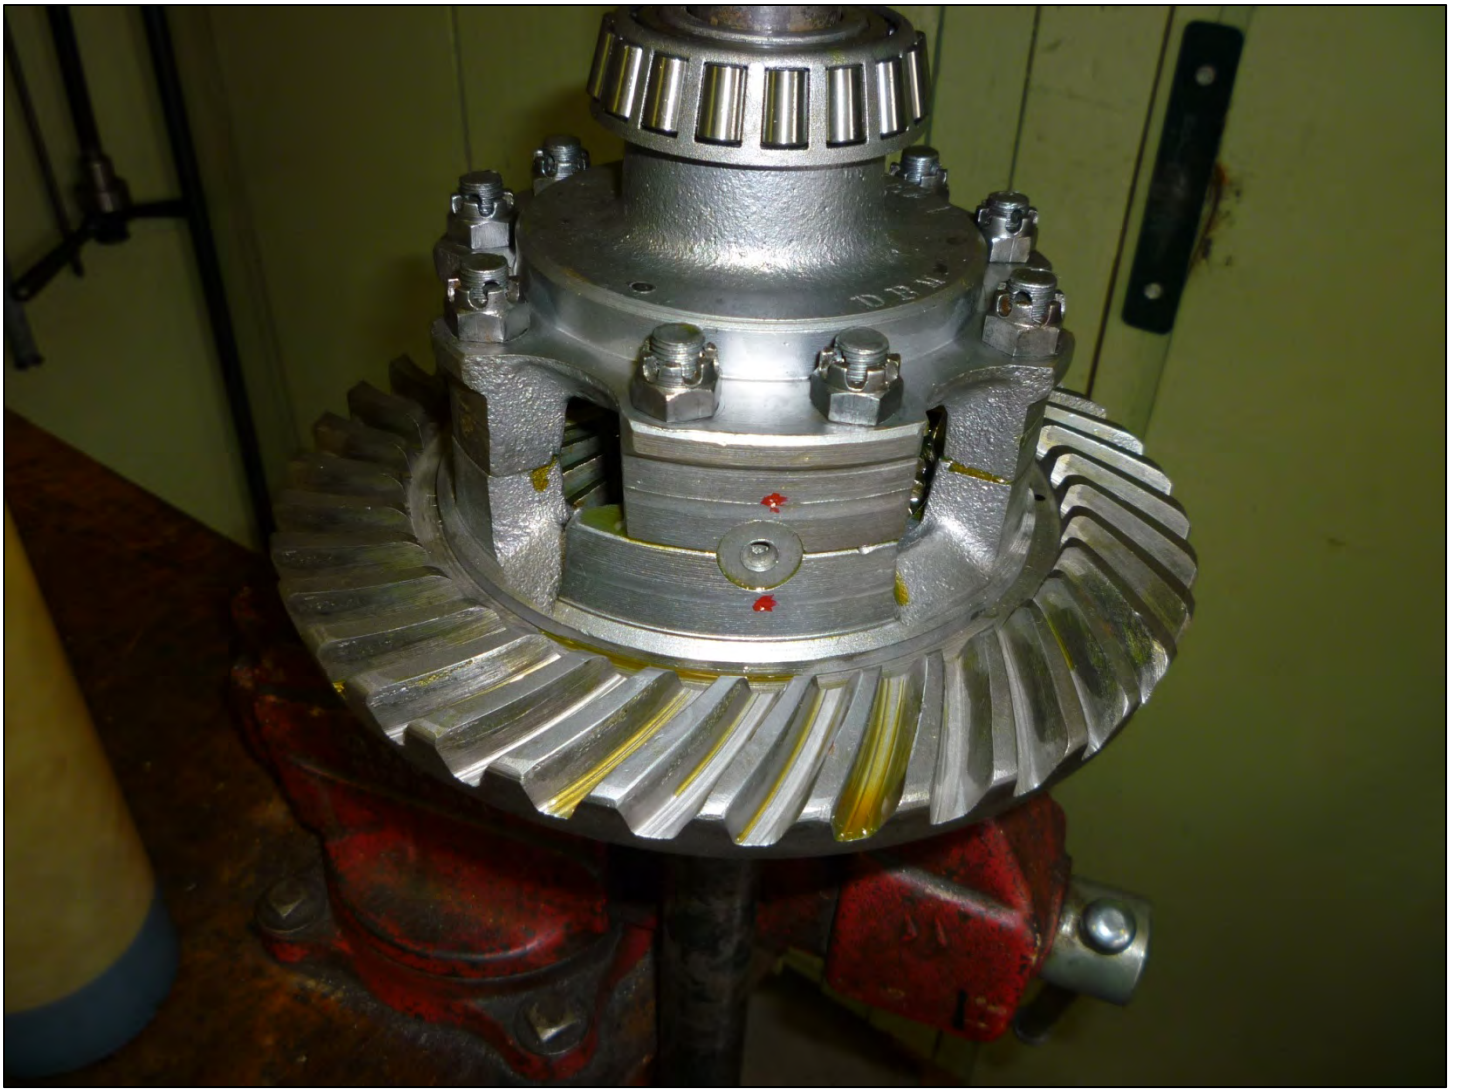
**The right carrier half has been installed and the castle nuts installed and snugged down enough to hold the assembly together. Note the two carrier half assembly marks in red. These were placed there before disassembly. The back side of the three spider gears rides against the inside of the carrier and cause three wear patterns. It is best to line up the wear patterns as before. In some instances the wear patterns are severe and the carrier should be discarded in favor of a better one.**

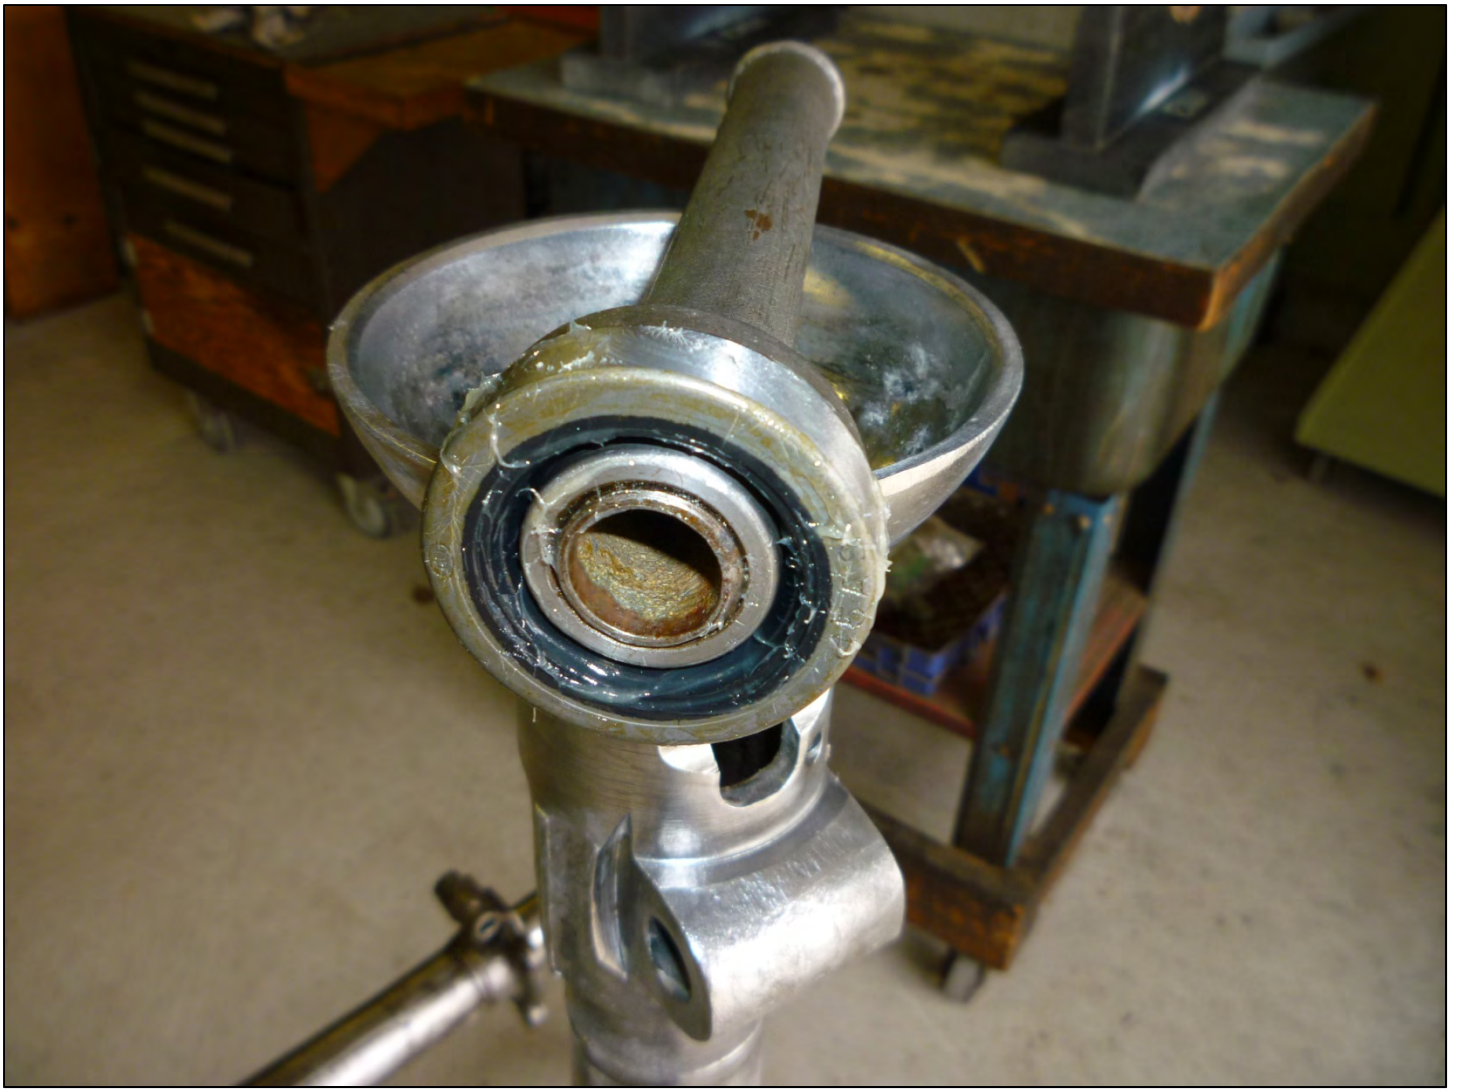
**A new grease seal is installed into the front of the torque tube before the roller bearing race is installed. A short seal insertion tool is used. The seal is the same part number as the two seals that were installed in the axle housing.**

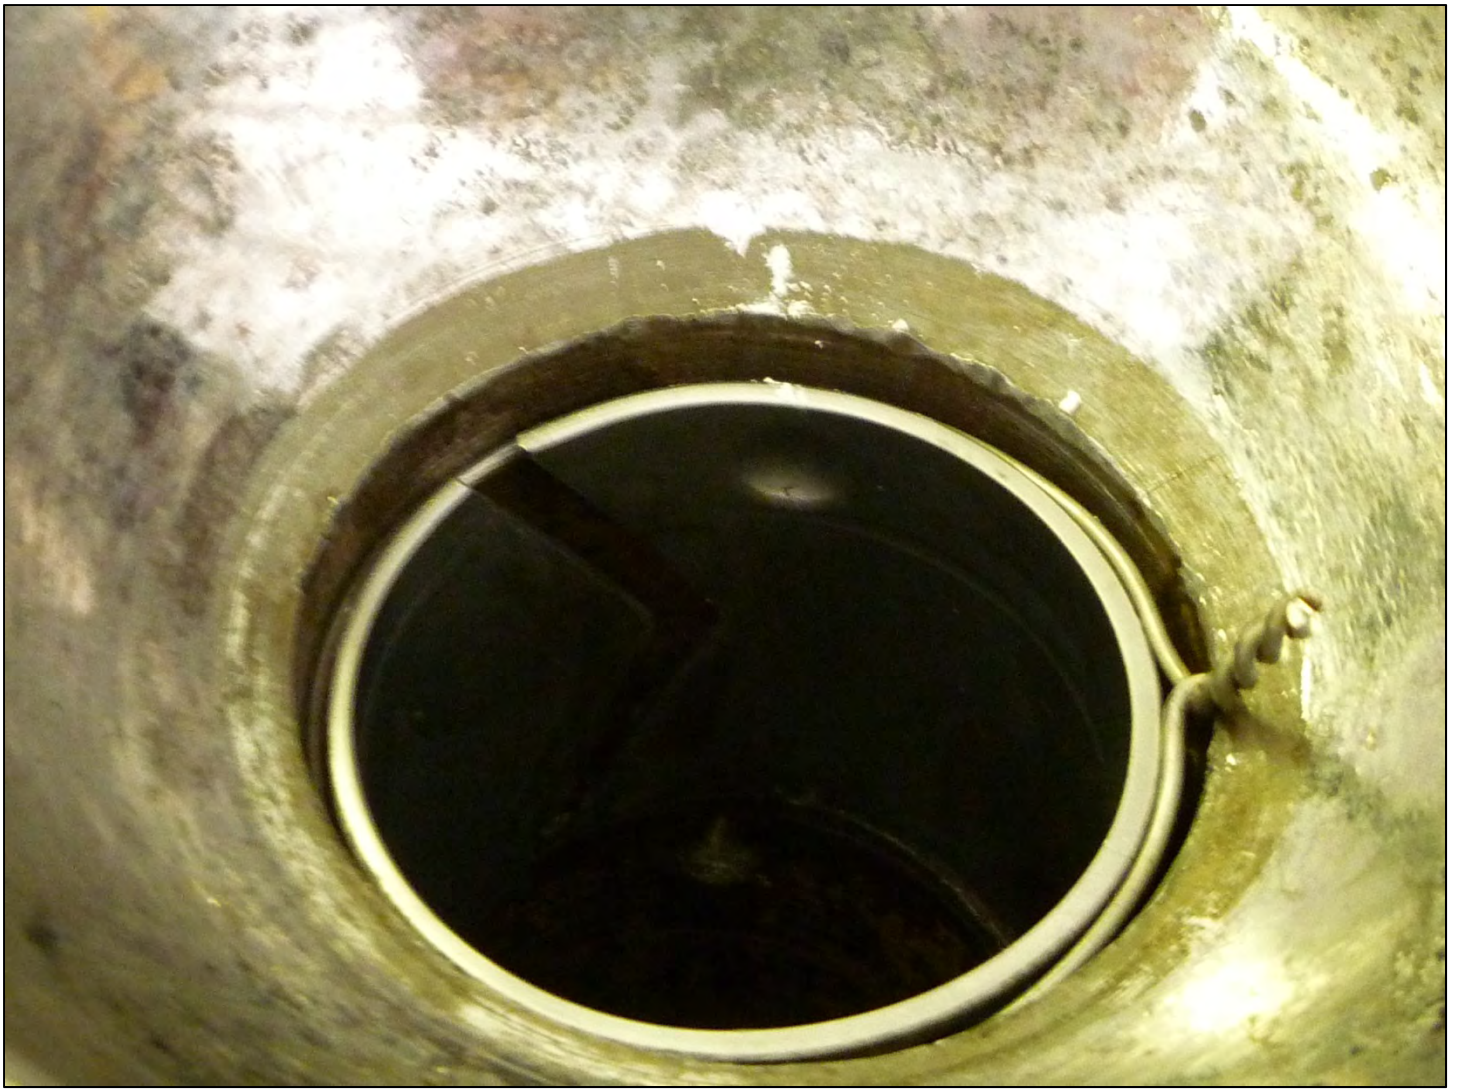
**A chalk mark is placed at the top edge of the sleeve right above the dimple. Another chalk mark is placed on the torque tube directly above the recess where the dimple fits into. The two chalk marks are aligned before the sleeve is driven into place.**

**It is important that the sleeve is properly seated or it will not be possible to install the roller bearing once the torque tube is installed. Examine the sleeve installation carefully. The sleeve should have expanded and be tight around the 360 degree circumference. If it is not, it is not fully seated. If it is only slightly hanging up at the dimple take a punch and insert it through the opening for the speedometer drive and place it in the dimple and give a sharp smack with a hammer.**

**If this does not properly seat it, it will have to be removed by driving the grease seal and the sleeve out together. The process will have to be started over again.**

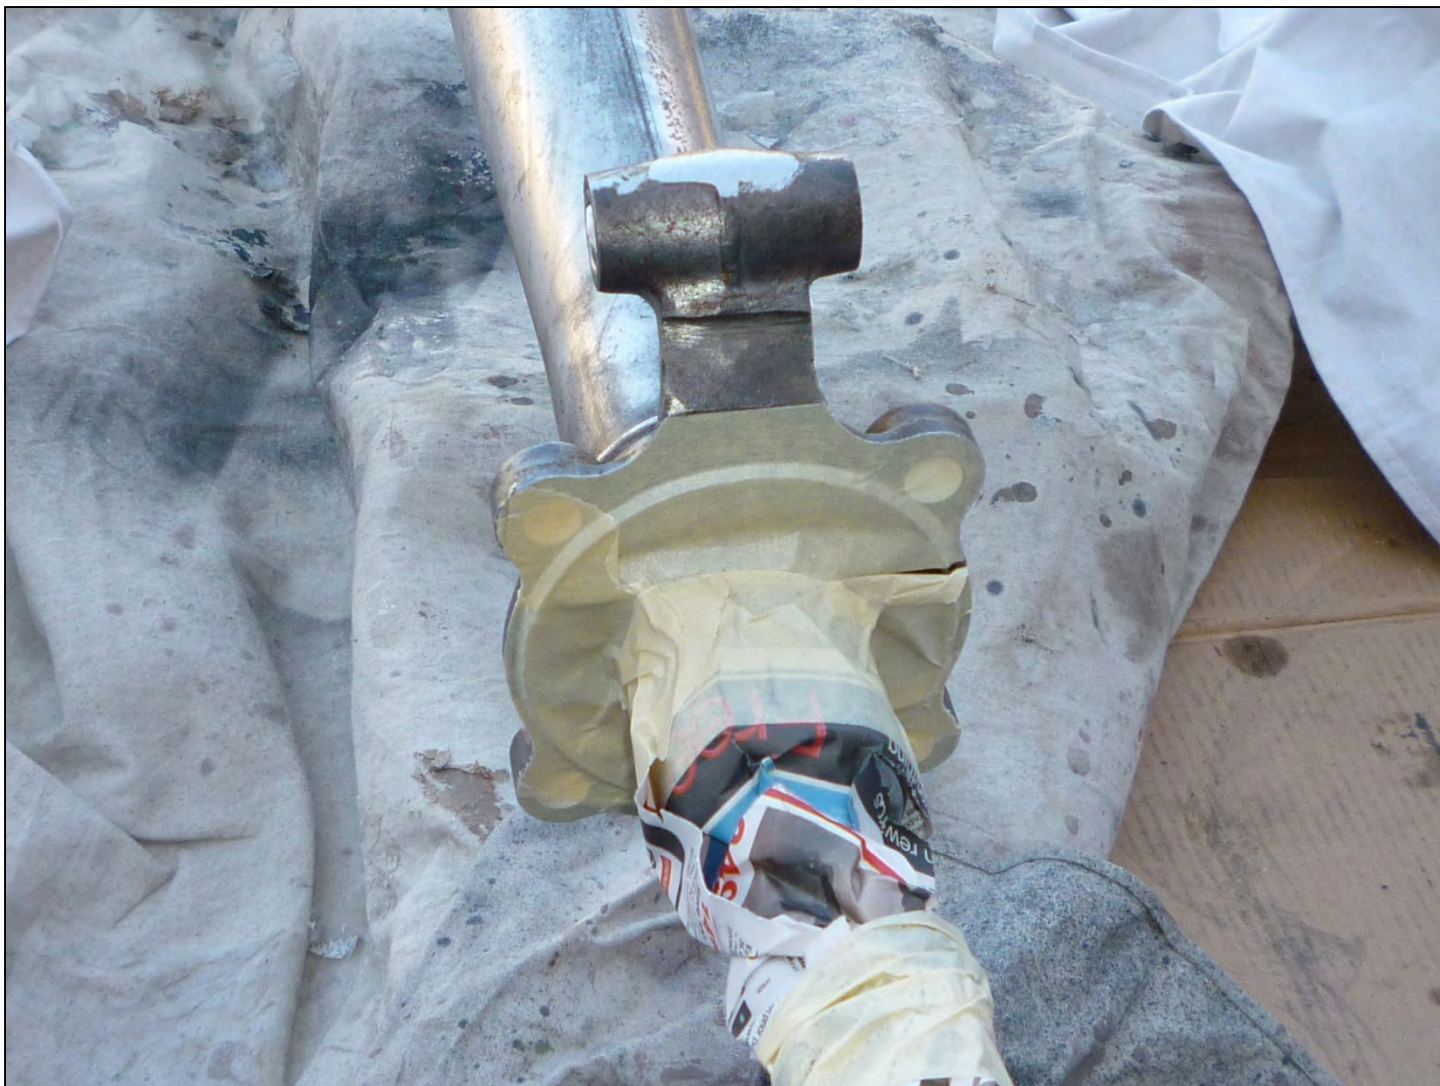
**Each end of the axle housings were masked off where the backing plates attach. Pieces of paper towel were pushed into the shackle bushing to prevent paint from entering.**

**Since this axle housing is going into a modified car, the shock arm perches on both axles had been previously sawed off. During the rebuild a grinder was used to smooth the area.**
