Rear Axle Assembly Rebuild Pictorial 2015

by Tom Endy

The following series of photos were taken during the rebuild of a Model A rear axle assembly.

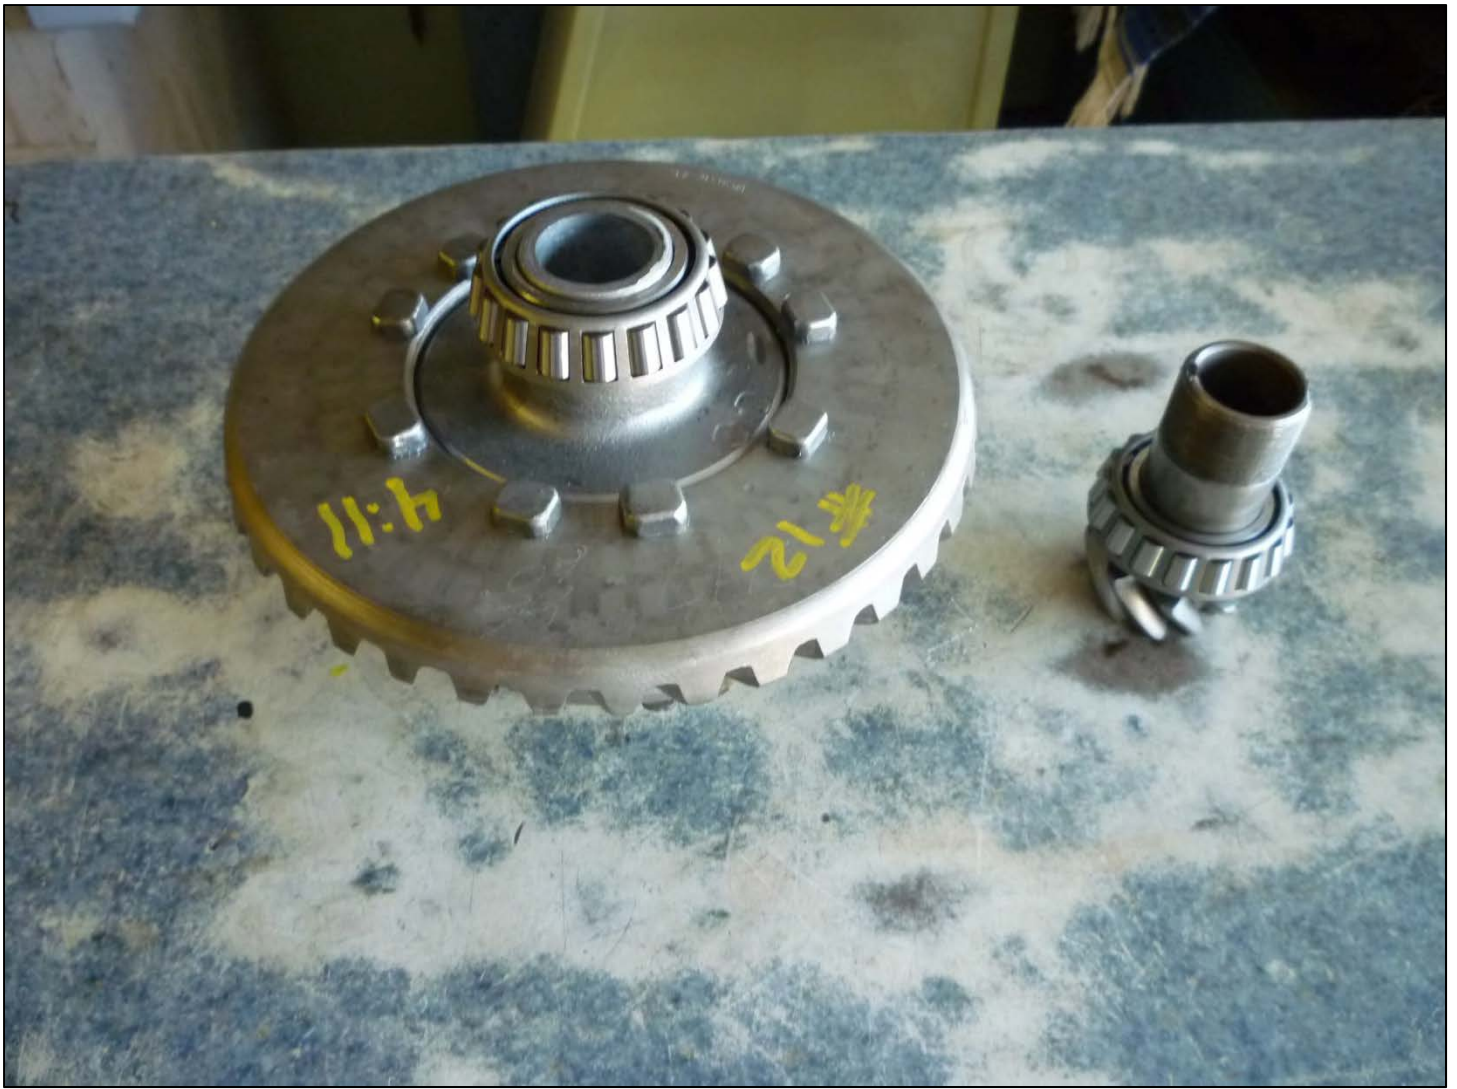
Another view of the 411 ring and pinion gear set. This is an original Henry Ford gear set. The first pinion bearing should seat with an interference press fit just behind the gear. The second bearing when installed should press on snugly, but not overly tight. On an original pinion gear sleeve there is a difference in diameter of .0015 where the two bearings mount. The reason is to allow the second bearing to be moved fore and aft to achieve the pinion bearing pre-load adjustment.

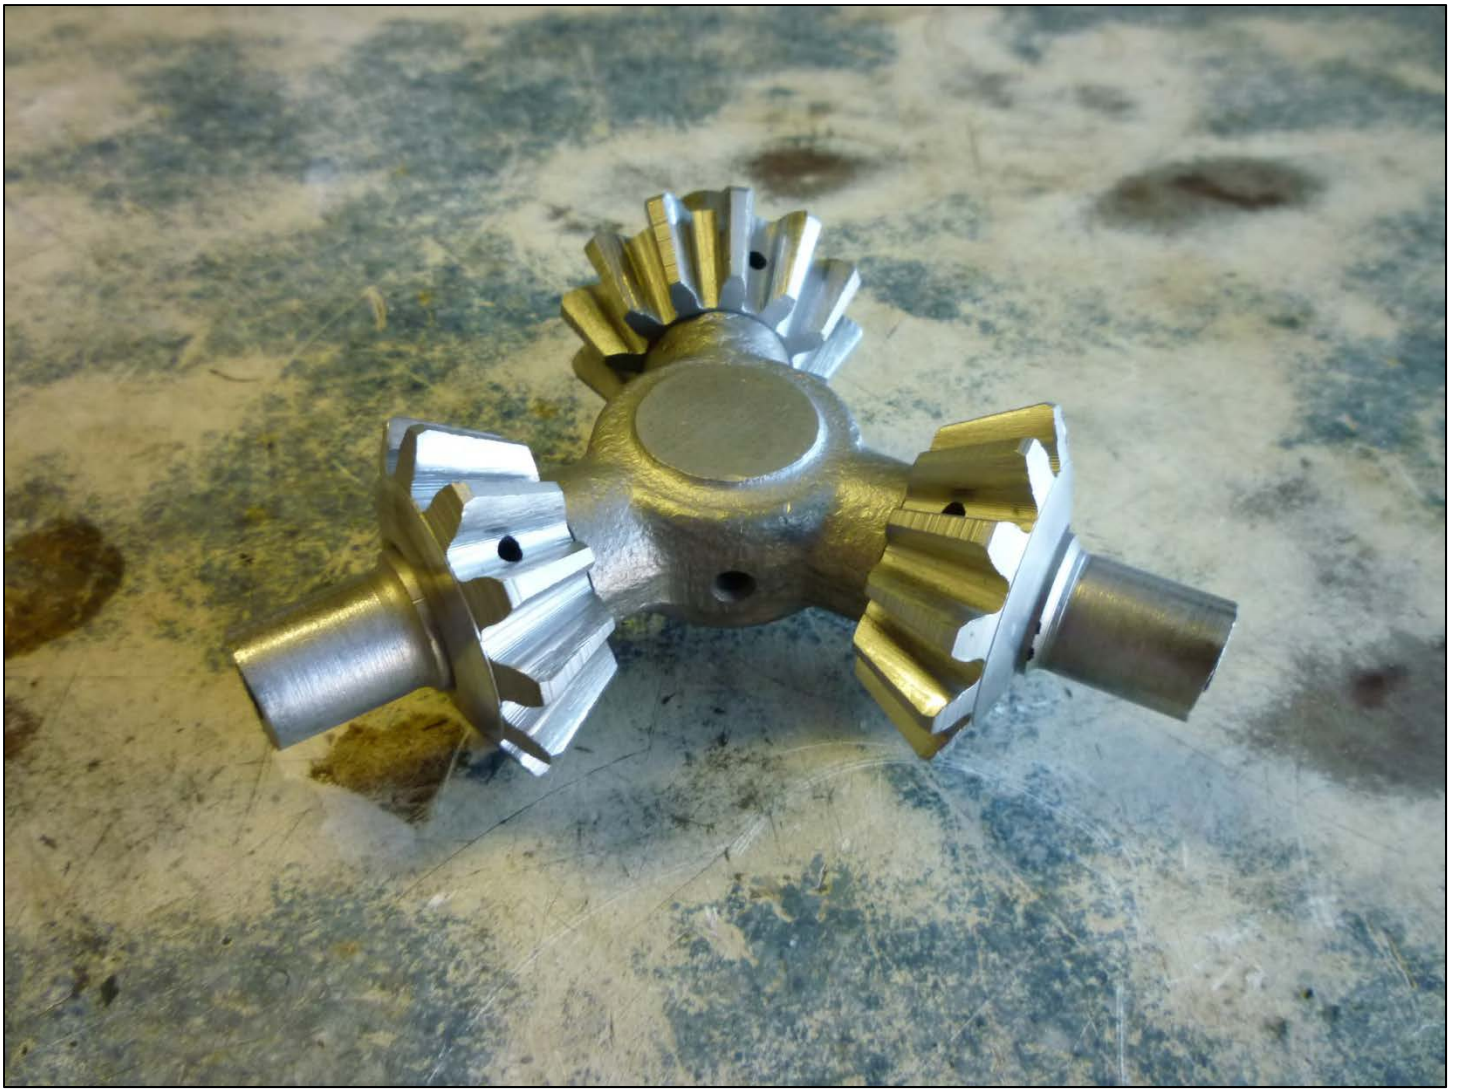
The spider gear assembly has been cleaned, inspected, and bead blasted. This particular set is a 1931 gear assembly with oil holes drilled into the three spider gears. The three spider gears normally turn loosely on the shafts. This spider gear assembly will be set aside until final assembly when it will be installed.

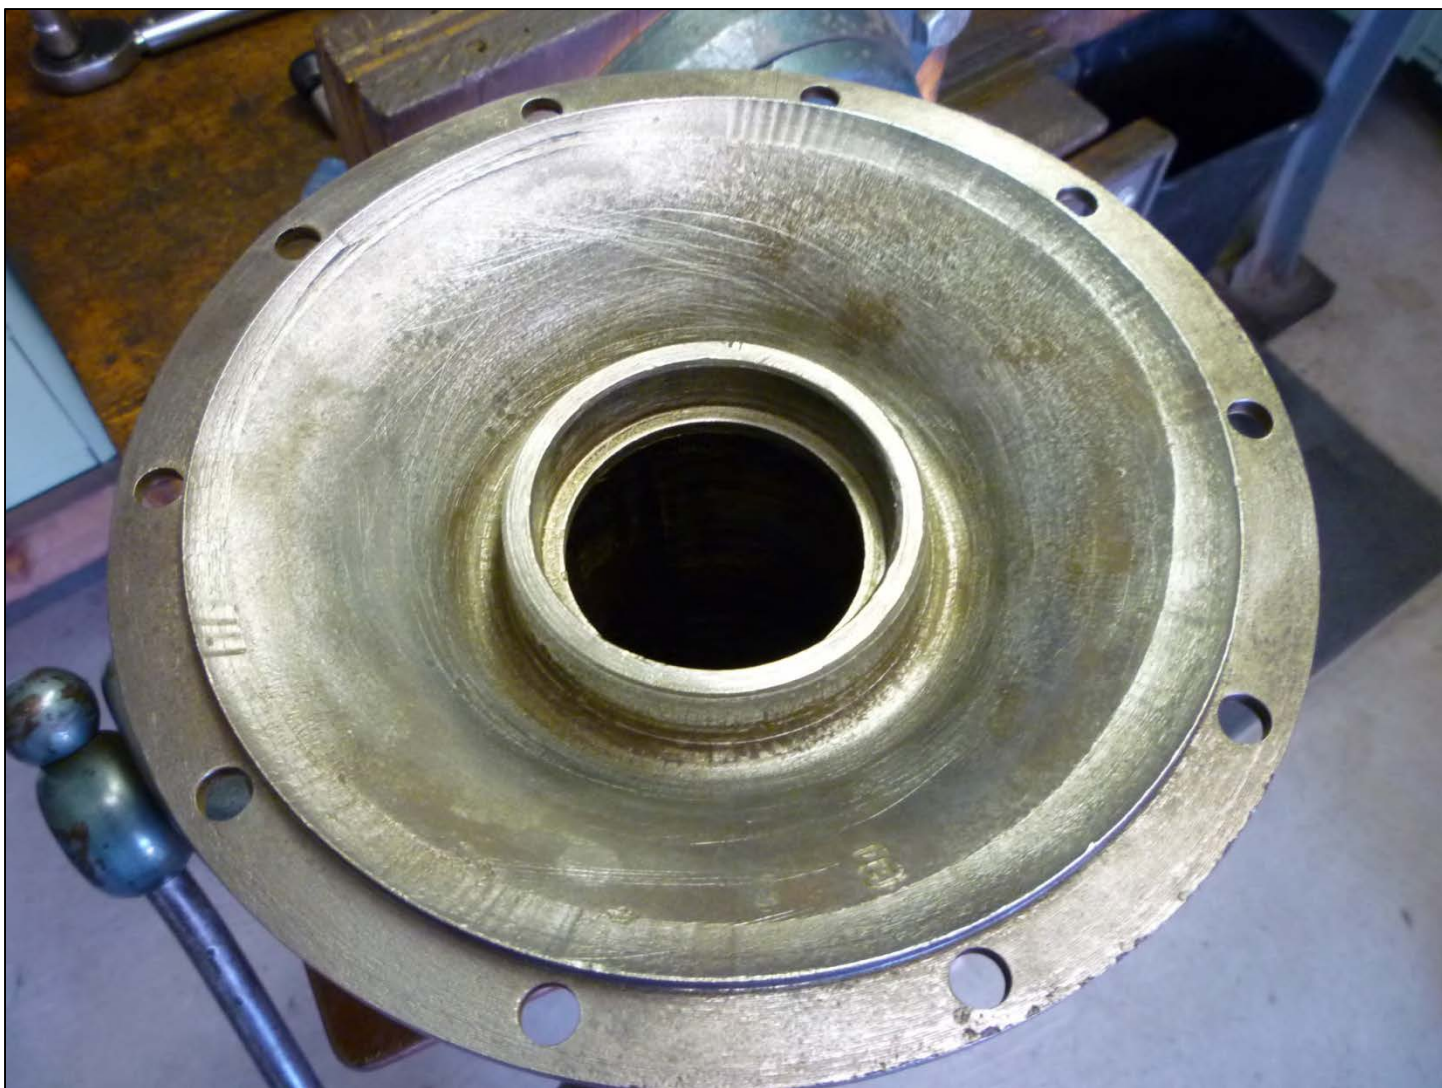
Both axle housings have been cleaned, wire wheeled, and the exterior sanded. The old bearing race has been removed and is ready for the installation of a new race.

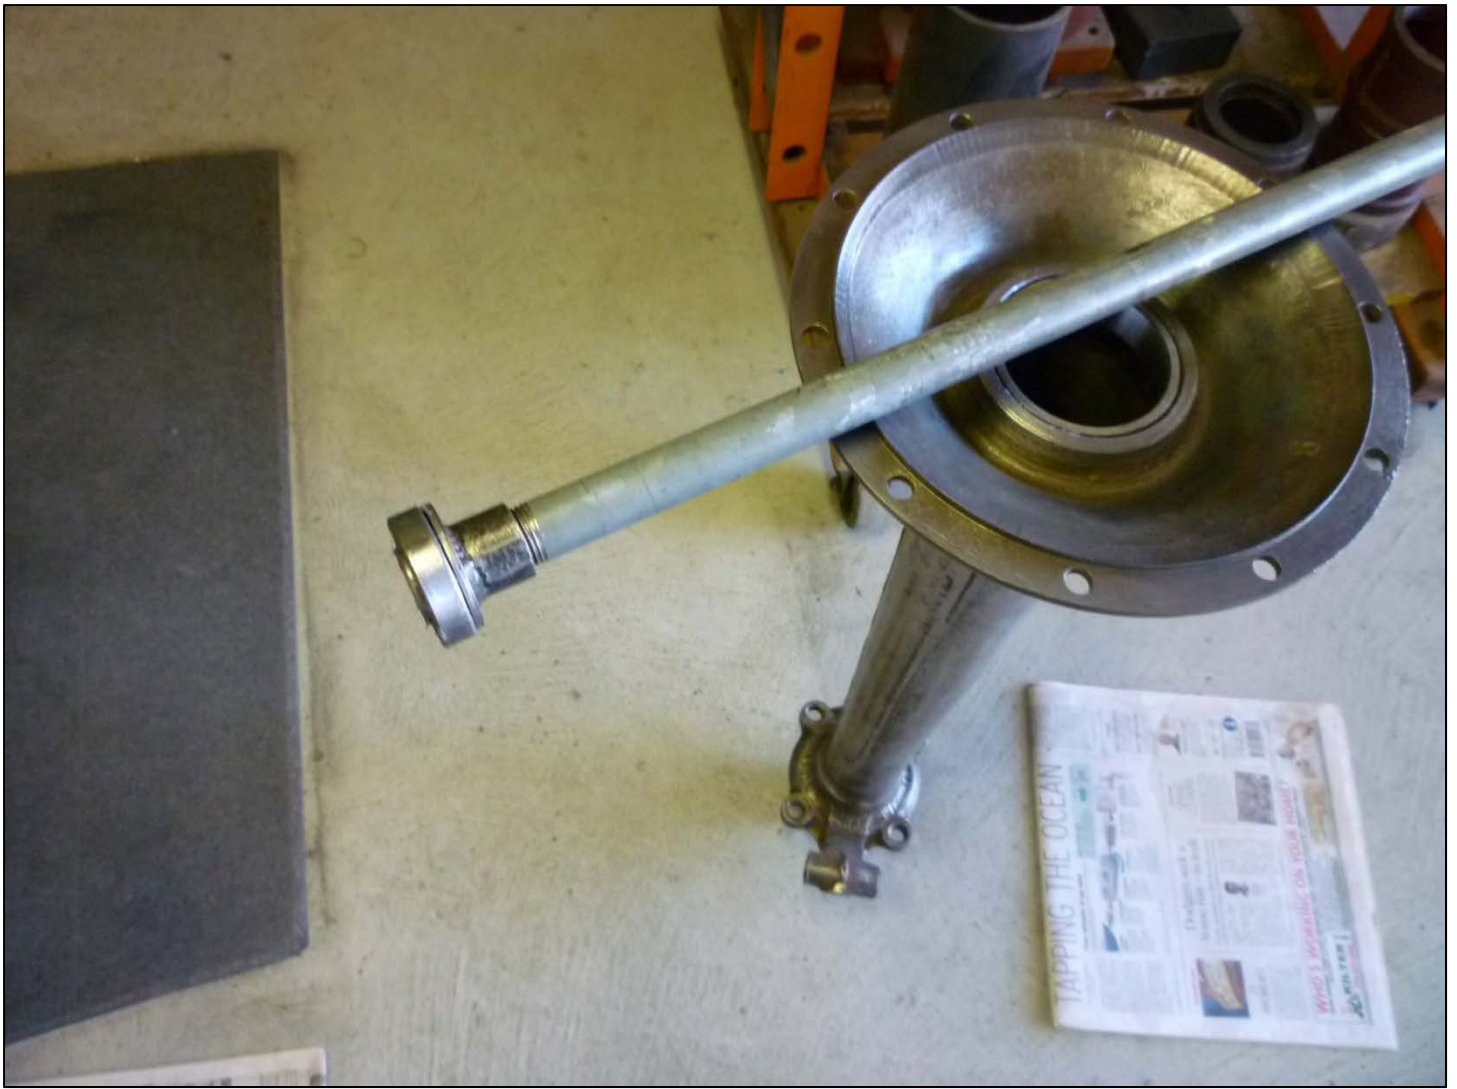
A new grease seal is hammered into place using a long insertion tool. The area where the seal will seat must be thoroughly cleaned before the seal is hammered into place. The seal is shown positioned onto the end of the insertion tool.

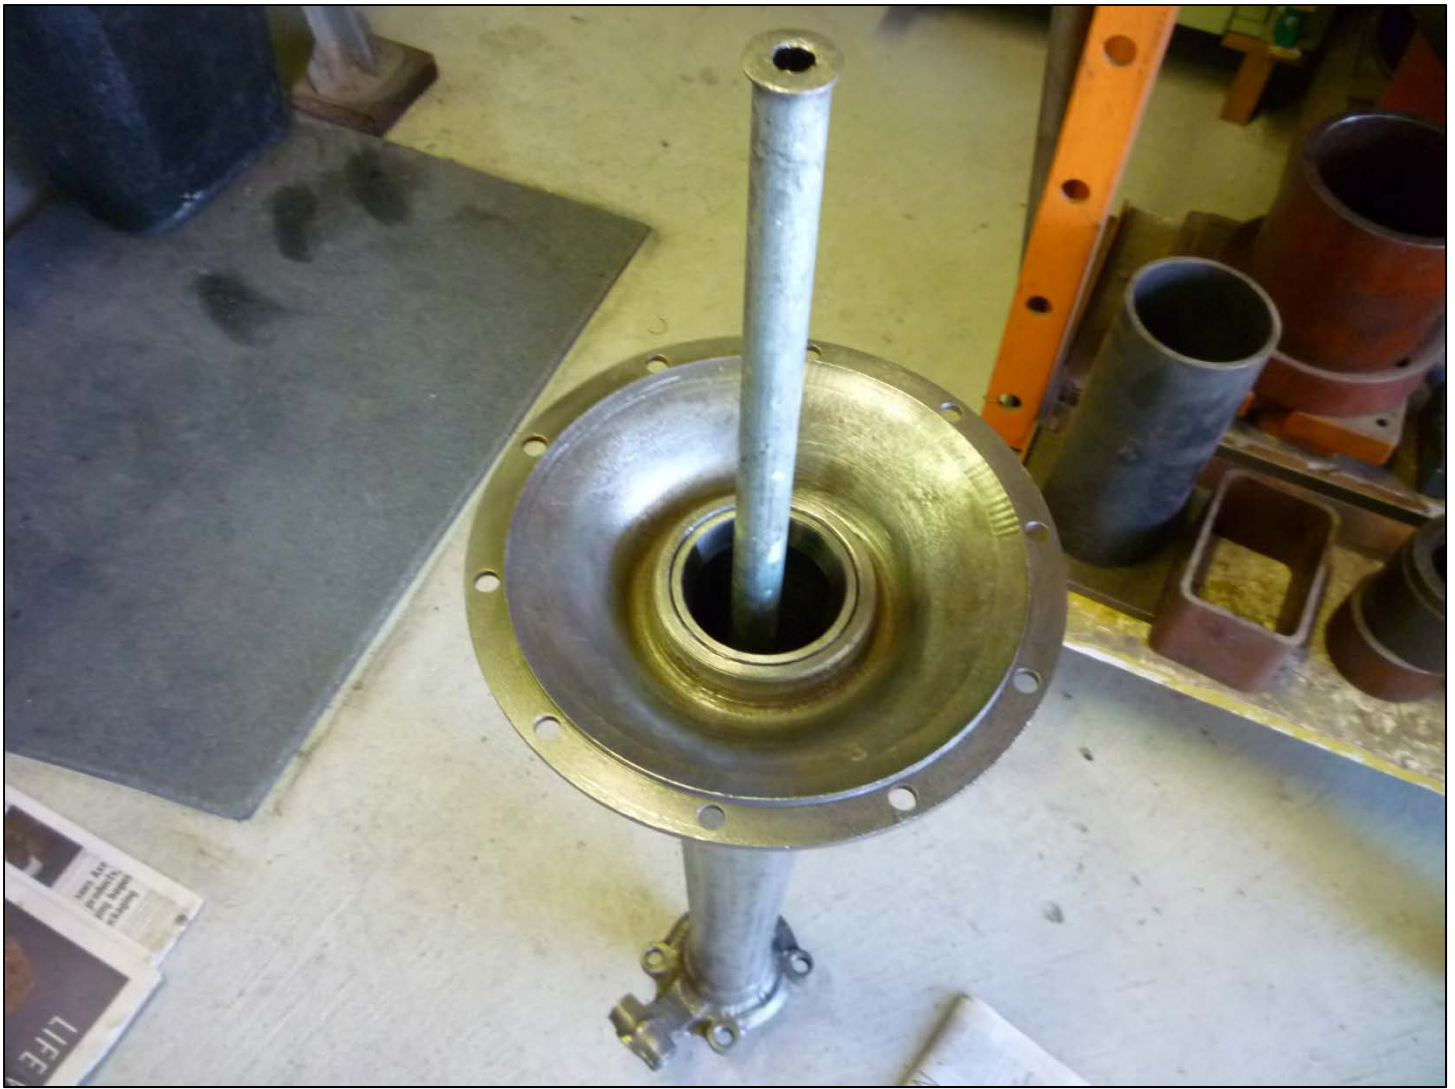
The grease seal is hammered into place by standing the axle housing upright and using a long insertion tool. It takes about 4 to 5 hammer blows to seat the seal into place. When the seal seats the hammer blow sound will change from a dull thud to a ringing sound. Check that the seal is fully seated by running your finger around the circumference at the other end of the housing.

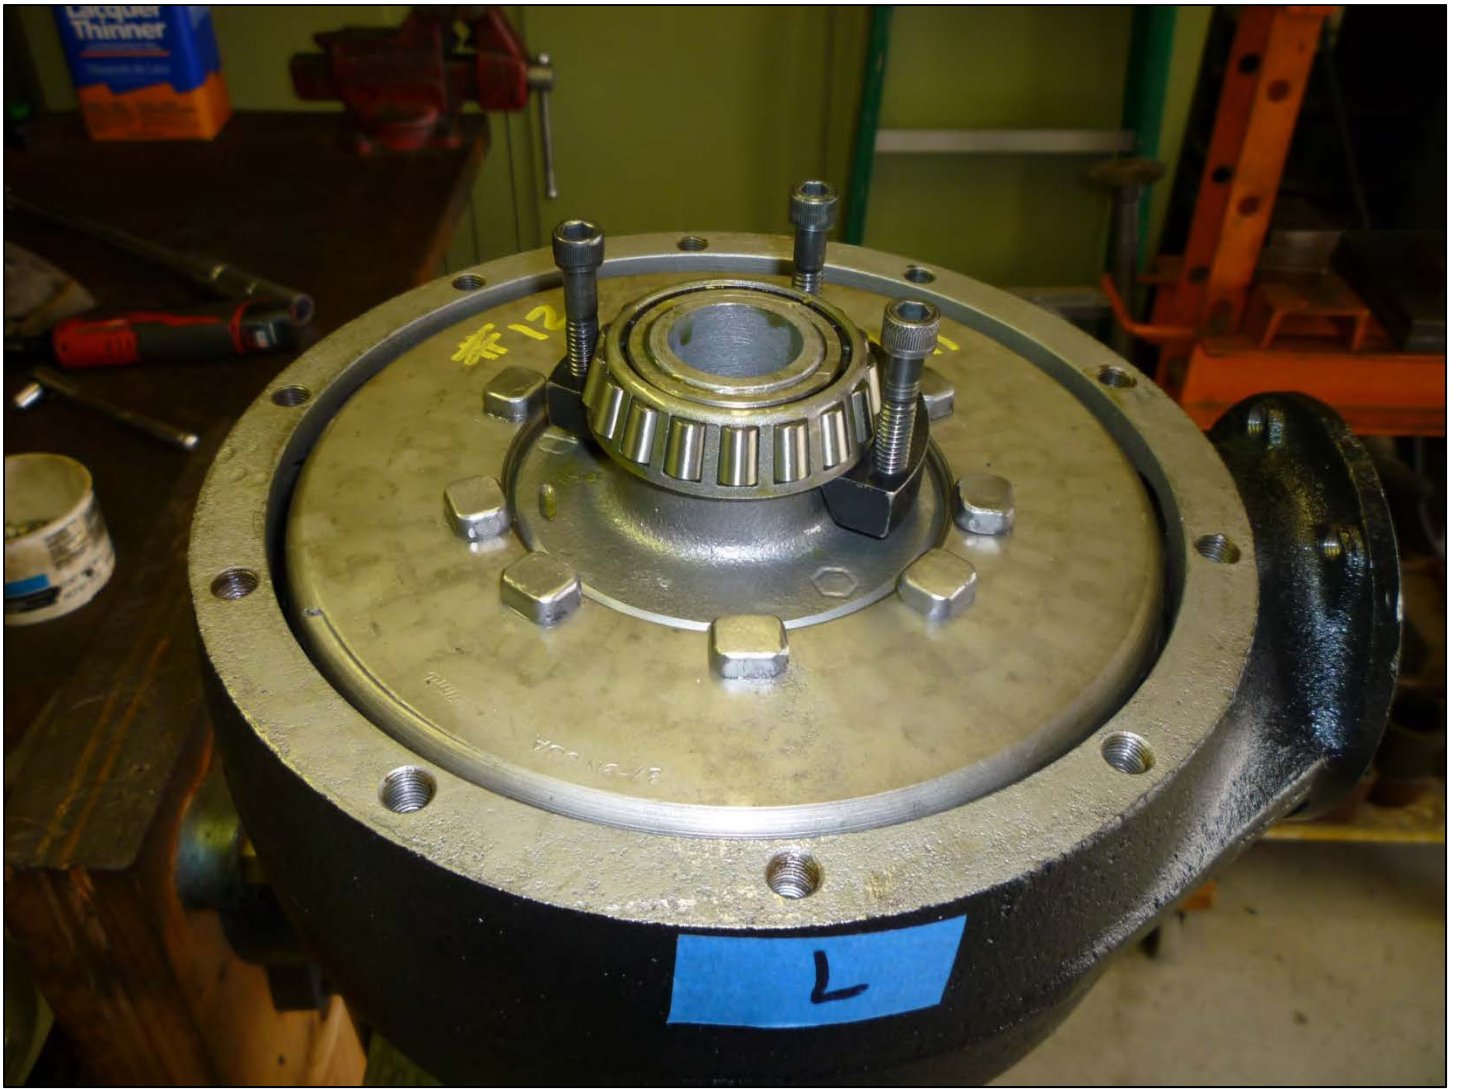
The left carrier bearing is being removed from the carrier hub using a specially made tool that will grip the underside of the bearing and remove it without damaging the skirt.

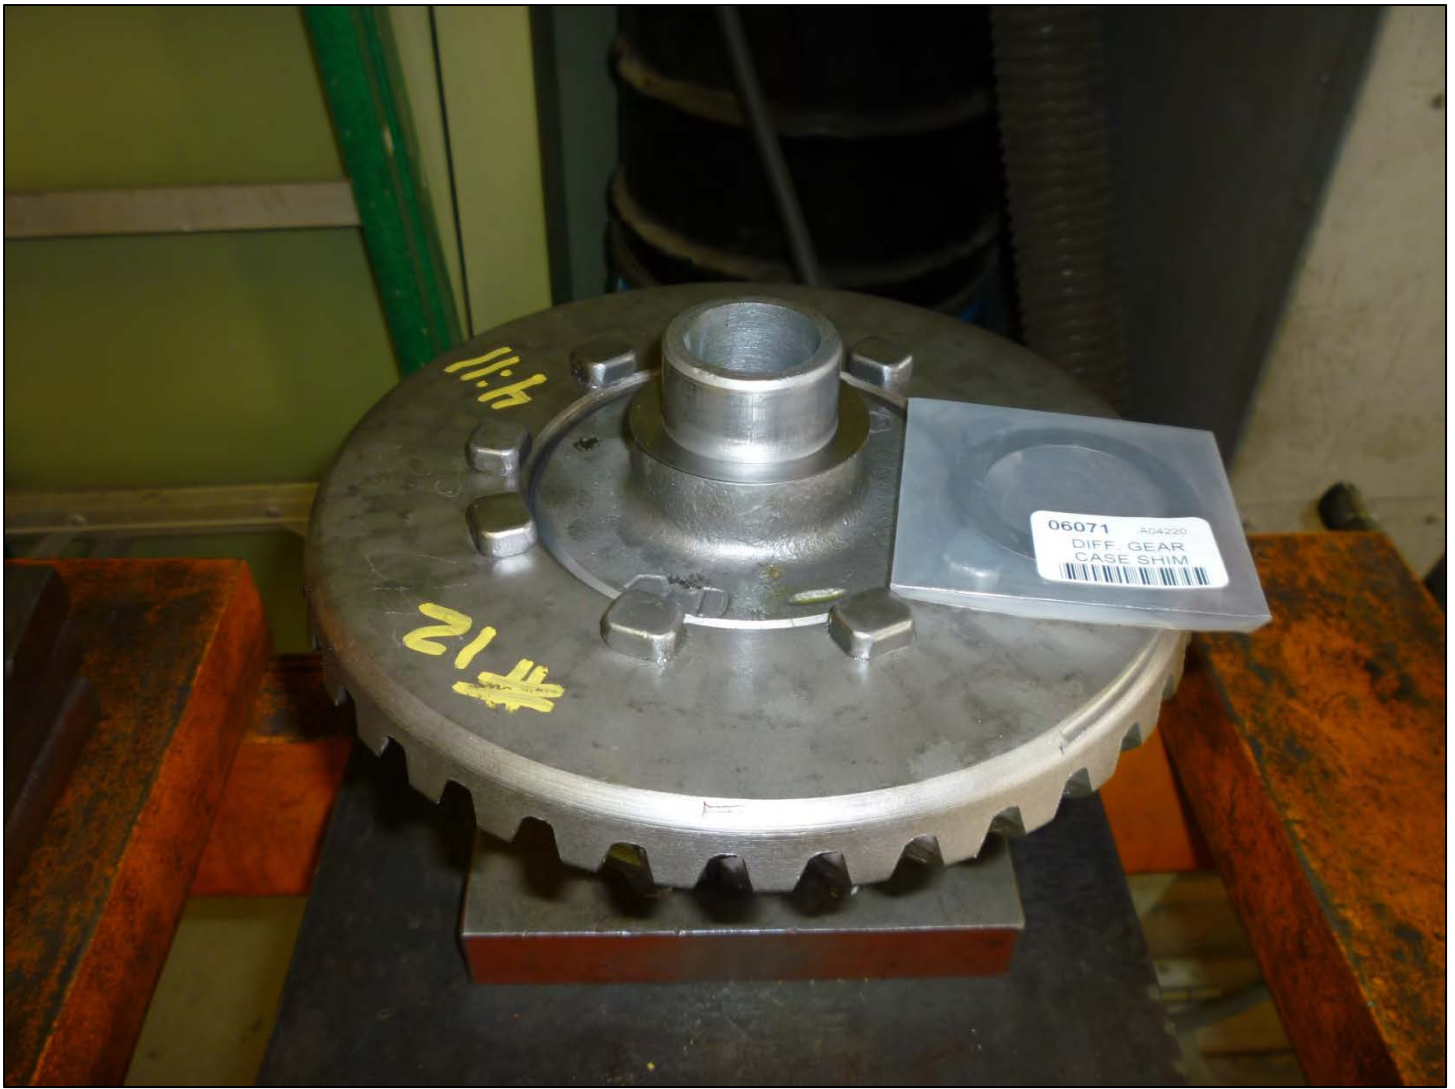
The carrier assembly is placed on a press with a .005 metal shim installed on the bearing hub on the left side of the carrier. Shims can be purchased from Bratton's. Each is .005 thick. Shims can be stacked if additional shimming is needed.

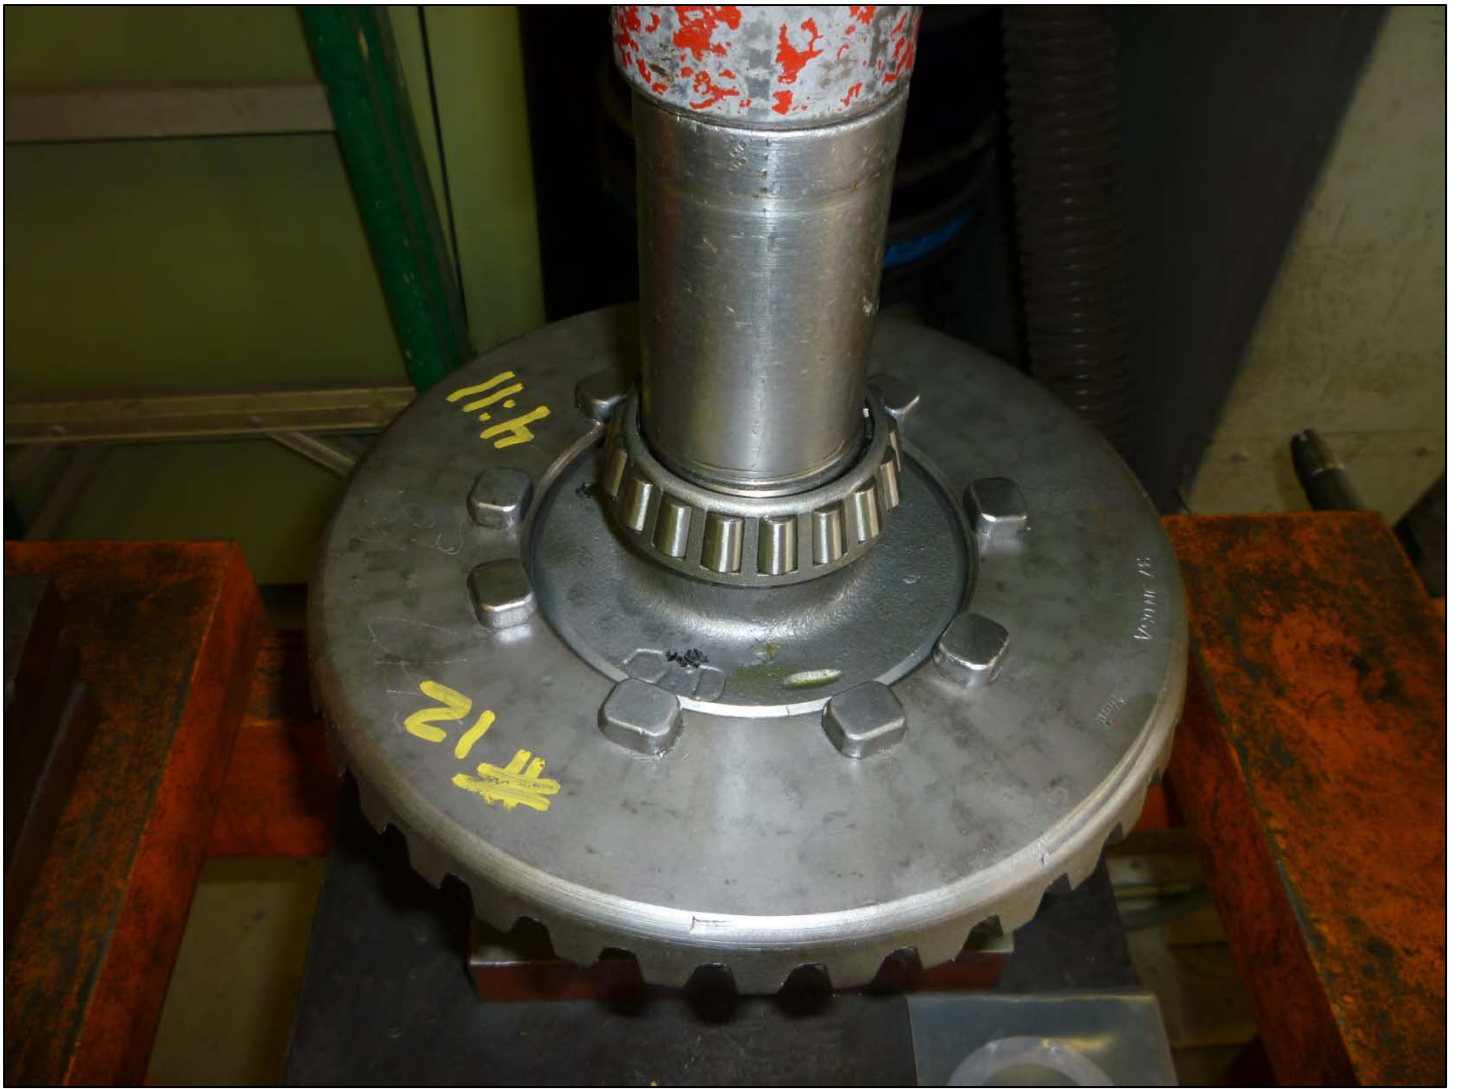
The carrier bearing for the left side is pressed back onto the hub with a .005 metal shim under it.

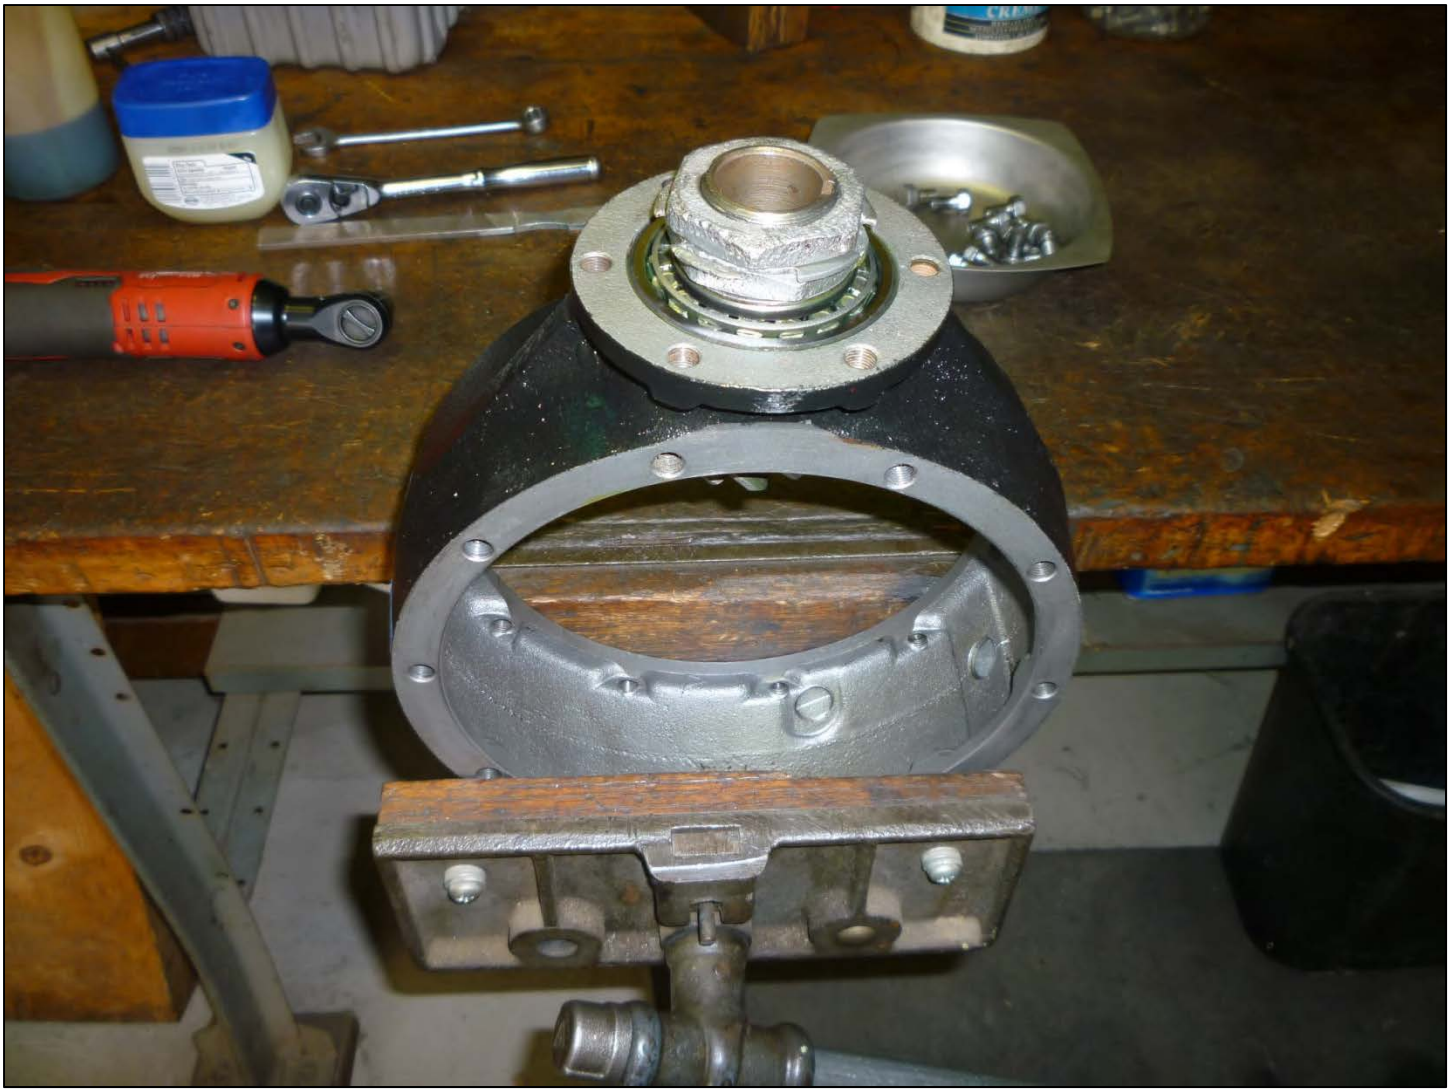
The pinion assembly has been installed. The second pinion bearing installed with ease and has the ability to move back and forth with little effort to facilitate the pre-load adjustment. The next step will be to rotate the banjo in the vice to a horizontal position for the installation of the drive shaft and torqueing of the shaft nut down to a nominal 100 ft. lbs. before attempting to set the pre-load on the pinion bearings.

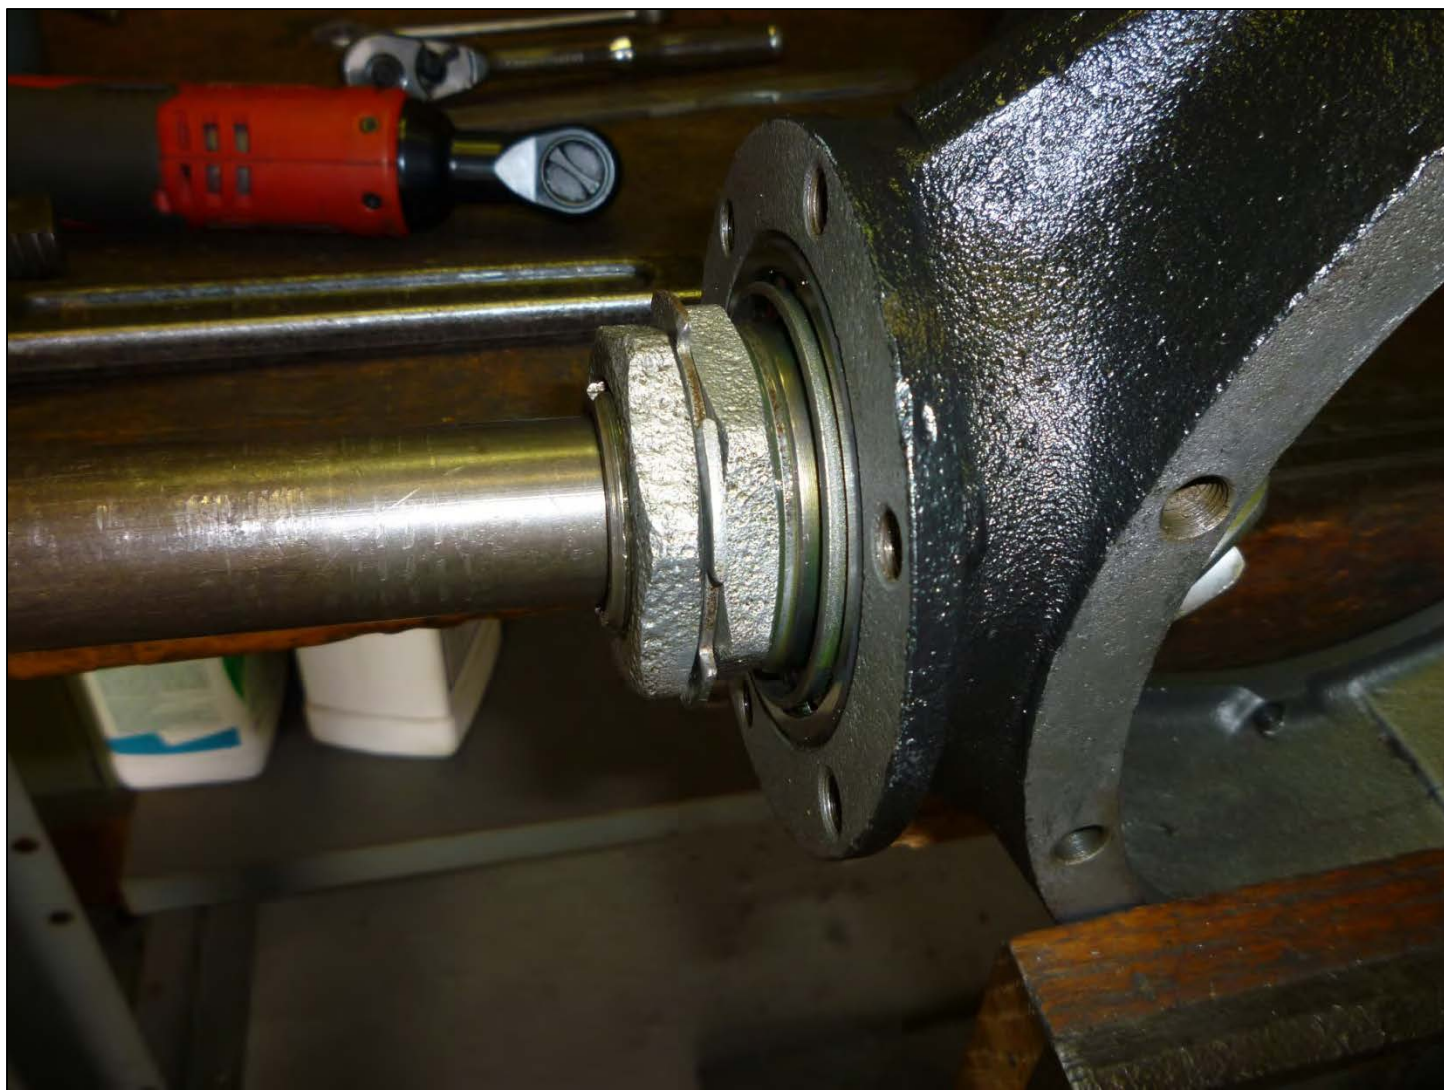
With the banjo in a horizontal position in a wood vice the drive shaft with locking key is inserted into the pinion gear sleeve. I always coat the taper on the drive shaft with anti-seize compound. Note that the two pinion nuts show signs of severe pitting from rust. This is acceptable as long as the flat mating surfaces are smooth. They should also be lubricated during assembly. Quite often you find chisel marks on these nuts where a mechanic of yester year adjusted the pinion bearing pre-load with a hammer and a chisel instead of using the proper wrenches. Both of these nuts have been bead blasted to remove all the rust.

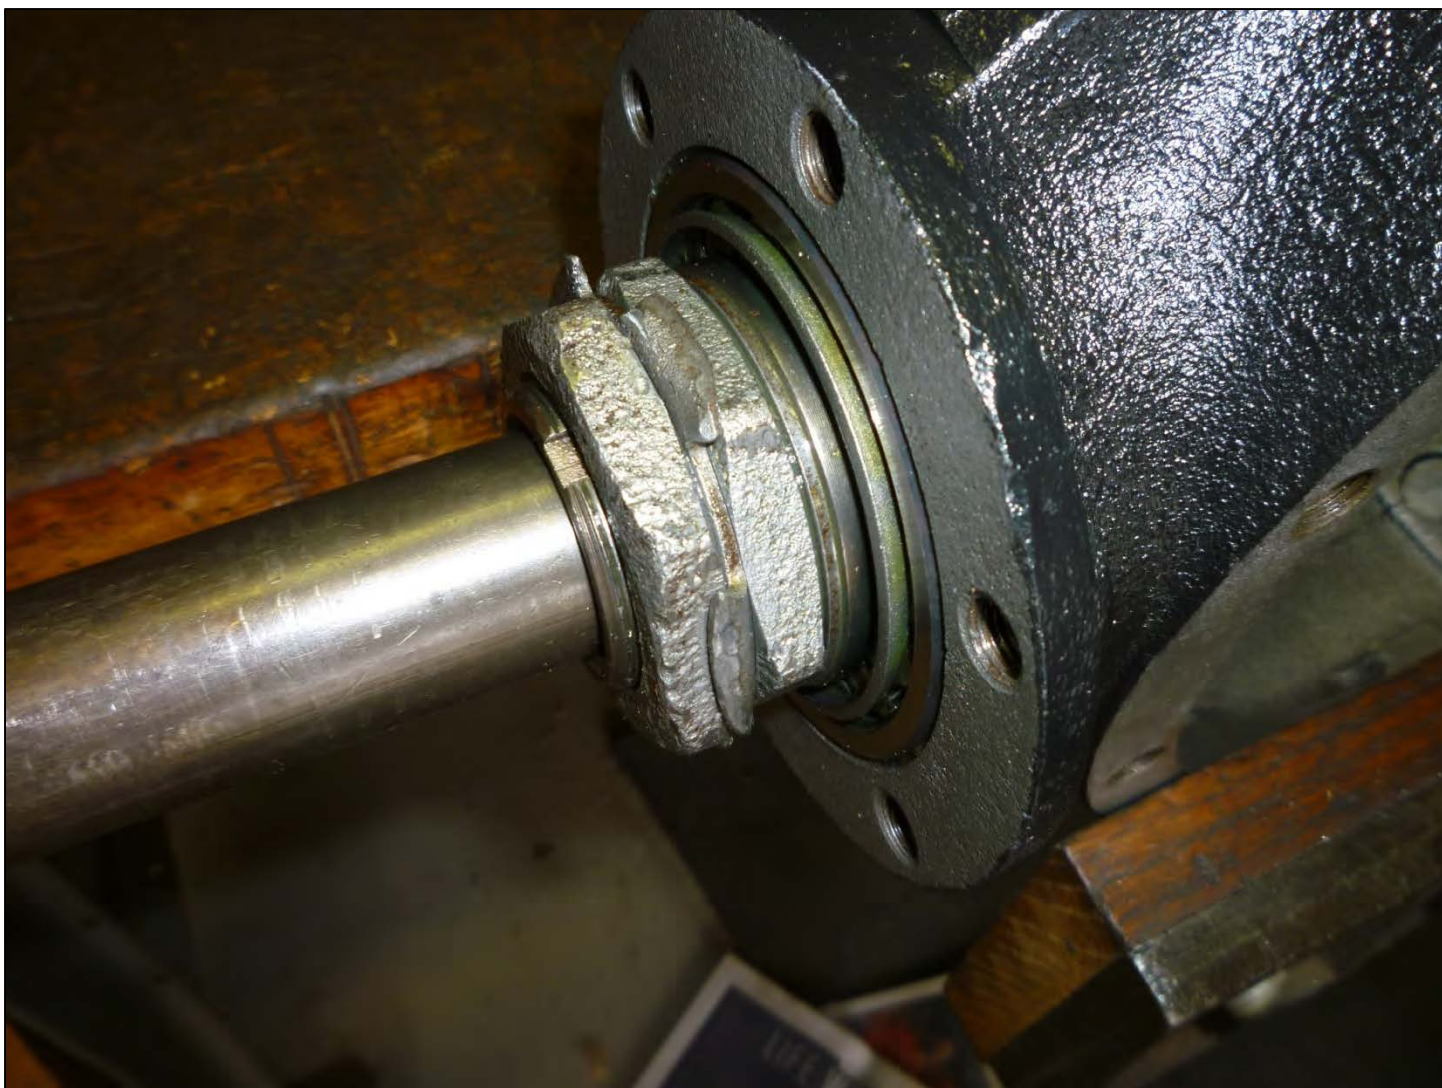
Once the pre-load adjustment has been achieved and both nuts are tight against each other two of the locking washer ears are bent over to lock the nuts in place. One is bent forward, the other is bent aft. The photo shows the two ears bend over.

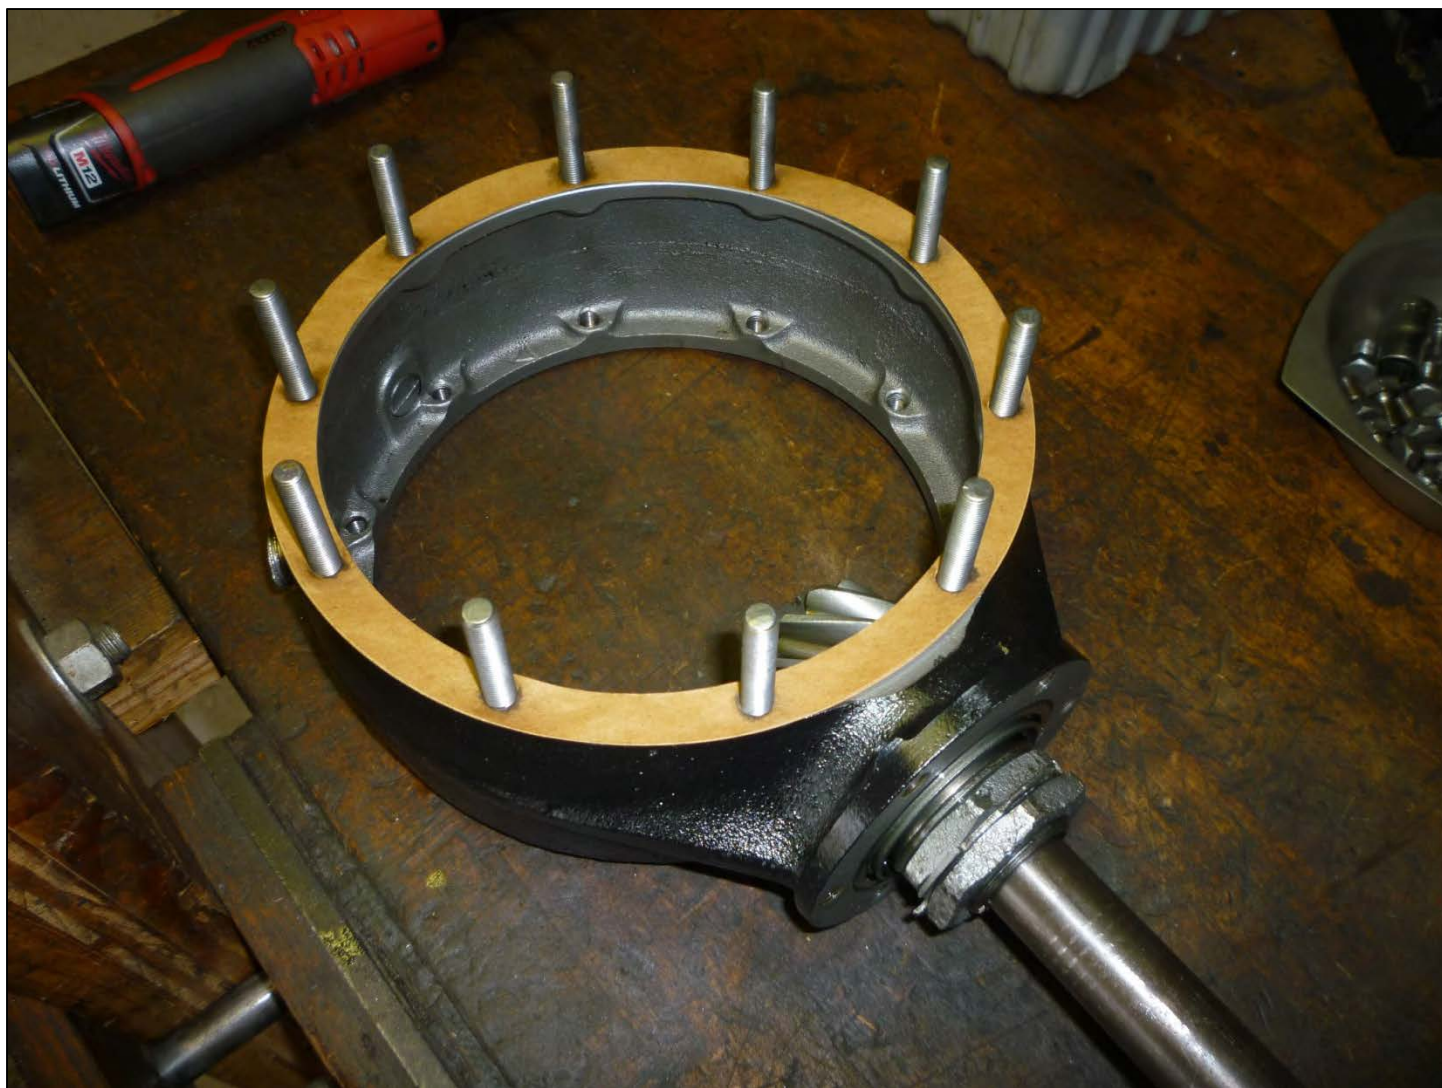
The photo shows gaskets being installed on the right side of the banjo using the threaded studs. One .010 and one .006 gasket was installed. Since in this case the only choice was which side of the banjo the .006 gasket would be installed on, the choice was to install it on the right side to minimize the backlash.

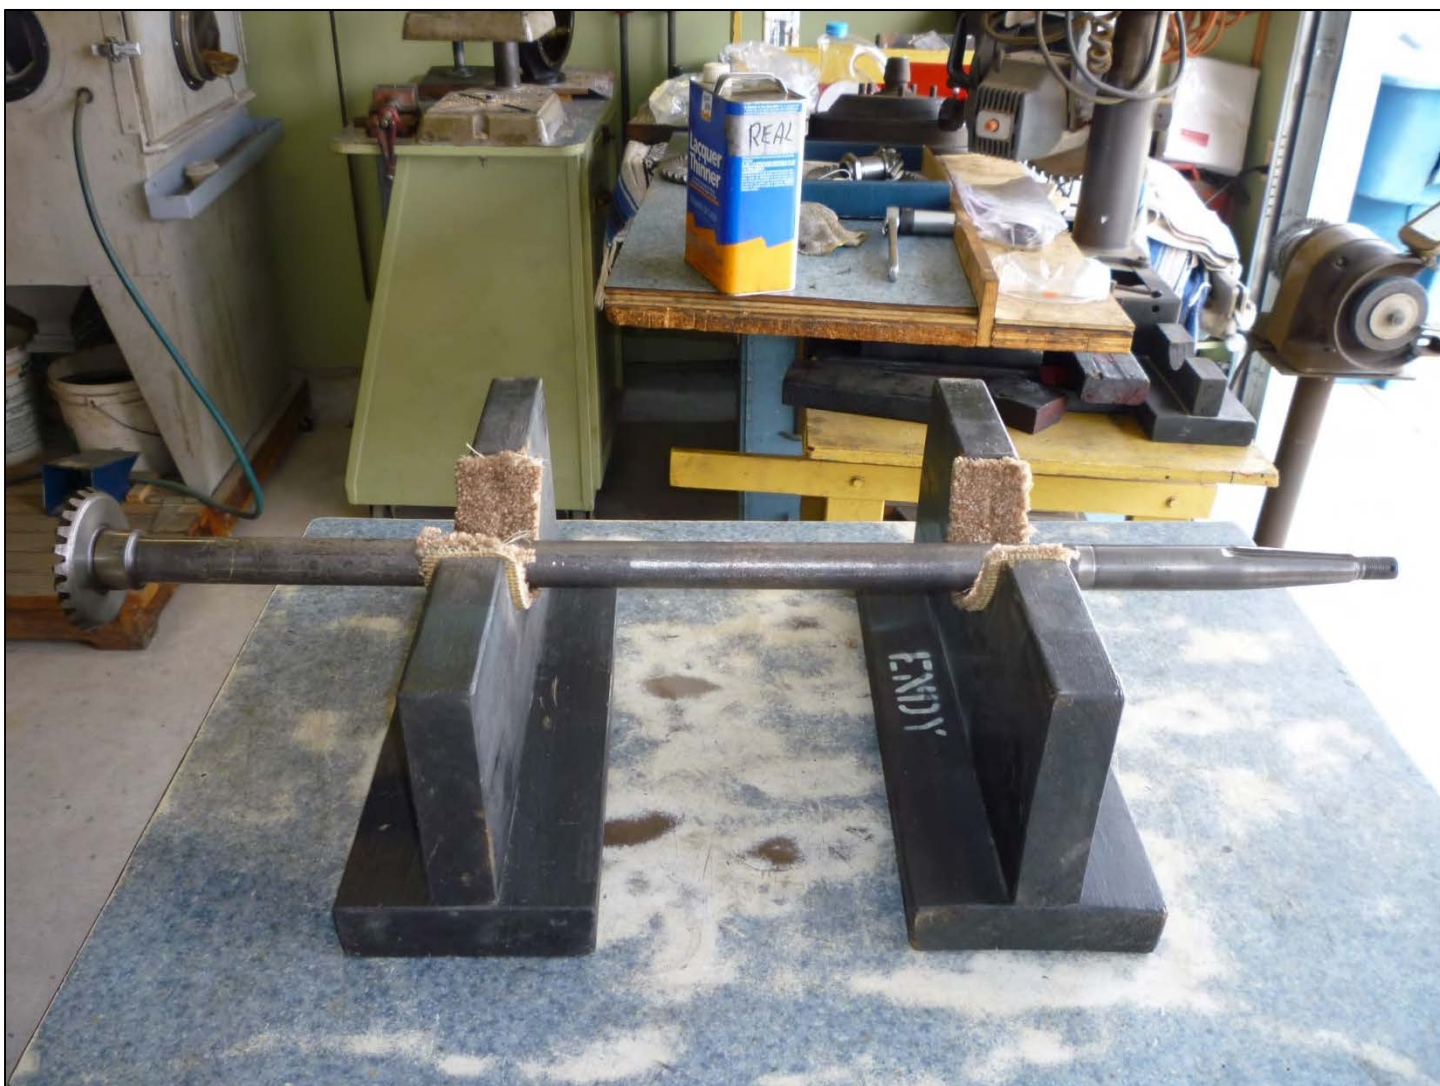
With both the carrier and pinion pre-loads determined and the backlash determined, the next effort is to prepare for the final assembly. The axle housings are once more disassembled.

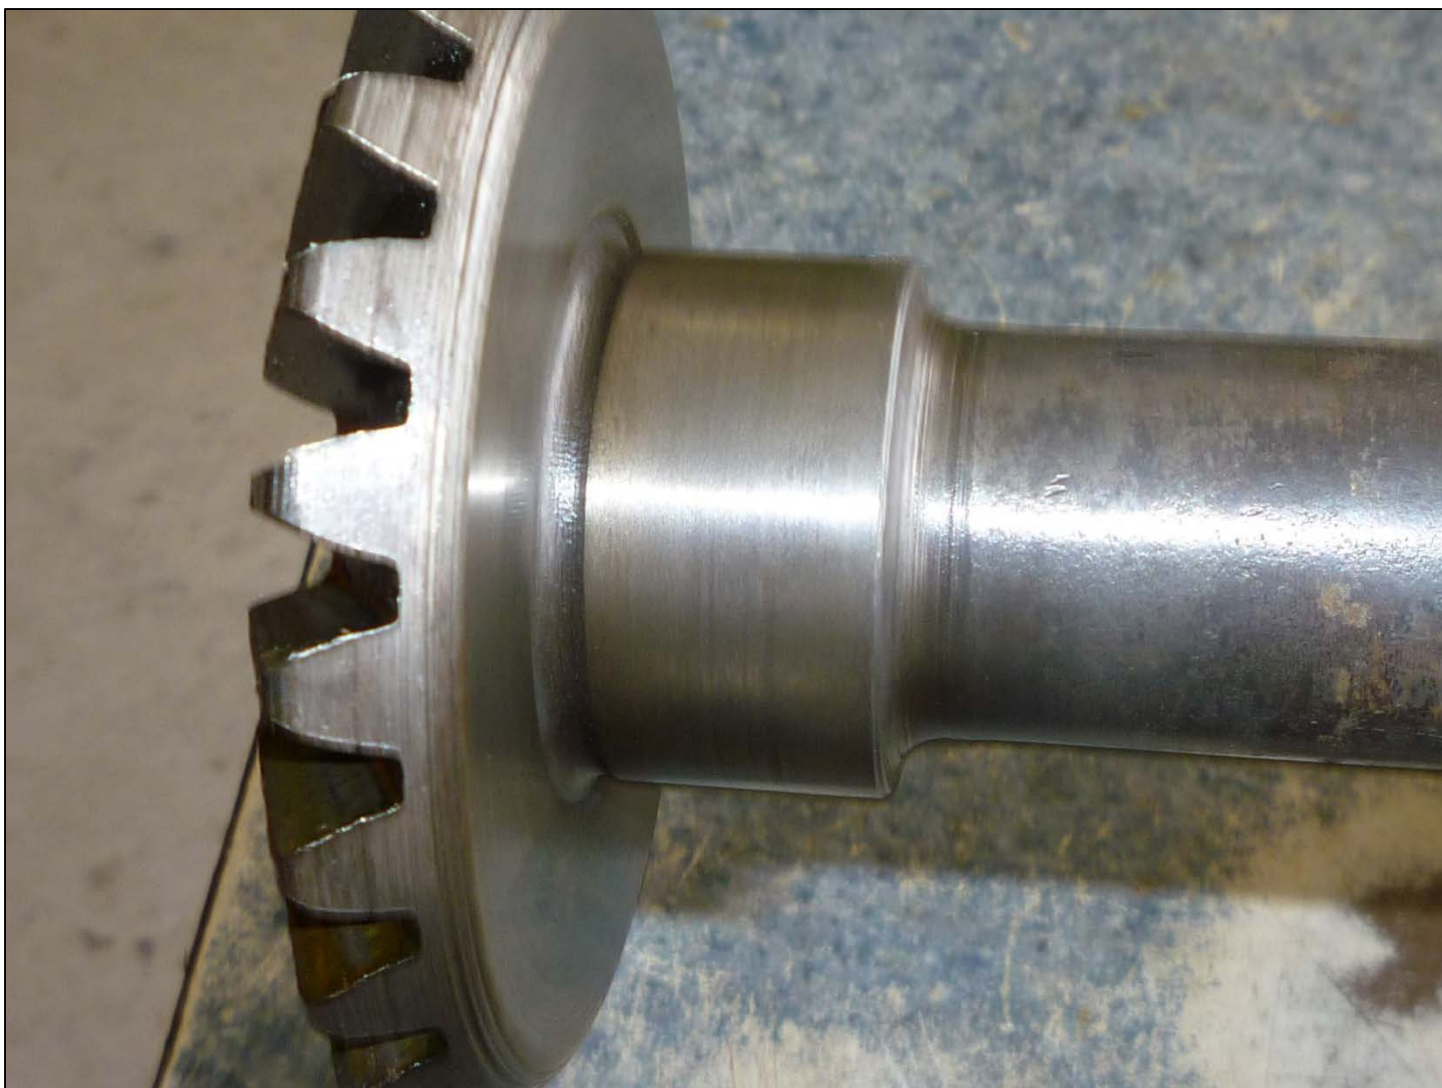
The axle shaft should be wire wheeled or bead blasted if rusted. The gear end of the axle shaft should be in good shape where it rides inside the carrier.
