Rear Axle Assembly Rebuild Pictorial 2015

by Tom Endy

The following series of photos were taken during the rebuild of a Model A rear axle assembly.

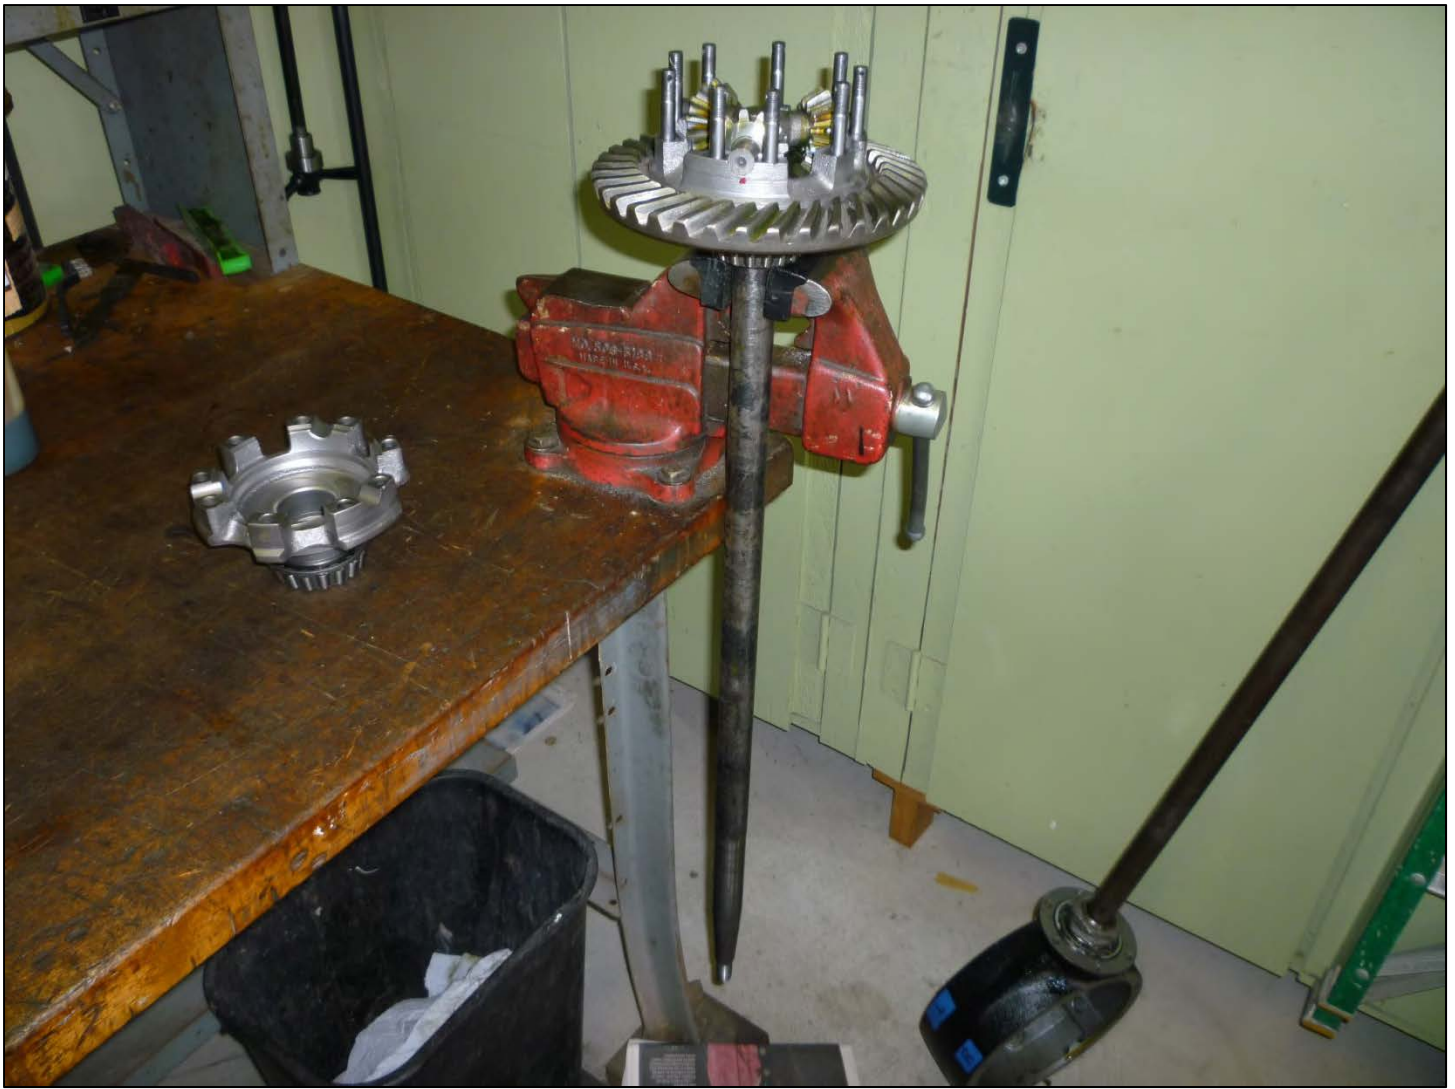
With the two axle shafts ready for installation, the carrier is taken apart and the spider gear yoke modified as a tool removed and replaced with the complete spider gear assembly that was previously cleaned up.

In the photo the left axle shaft is shown inserted into the ring gear side of the carrier. The spider gear assembly is placed on top. The right axle shaft will be inserted into the right carrier halve shown sitting on the workbench. The hardware is liberally coated with 600W oil during the assembly.

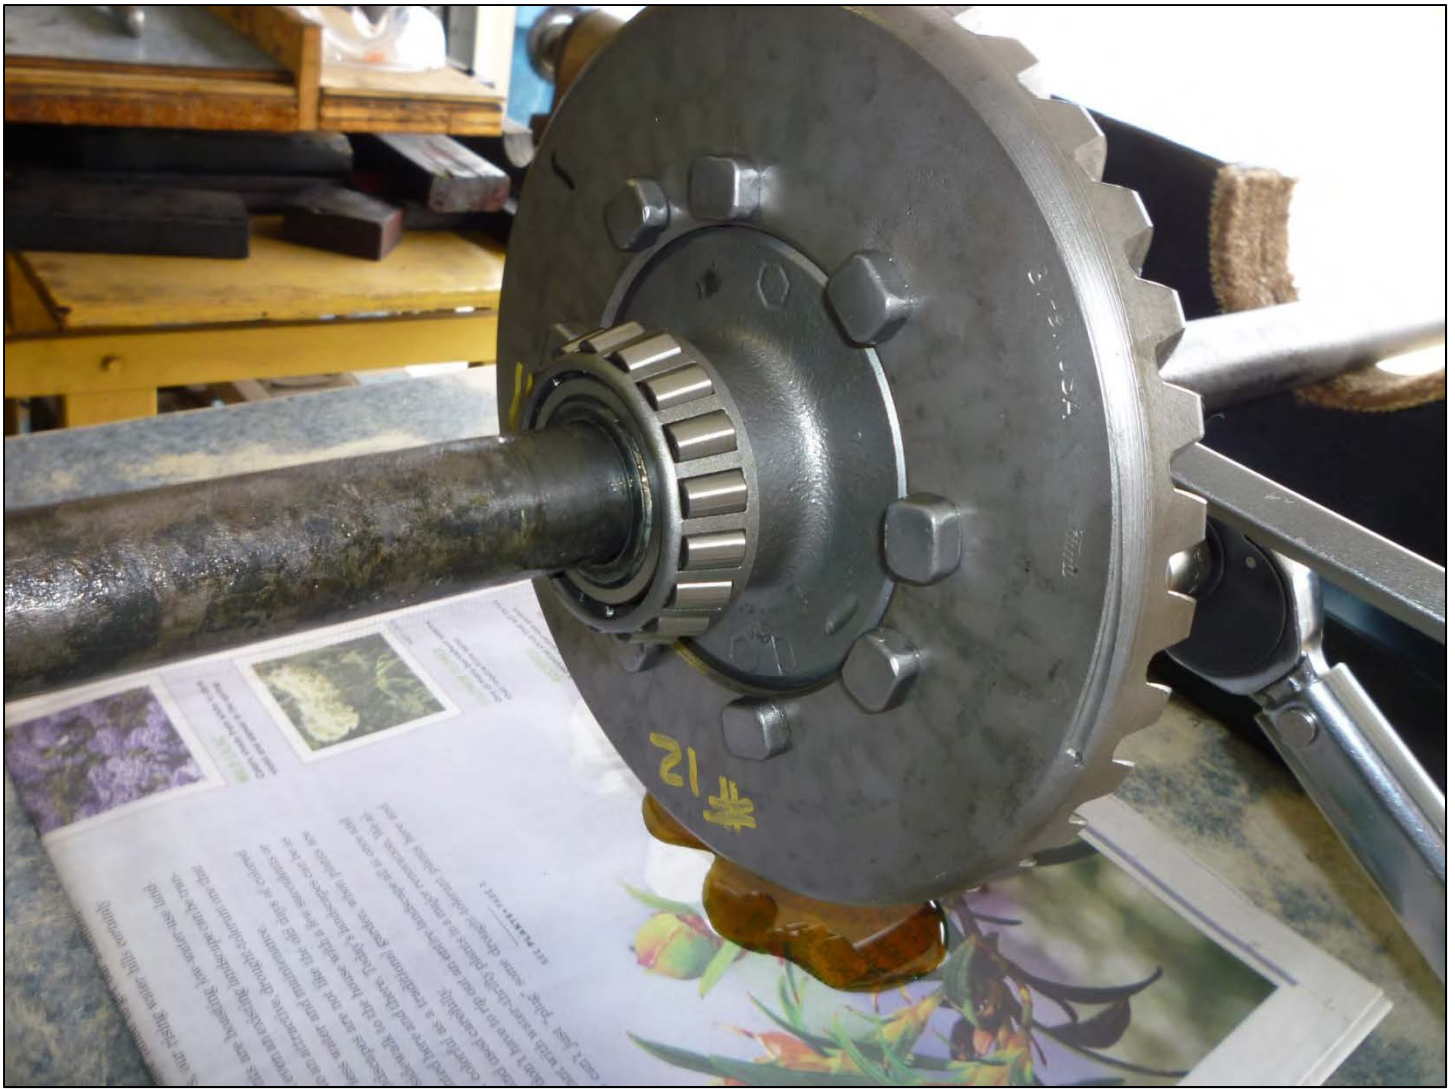
With the axle assembly in the horizontal cradle the nine carrier bolt and nuts will be torqued to 35 ft. lbs. before doing that rotate each of the bolts so that the wide part of the rectangular bolt head is perpendicular to the carrier hub. This will align the safety wire holes in the bolt with the carrier. Use a 5\8" open end wrench to hold the head in place while the nut is tightened.

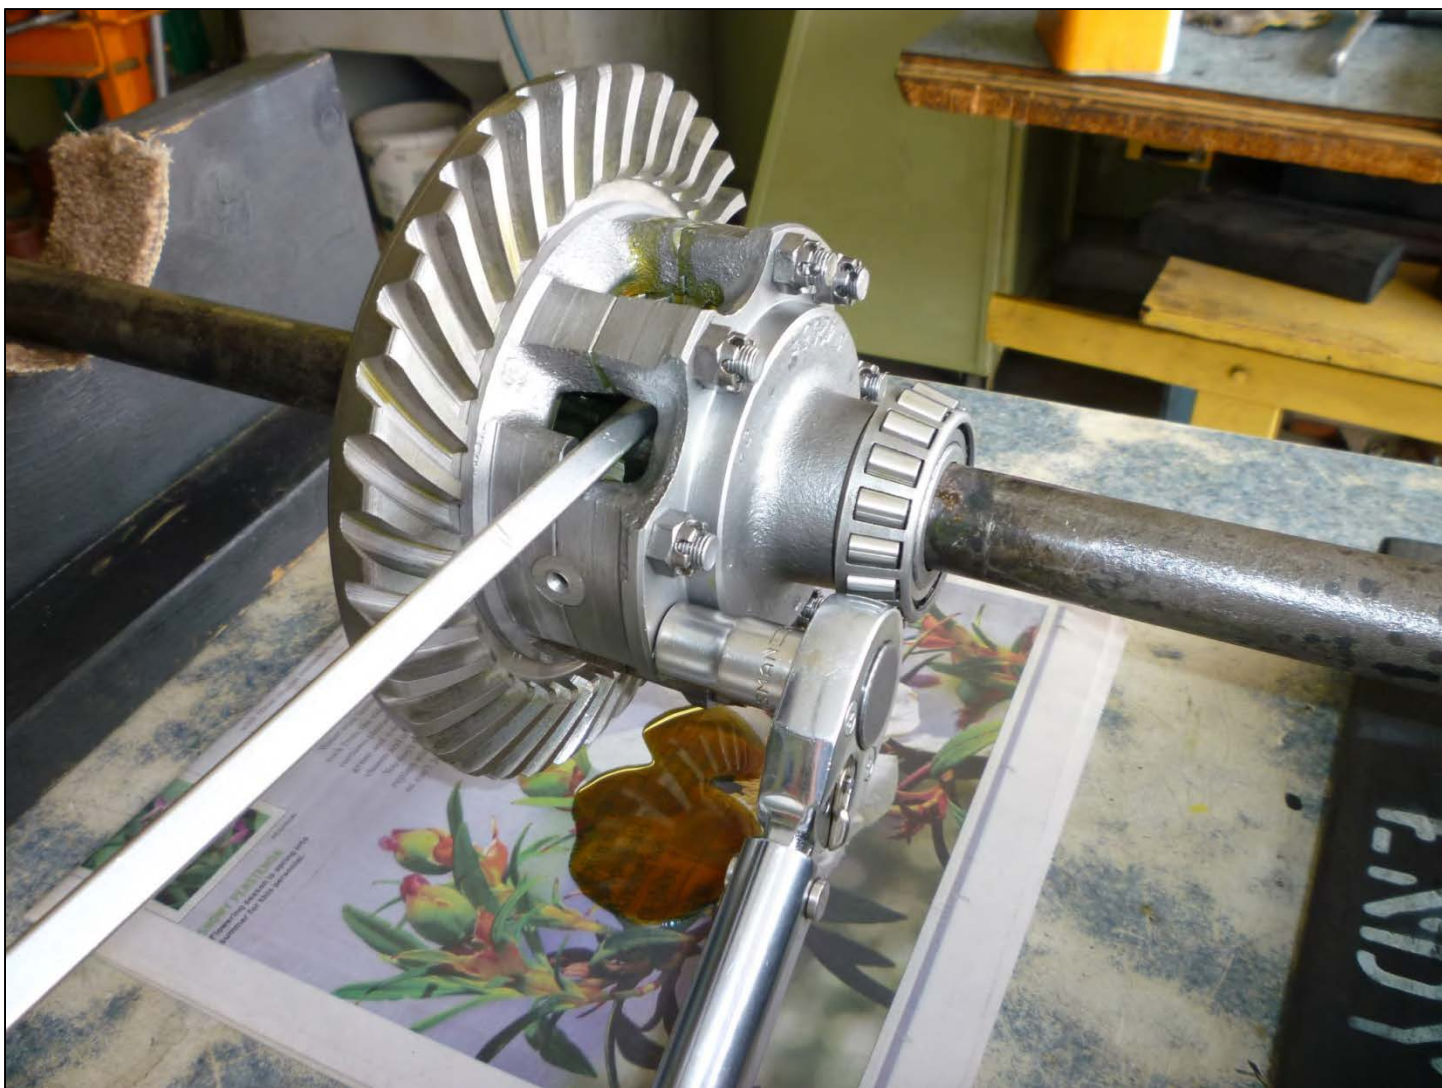
A long screwdriver inserted into the openings of the carrier is used to hold the carrier from rotating while the nuts are torqued down.

After each nut is torqued note where the safety wire hole is located in each castle nut. If the hole is not in a window, tighten the nut more to bring it into a window.

Before applying the safety wire grasp each axle up close to the bearings and rotate the axles by hand in opposite directions. There should be no binding.

Some reproduction axle shafts are not made correctly and will bind the inside of the carrier. These should not be used.

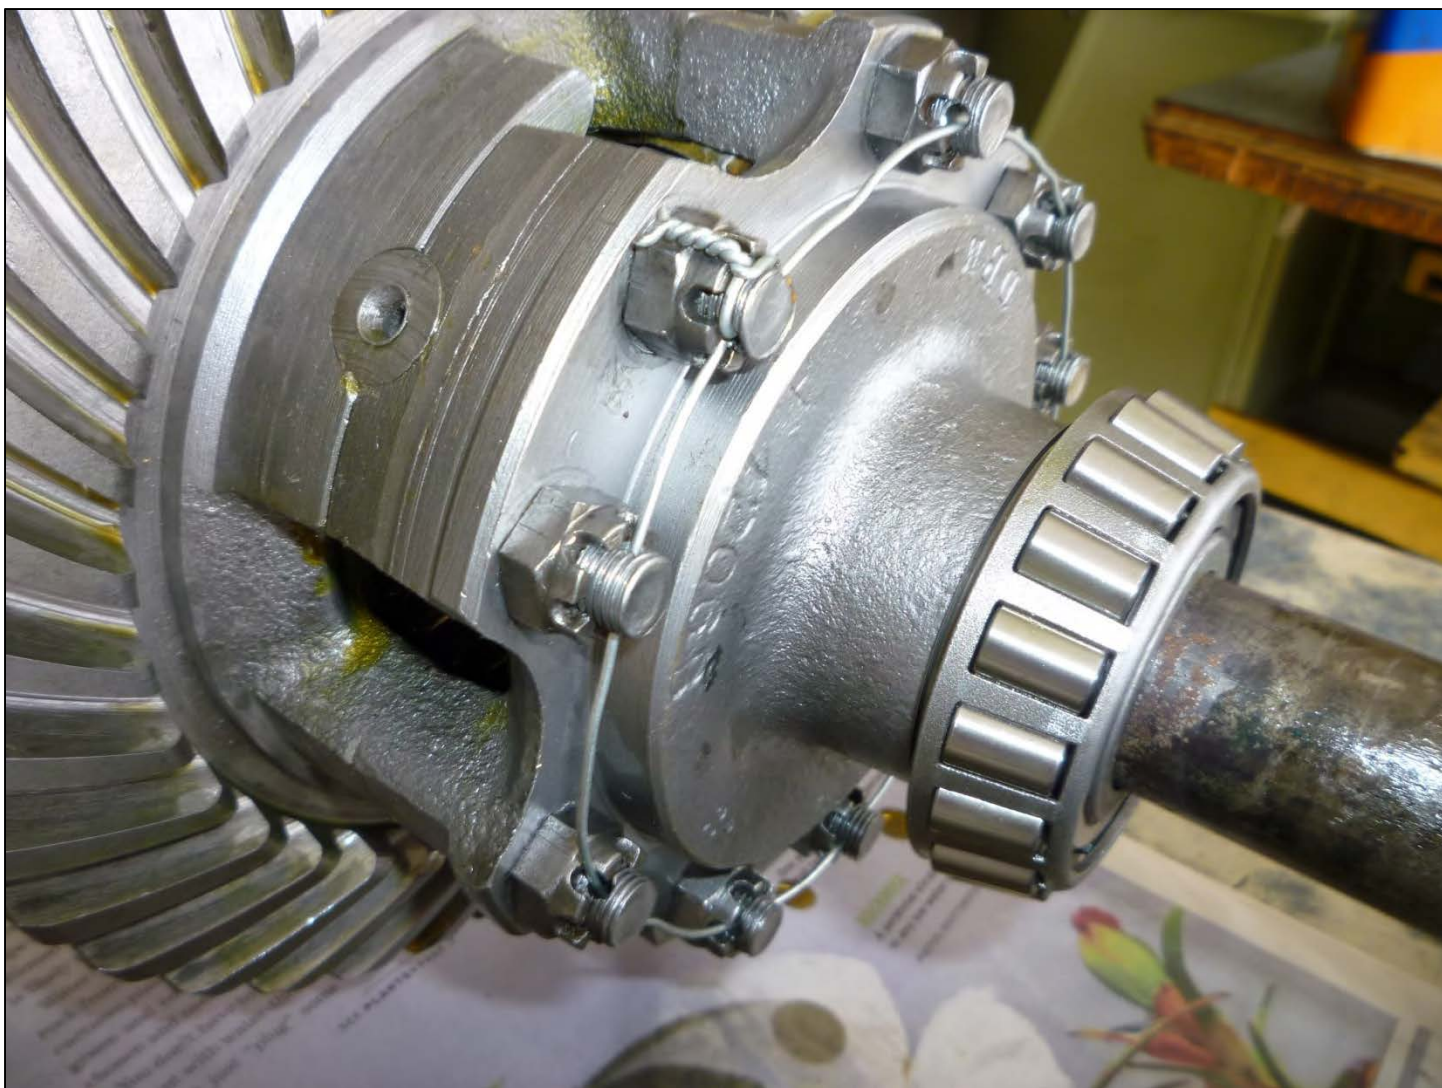
With all the nuts torqued down and each hole in a window safety wire the assembly. My technique is to form the safety wire in a perfect circle, overlap the wire by passing it through a bolt hole in opposite direction and twisting it as shown. It may not be according to Henry, but it looks very neat and is my Hallmark.

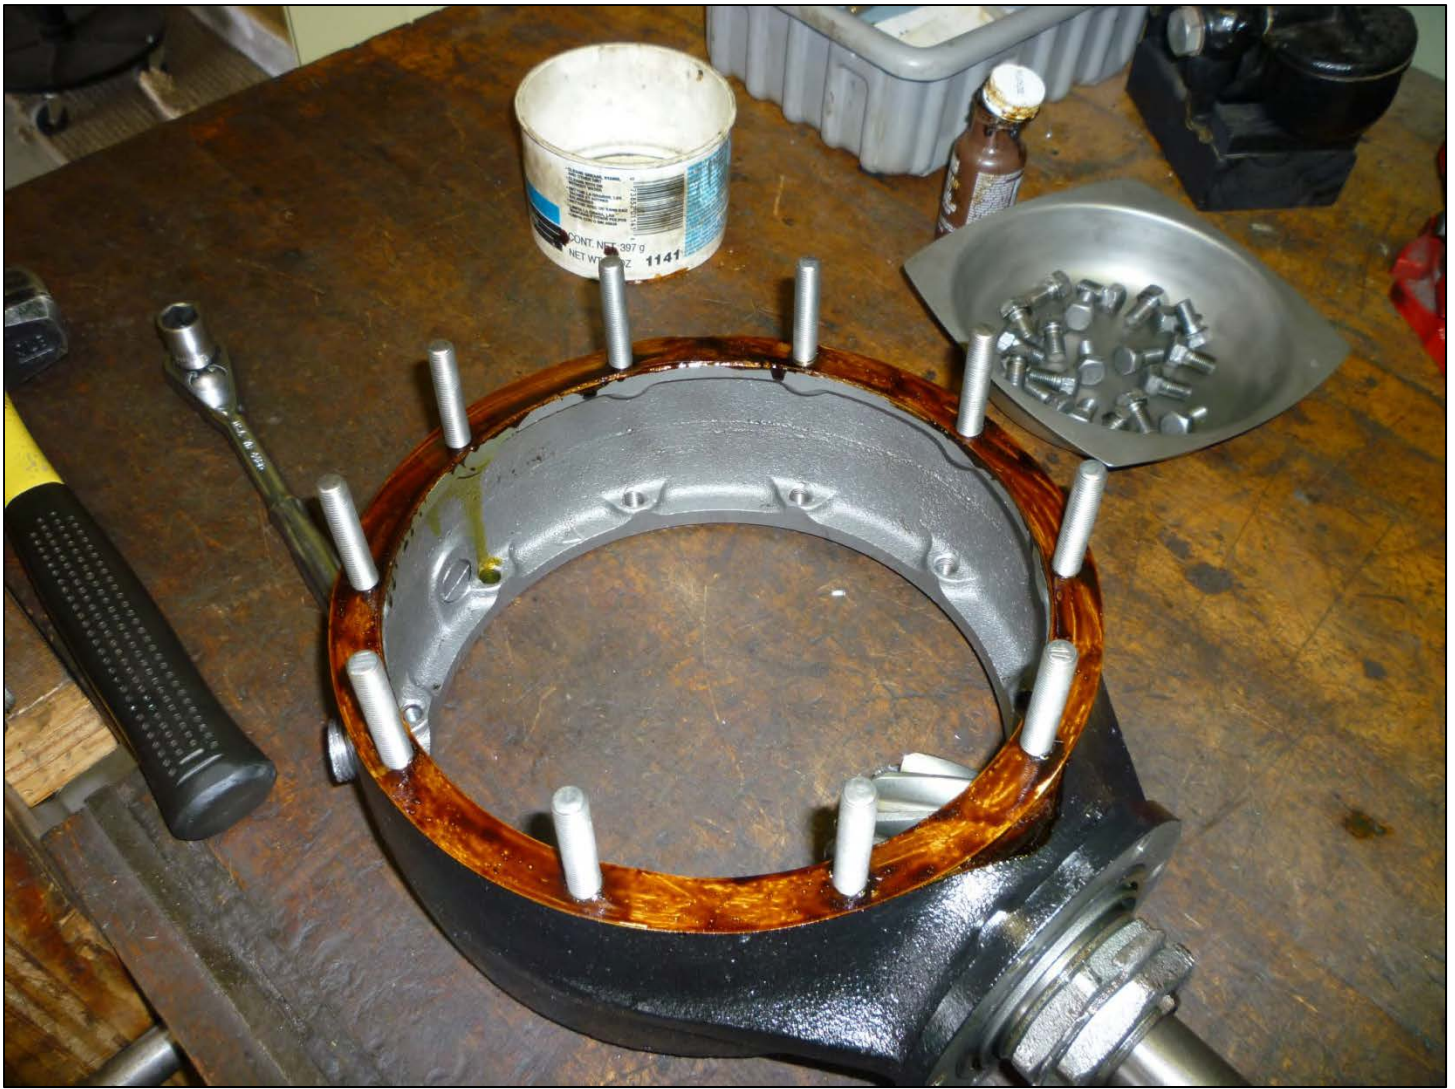
The next step is to do the final assembly with all the hardware installed. The photo shows the right side of the banjo with the two gaskets coated with Indian Head gasket sealer. Both sides of each gasket are coated. The threaded studs are used to align the gaskets with all the bolt holes.

Indian Head sealer is good to use in this application. It will get into the threads of the banjo and form an oil seal. Most of it will squeeze out when the banjo bolts are torqued, but it will form a good seal and will not affect gasket thickness and the pre-load previously established.

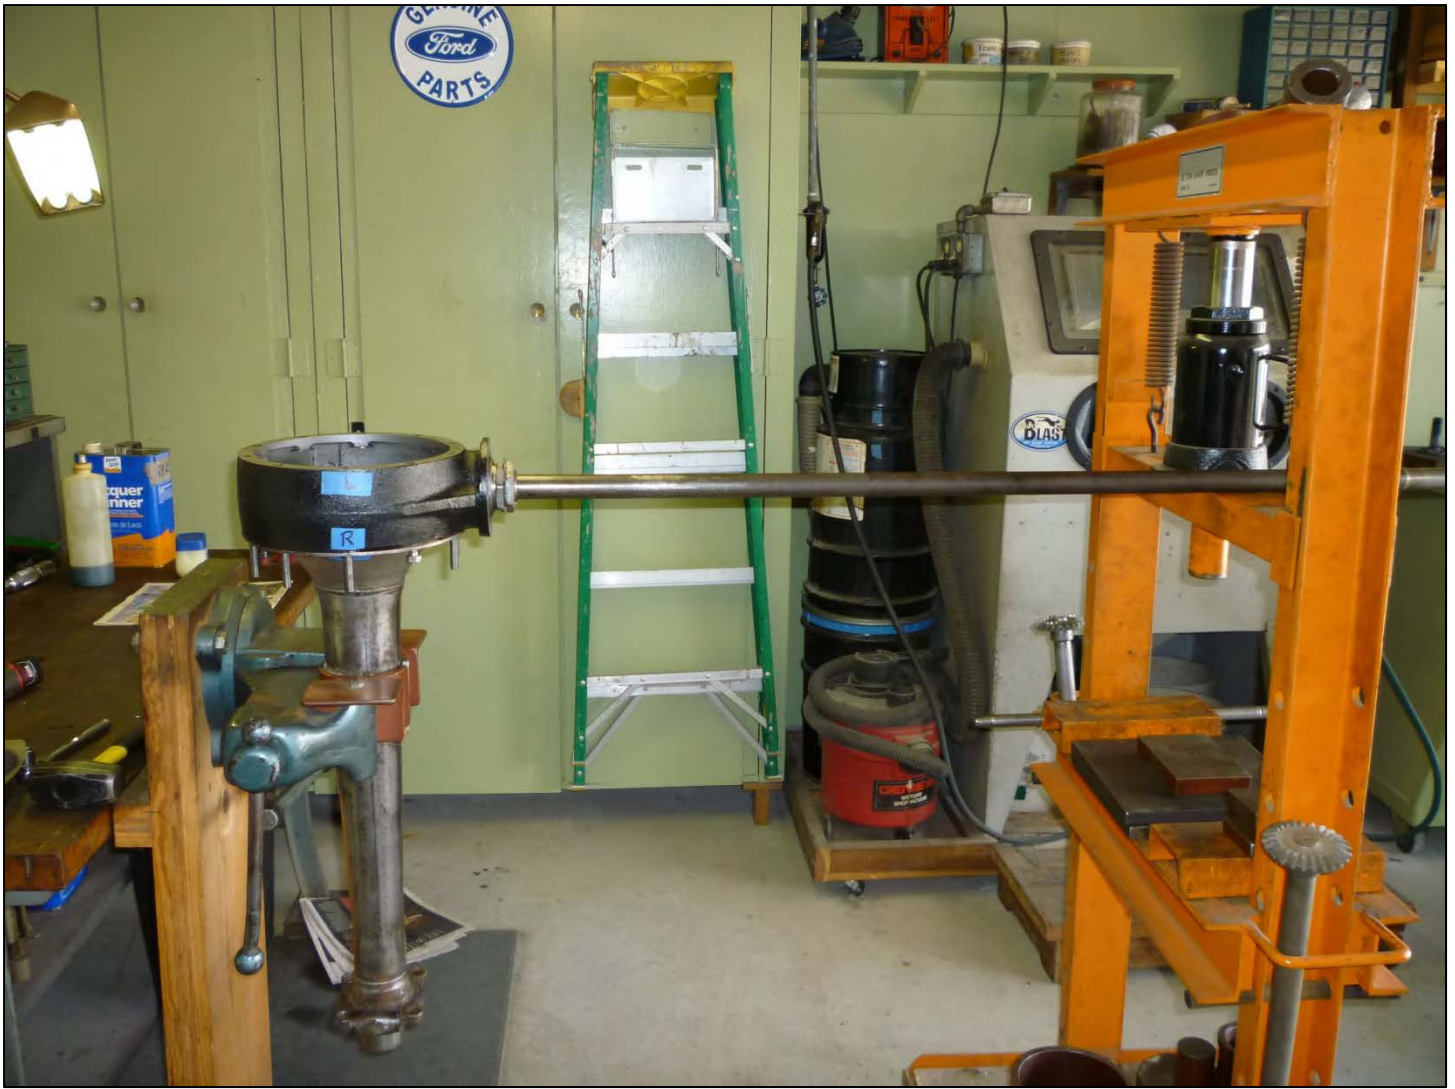
The banjo with the drive shaft and pinion assembly installed is bolted to the right axle housing as before.

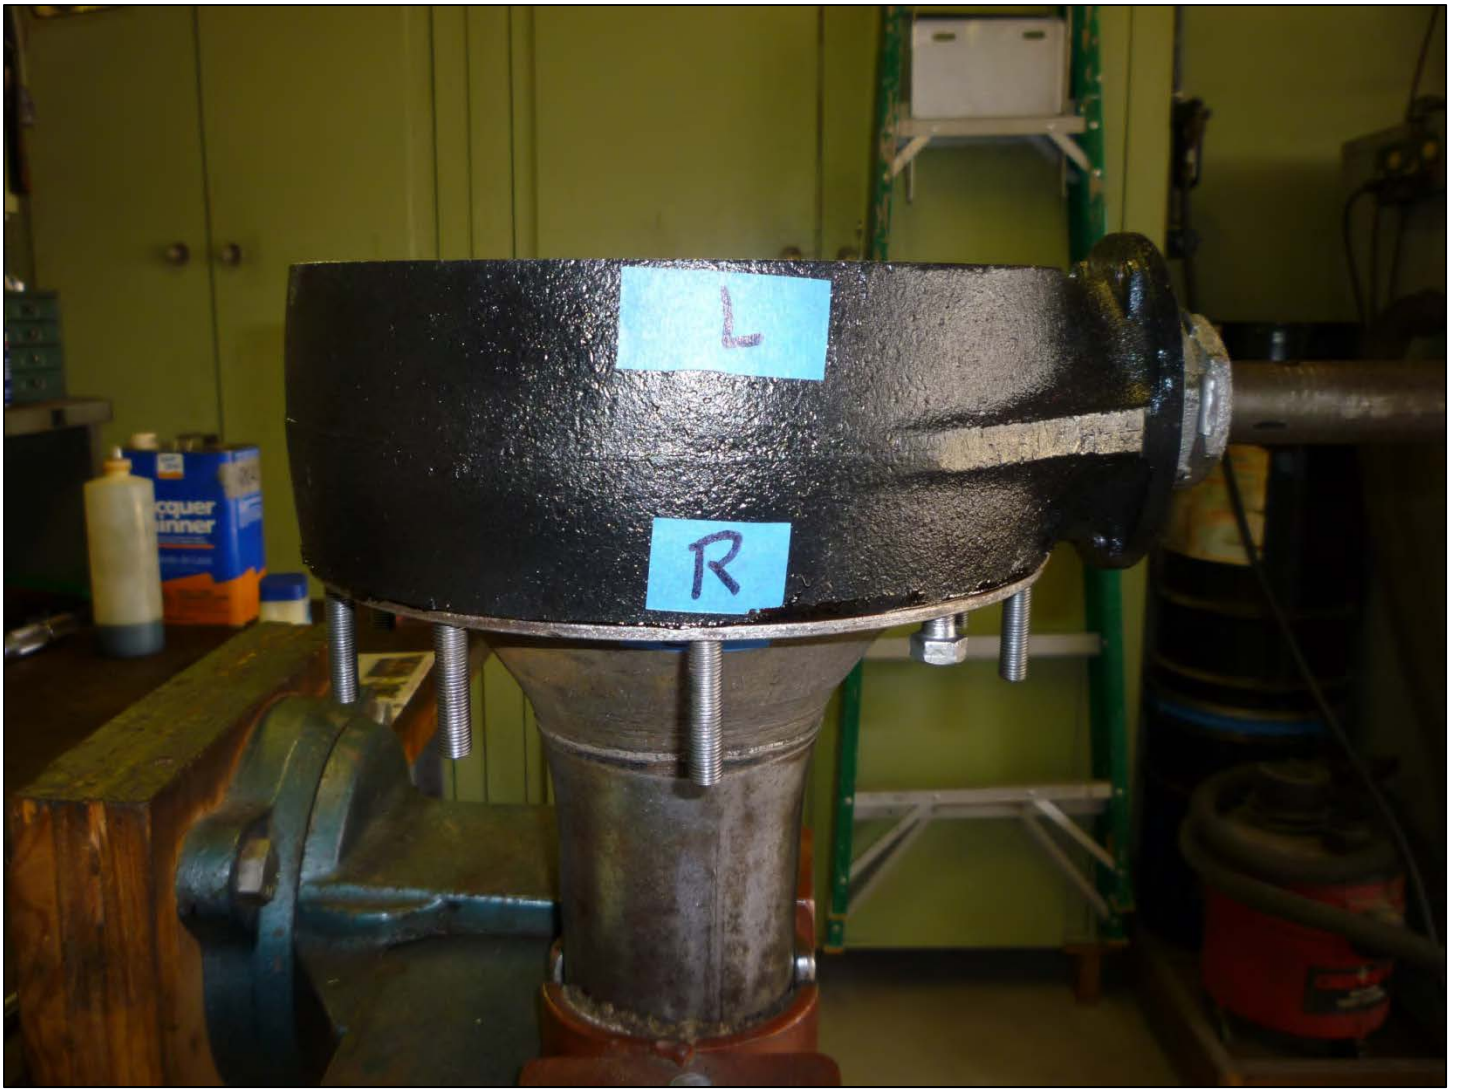
As each threaded stud is removed from the right side of the banjo a banjo bolt is installed. When all the bolts are in place they are torqued down to 35 ft. lbs.

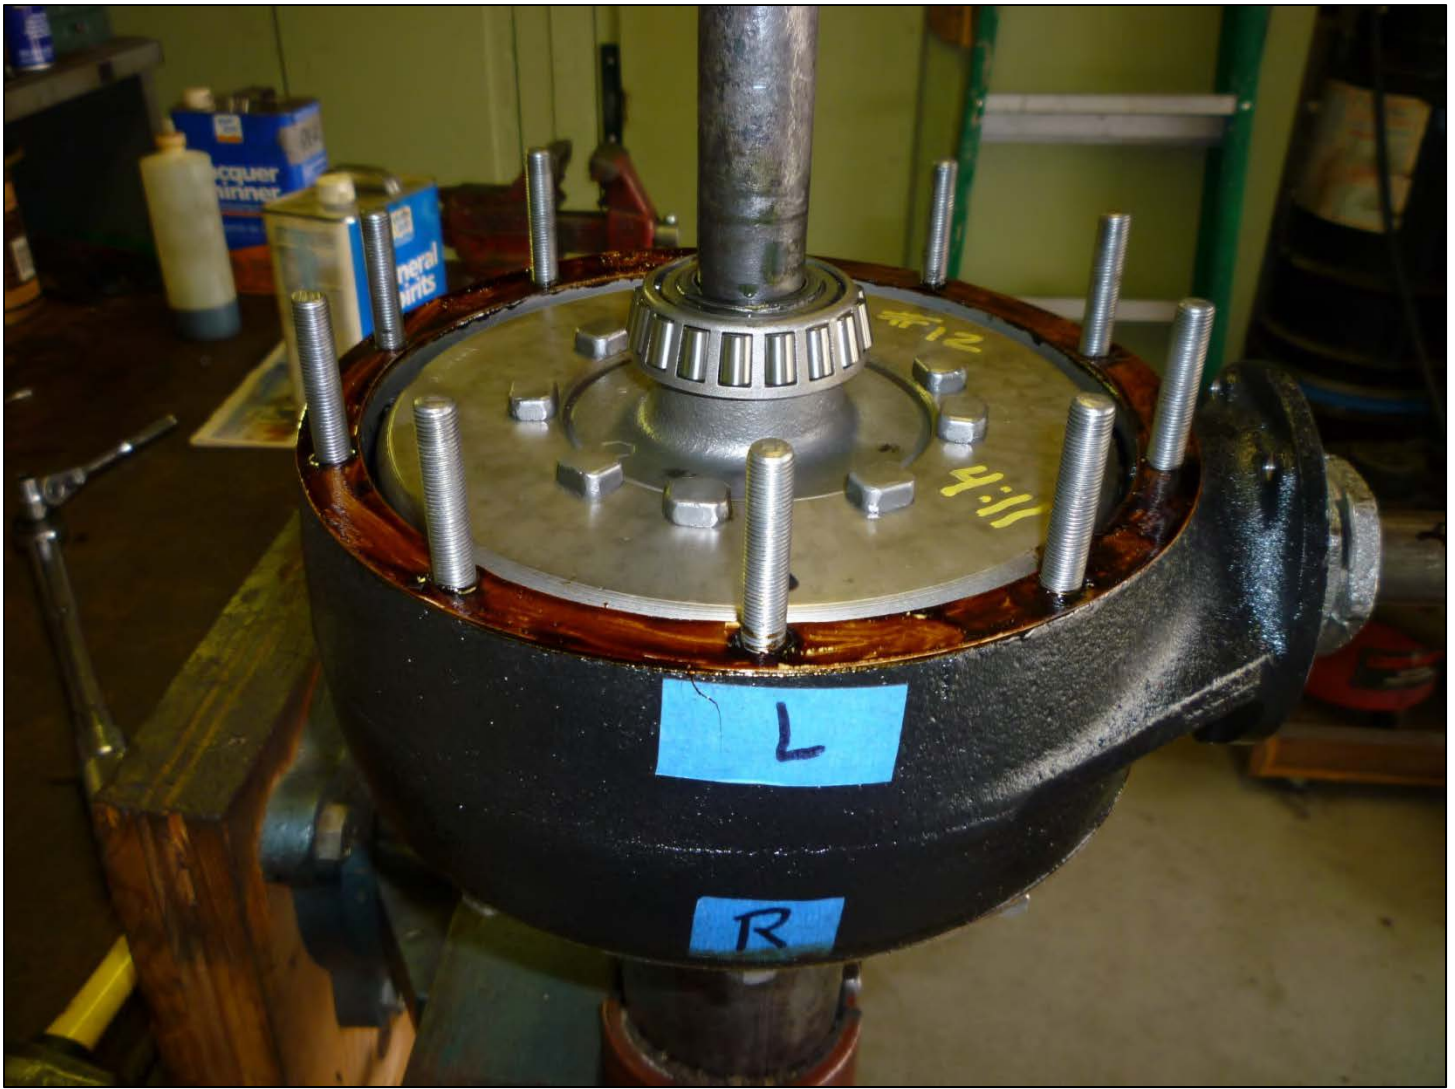
The fully assembled carrier with the spider gears with both axles installed is lowered down into the banjo. The flat side of the ring gear faces up as before. The banjo gasket is installed on the left side of the banjo. Both sides of the gasket are coated with Indian Head gasket sealer. The threaded studs are again used to align all the banjo bolt holes.

It should be noted that the carrier assembly with the two axles can be installed from either the right or left side. The correct position is to have the ring gear on the left side of the pinion gear. It is possible to install the assembly so that the ring gear is on the right side of the pinion gear.

The rear axle assembly when installed in the car with the ring gear on the wrong side will function when the car is all back together, however, there will be one speed forward and three speeds in reverse.

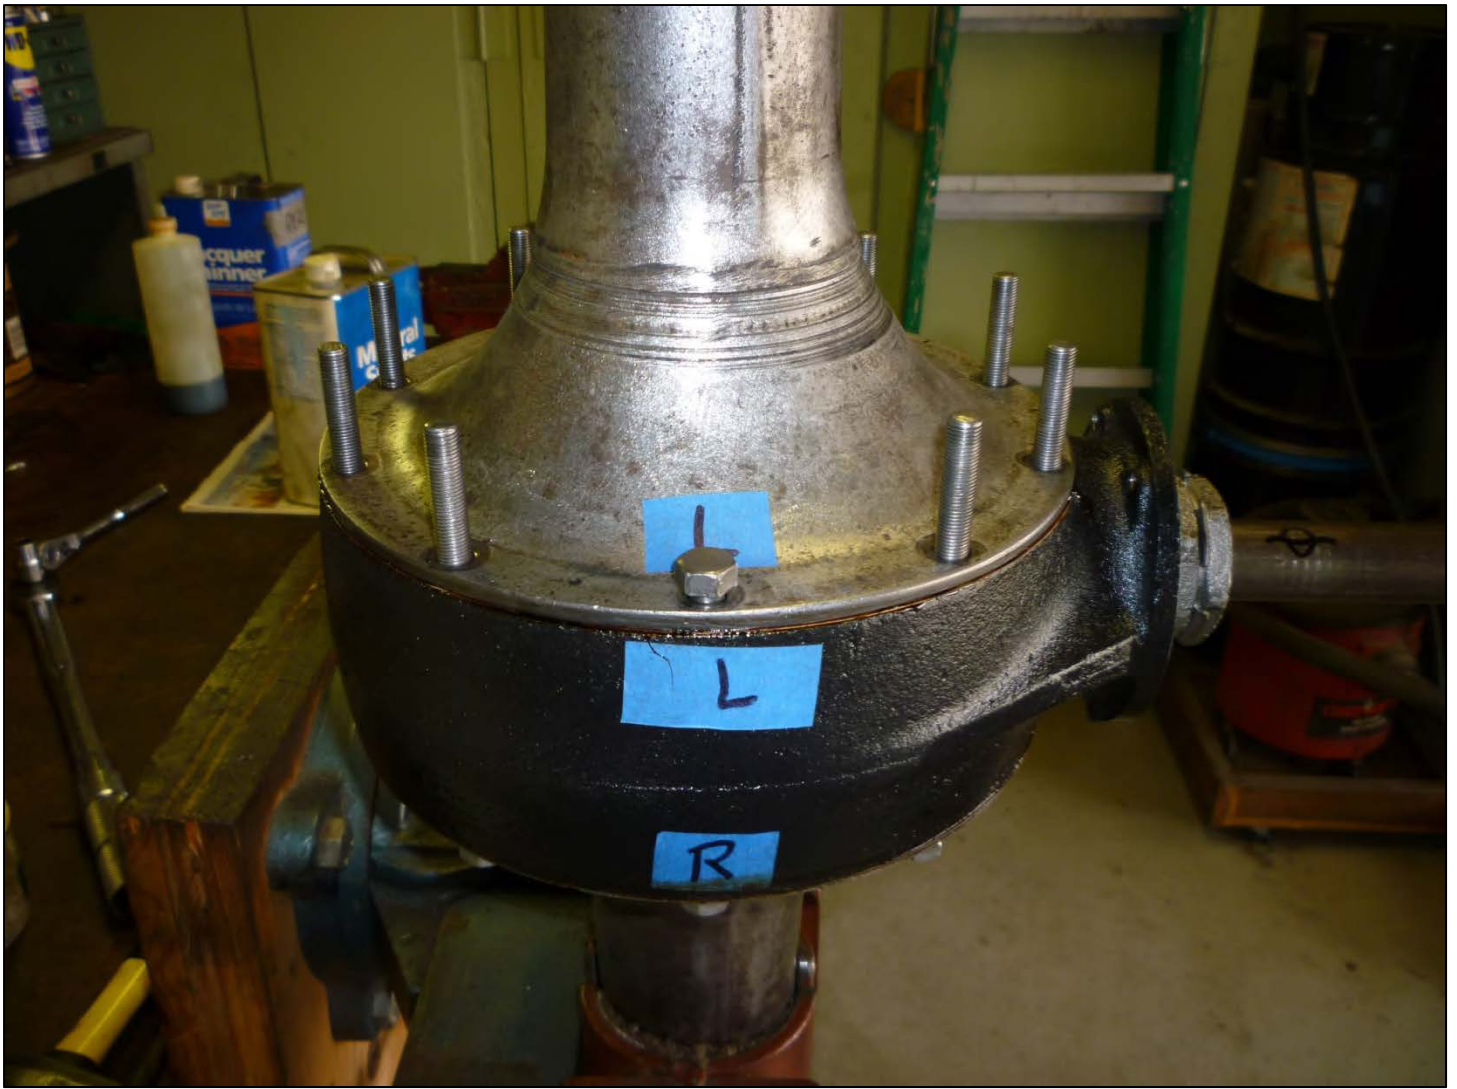
The left axle housing is placed over the left side of the banjo. A banjo bolt is installed as each threaded stud is removed. When all the bolts are installed they are torqued down to 35 ft. lbs.

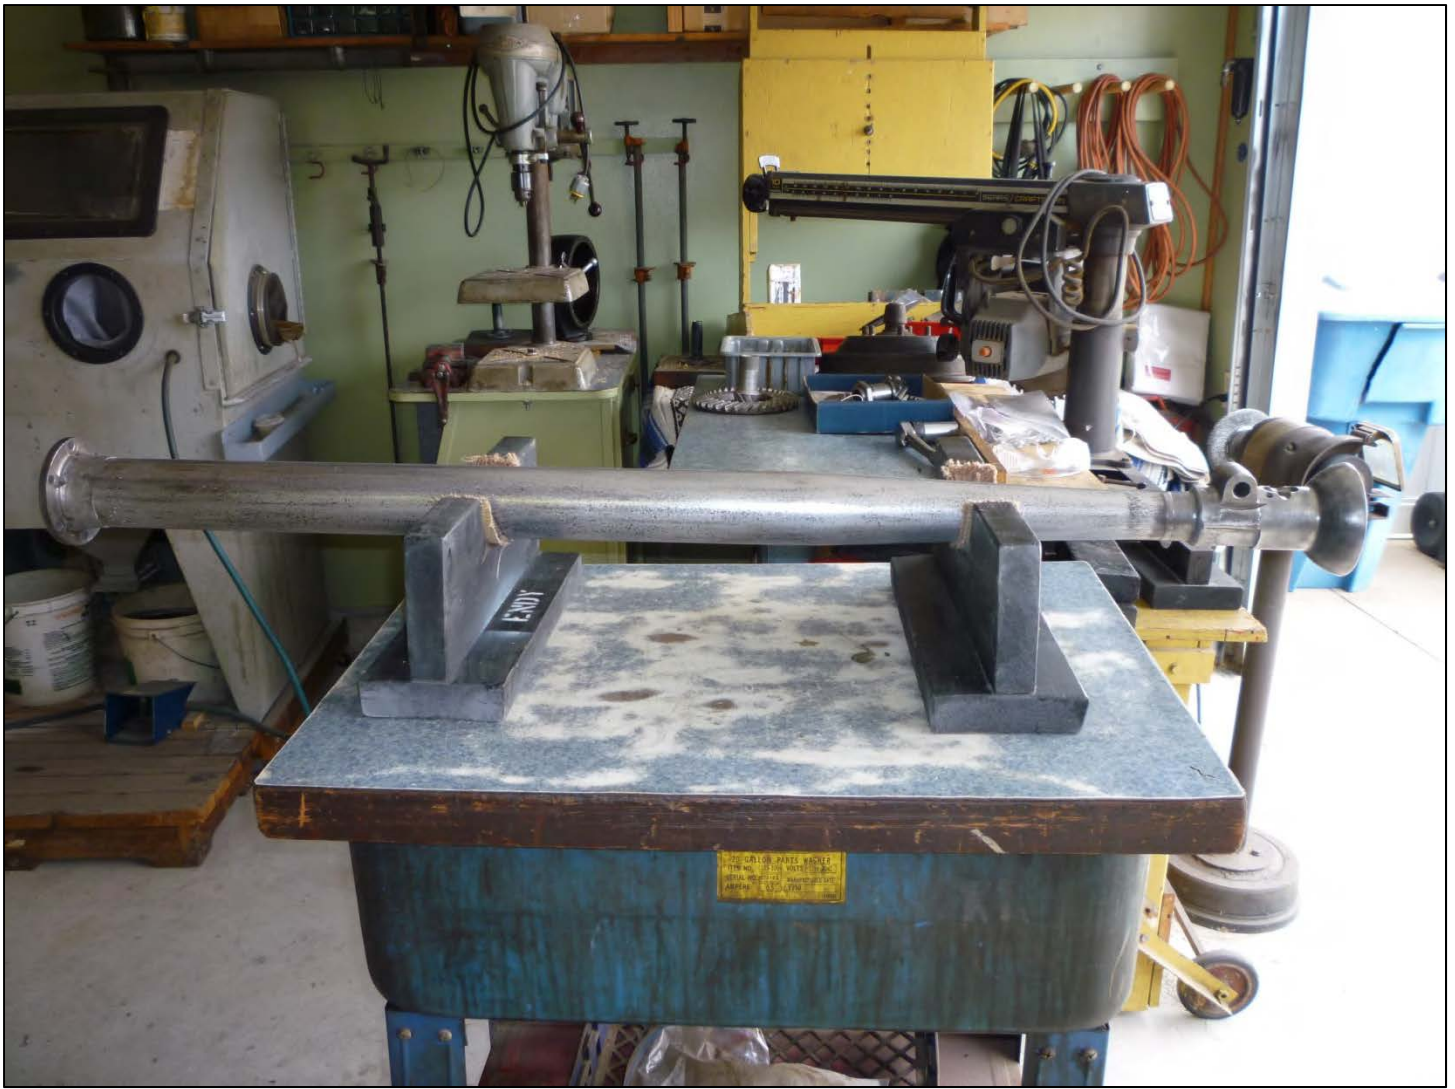
The torque tube has been cleaned up. The old seal and the roller bearing race have been removed. The exterior of the housing has been sanded down.

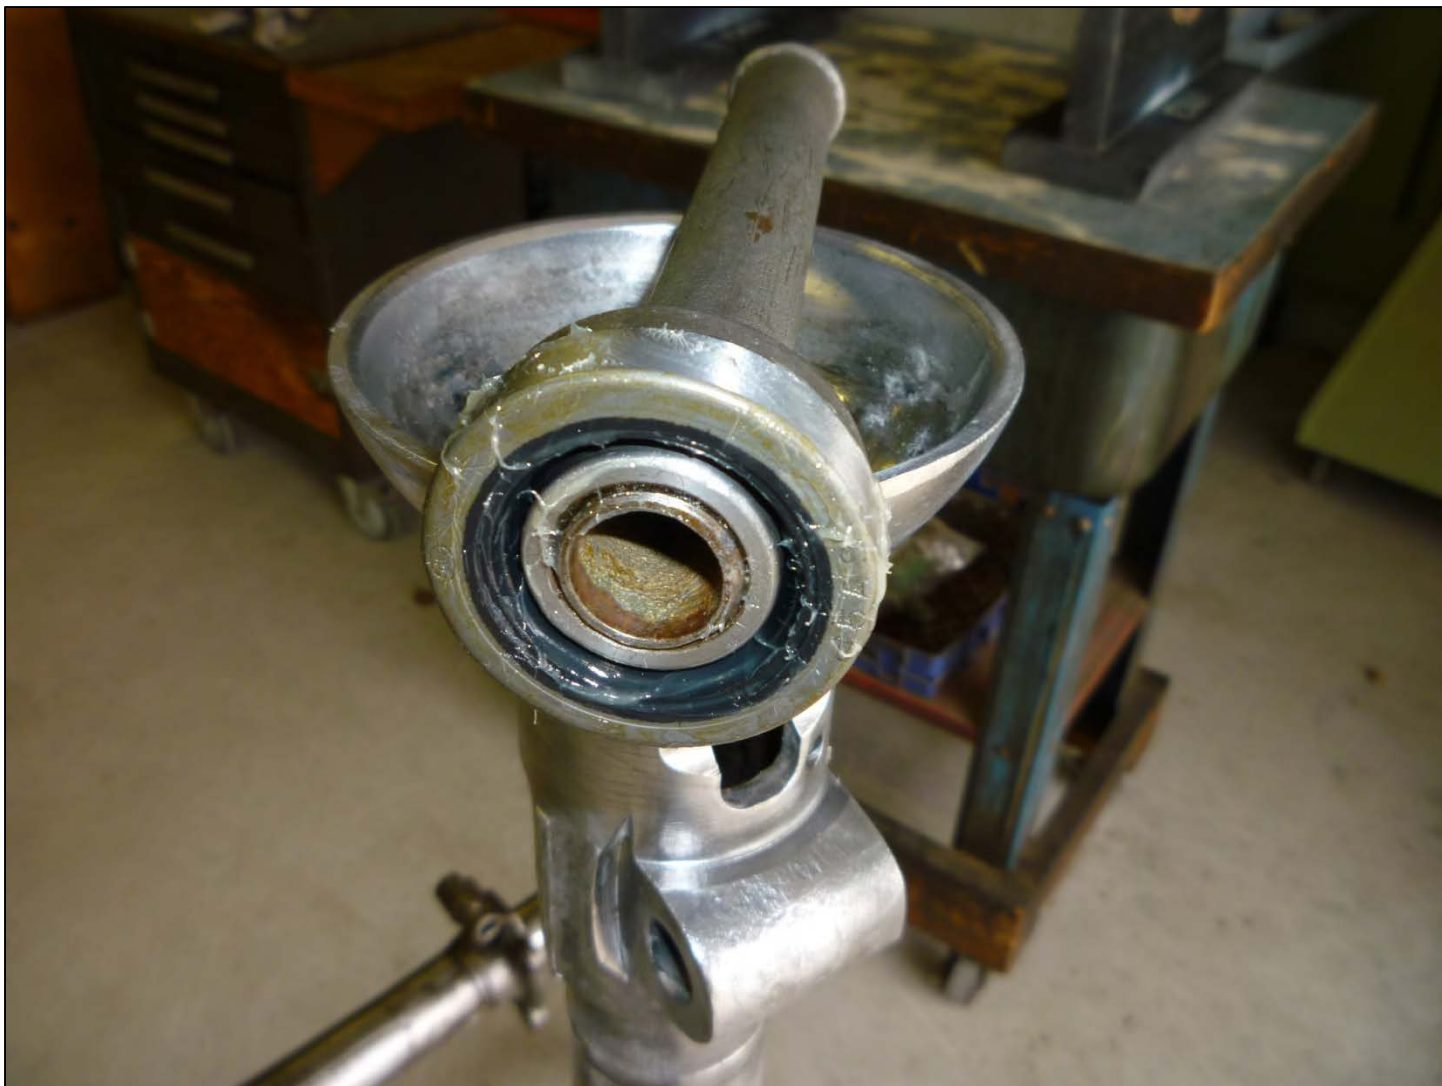
A new grease seal is installed into the front of the torque tube before the roller bearing race is installed. A short seal insertion tool is used. The seal is the same part number as the two seals that were installed in the axle housing.

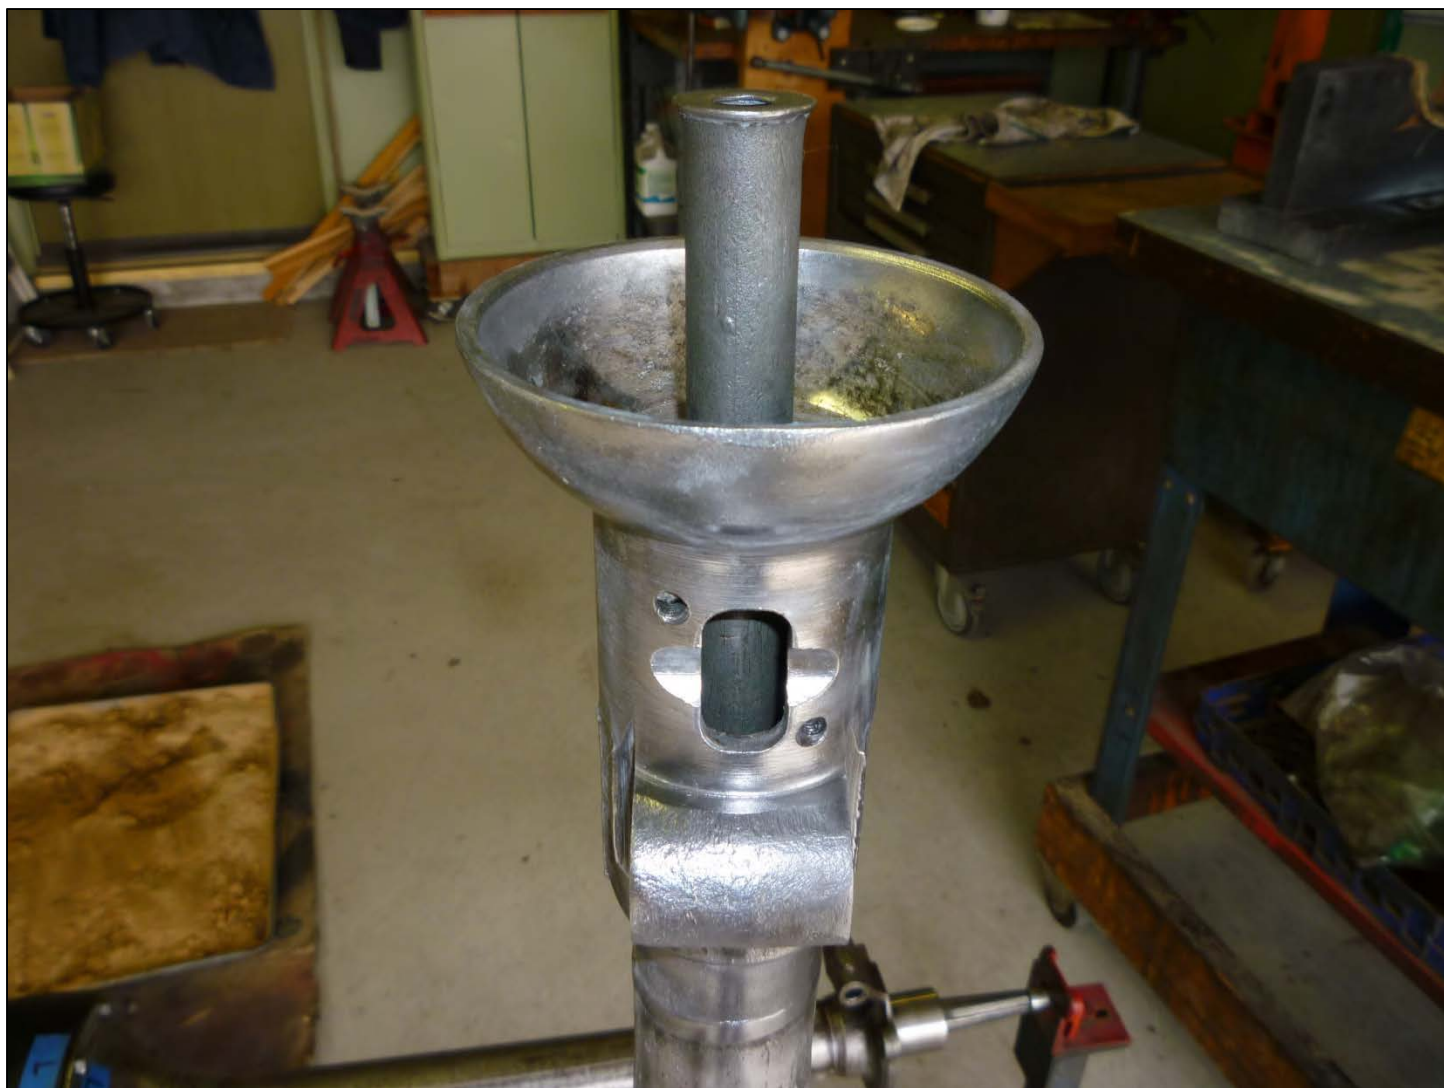
The torque tube is stood up vertically and the seal is driven in with a hammer. It takes about 4 to 5 hammer blows to seat the seal. When the seal seats the hammer blows will change from a dull thud to a ringing sound.

It is important that the seal be installed before the bearing race is installed. If the race is accidentally installed first you will have a difficult time removing it and will likely destroy it in the process.

It is best to use an original race if possible. Many of the reproductions on the market are of very poor quality. The one Bratton's sell is of good quality.

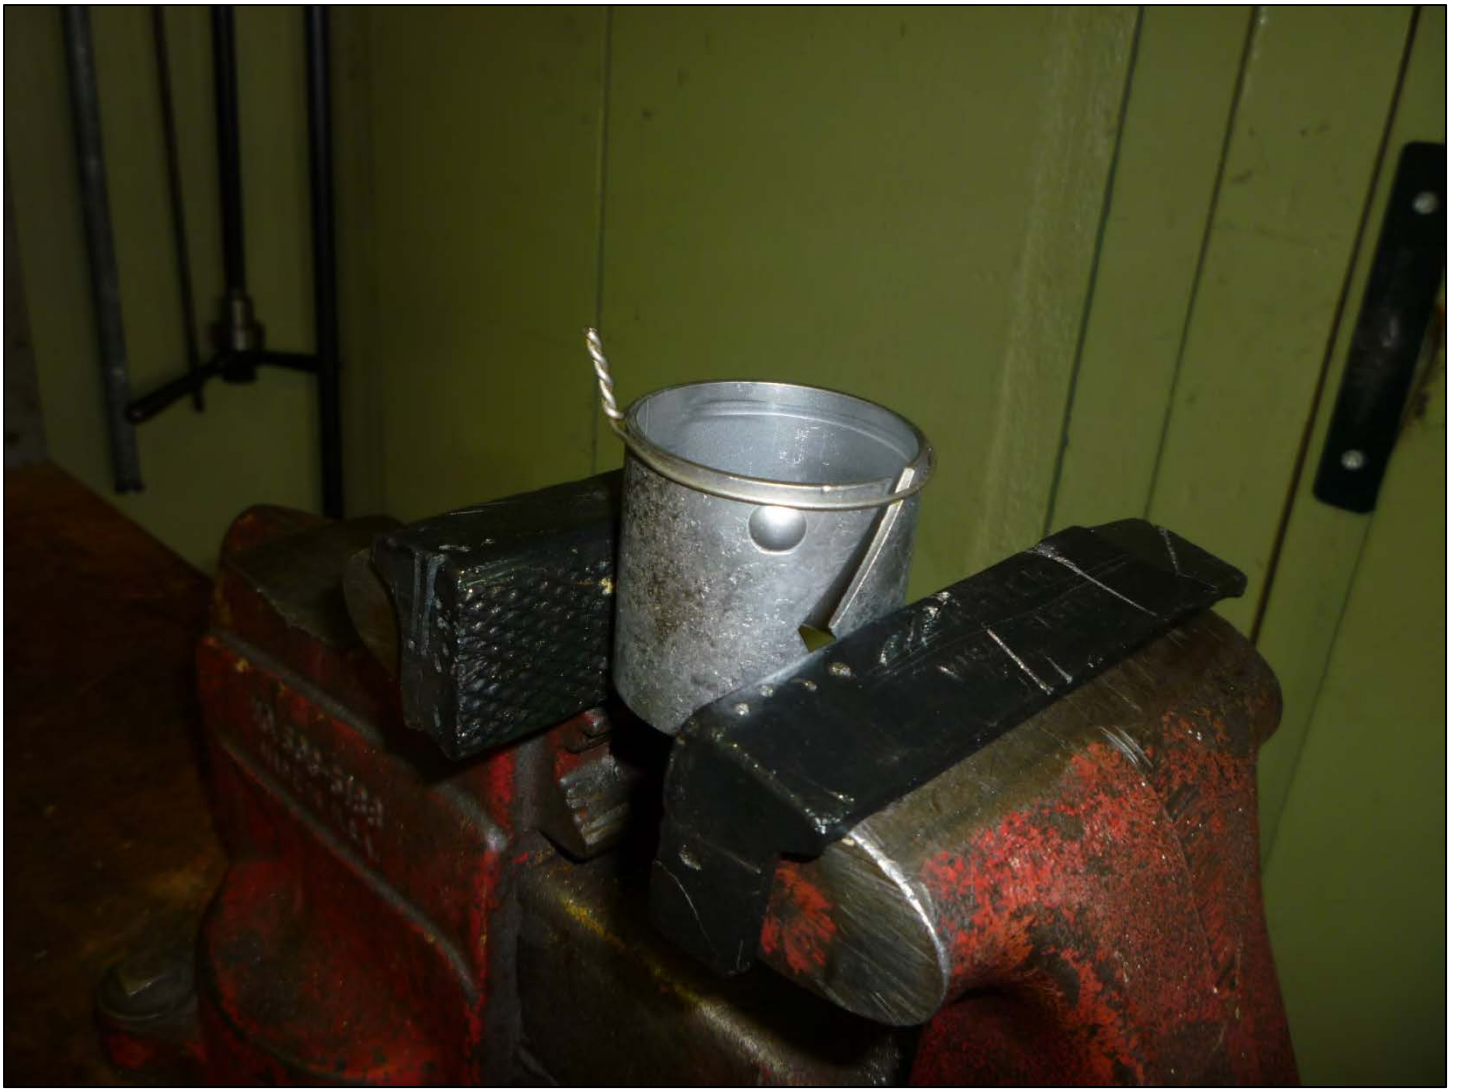
The roller bearing race (sometimes referred to as a sleeve) is prepared prior to installation in the front of the torque tube. The race has a split in it that expands when outside the torque tube. It must be compressed slightly for installation; the race is placed in a vice and squeezed slightly. A piece of wire is wrapped around the top to hold it slightly squeezed.
