Rear Axle Assembly Rebuild Pictorial 2015

by Tom Endy

The following series of photos were taken during the rebuild of a Model A rear axle assembly.

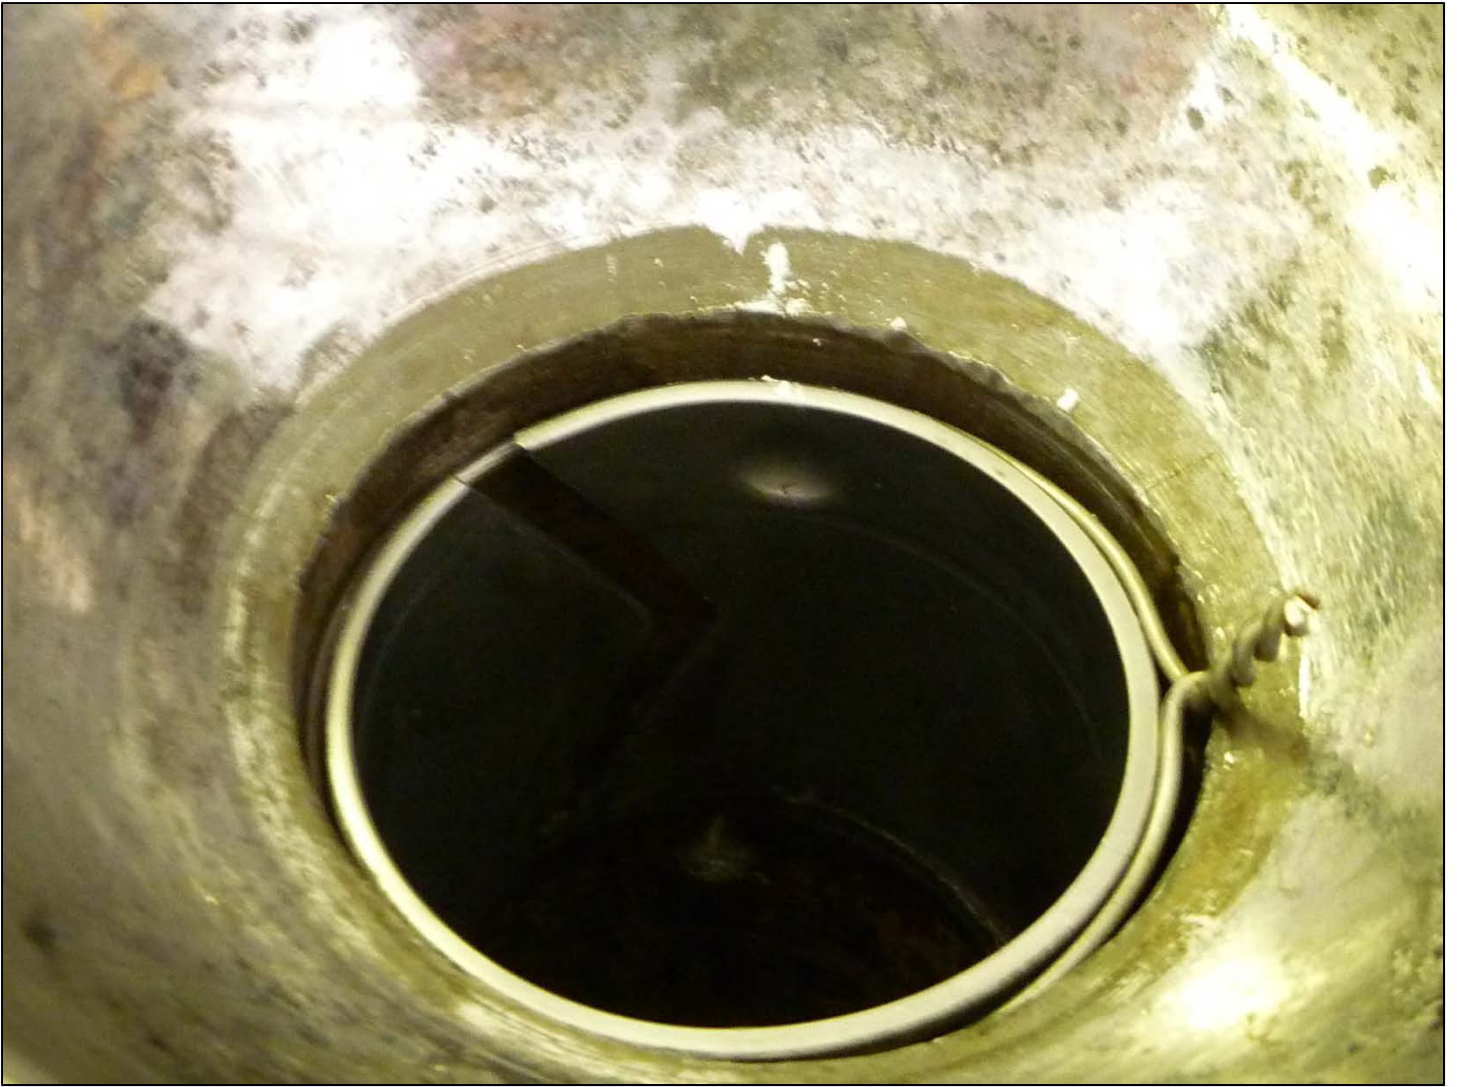
A chalk mark is placed at the top edge of the sleeve right above the dimple. Another chalk mark is placed on the torque tube directly above the recess where the dimple fits into. The two chalk marks are aligned before the sleeve is driven into place.

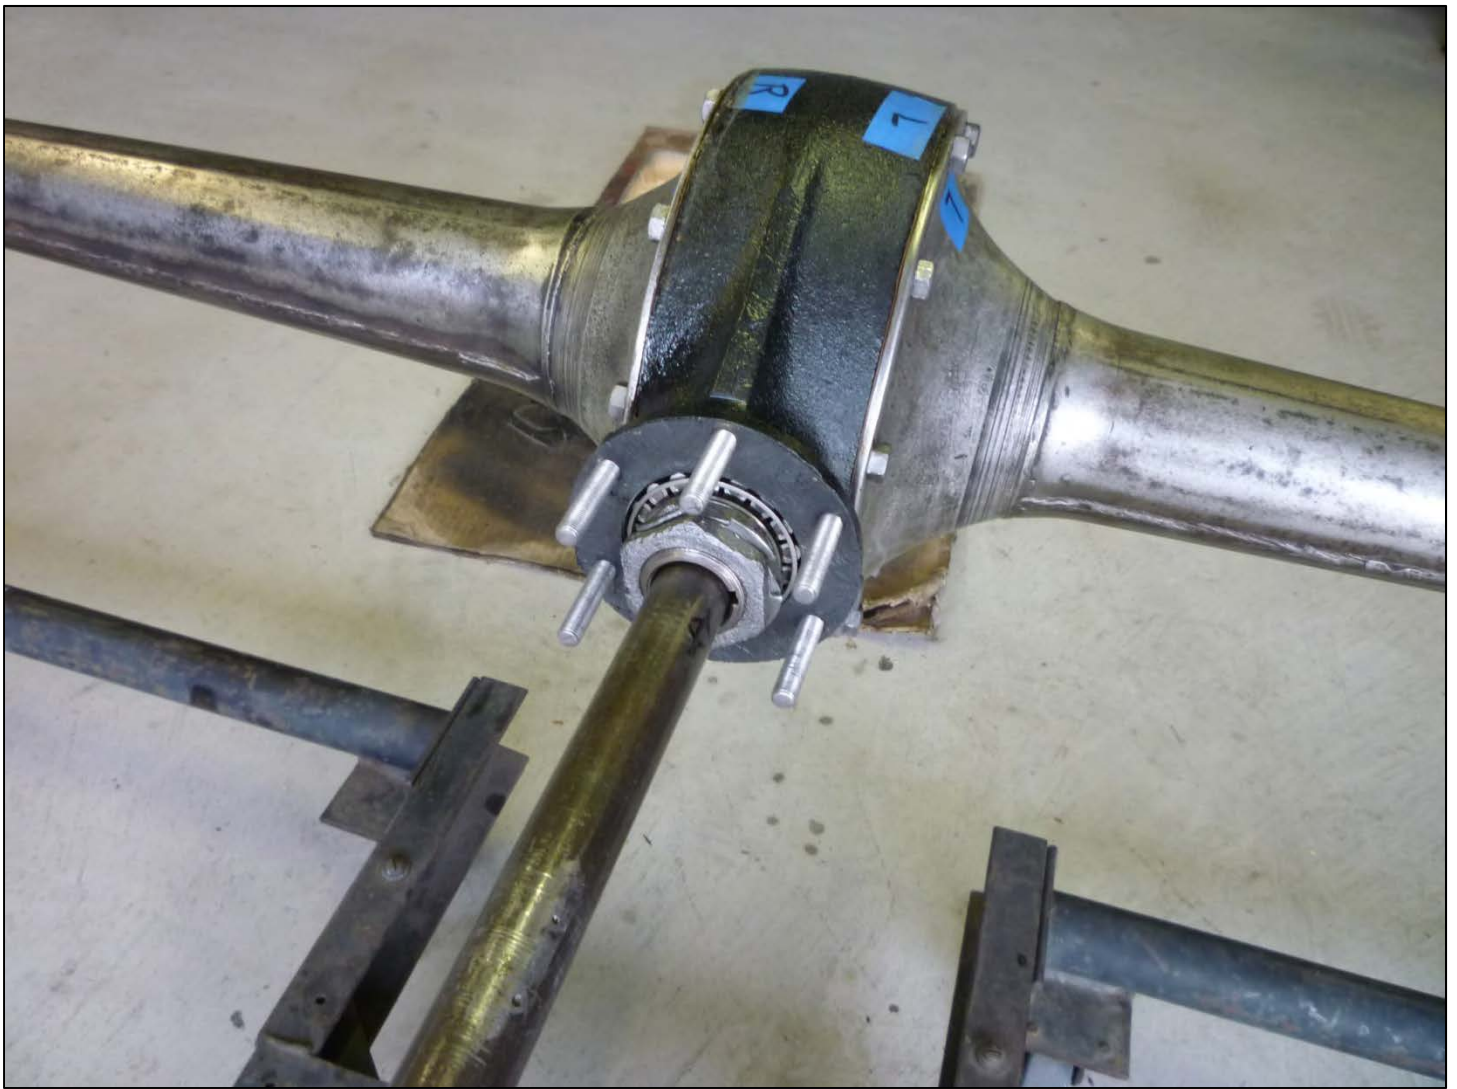
The torque tube is ready for installation. A gasket is coated with sealer and placed on the flange of the banjo. Six of the threaded studs are used to align all the holes. The torque tube is then slid over it and bolted down.

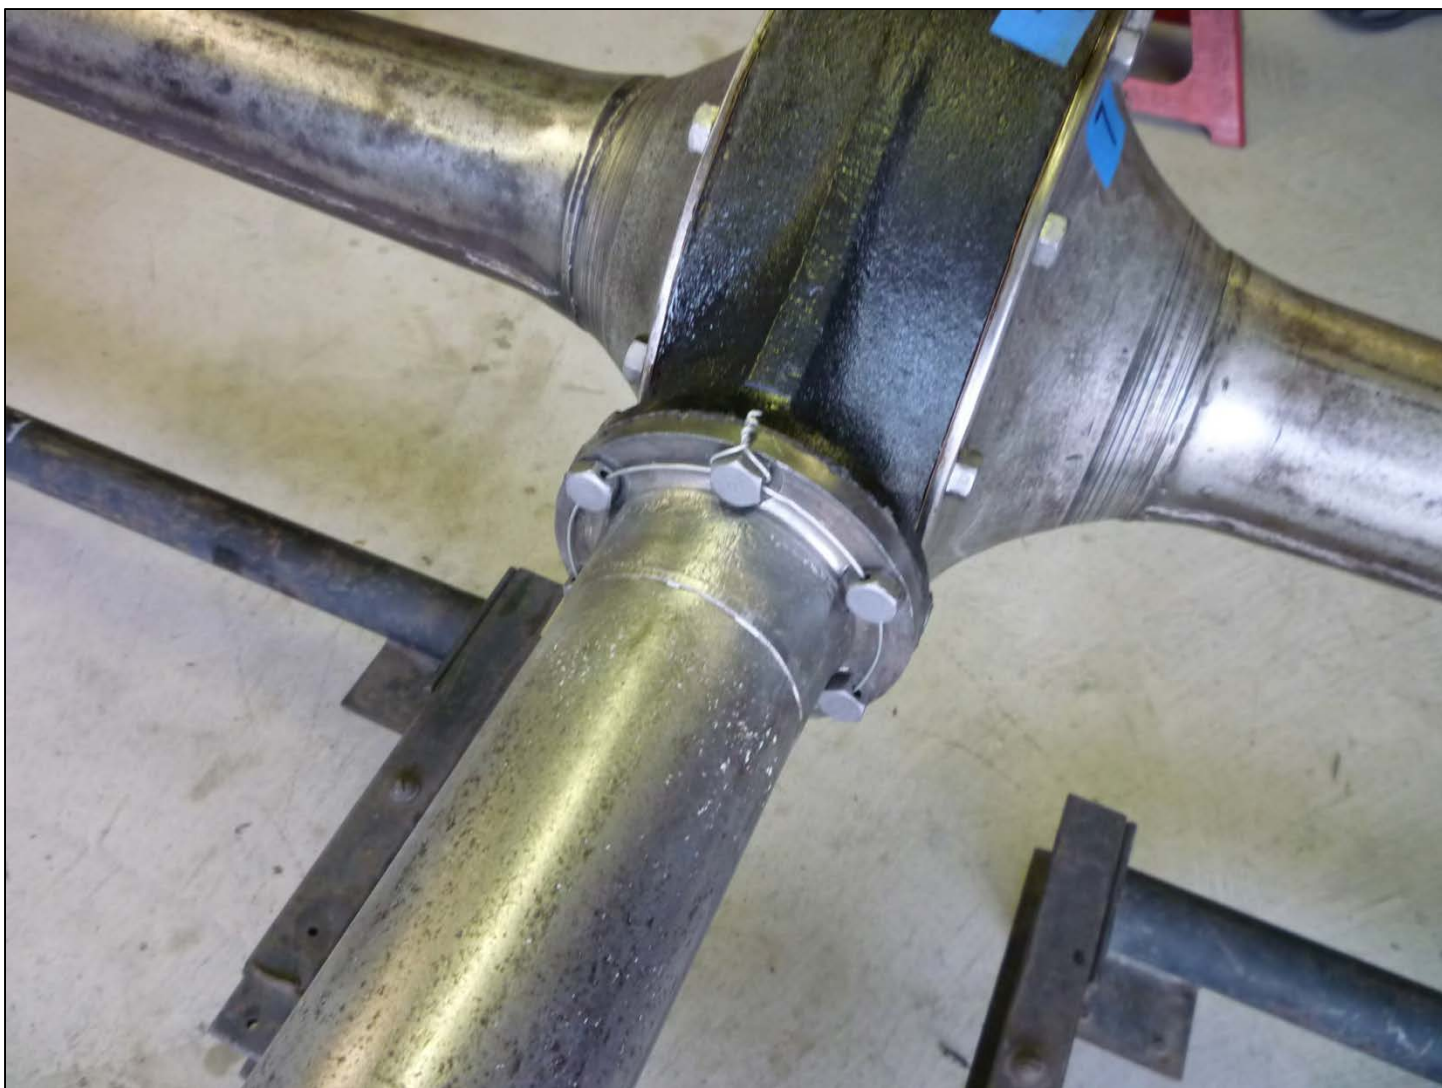
The bolts are torqued to a nominal 35 ft. lbs. and safety wired. This completes the full assembly of the rear axle assembly. The assembly is ready for painting. According to Ford documentation all the bolt heads and the safety wire are painted black enamel along with the housings.

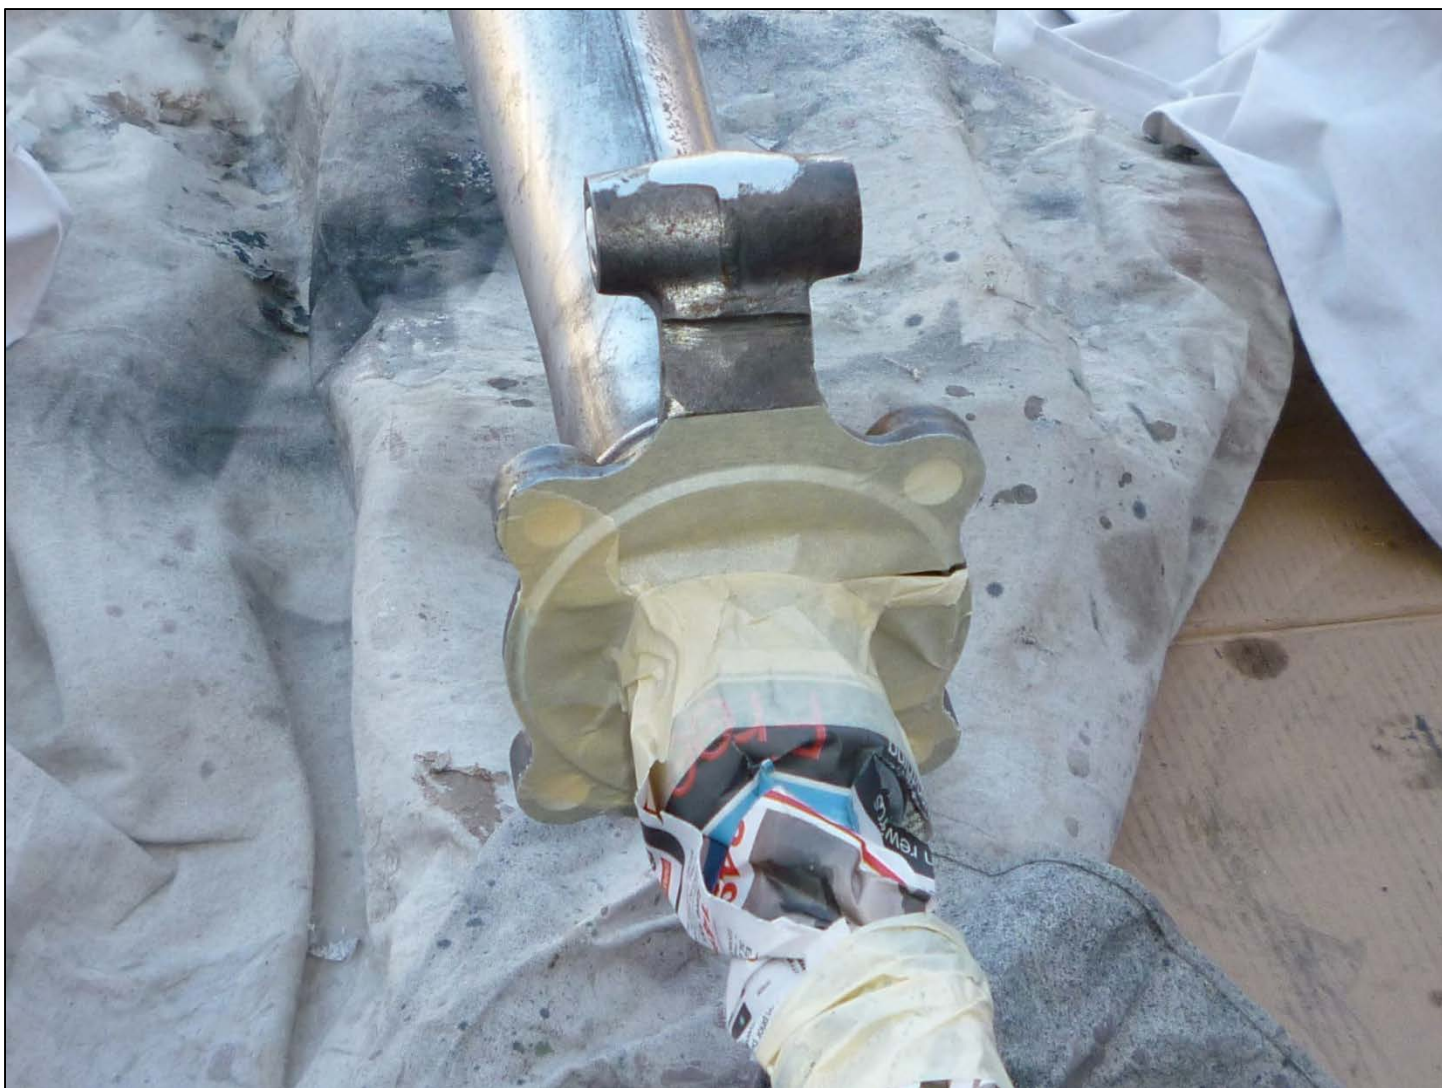
Each end of the axle housings were masked off where the backing plates attach. Pieces of paper towel were pushed into the shackle bushing to prevent paint from entering.

Since this axle housing is going into a modified car, the shock arm perches on both axles had been previously sawed off. During the rebuild a grinder was used to smooth the area.

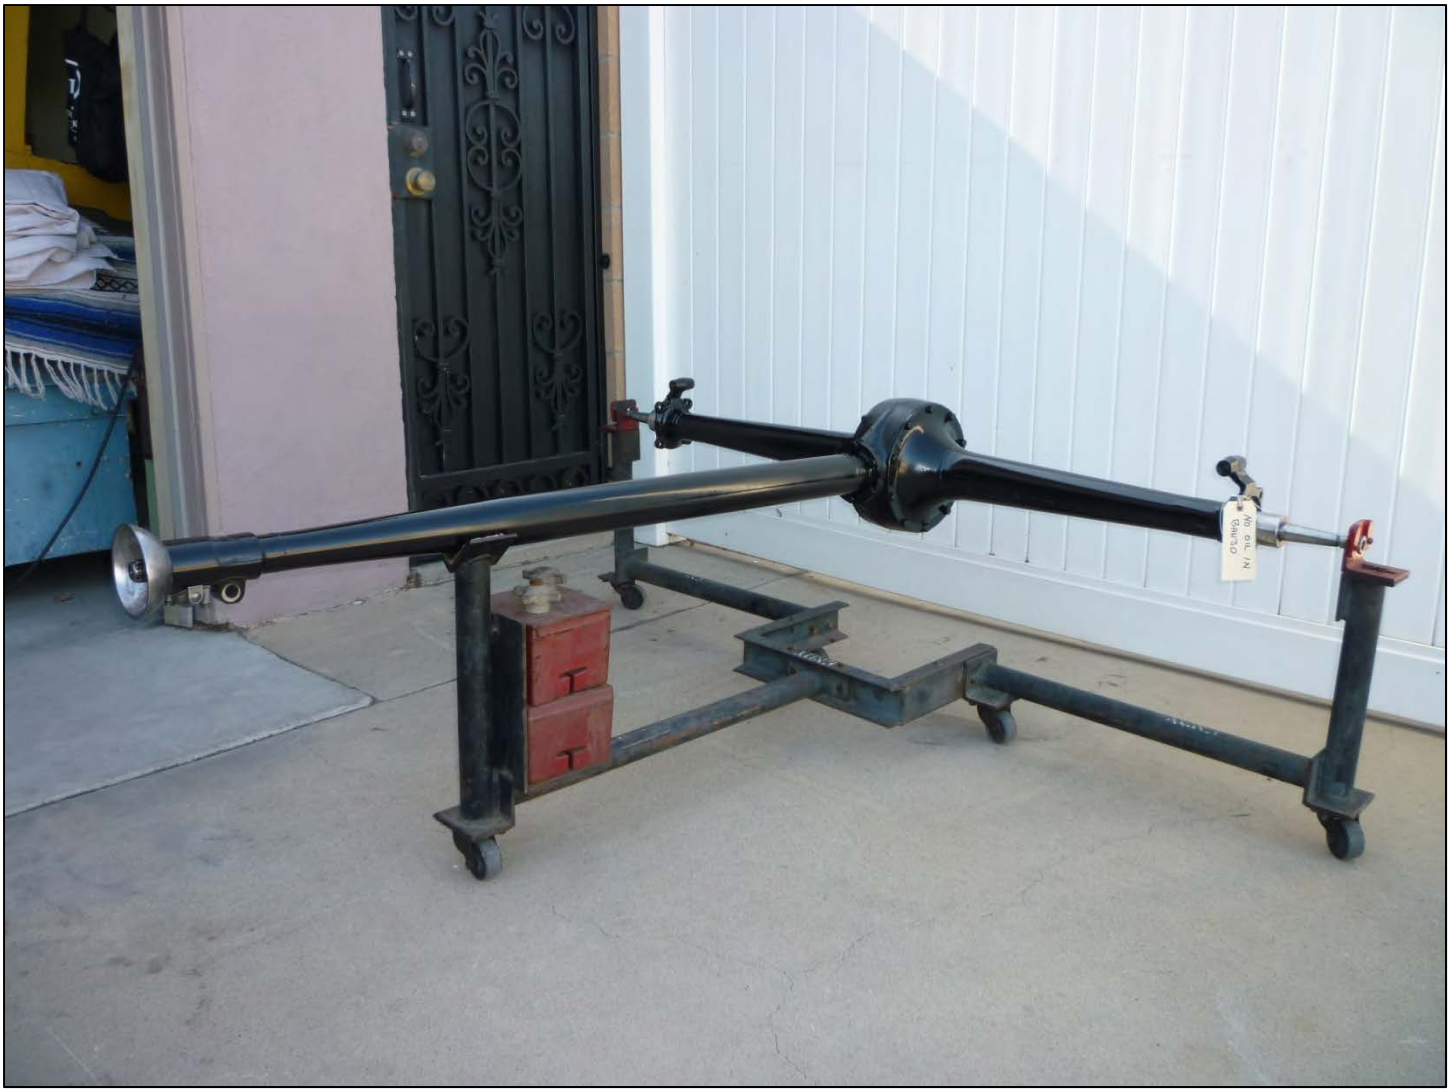
The project is finished. The speedometer drive gear assembly has been installed along with both axle housing grease fittings.

One final step is to attach a tag to the assembly that reads; “no oil in banjo”. The tag should be left in place until the banjo is oil serviced.
