Differential failure 2018

by Tom Endy

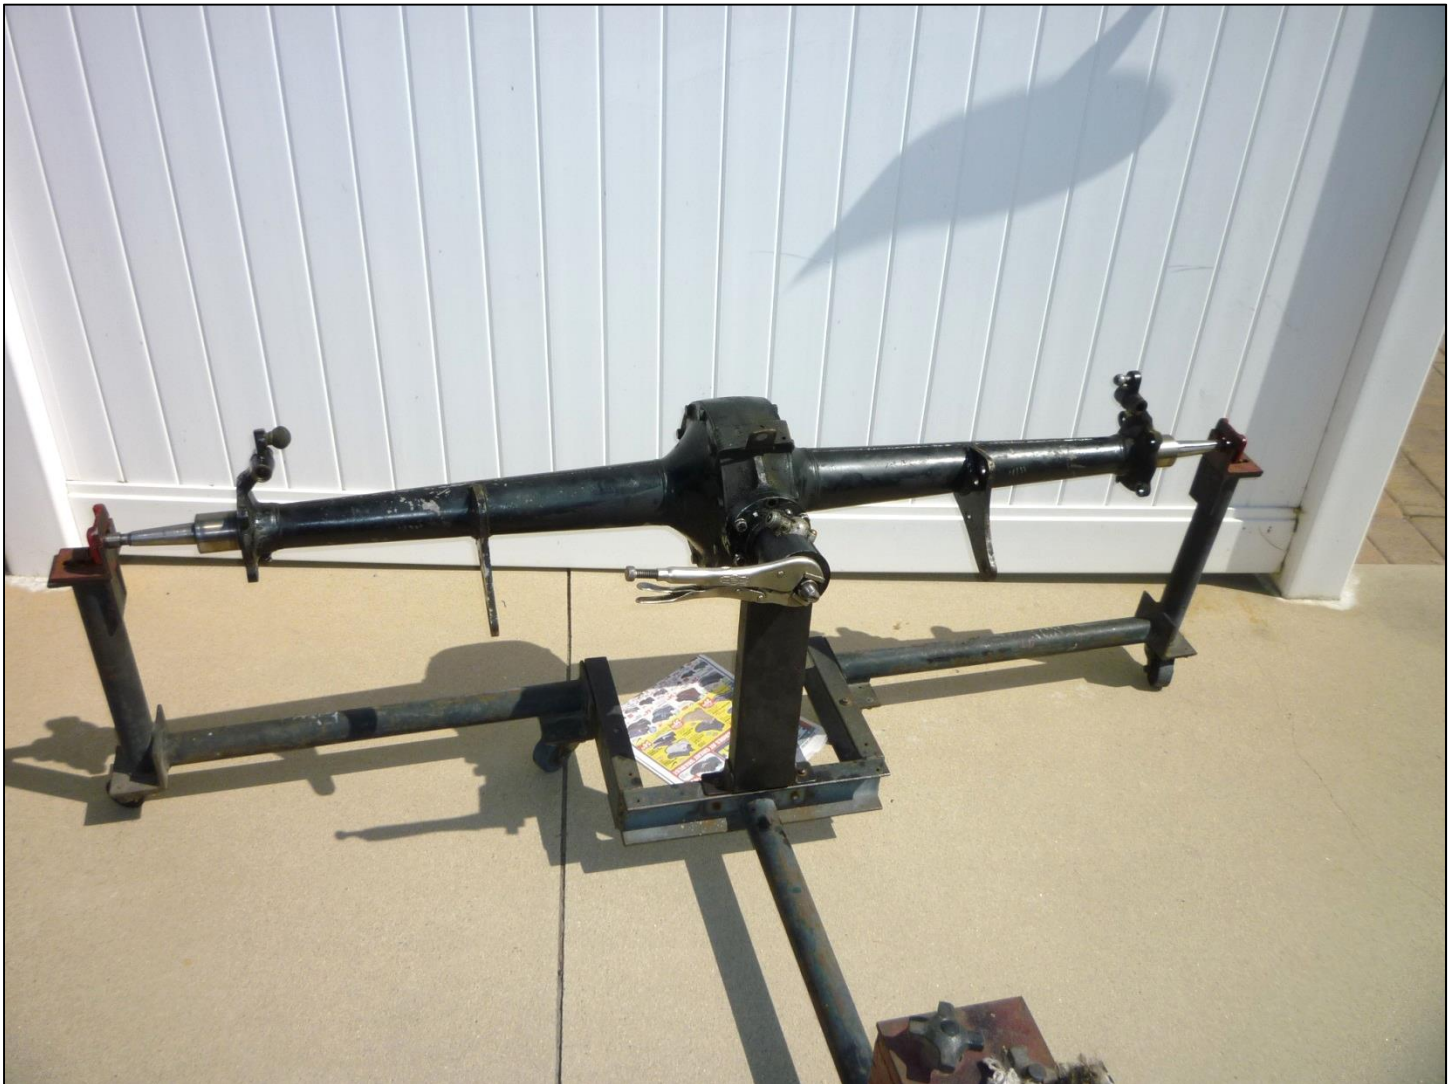
The rear axle assembly was brought to my shop after being removed from the car. Since the car has a modern five-speed transmission installed it does not have a normal Model A drive shaft and torque tube. There is a small housing attached to the banjo flange that houses the protruding pinion gear assembly and a short stub shaft that attaches to a U-joint and an open drive shaft. At the front end of the housing are two small ball bearings and an oil seal. The vice grips attached was used to rotate the assembly.

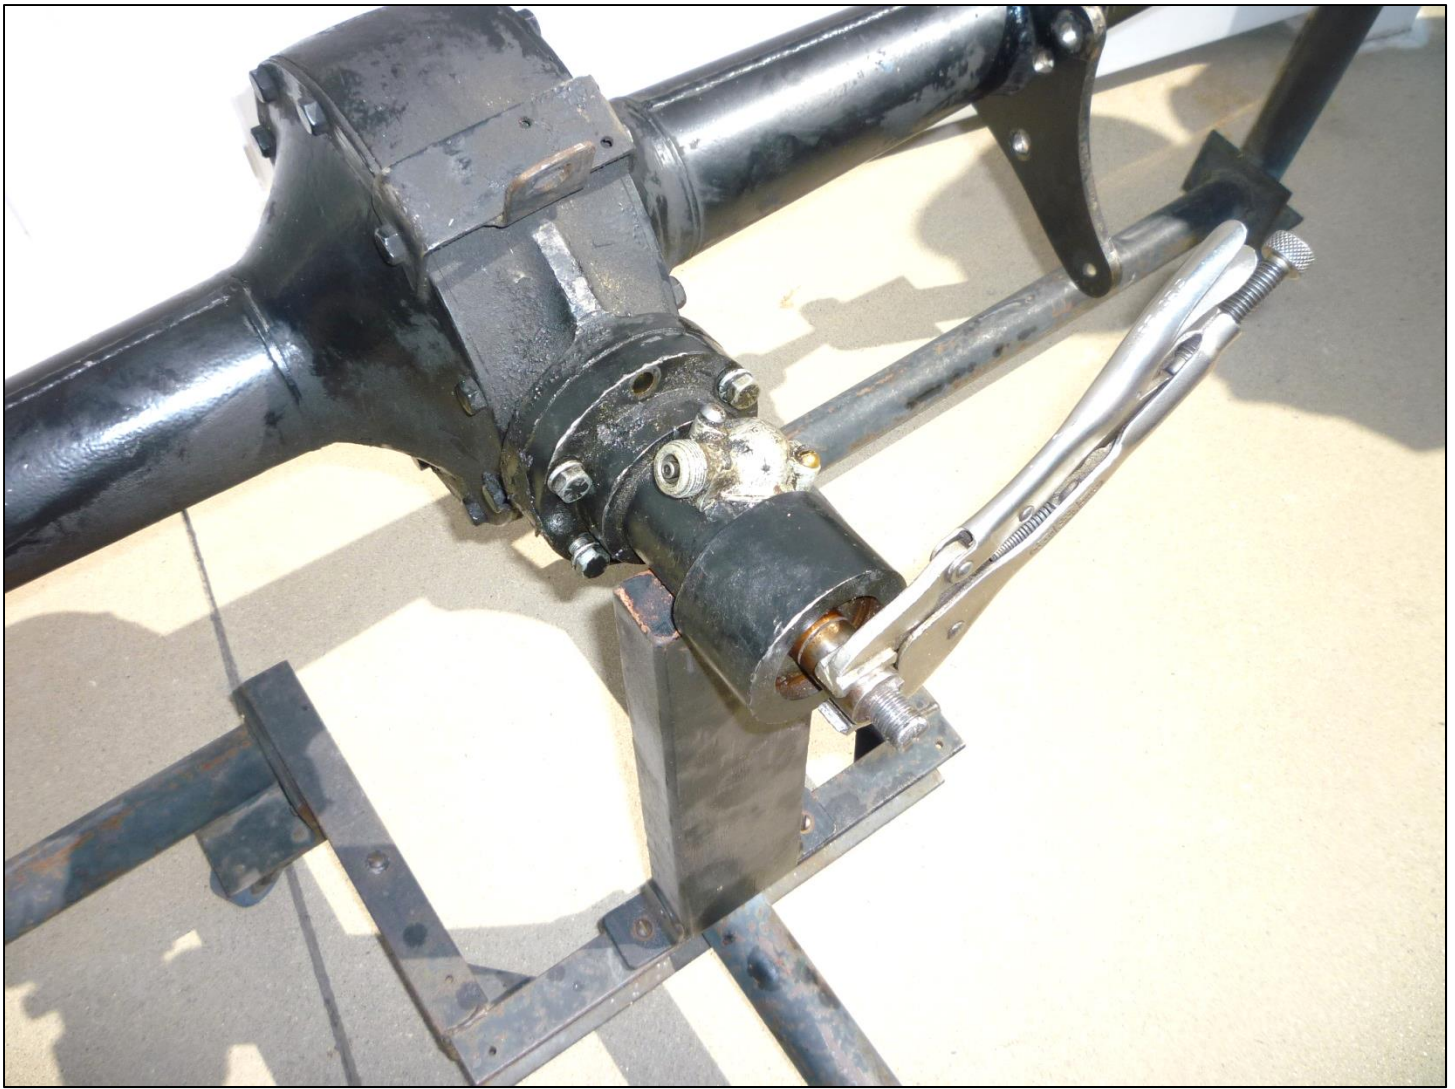
A close up look at what suffices as a torque tube: The short stub shaft can be seen protruding from the front of the housing. The end of the shaft is threaded where a U-joint attaches. The forward part of the housing directly behind the vice grips contains an oil seal and two small sealed ball bearings the shaft rides on. The next section of the housing has a standard Model A speedo housing attached. Directly under it inside the housing a speedo drive gear is attached to the stub shaft. The next section slides over the protruding end of the pinion assembly and has a flange that bolts to the banjo flange with six bolts.

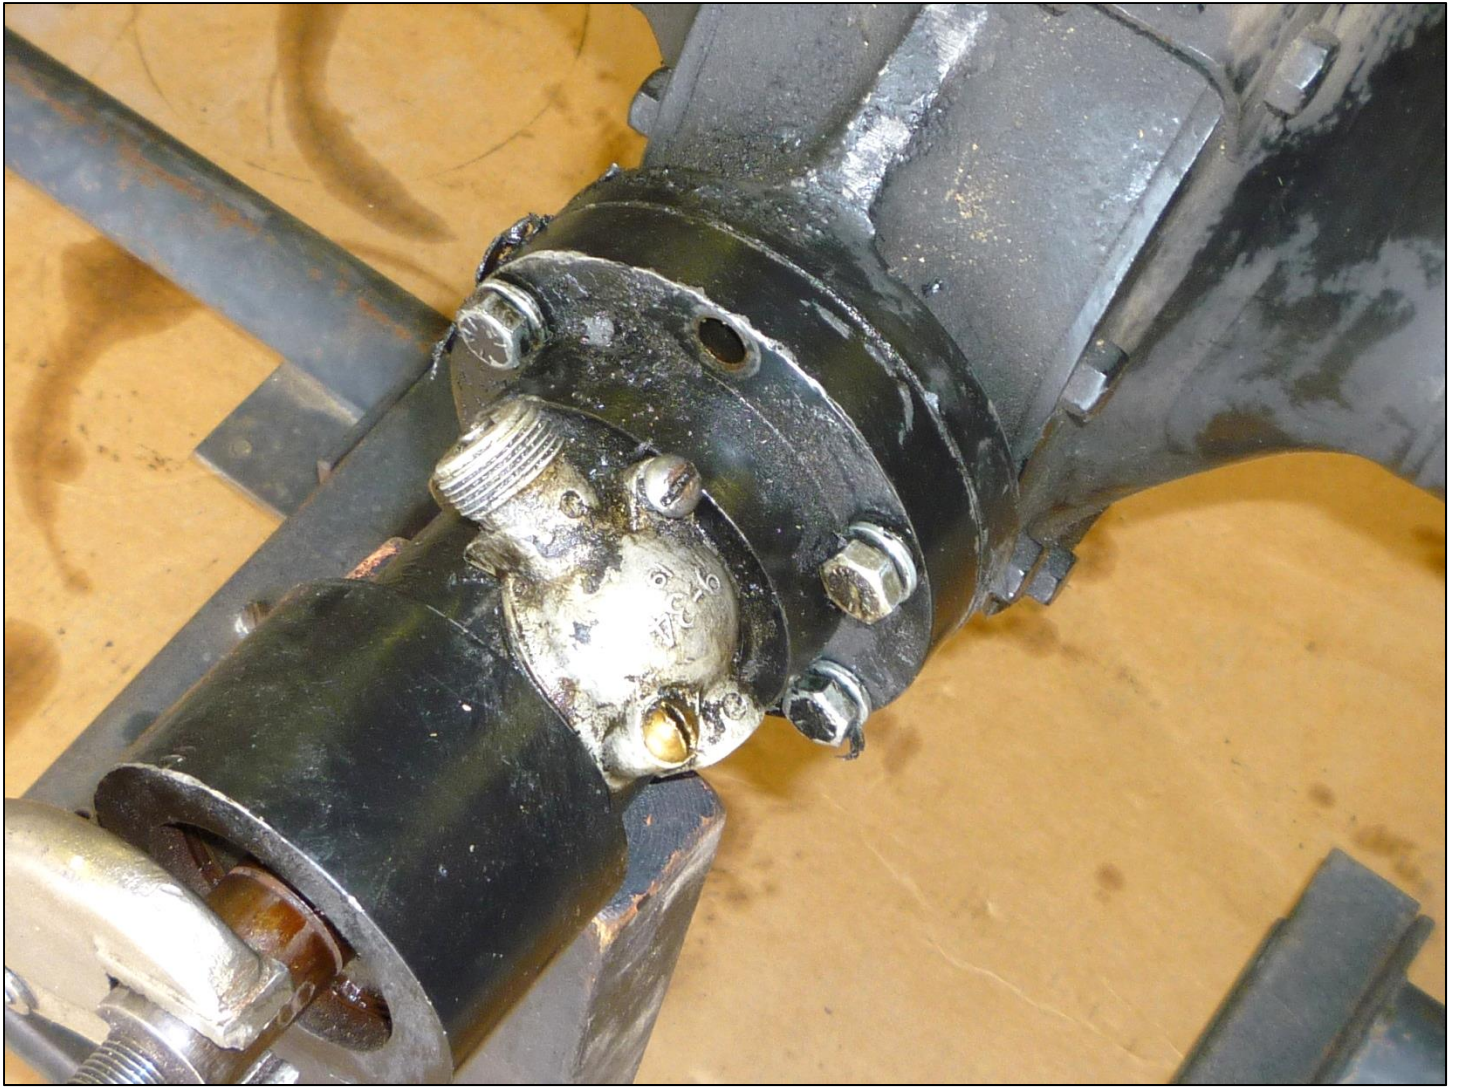
The speedo housing sits at the two o'clock position where the speedo cable attaches to it.

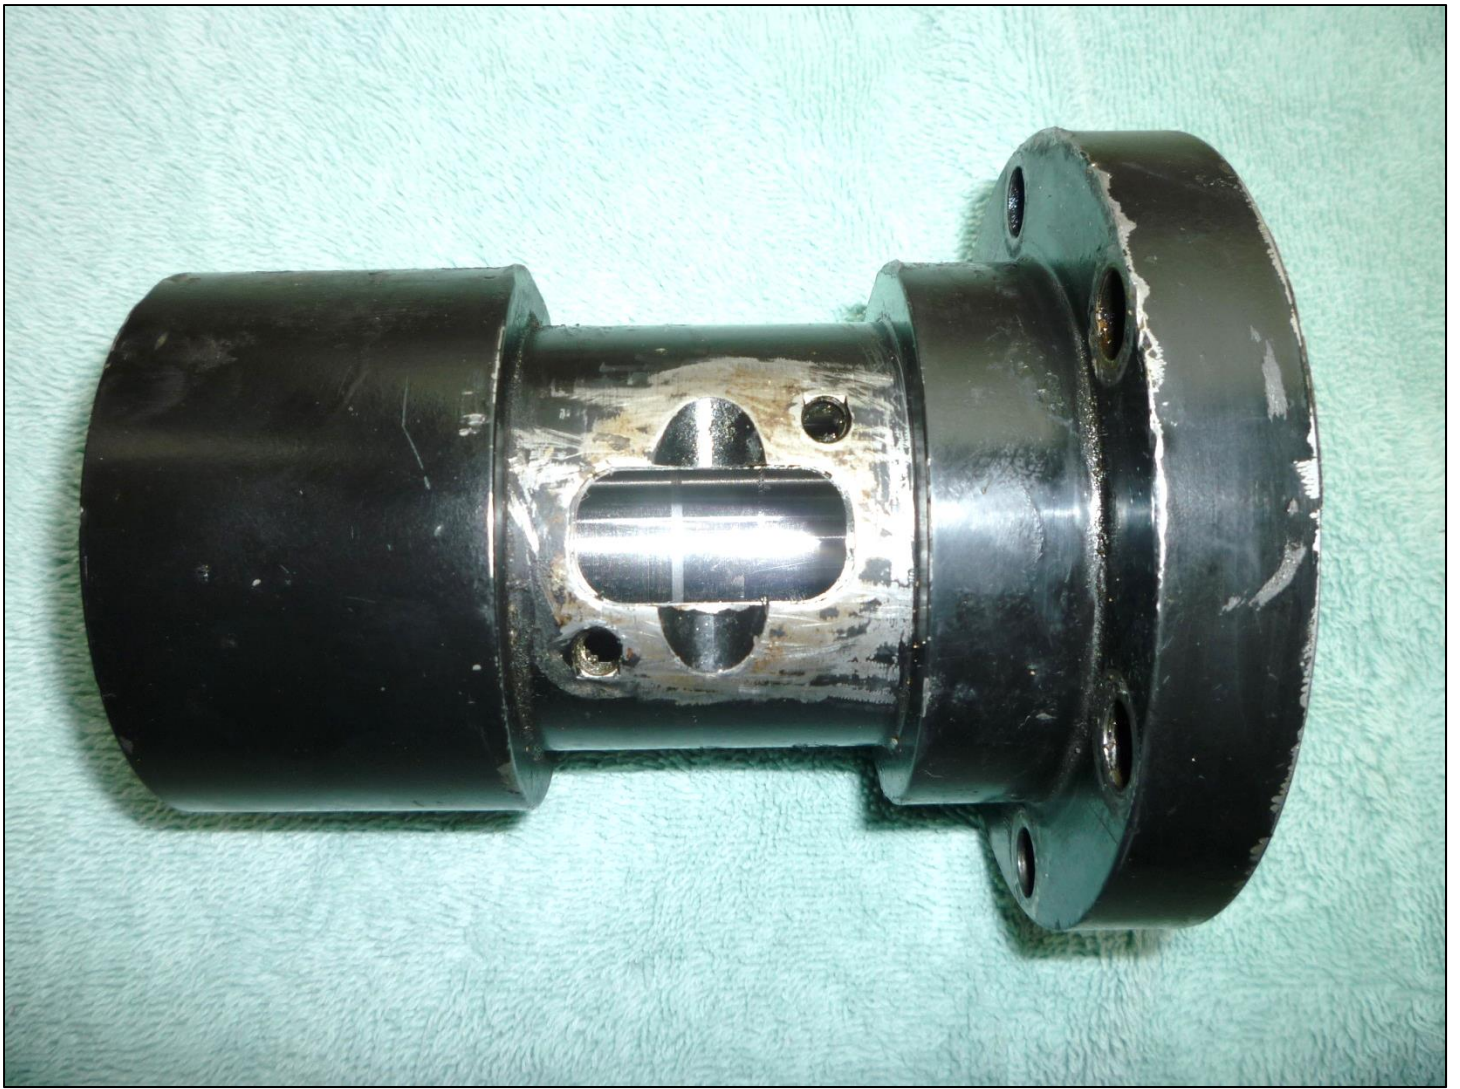
Another look at the “torque tube”:

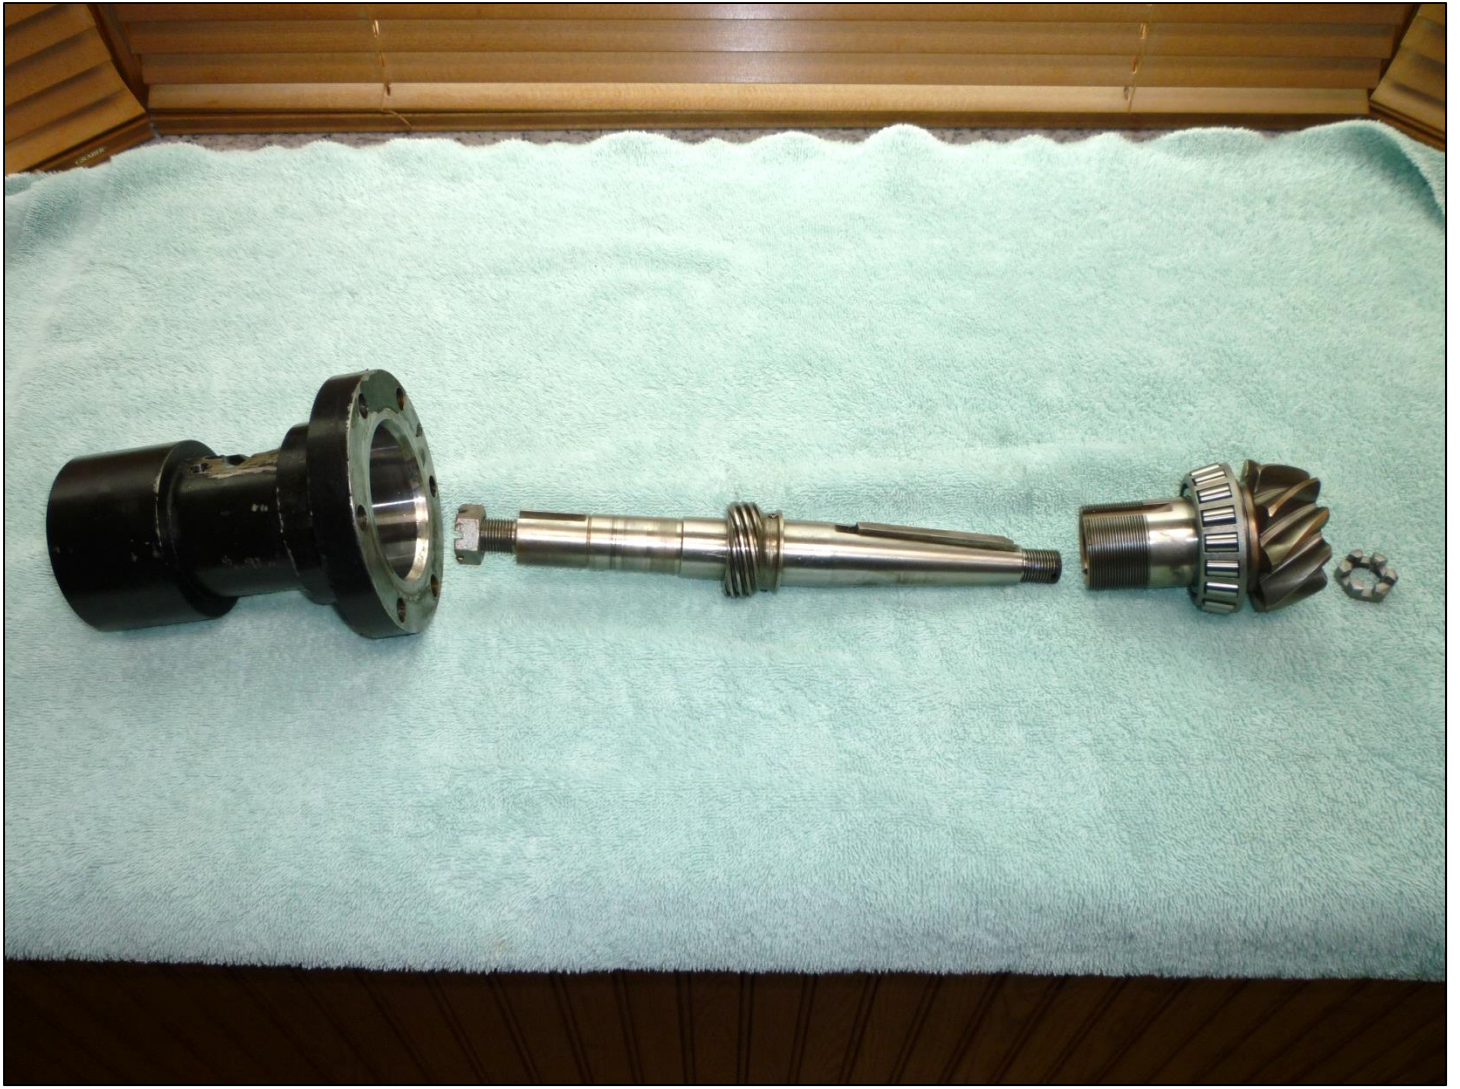
The sequence of the torque tube, drive shaft, and pinion gear:

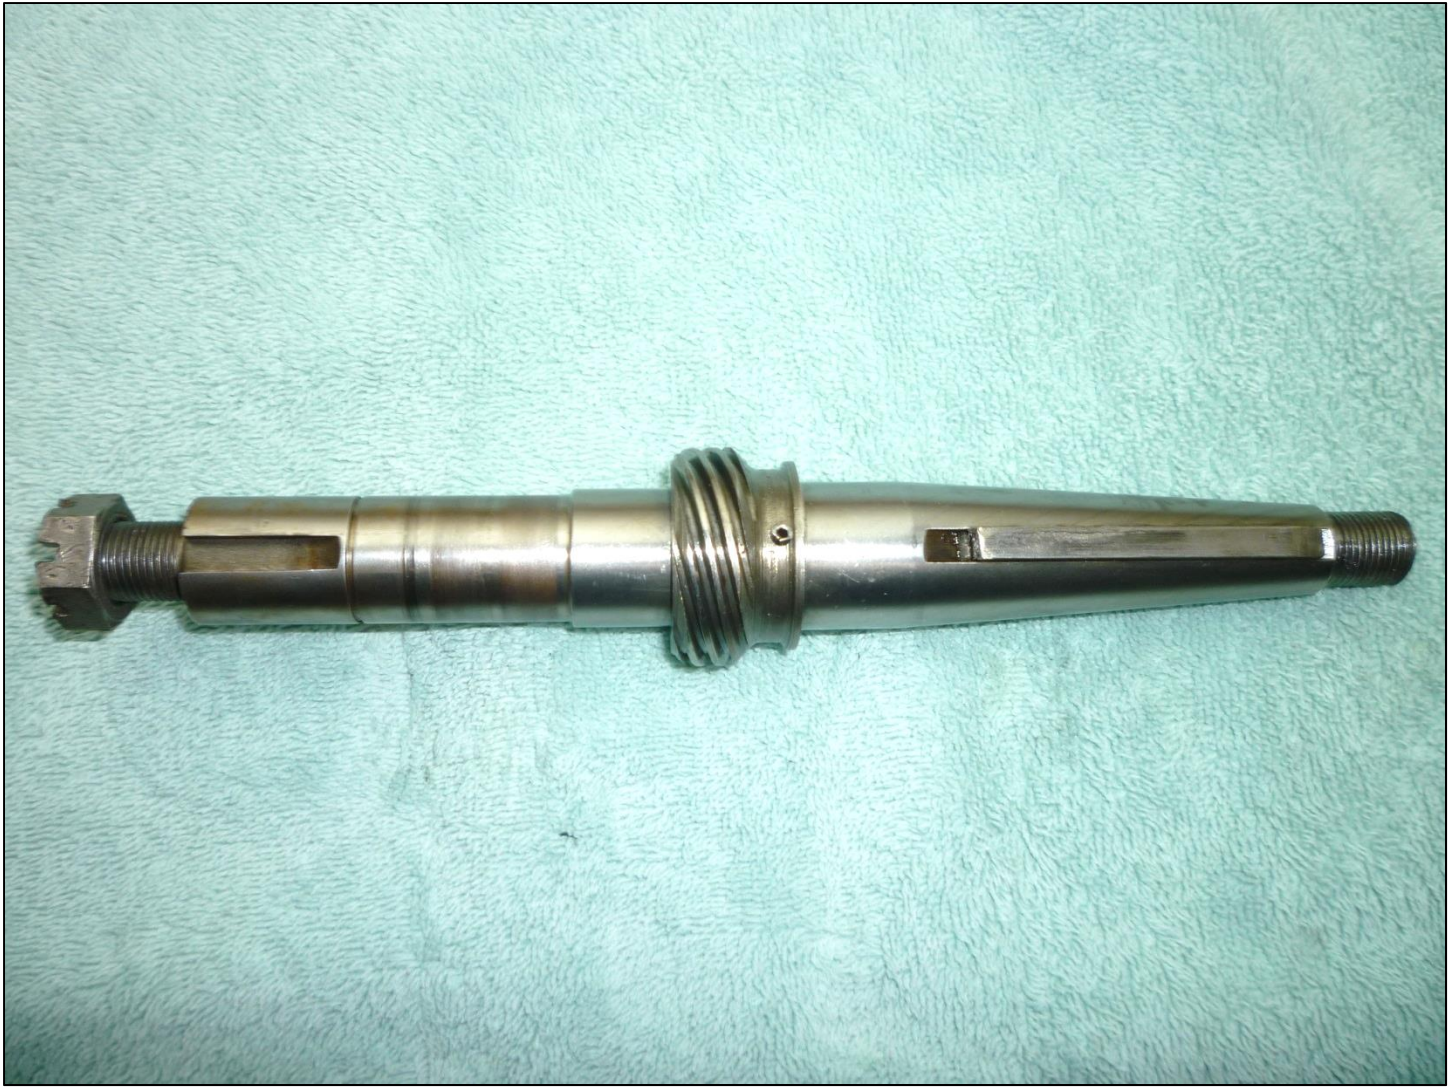
The drive shaft (stub shaft): The left end of the shaft is where the U-joint is attached. The U-joint is locked to the shaft with a woodruff key and retained with the nut. The next section of the shaft rides on an oil seal and two small ball bearings inside the short torque tube housing.

The short section of shaft just to the right of the speedo drive gear is the only area of the shaft that can be held with a tool in order to put a hundred ft. lbs. torque on the pinion gear retaining nut at the right end of the shaft. This area is also held while setting the pre-load on the pinion bearings when adjusting the two large nuts and tightening the outer one. This makes this portion of the repair job very challenging.

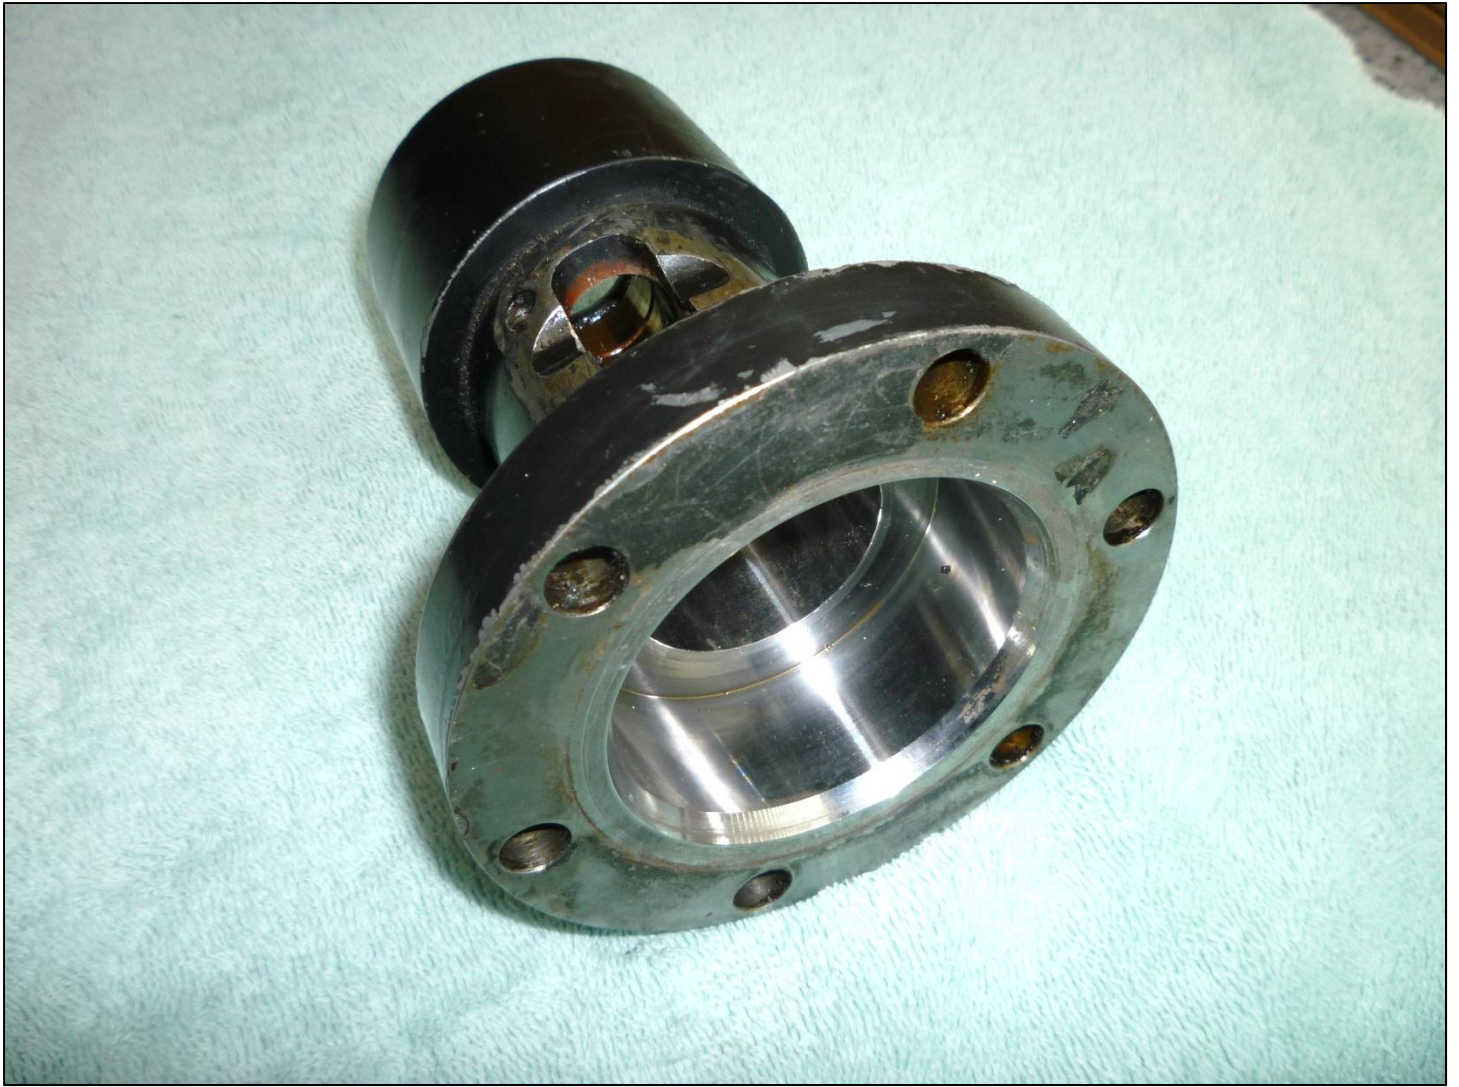
A look at the end of the torque tube housing that attaches to the banjo: The machined space on the flange end is to provide clearance for the end of the pinion assembly that protrudes from the banjo.

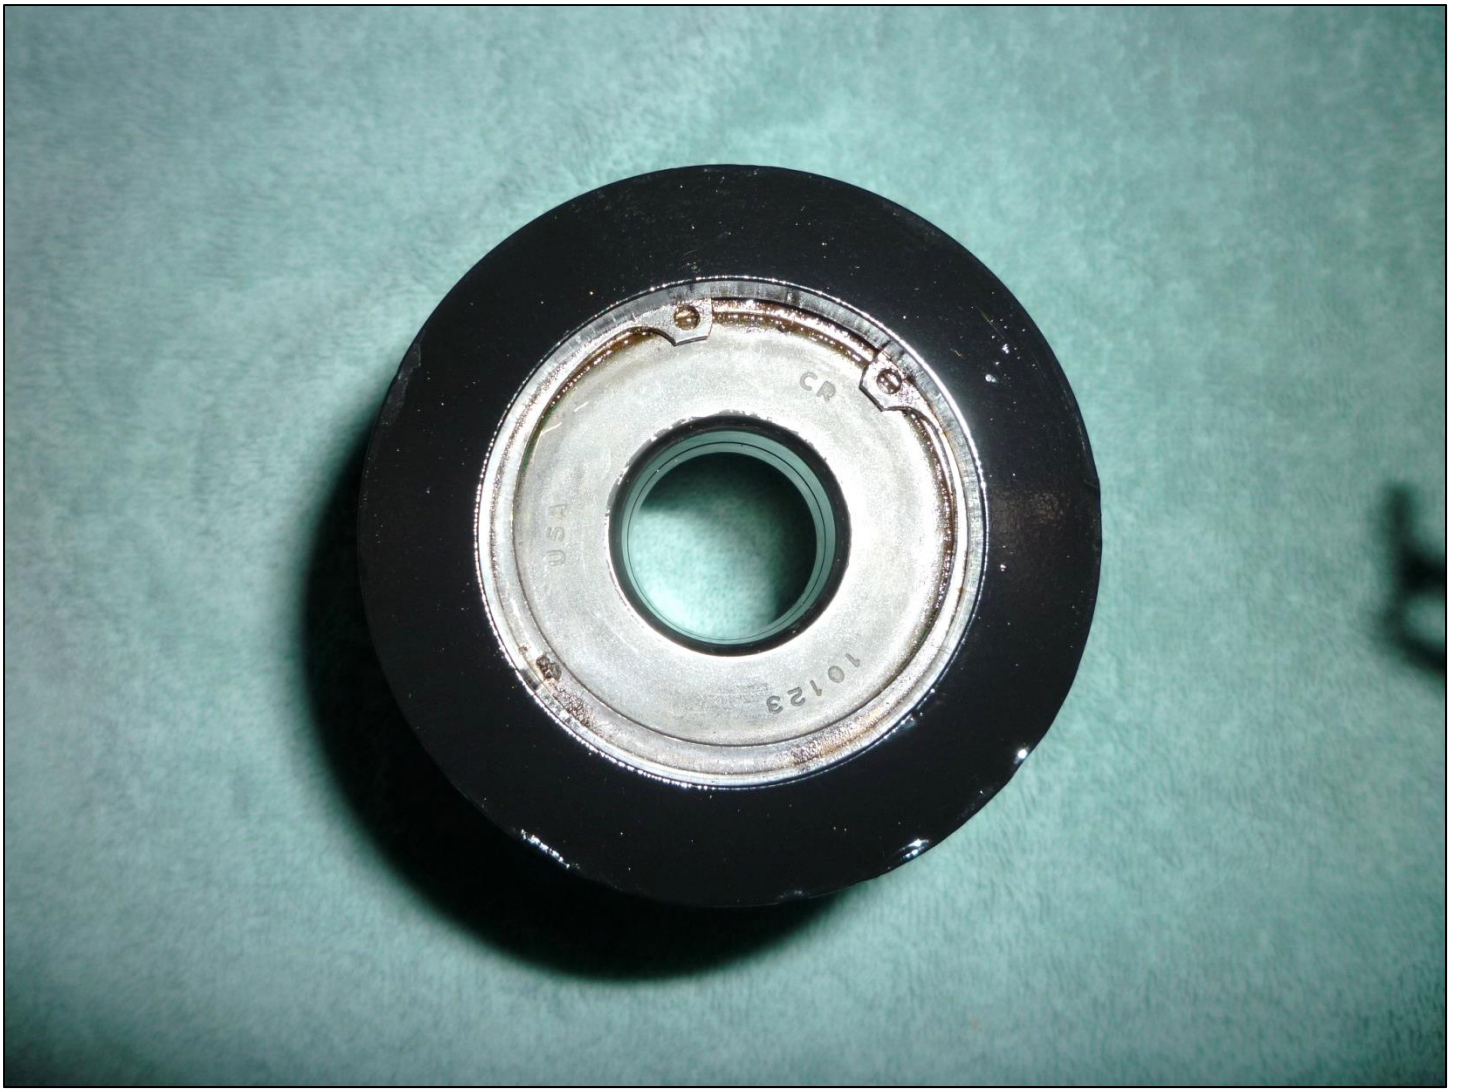
Shown here is the U-joint end of the torque tube housing where the oil seal and the two small ball bearings reside. The snap ring prevents the oil seal and bearing assembly from coming out, however the assembly appears to have been installed with an interference press fit.

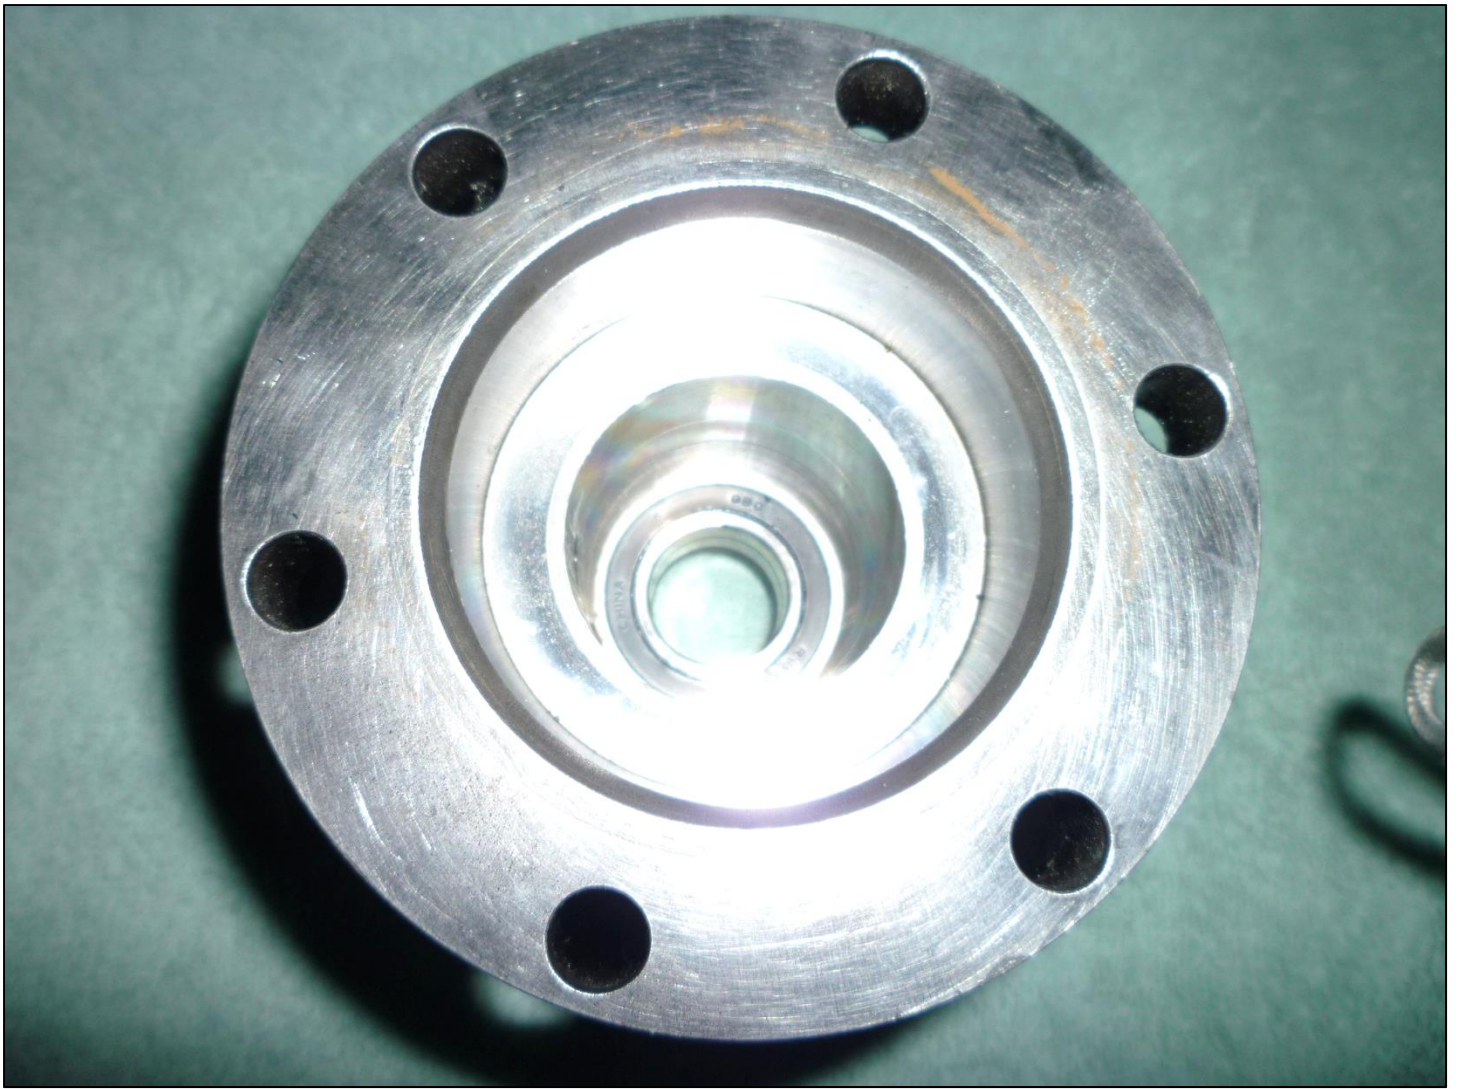
The banjo end of the torque tube housing is shown here. The two small sealed ball bearings can be seen at the bottom at the opposite end of the mounting flange.

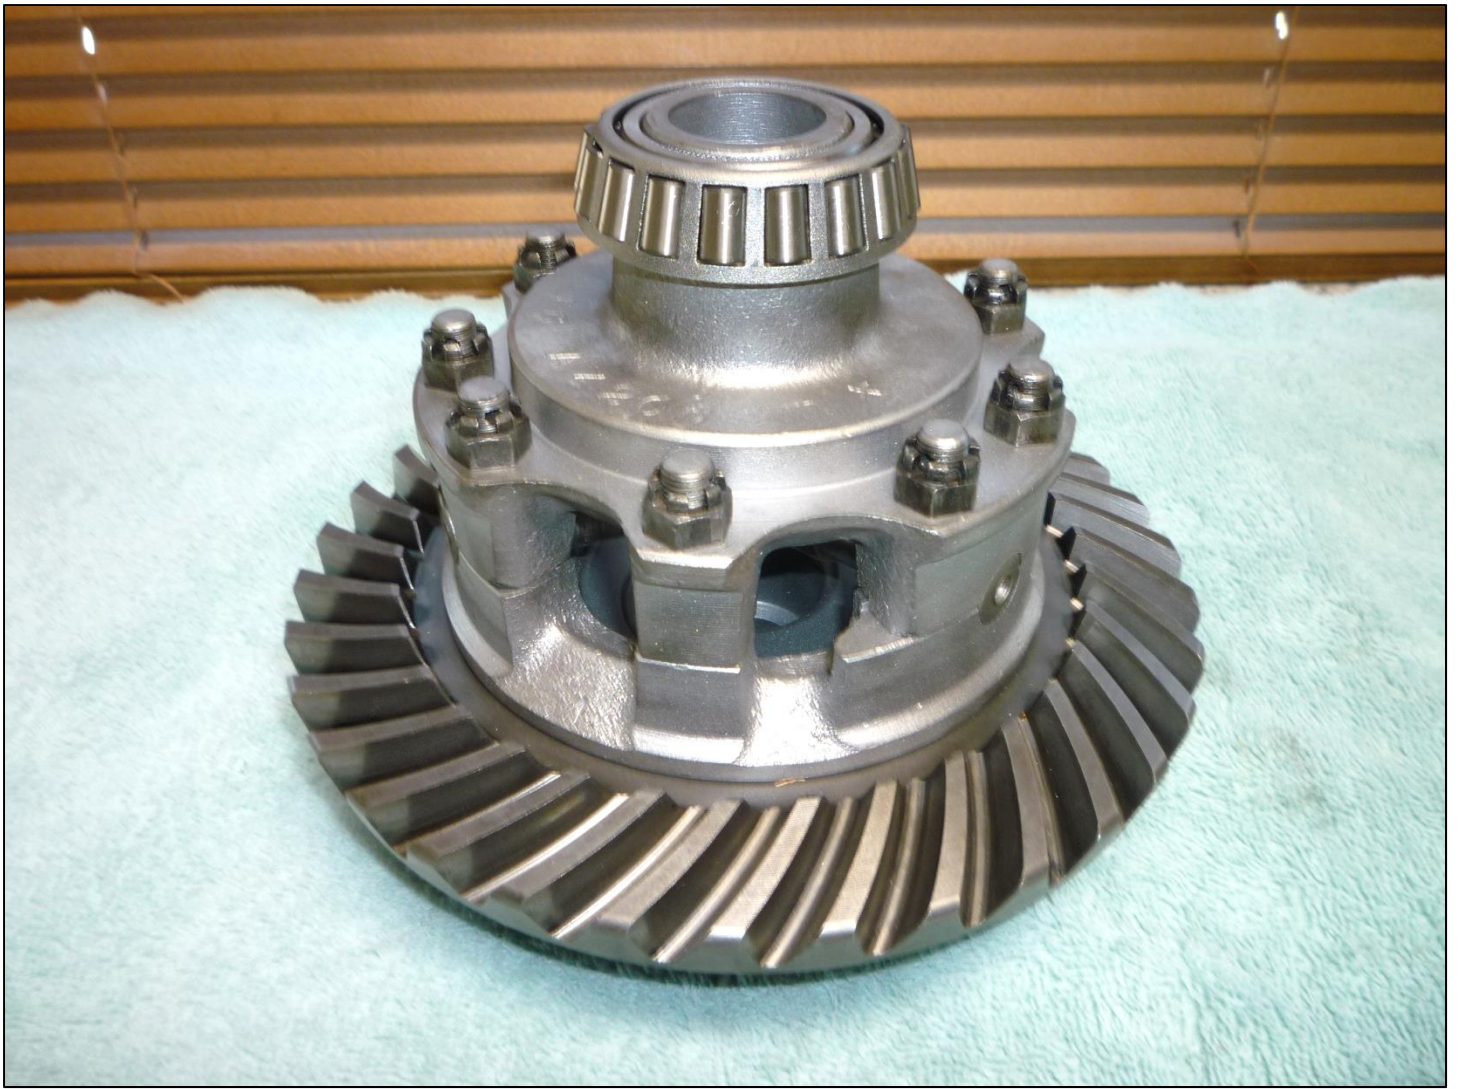
Another view of the replacement carrier and the ring gear: The ring gear was undamaged and appears to be in excellent condition.

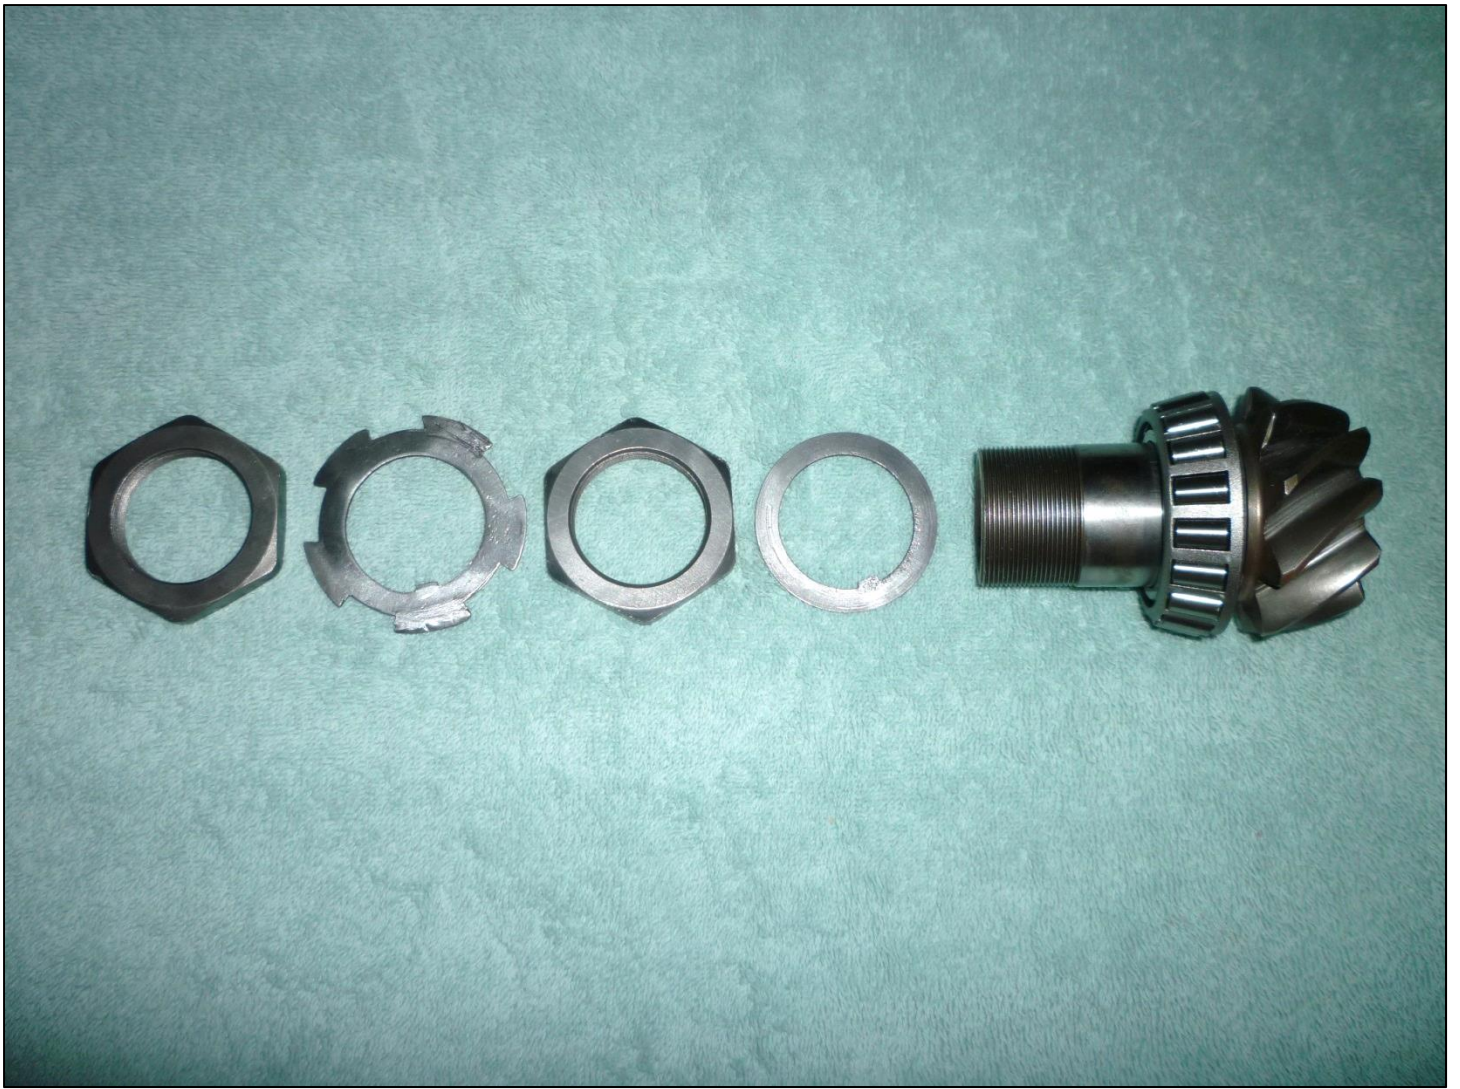
A view of the undamaged pinion gear with a new rear bearing installed:

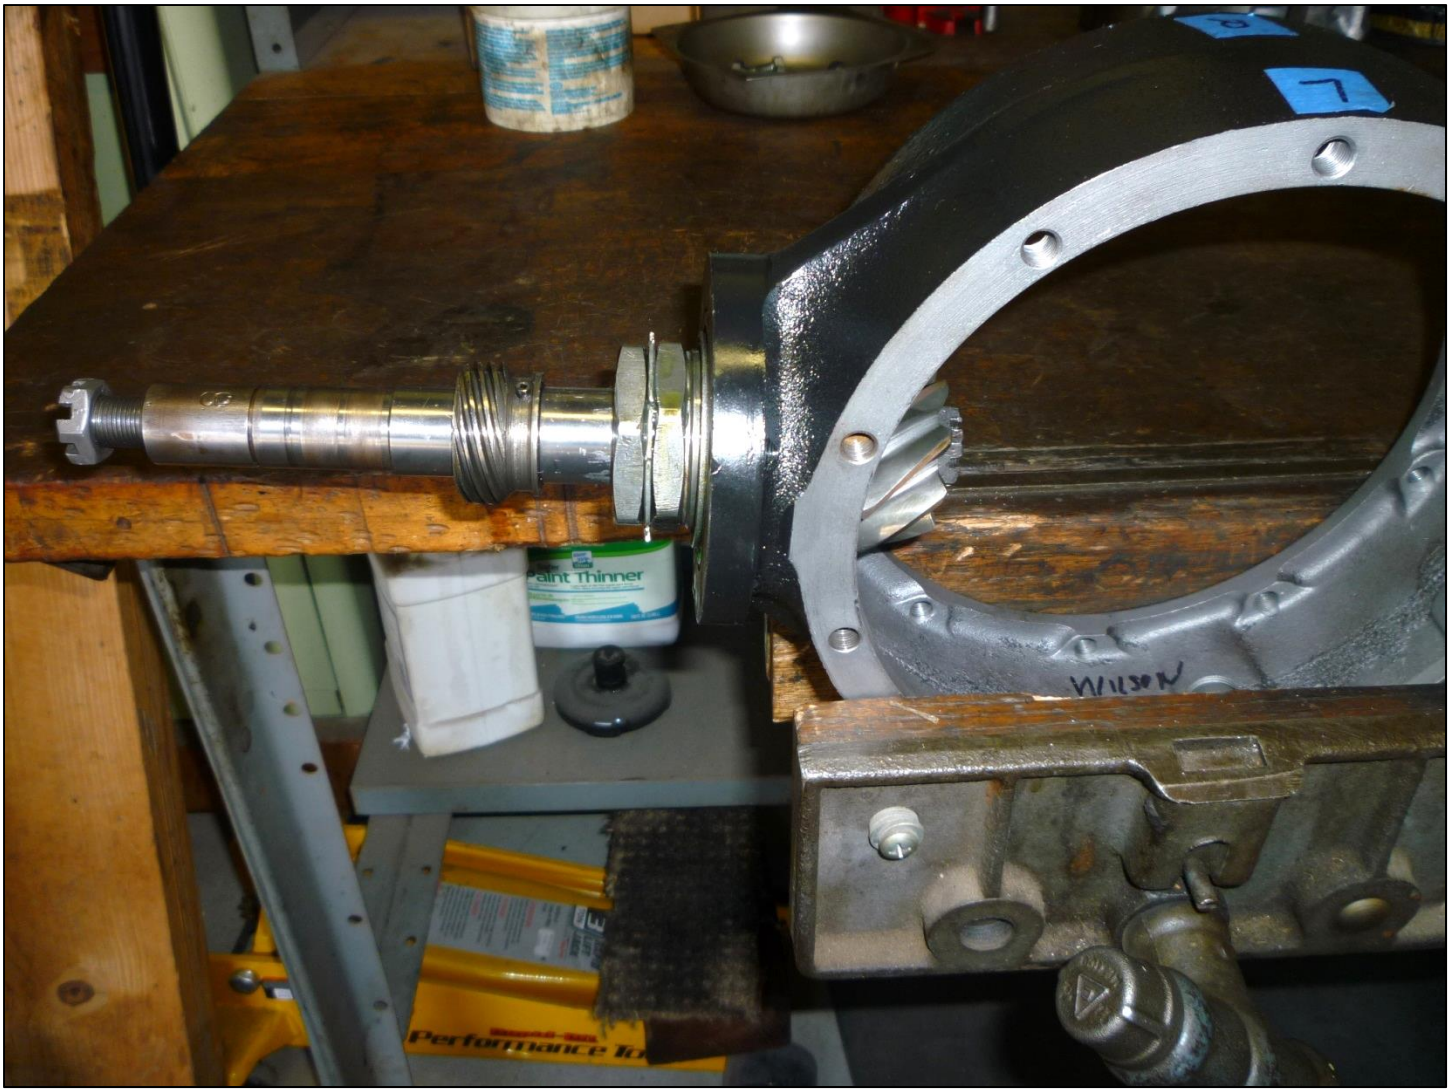
The pinion gear has been installed in the replacement banjo. The preload setting of the pinion gear bearings is going to be more difficult because there is no lengthy drive shaft or overdrive stub shaft to grab hold of with a pipe wrench. The only area to grab hold of on this very short stub shaft is the space between the speedo drive gear and the two large pinion nuts. This is the only area of the stub shaft that is not critical and galling by pipe wrench jaws is of no consequence.

The photo shows assembly ready to have the nut on the end of the pinion gear torqued to 100 ft. lbs. and the bearing pre-load of 20 in. lbs. established with the two large pinion nuts.

The 20 in. lbs. pre-load on the carrier bearings has already been accomplished and was no different than a traditional differential overhaul.
