Model A Carrier Repair

by Tom Endy

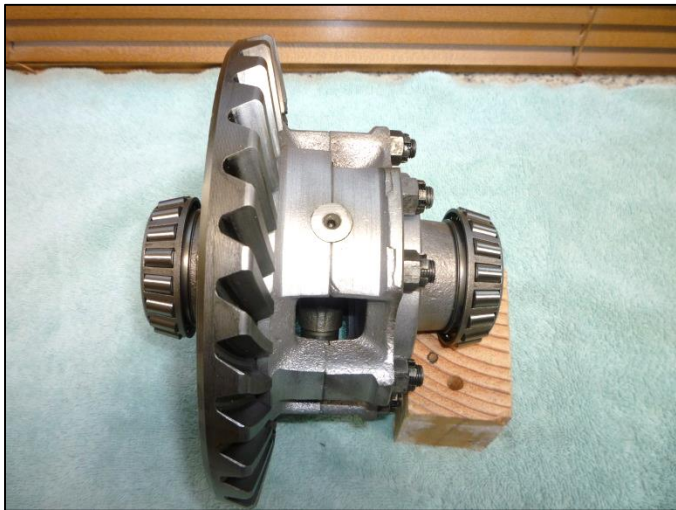
The carrier has the ring gear attached to the left side. The spider gears are inside the two carrier halves. A rear axle shaft will protrude from each side. There is a carrier bearing on each side that is mounted to the hubs with an interference press fit. The carrier bearings must be set up against their races with a pre-load of 20 inch pounds.

There are two different failure modes. One is caused by in-service wear. The inside area of the carrier can become worn from the backside of the three spider gears rubbing against it. The wear can cut an indentation as much as $1/16$ " deep. There is no repair for this that I am aware of. The only resolve is to discard the carrier and find a better one.

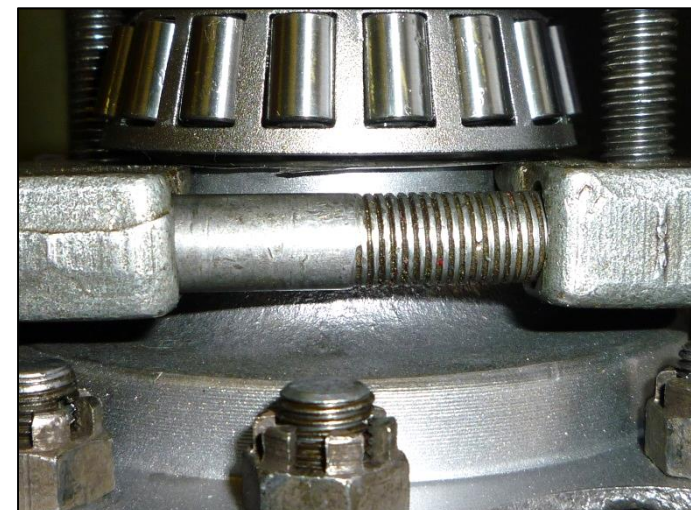
The photo on the right shows the bearing puller installed to pull the new bearing back off. The second cut taken to the base of the carrier hub provides more room so that the tool does not slip off and damage the bearing.
