Differential Rebuild 1932 V8 Ford June 2, 2019

by Tom Endy

This job came into the shop for the purpose of having the ring & Pinion gear ratio changed from what ever found to a 354:1 ratio. The owner supplied a new gear set. The unit came out of a 1932 Tudor with a V8 engine. The early 1932's are similar to a Model A rear axle assembly; however, there are several differences. This will be a complete overhaul with new bearings, races, seals, and gaskets.

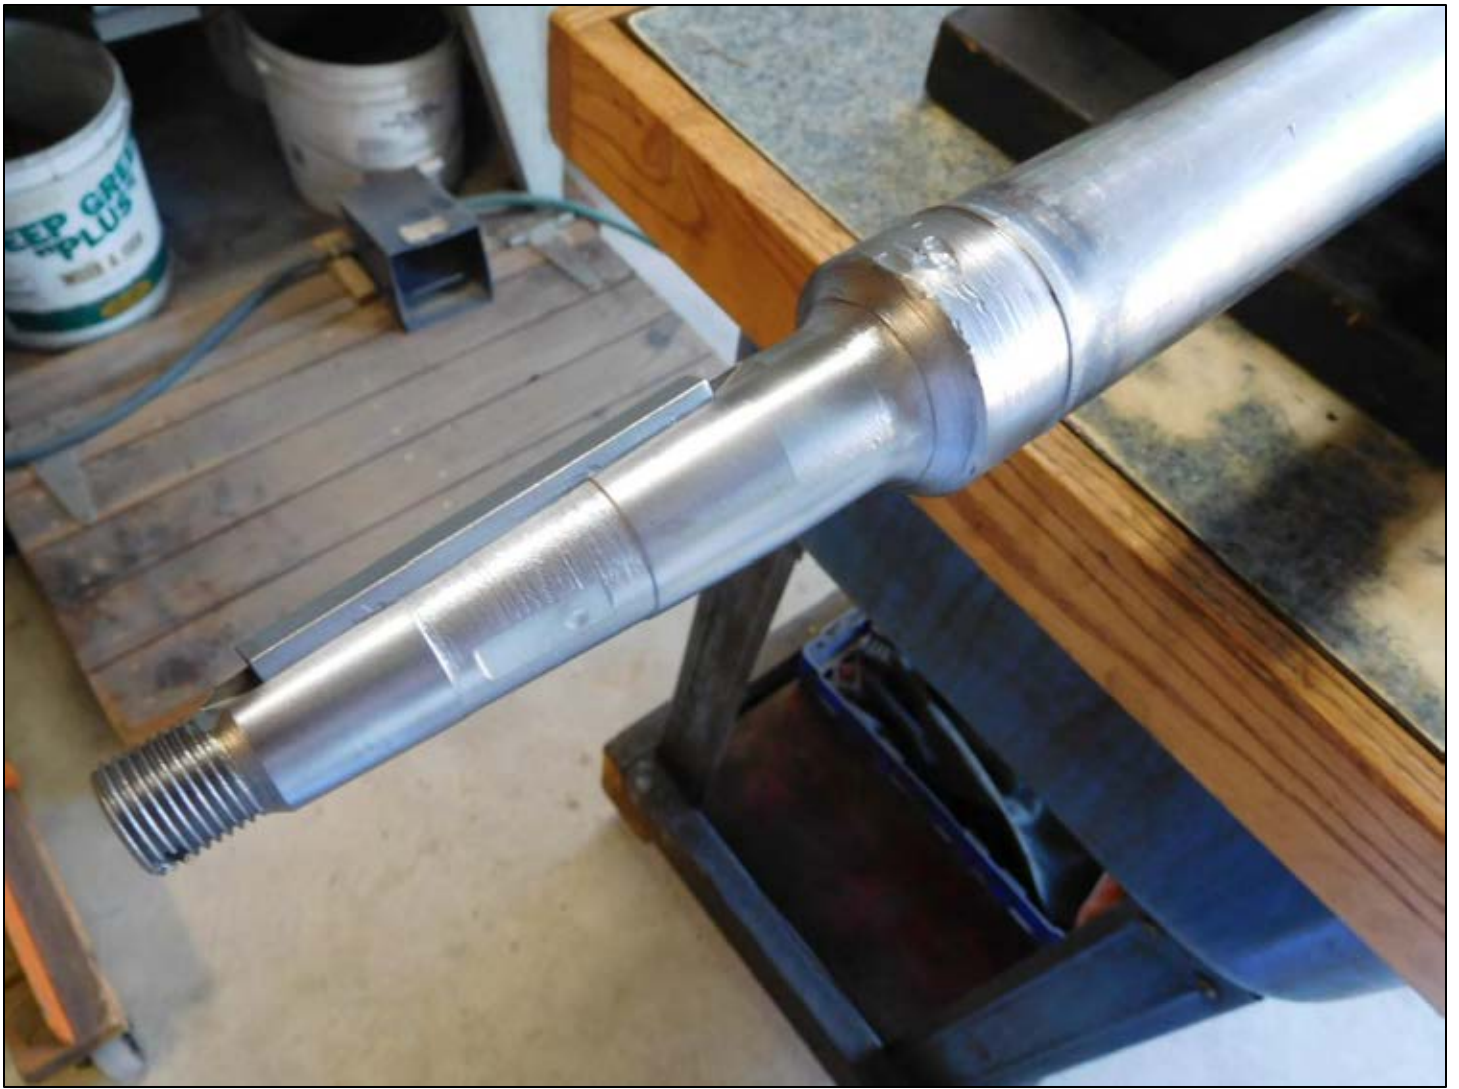
The rear plate of the Model A pinion puller was used in conjunction with a commercial bearing puller. The bearing puller was placed in the recess in the area where the large tube is welded to the end of the drive shaft and used as a locked in place device on the drive shaft. The two bolts shown in a vertical position were run in to pull the pinion bearing assembly out. Once it was out it was an easy task to remove the pinion gear from the drive shaft and disassemble the pinion bearing assembly.

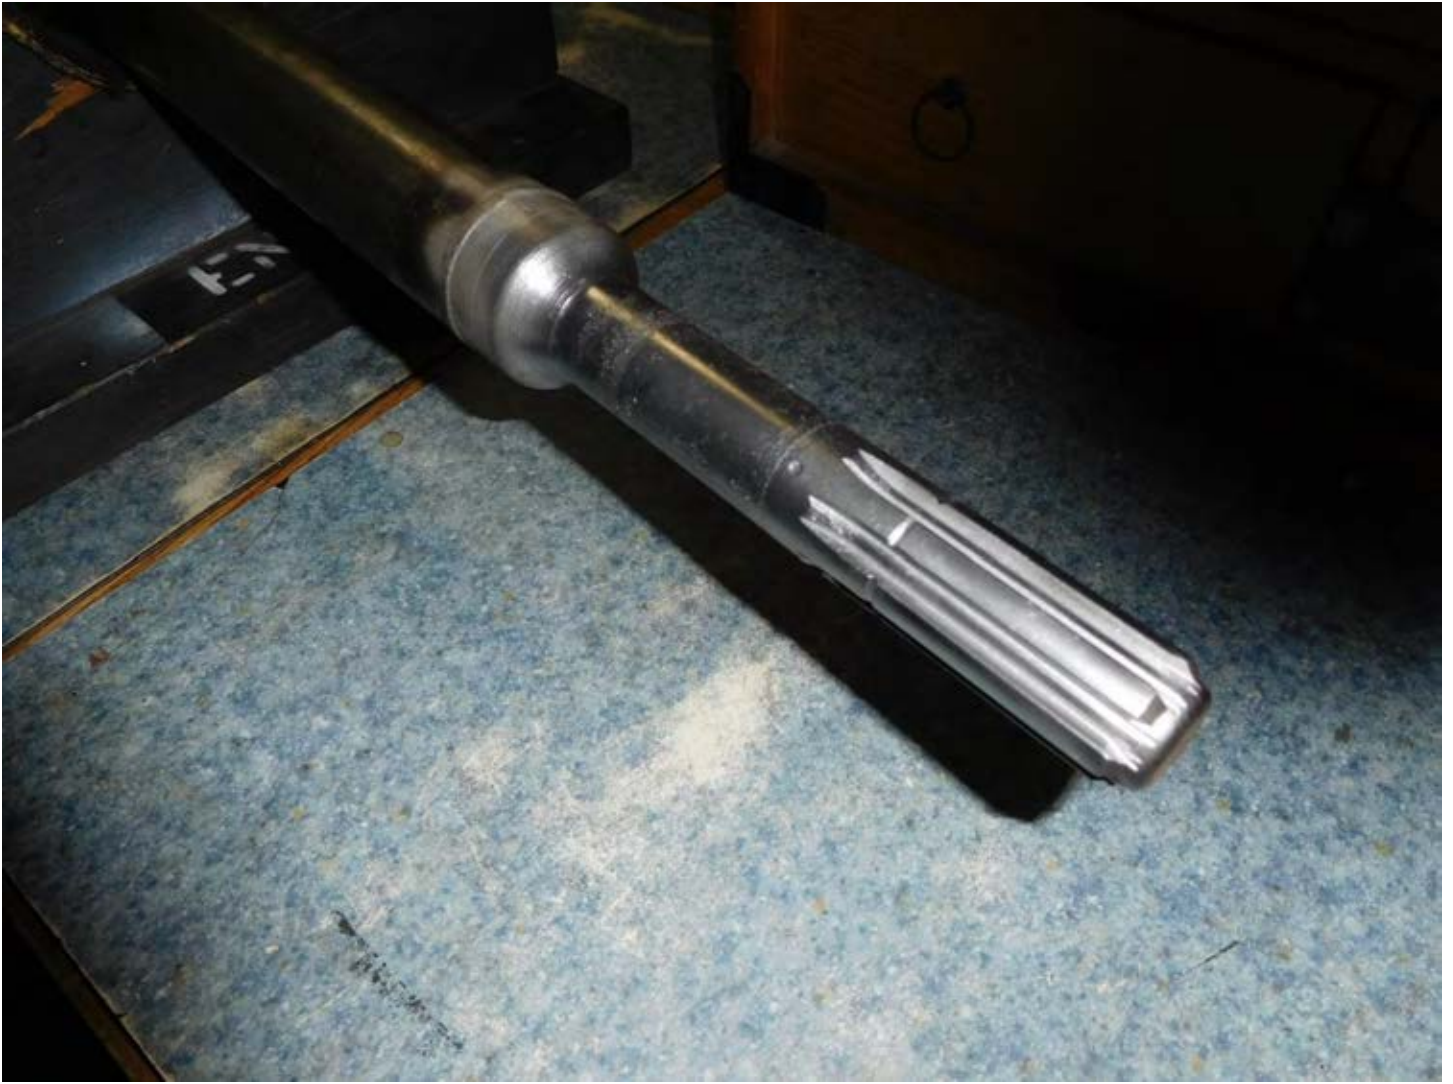
Once the pinion bearing assembly was removed from the end of the drive shaft it was cleaned up and bead blasted and is ready to accept the new pinion gear and bearing assembly.

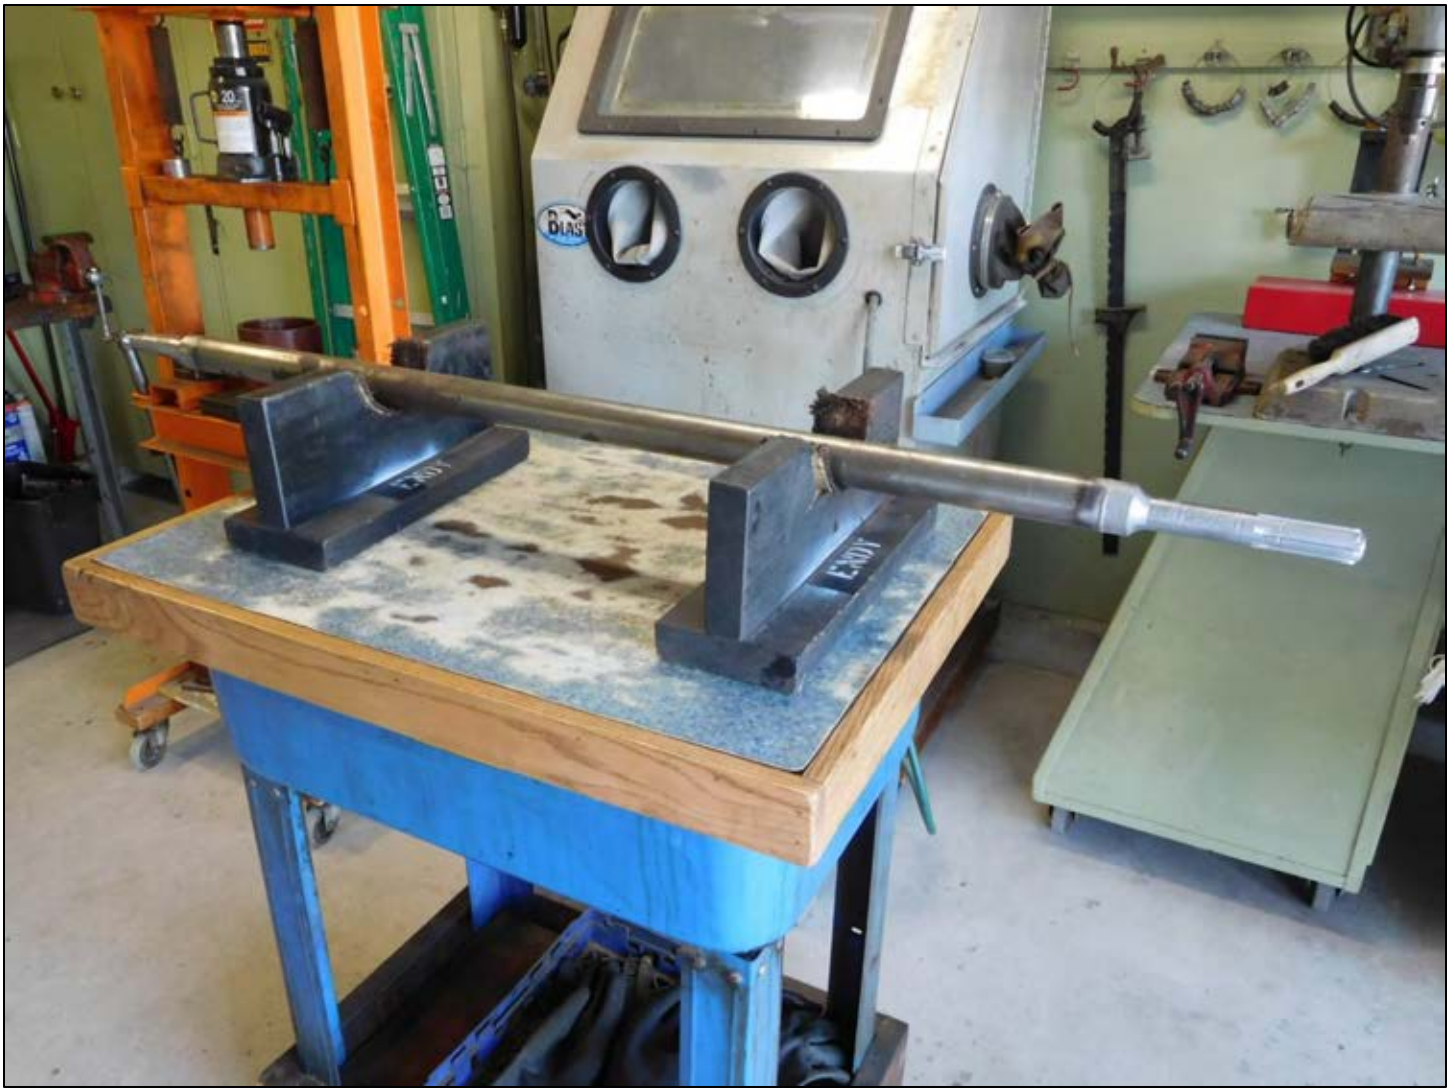
Once the torque tube was removed after the removal of the frozen speedo drive gear it was discovered that the drive shaft was found to be a 1&3/4" diameter hollow tube welded over a smaller solid drive shaft. Apparently this is particular to the 1932 V8's. This prevents the two large nuts, lock and thrust washers, and the front pinion bearing from being slid off over the drive shaft and then the drive shaft with the pinion gear on it from being pushed out the side of the banjo.

Shown here is the front end of the drive shaft. A hollow tube is installed over the smaller diameter drive shaft and welded into place. The splined end will connect to a U-joint the same as a Model A.

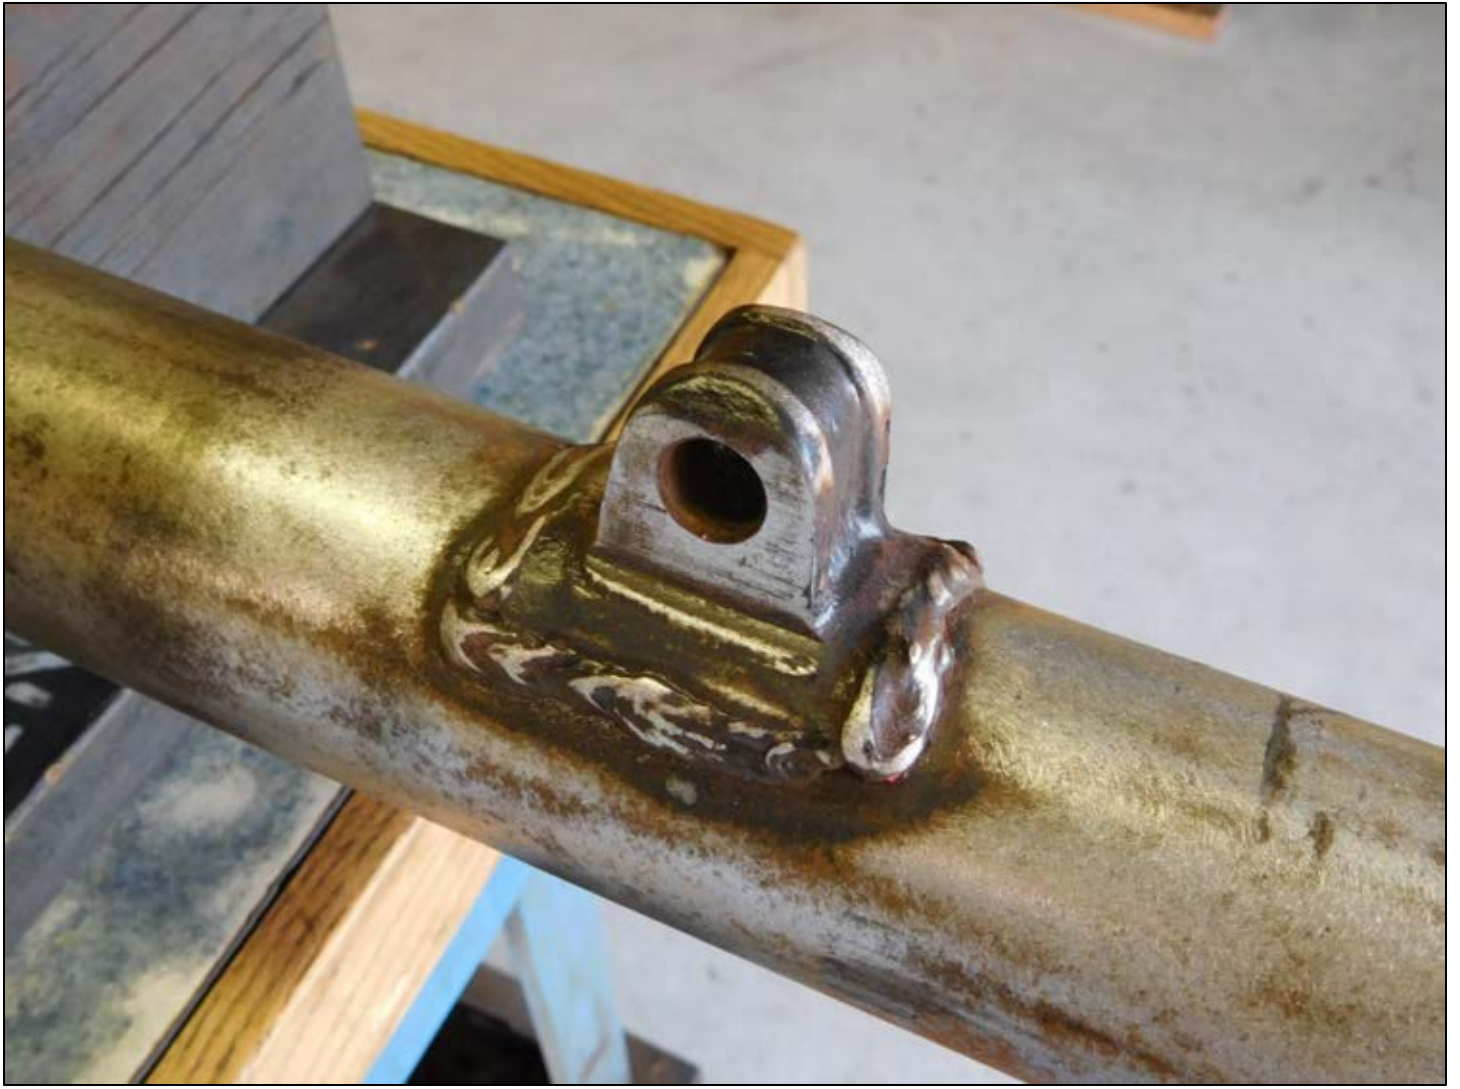
Shown here is the torque tube after it was cleaned up and sanded down with an orbital sander. Note the U-joint housing on the right end, it is captured there by virtue of the manufacturing process. It cannot be removed. To the left is a bracket welded to the torque tube to attach the front of the two radius rods.

The torque tube is three inches longer than a Model A.

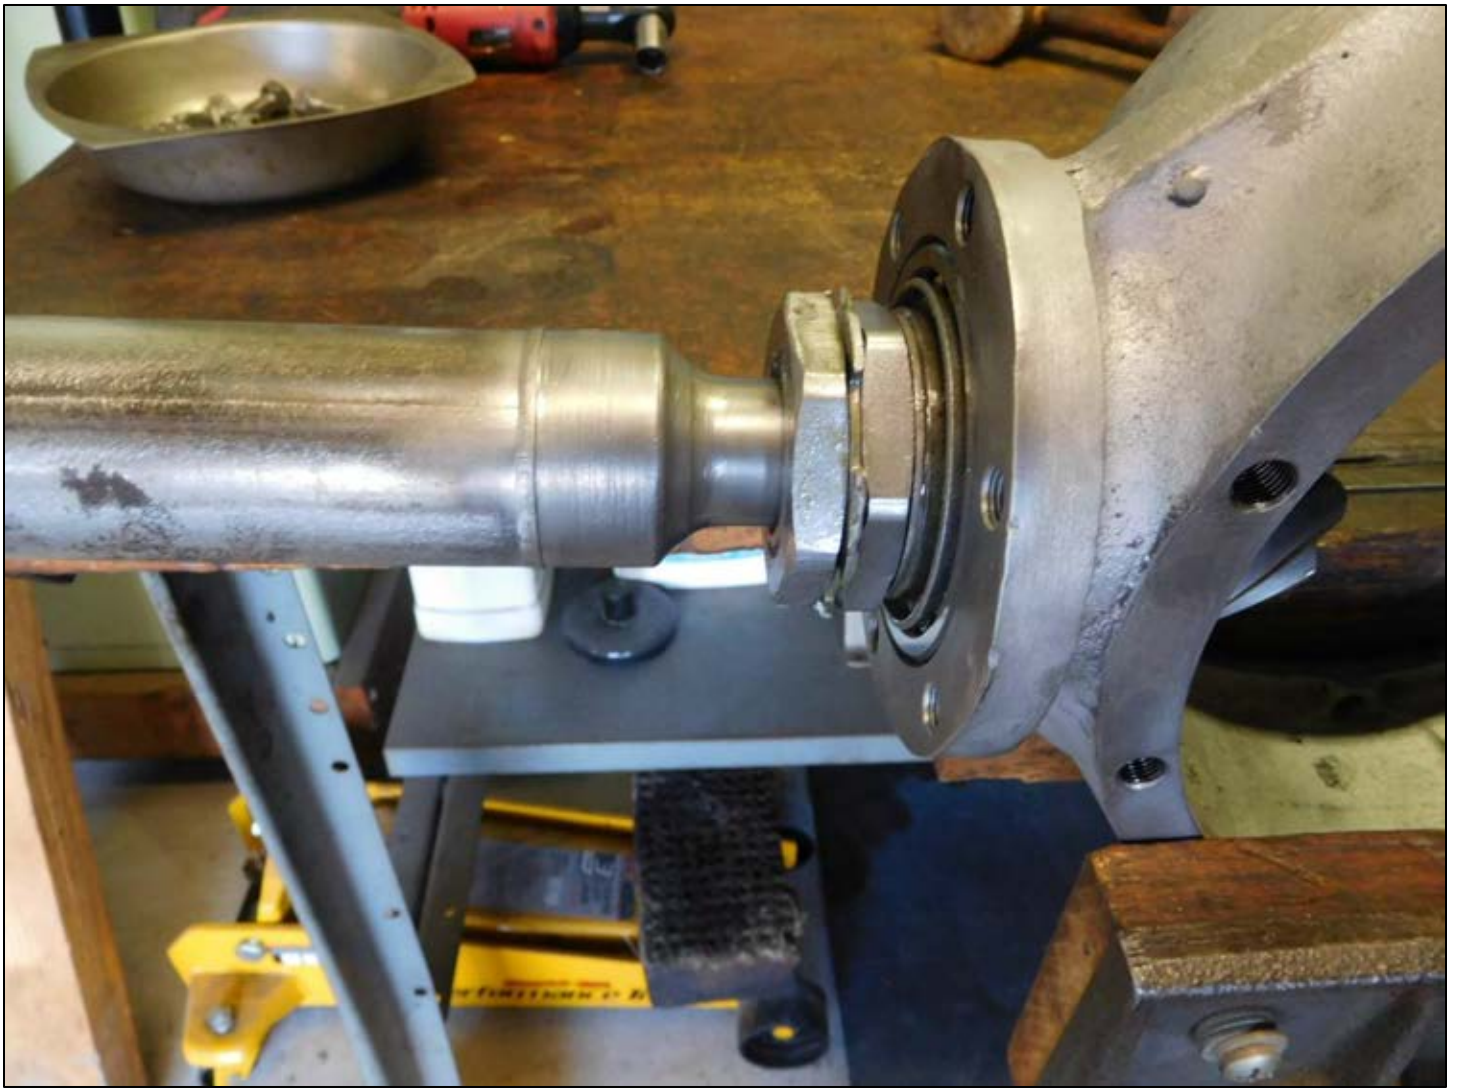
The pinion gear with the rear bearing installed has been inserted into the banjo, the second bearing was then installed, along with the two large nuts, the thrust washer, and the locking washer. The drive shaft will be installed next and the $\frac{5}{16}$ " hex nut will be torqued to a nominal 100 ft. lbs. before the pinion bearing pre-load is established by the adjustment of the two large nuts.

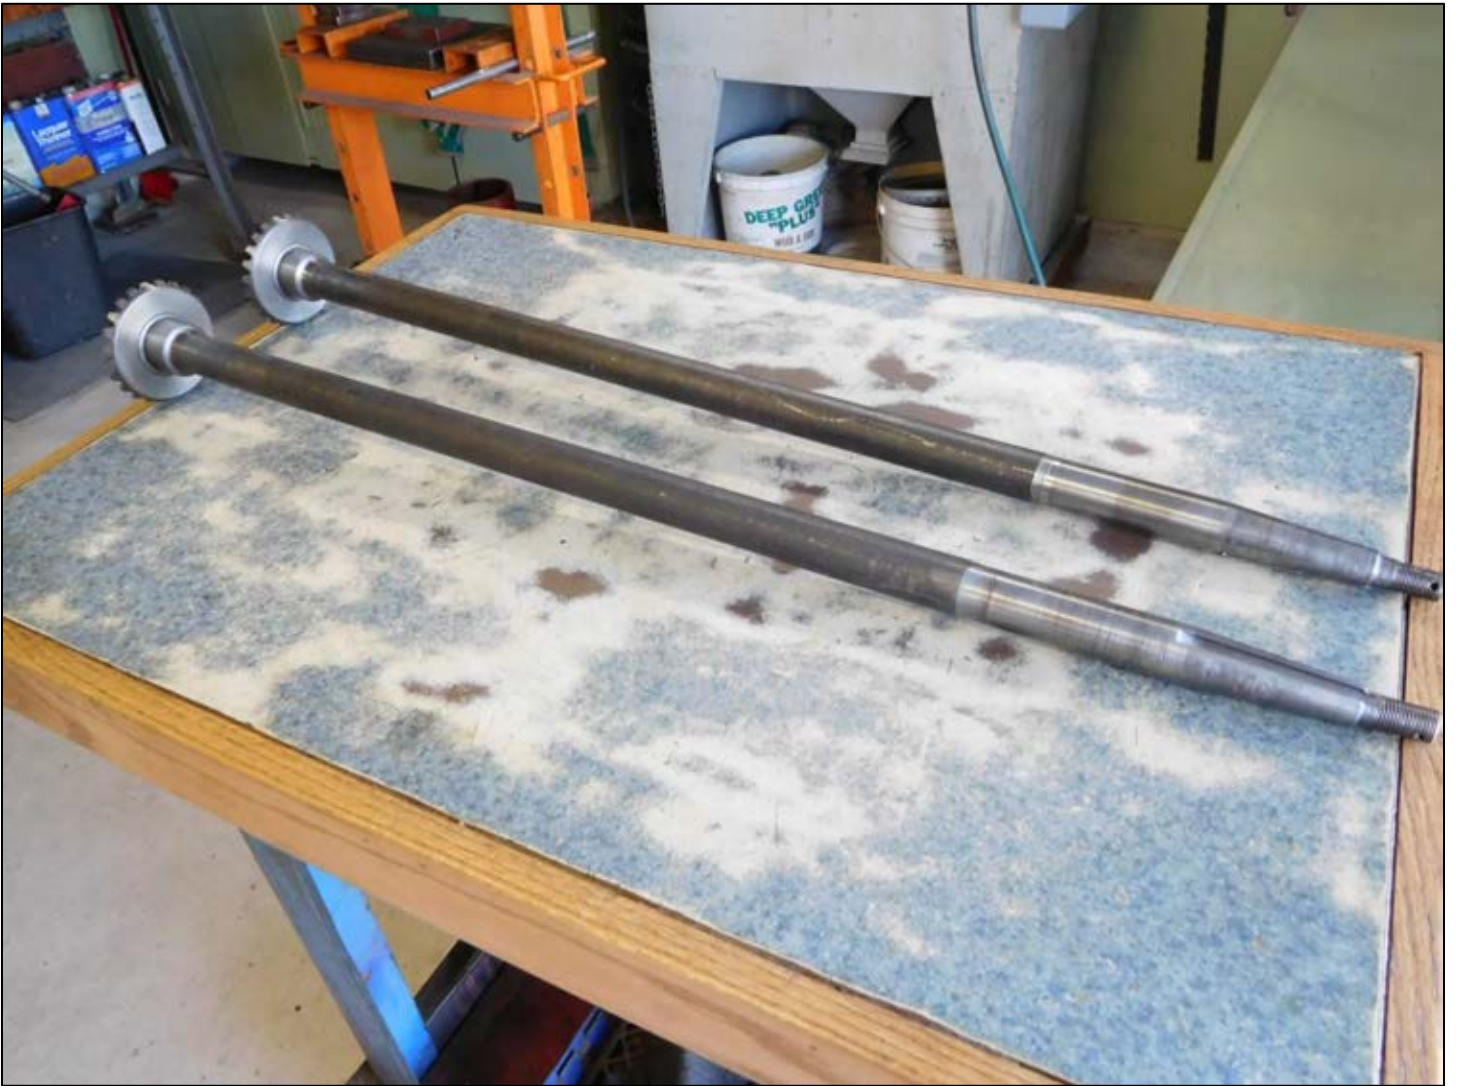
Shown here is the pinion gear assembly and the drive shaft assembled into the banjo. The next step is to install the two axle housings and adjust the backlash between the pinion and ring gears. This will be done by distributing the quantity of banjo gaskets that were previously selected to establish the pre-load on the carrier bearings.

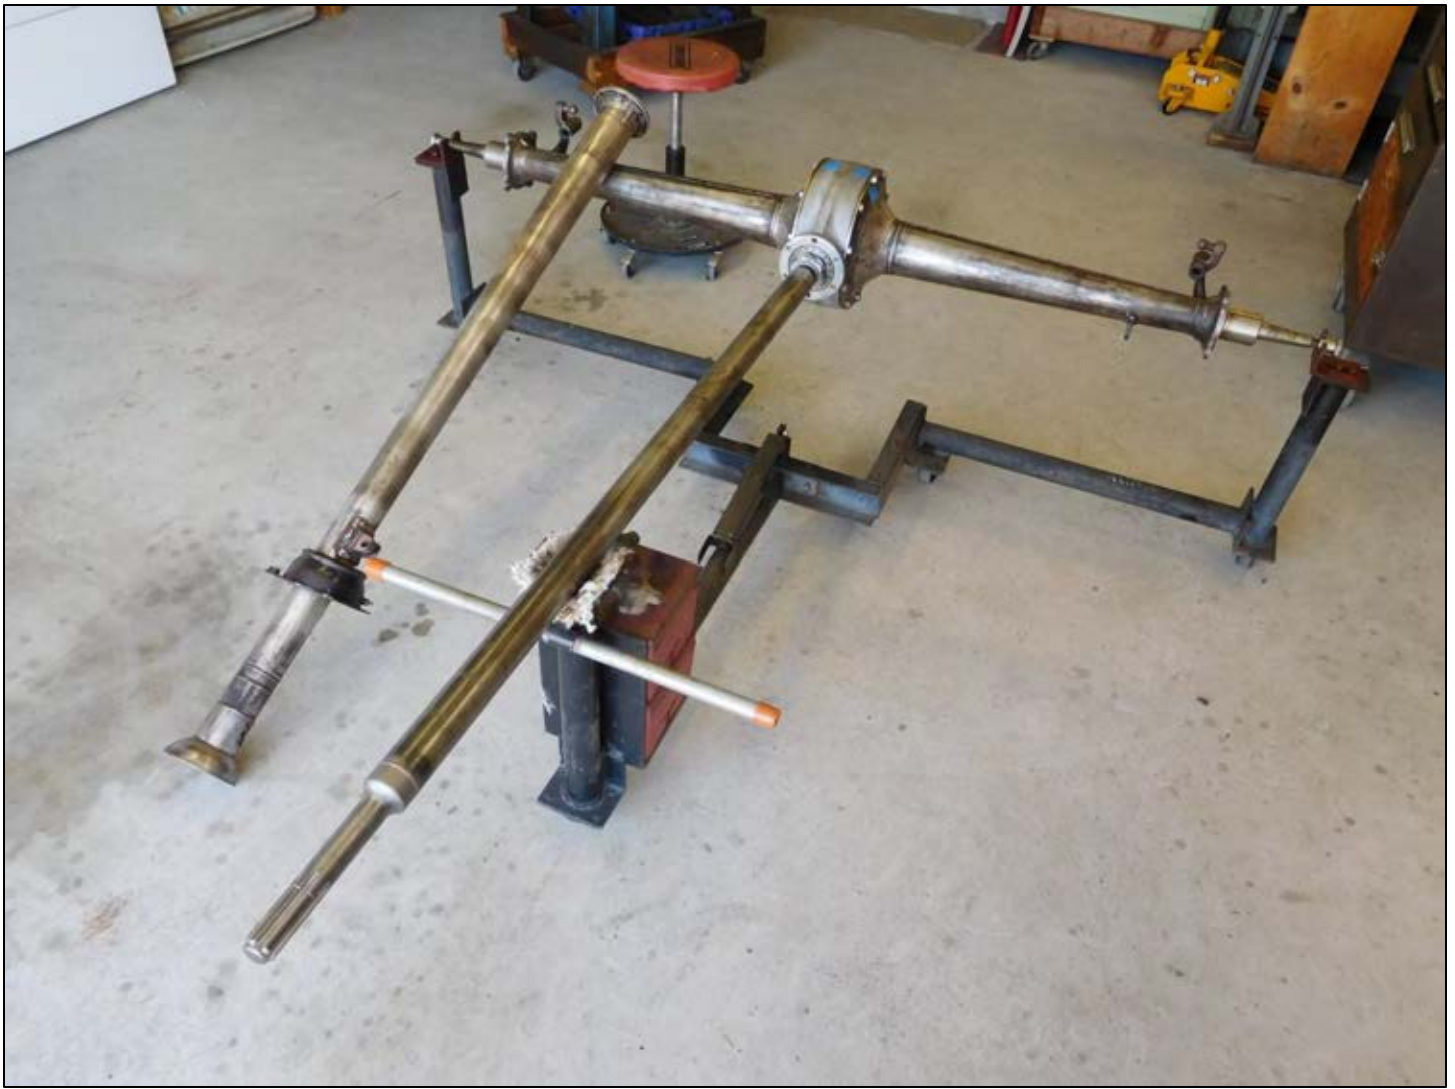
The two rear axle shafts were found to be in good serviceable condition and were cleaned up. Shown here they are ready for installation. They are the same as used in a Model A.

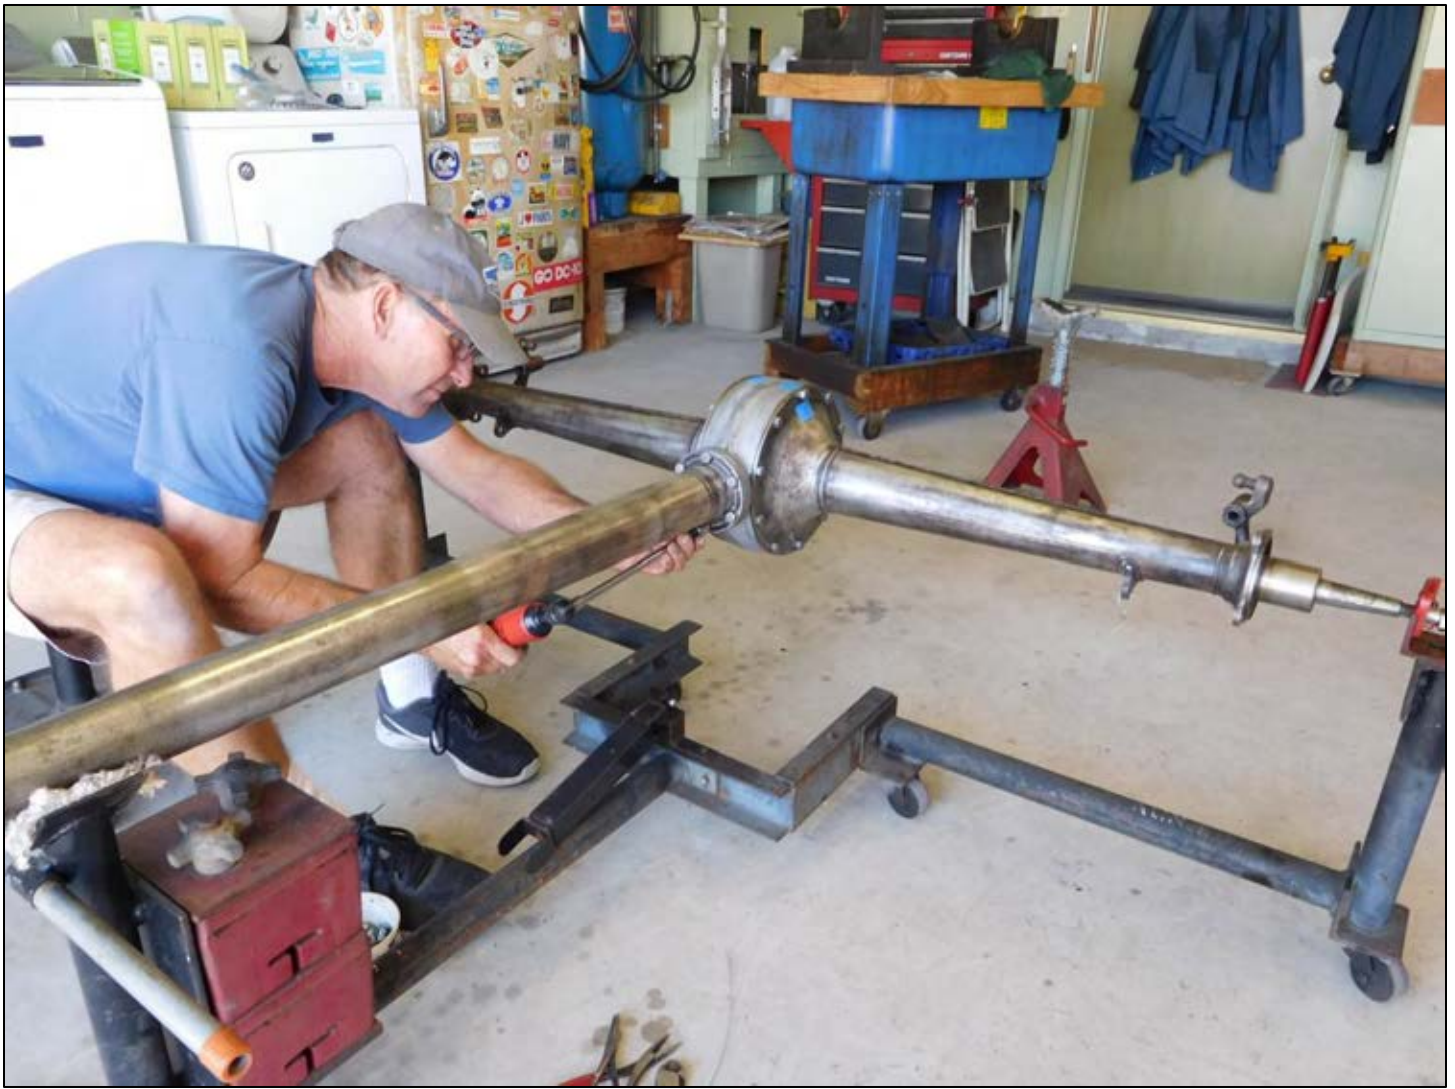
The backlash was set by installing two of the .010 gaskets on the right side of the banjo and one .010 on the left side. The two axle shafts and the spider gears were installed and the housings were then bolted together using Indian Head gasket sealer on the banjo gaskets. The unit was then moved from the vertical jig to the roll-around cradle. It is shown here ready for the torque tube to be installed over the drive shaft.

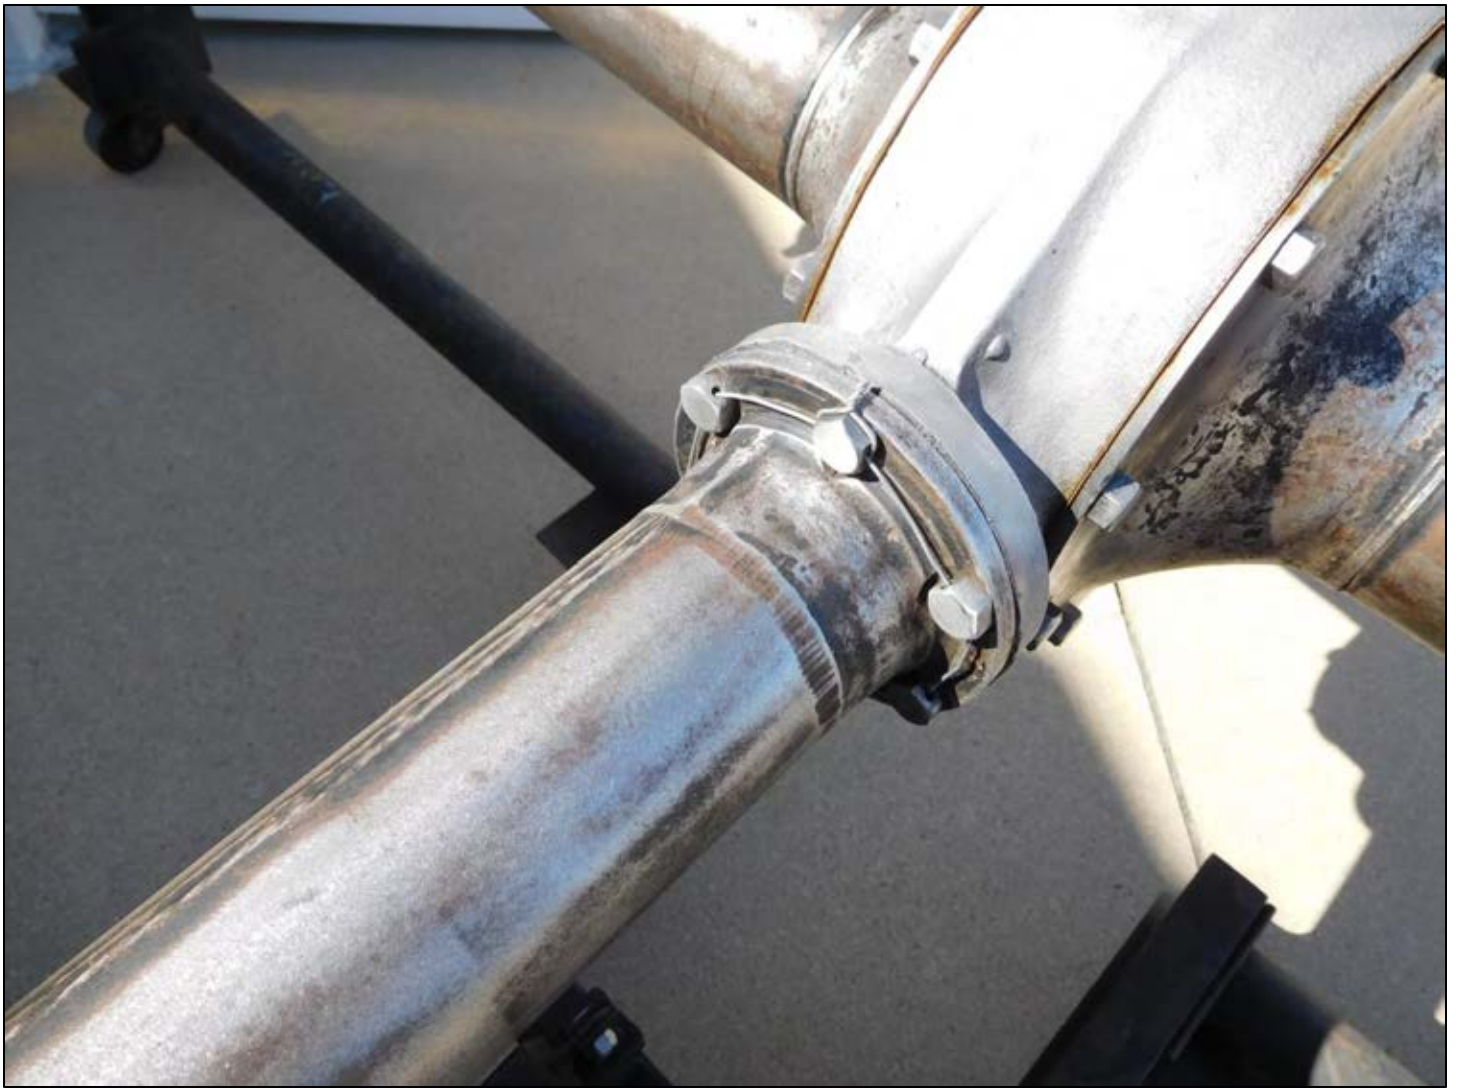
Shown here is Bryan installing the six bolts that secure the torque tube to the banjo flange. This is a trial and error effort to have each bolt sufficiently tight with the safety wire hole parallel to allow the safety wire to install in a perfect circle. This is made possible by having a large collection of original torque tube bolts.

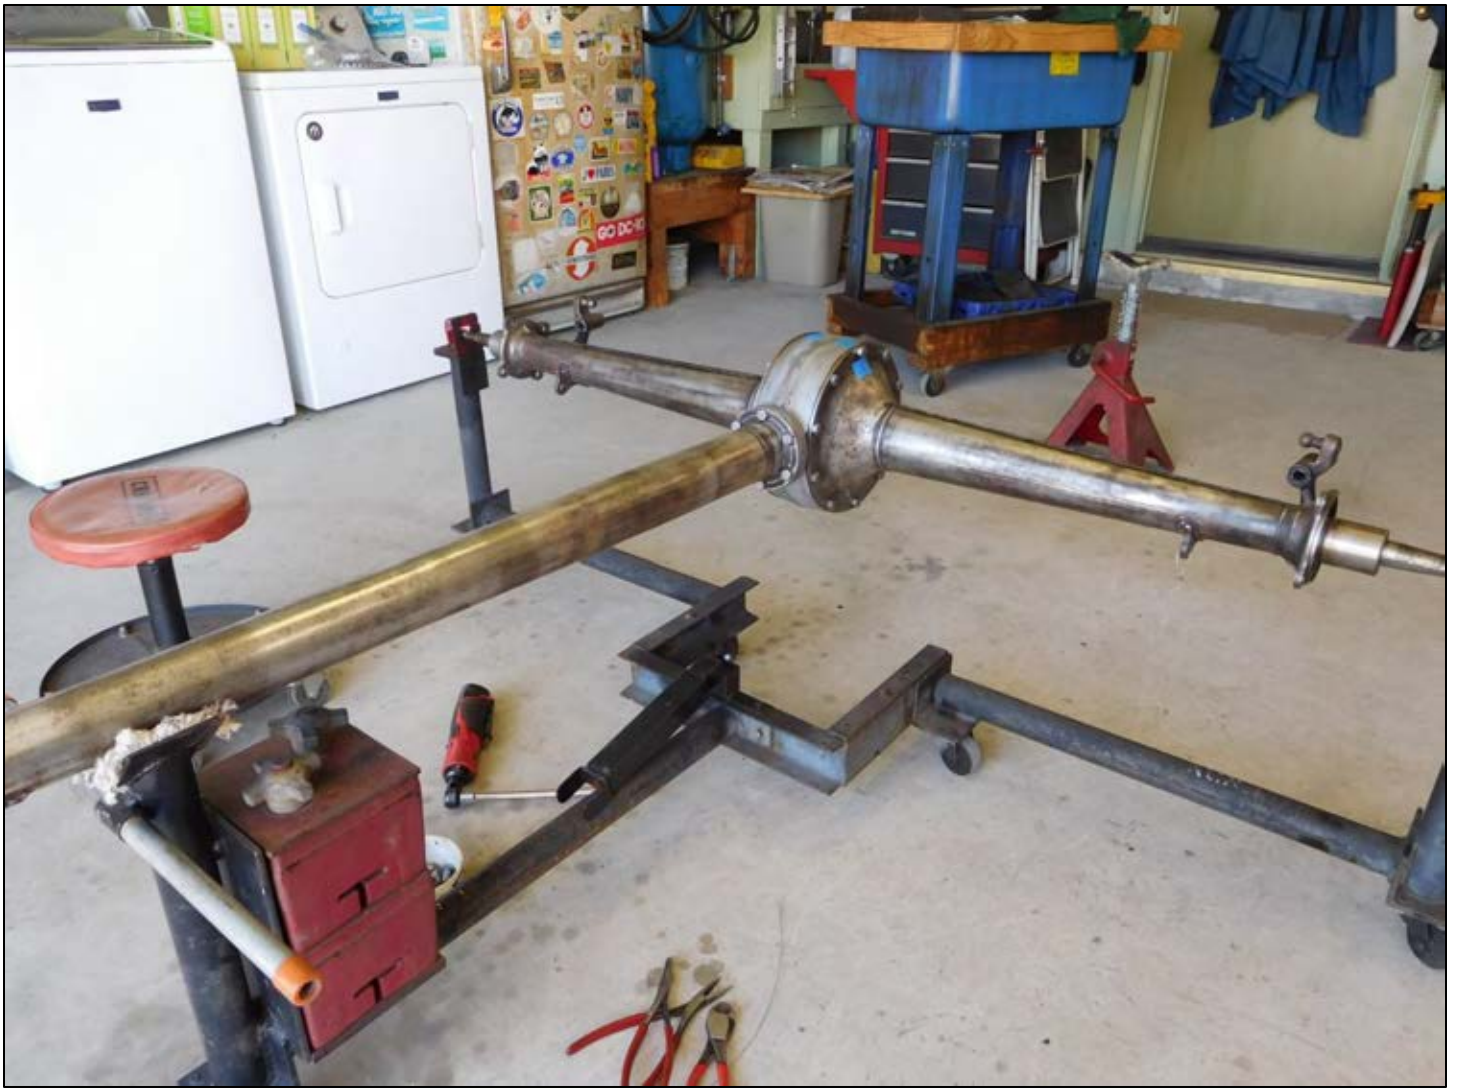
The torque tube bolts have been securely tightened and safety wired in a hallmark perfect circle.

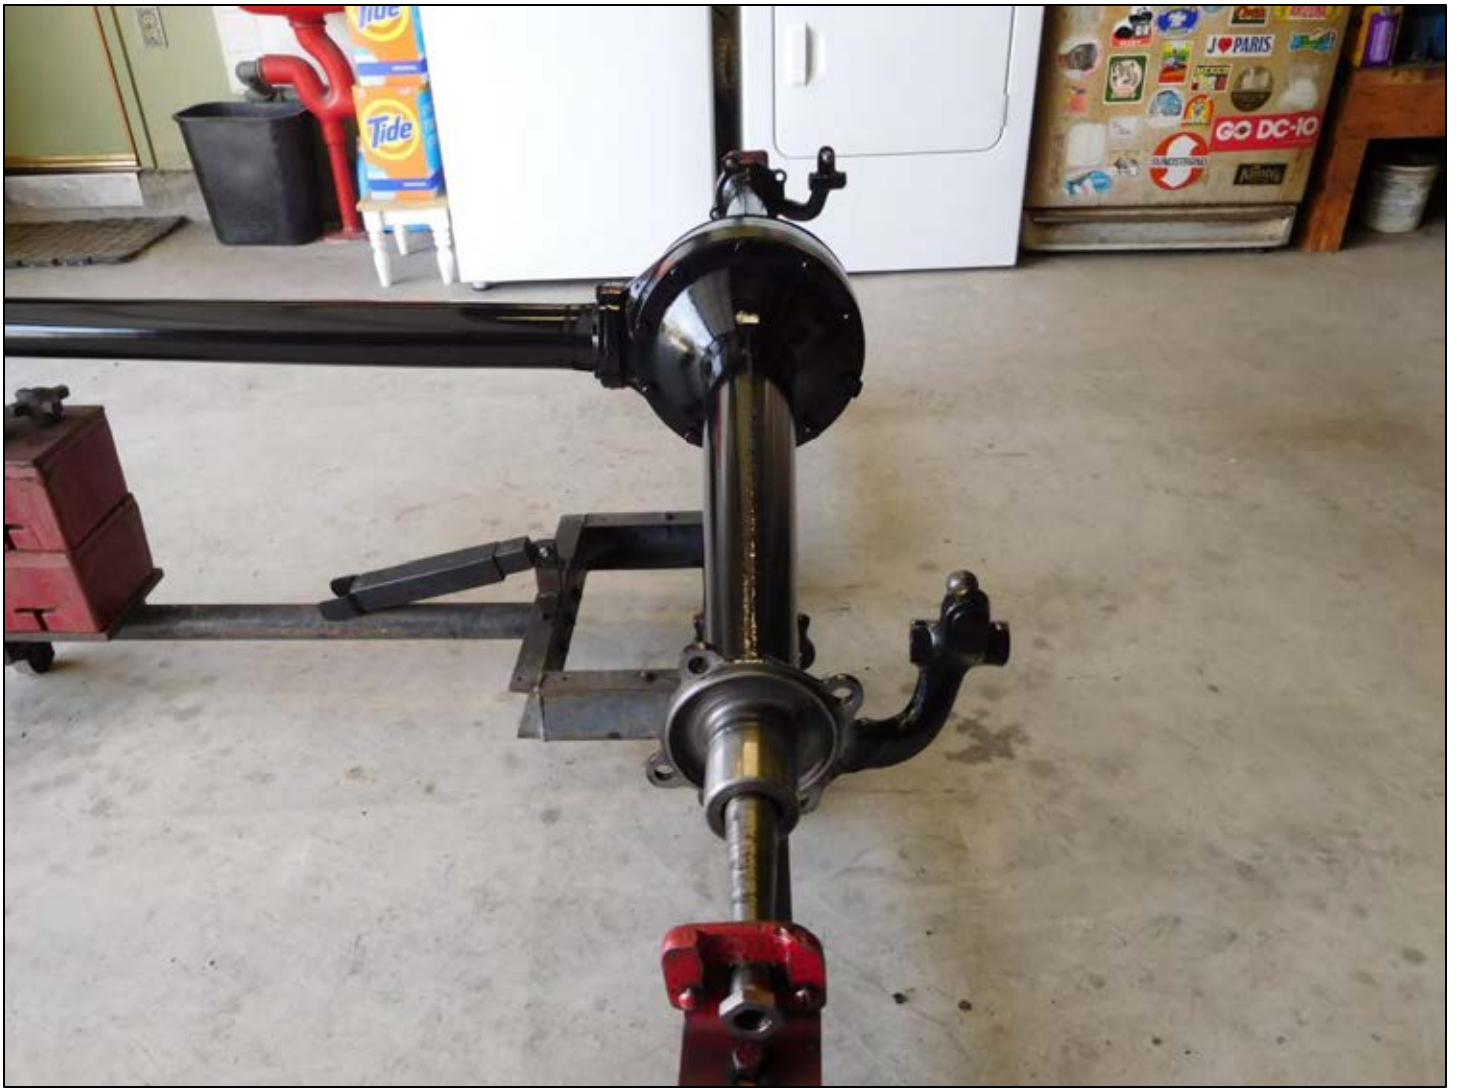
Note that on a 1932 rear axle assembly the mounting to the speedo drive gear is off-set from the bottom center line of the torque tube to the right about 20 degrees.

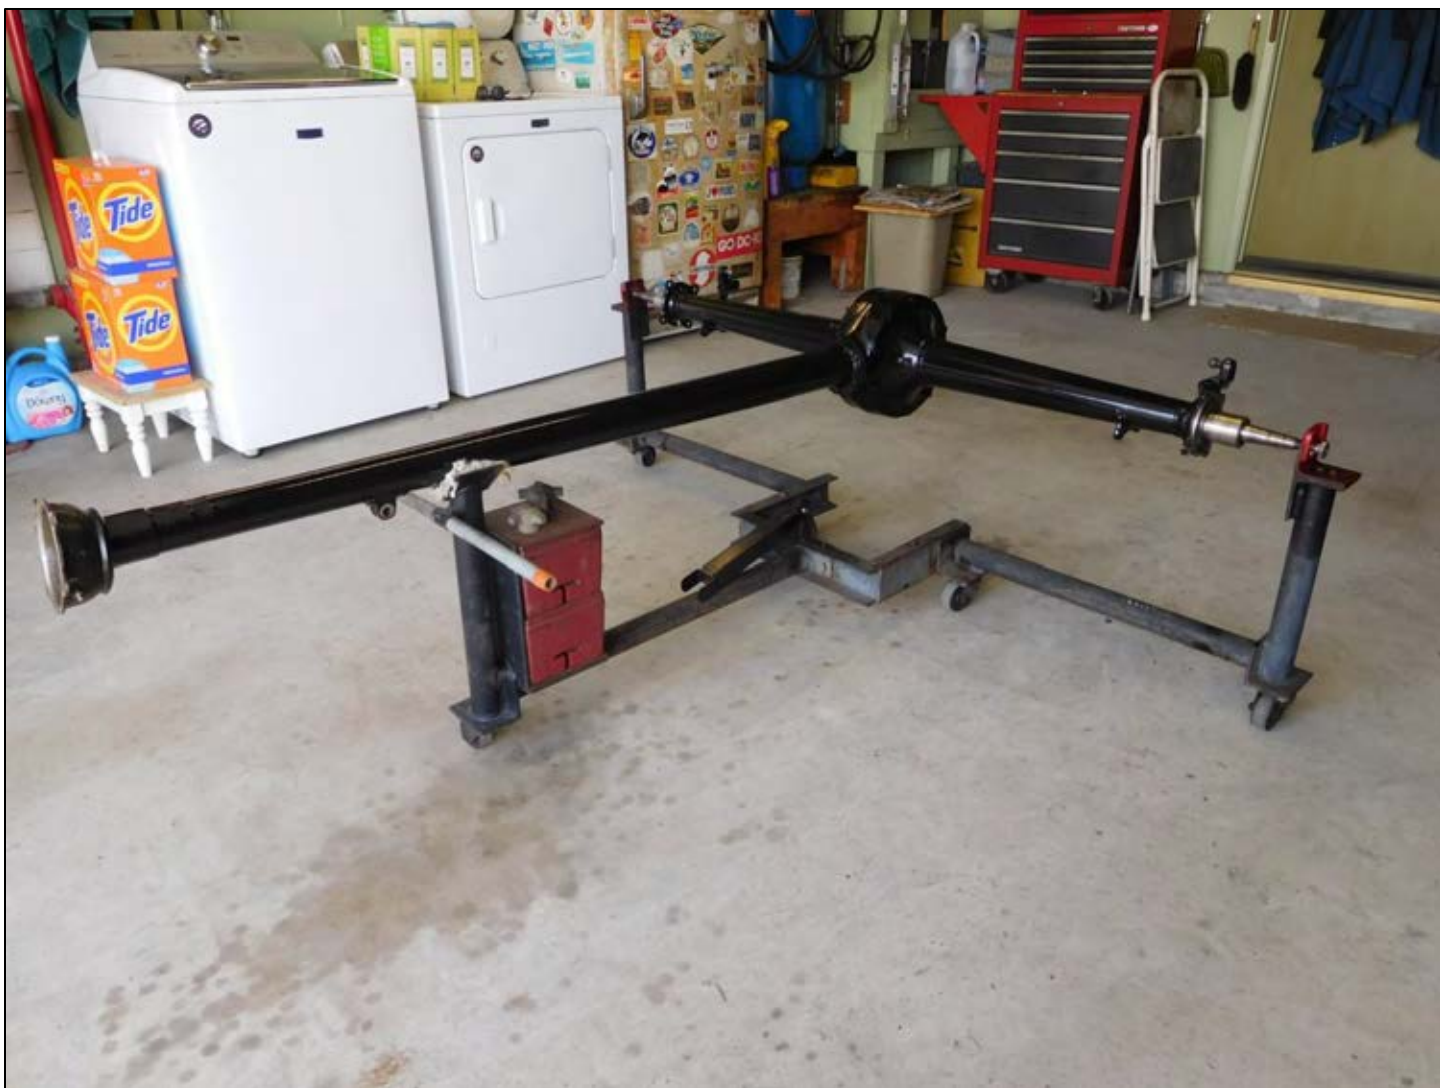
Note that on a 1932 rear axle assembly the two spring perches are set back from the centerline of the axle housings by five inches.
