Rear Axle Assembly Overhaul Pictorial

July 2018 by Tom Endy

This is a pictorial of a typical rear axle assembly that has been received for overhaul. It is long and tedious. However, for those who have taken on the task of overhauling a rear axle assembly themselves, the photos and captions may be of help.

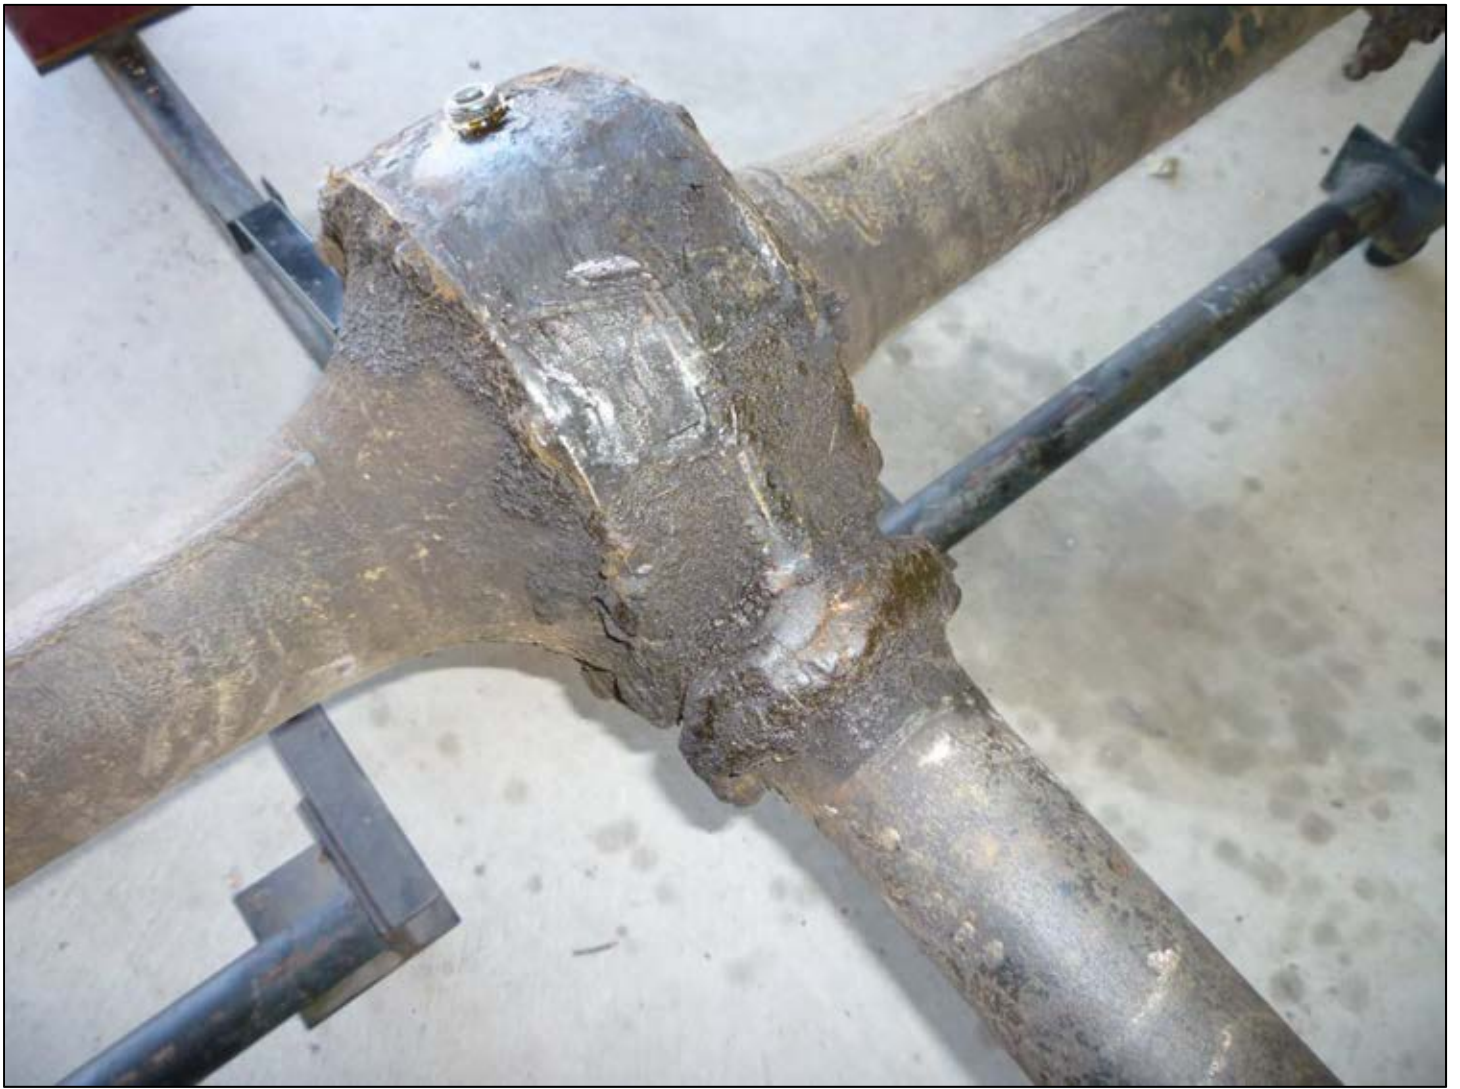
The bottom side of the torque tube flange is almost hidden in crud.

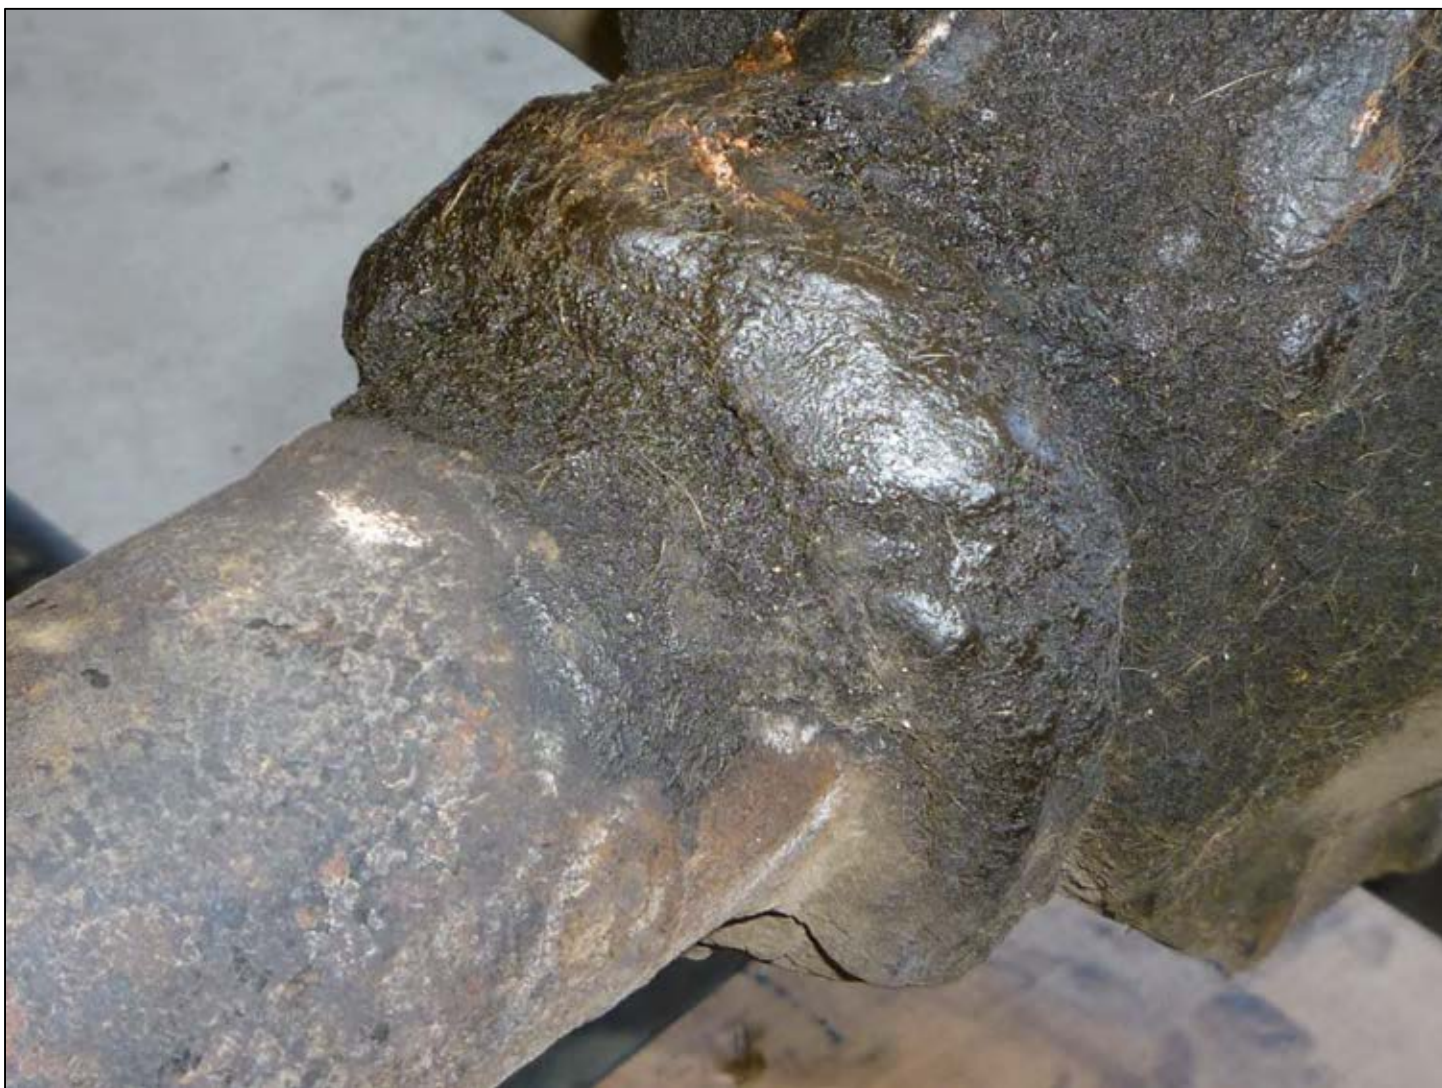
The top side of the torque tube flange is hidden in crud.

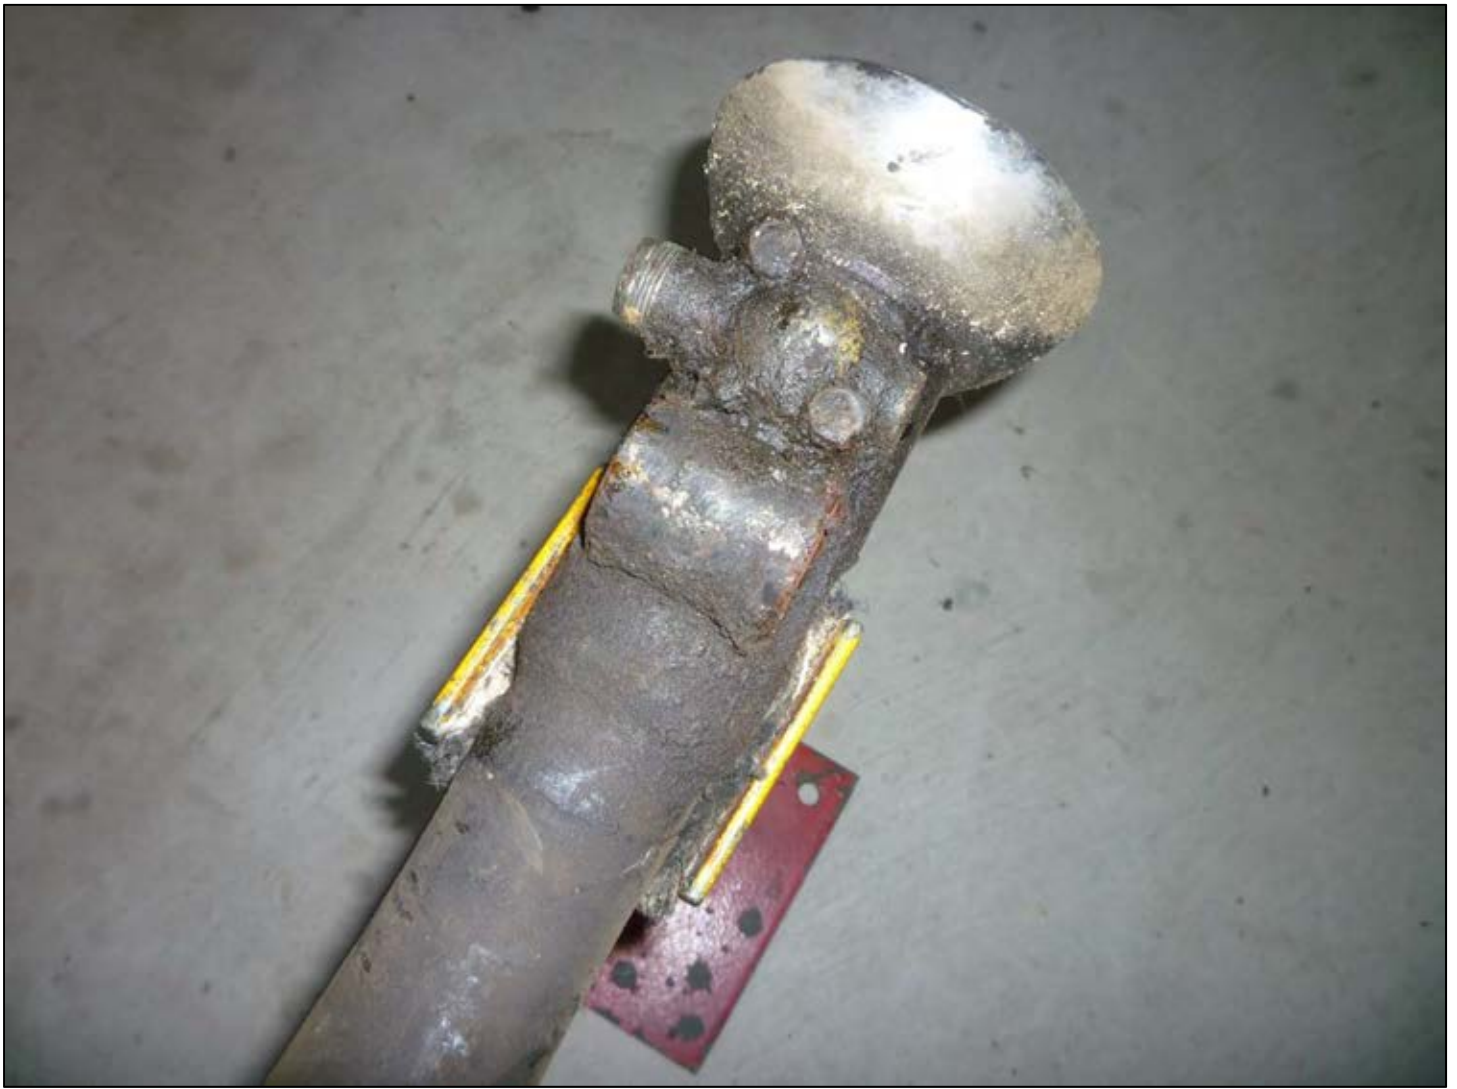
The speedo housing at the front of the torque tube is partially hidden in crud.

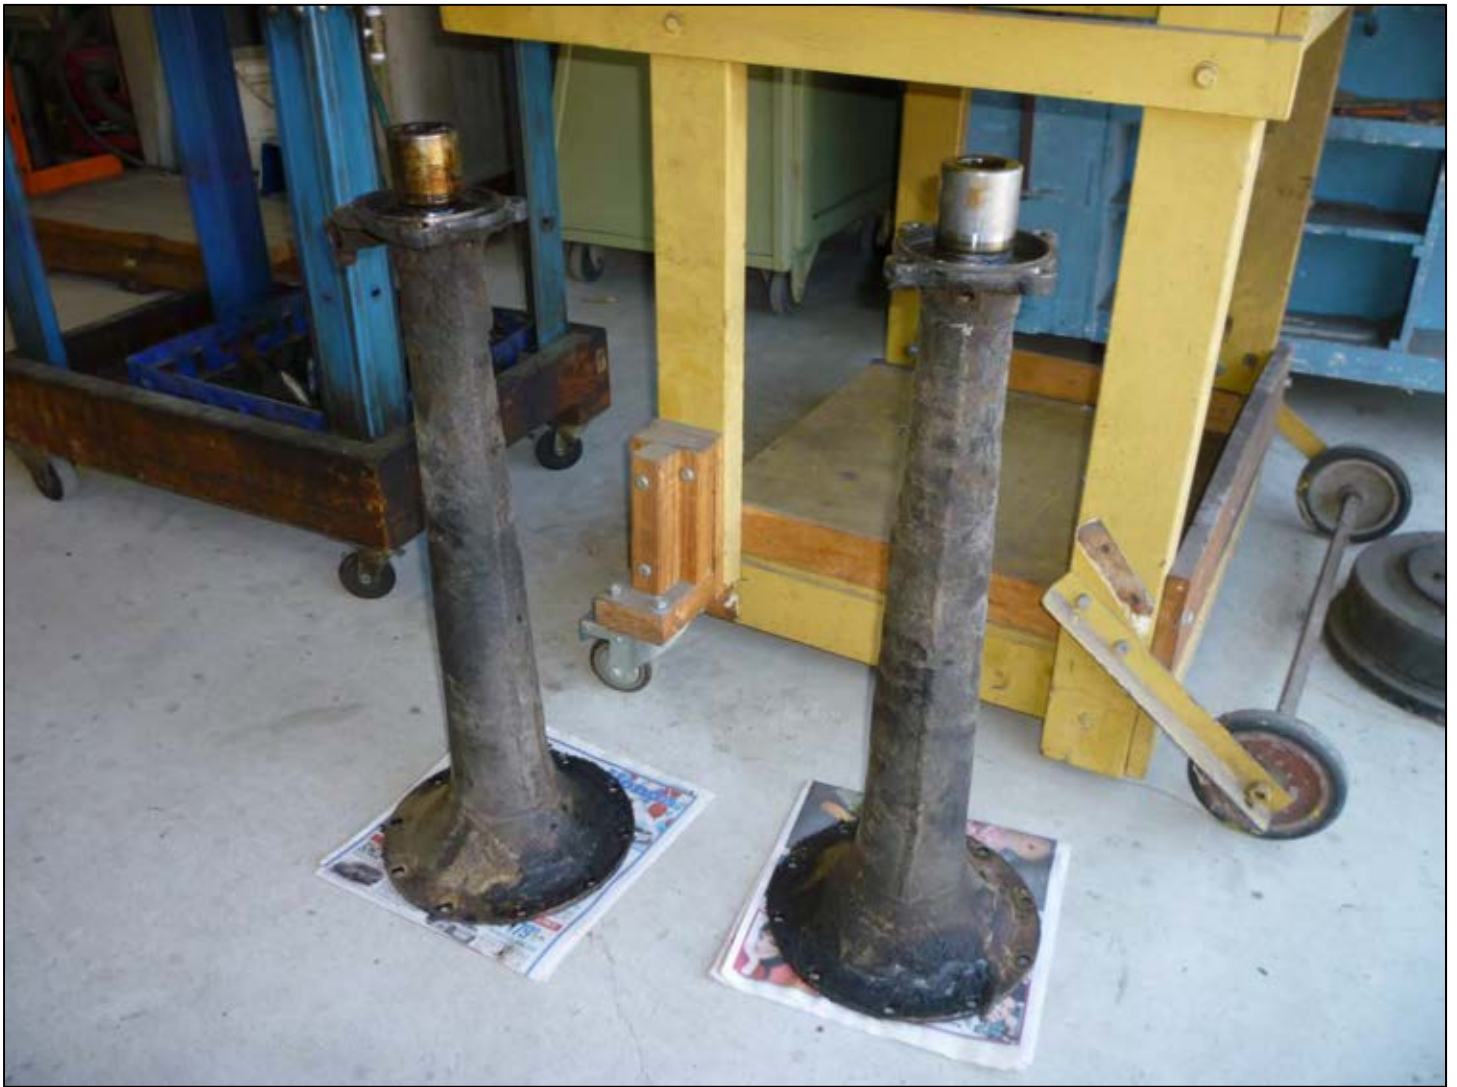
The two axle housings have been removed and both grease seals have been driven out. All three of the grease seals associated with the rear axle assembly were found to be the originals installed at the factory. The seals are made of leather, have the Ford logo on them, and the letters CR (Chicago Rawhide) stamped on them.

The leather found on these particular seals was largely deteriorated, which is usually the case when original seals are discovered to still be installed in a rear axle assembly.

Both rear axle housings will have to be thoroughly cleaned and both carrier bearing races removed. New races and grease seals will then be installed.

Both shackle bushings will be replaced.

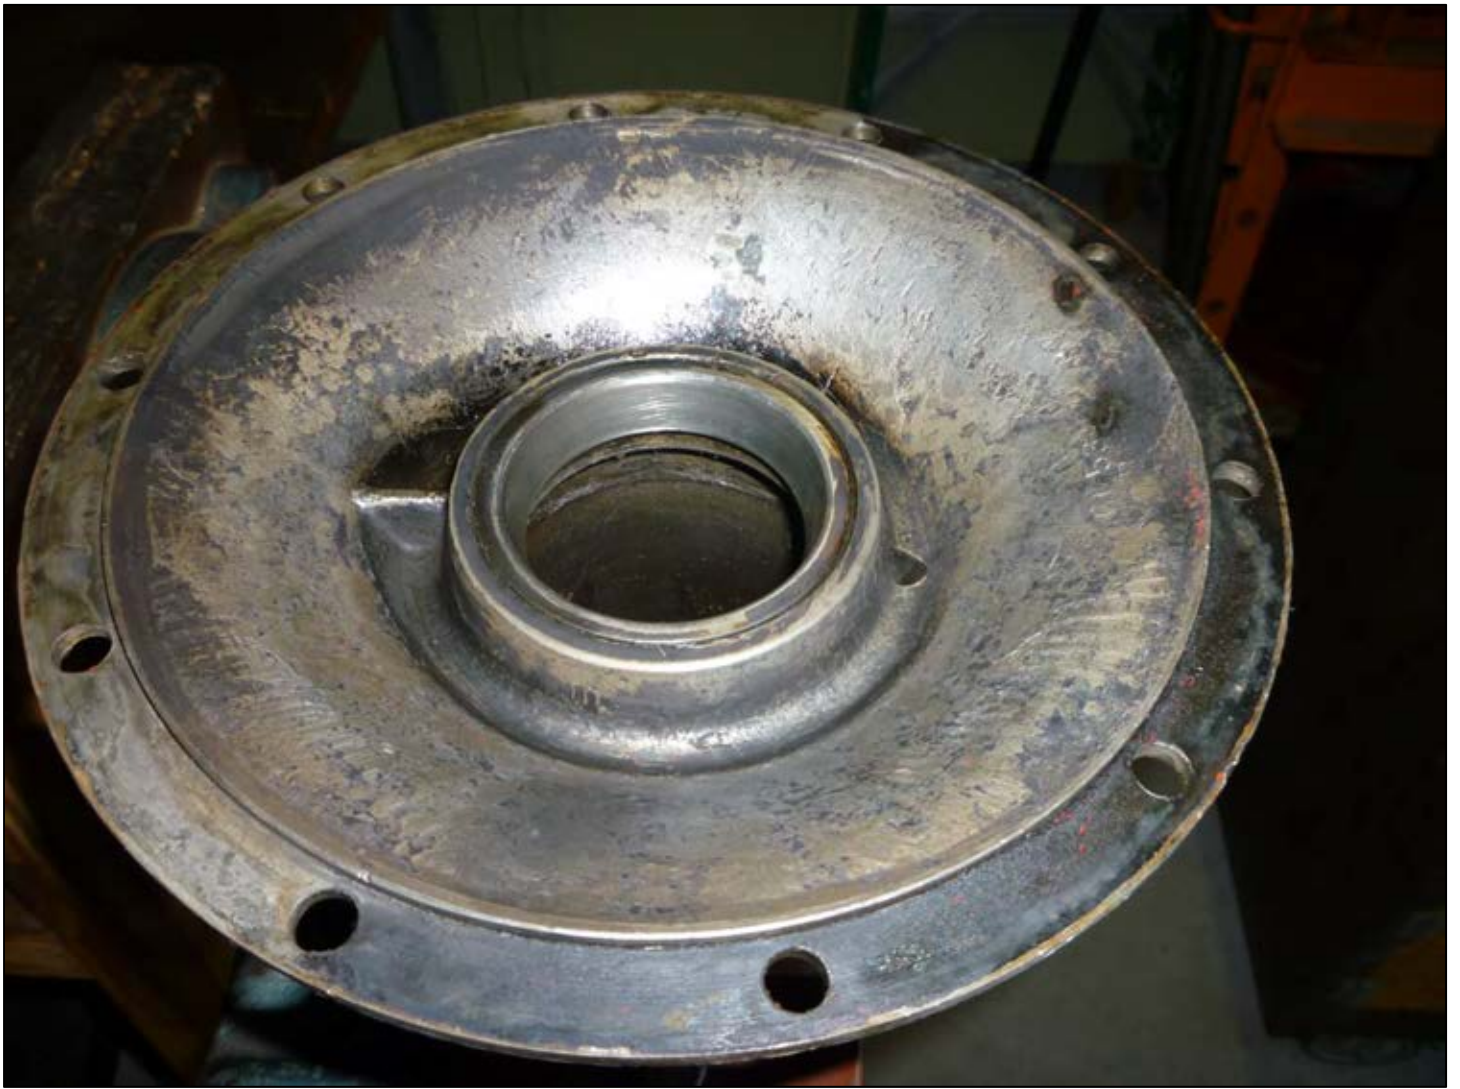
The old axle housing races have to be removed. The old race is shown in place on one of the axle housings.

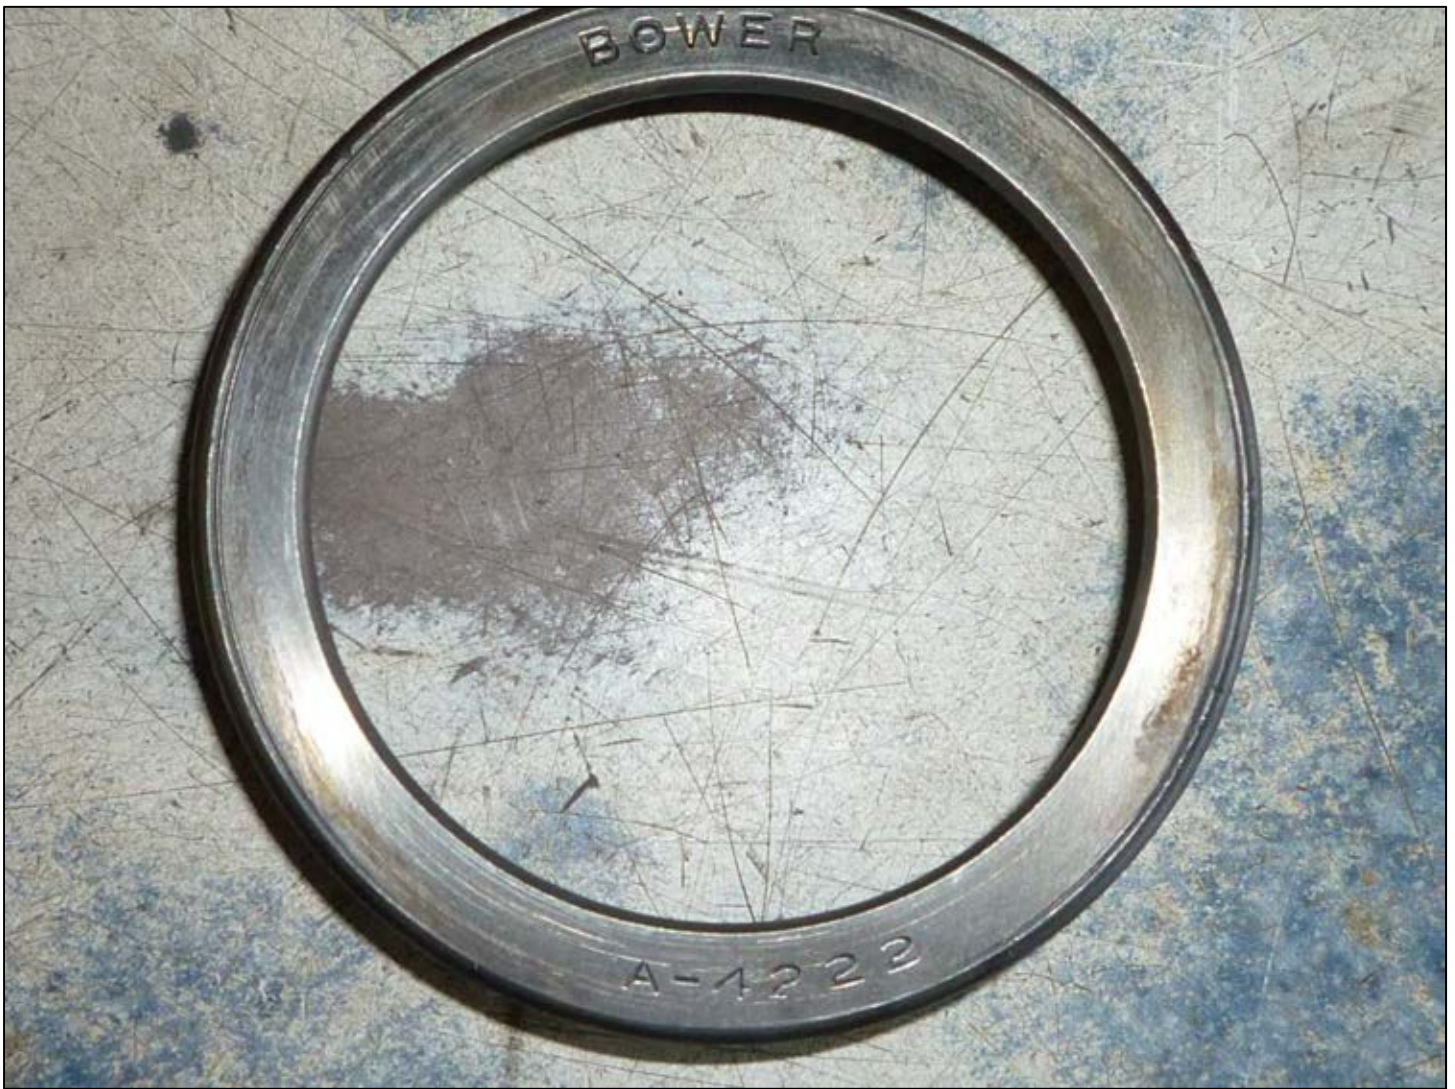
This photo shows the back side of the old race removed from one of the axle housings. Note it has the word Bower stamped on it. Bower was the original bearing supplier to Ford during the manufacture of the Model A. Note also the part number A-4222 is the original ford part number. This is a clear indication that the race is the original that was installed at the factory.

The bearings that were removed were made by Timken and had the later Timken part number indicated.

This is often found to be the case. Over the years people have been overhauling rear axle assemblies with half measures. People will change the bearing, but not the race.

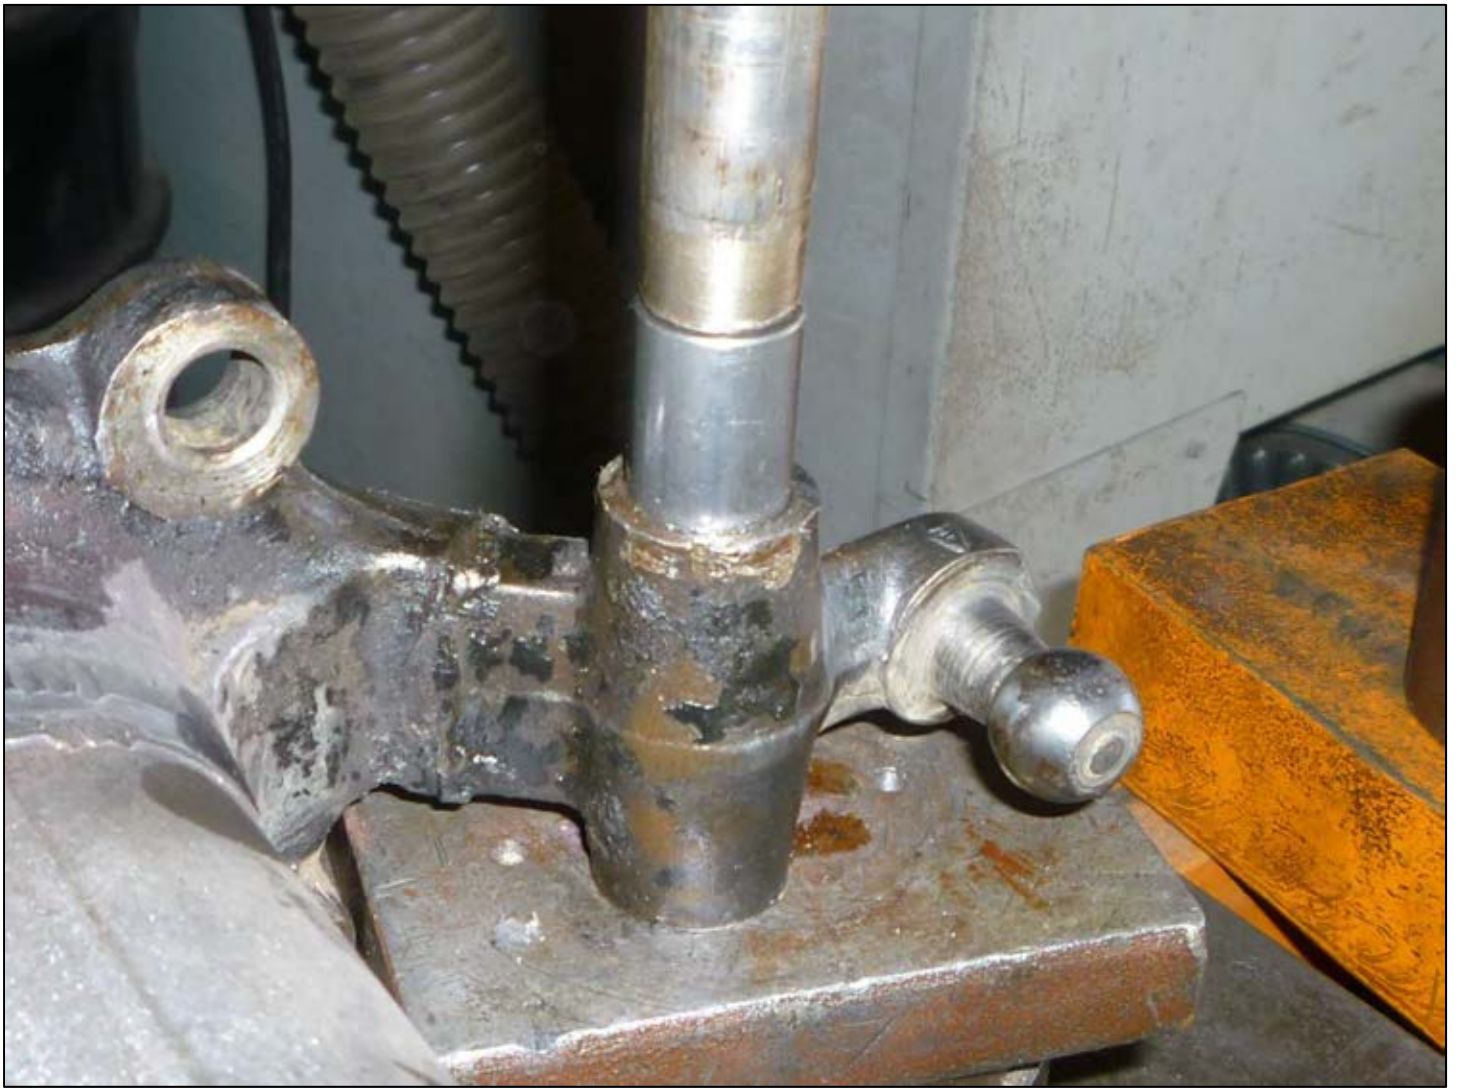
A new shackle bushing is pressed into place.

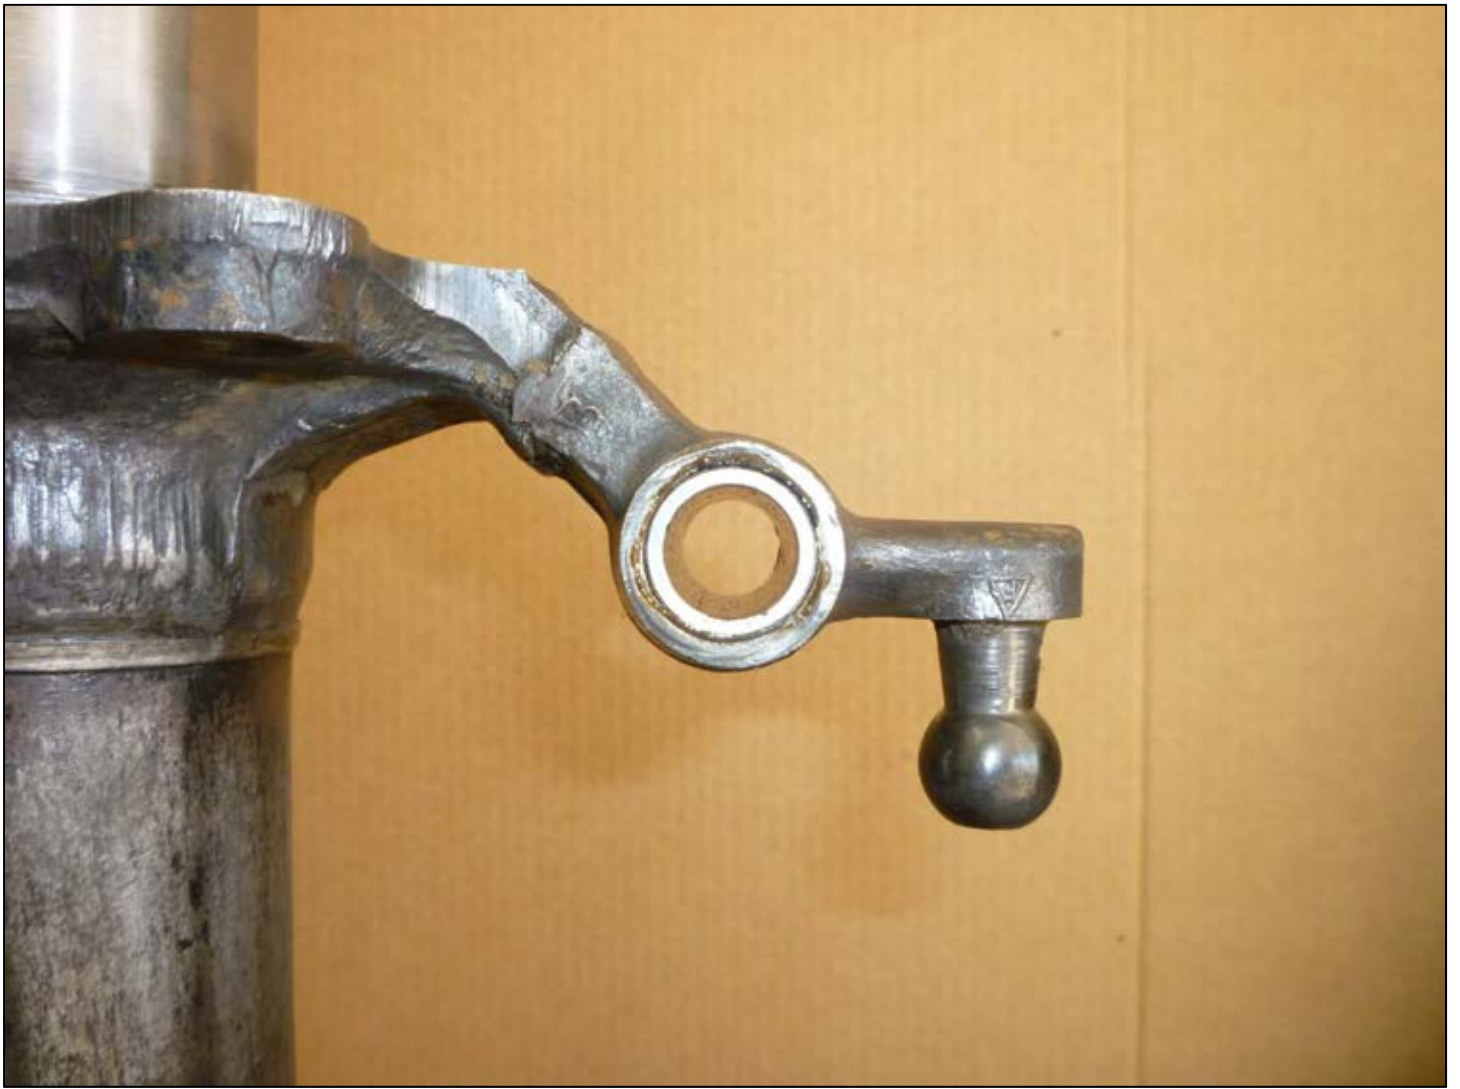
A new shackle bushing has been installed.

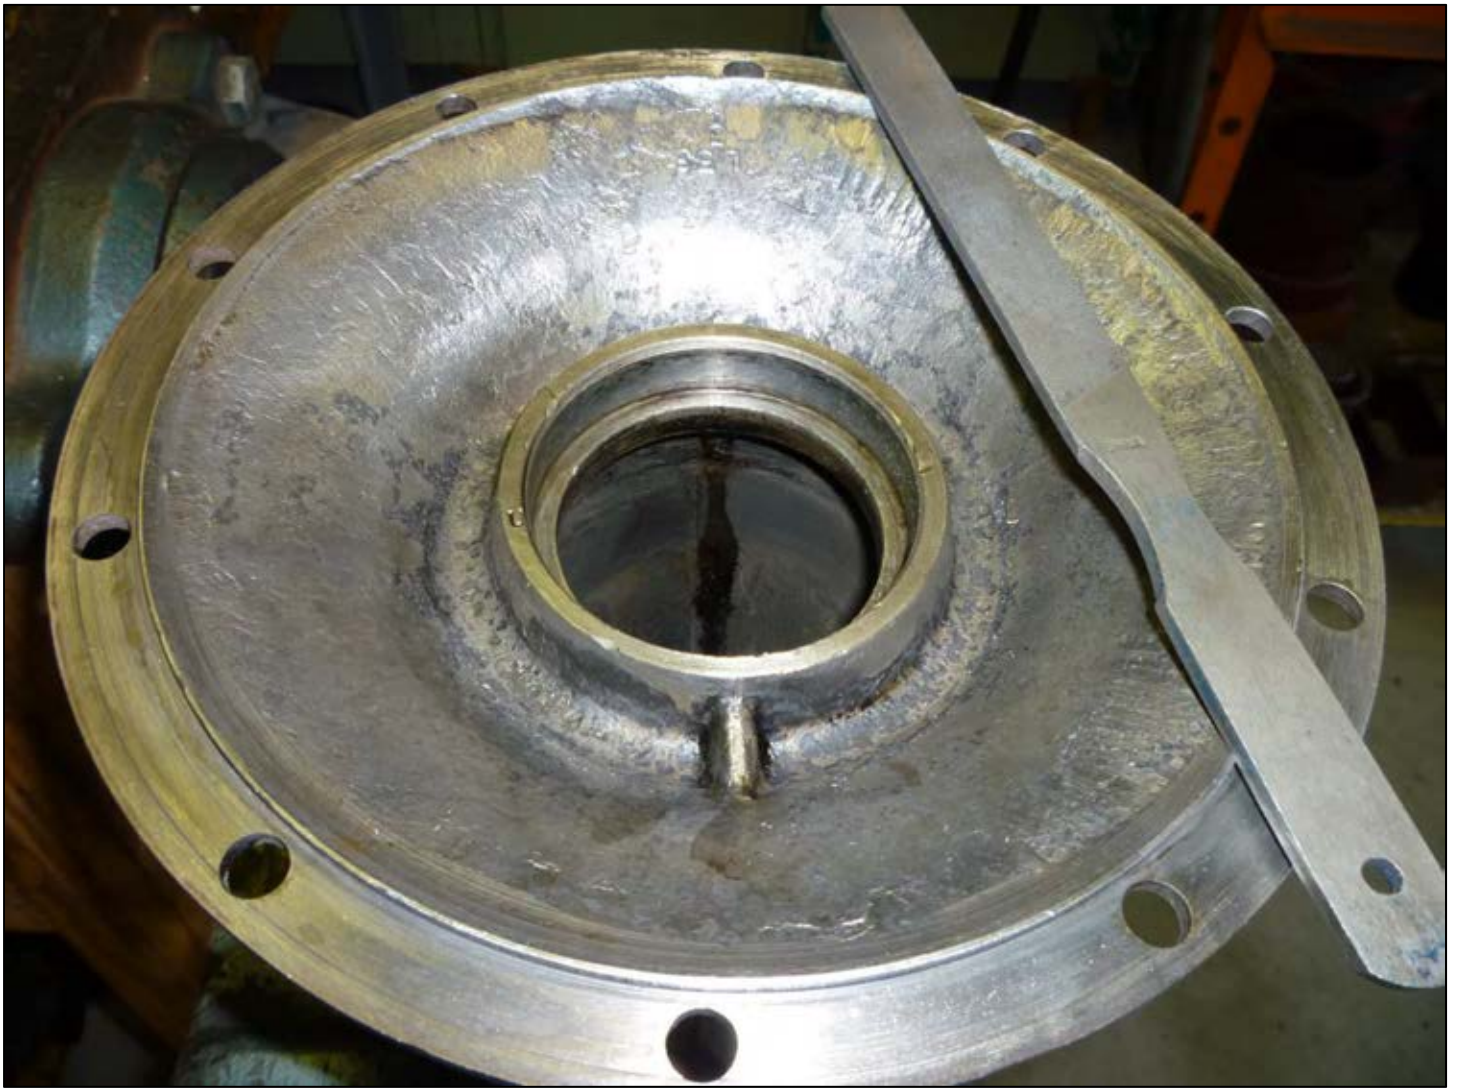
The axle housing has been cleaned up. The gasket surface has been wire wheeled to remove any crud and any residual gasket material. A flat file has been run over the gasket surface to remove any burrs. The race stop has been cleaned and inspected for any burrs. It is important that both surfaces be clean and flat.

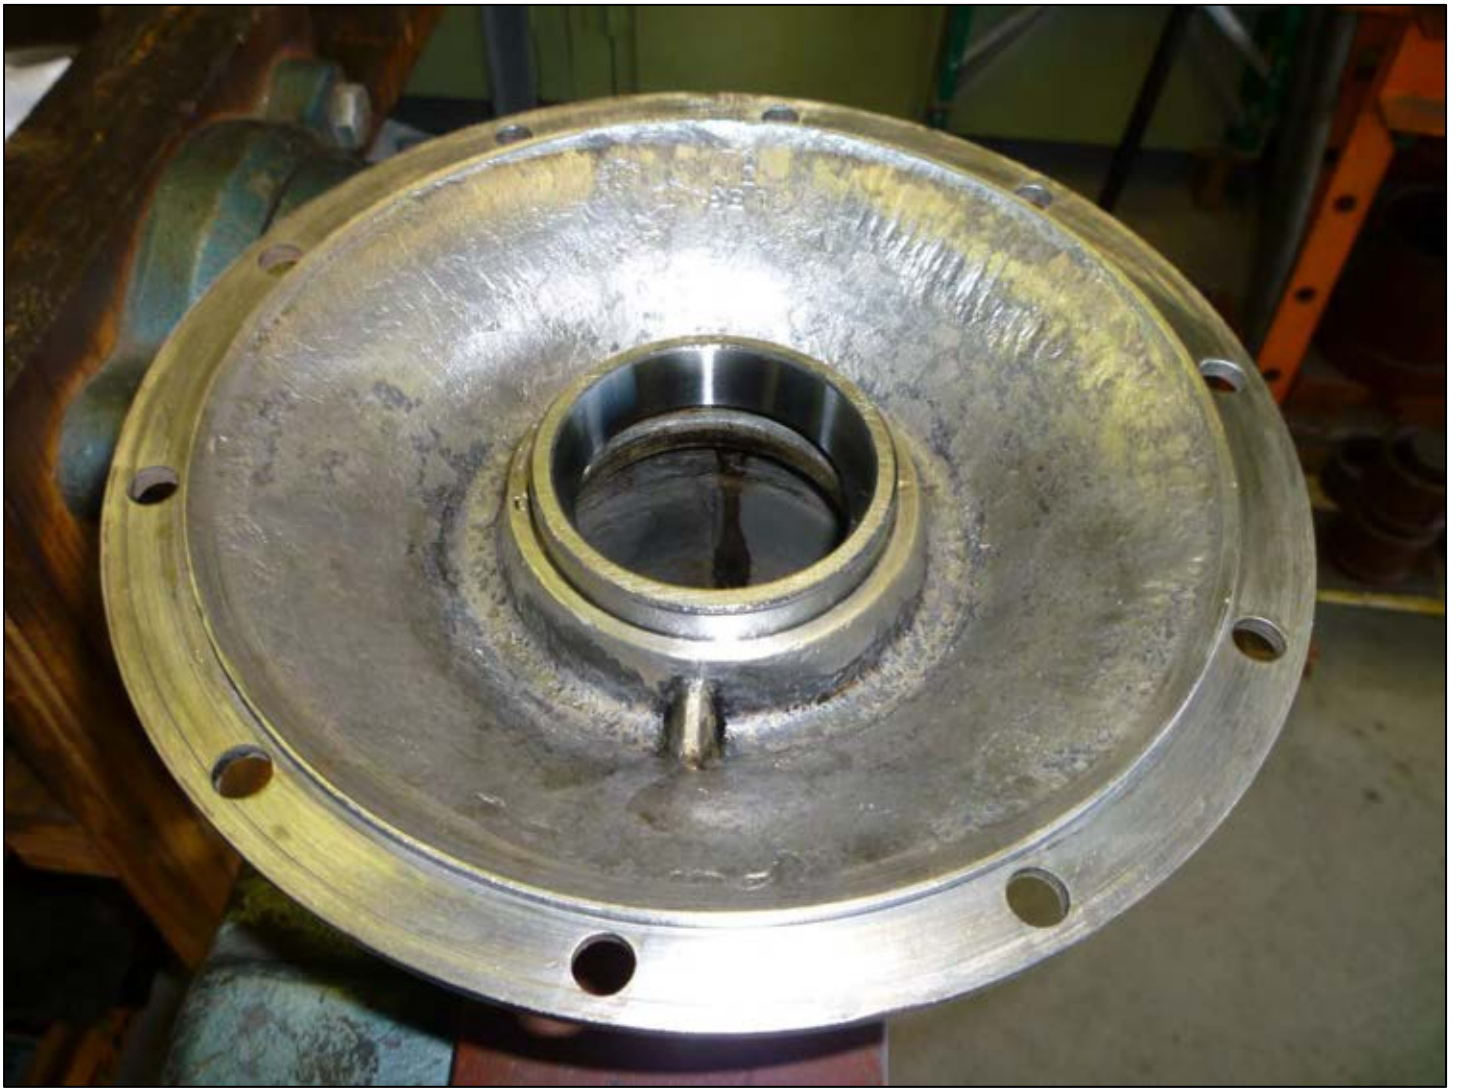
A new race had been set into place and is ready to be pressed in.

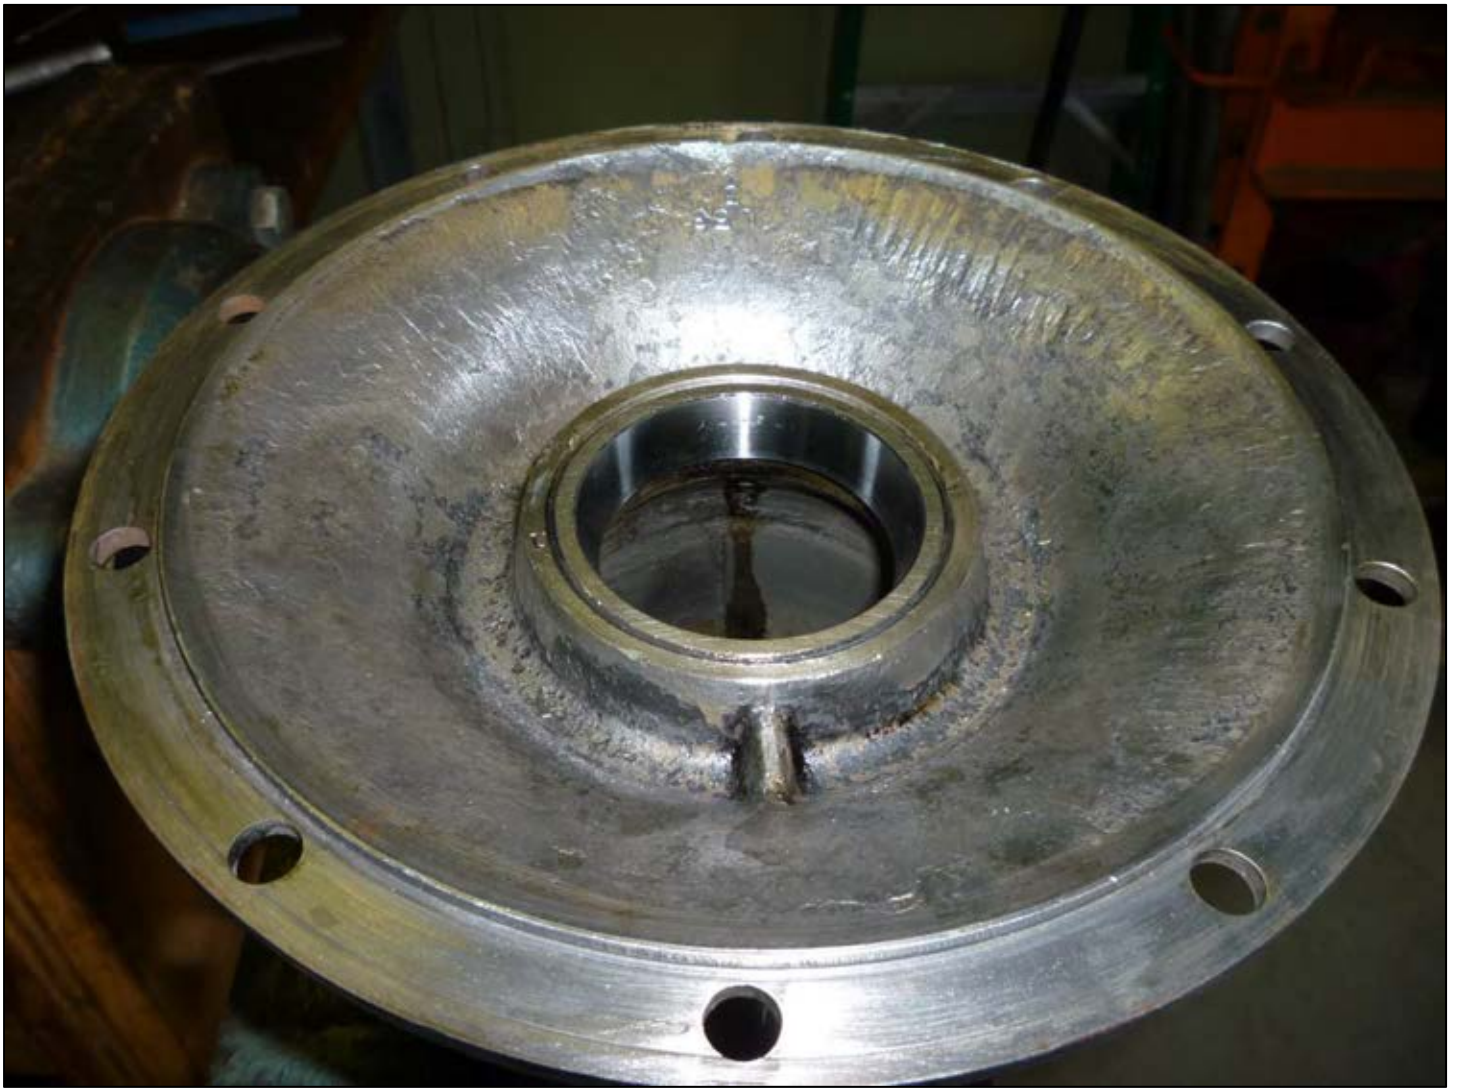
A new race is shown installed.

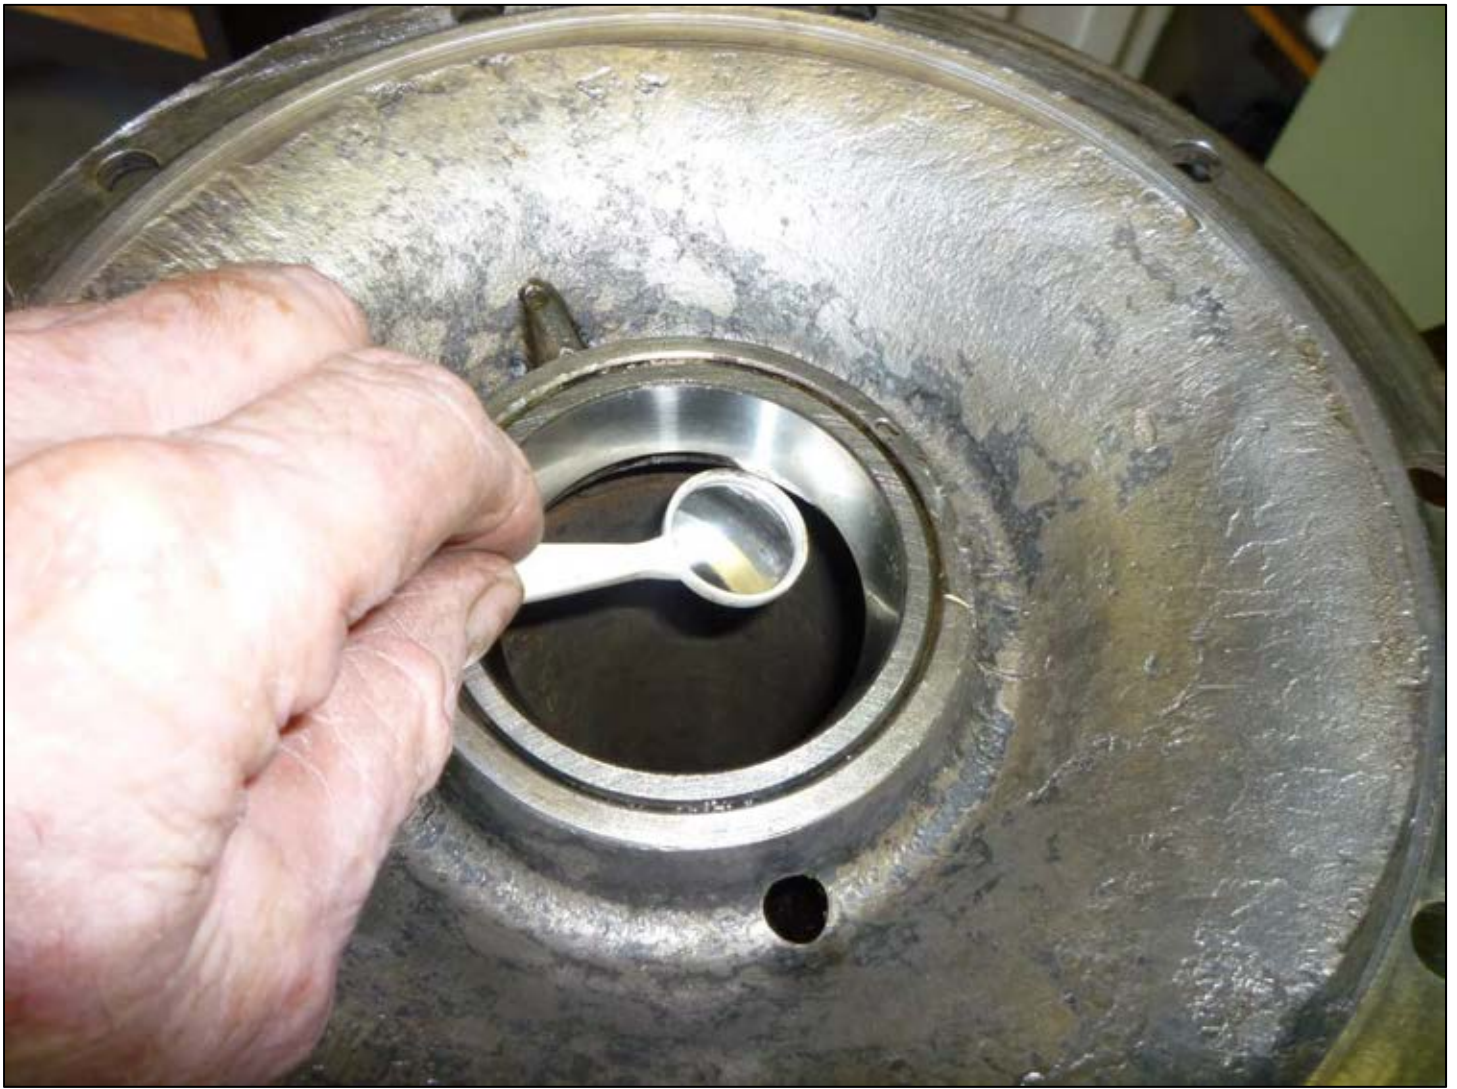
It is important to check the seating of the axle housing race with a dental mirror. The race must be seated against the stop all the way around its circumference.

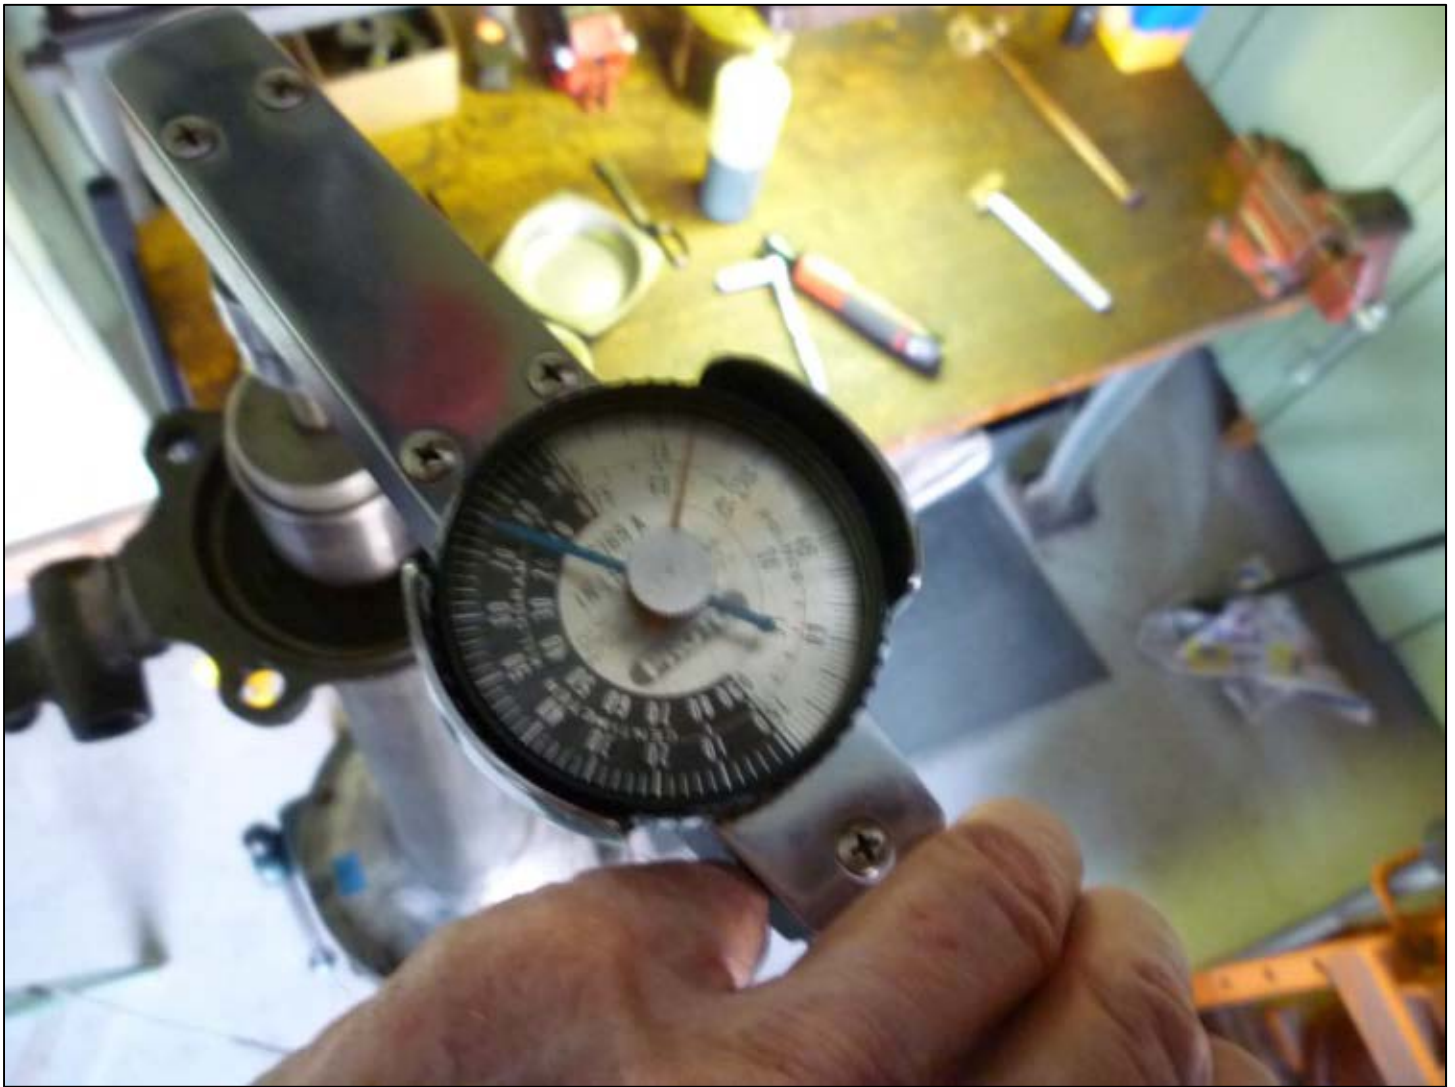
The carrier bearing pre-load is measured on an inch-pound dial indicator torque wrench. The nominal desired value is 20 in. lbs.; anything between 14 in. lbs. and 22 in. lbs. is acceptable. The pre-load value is adjusted by adding or subtracting banjo gaskets to the left side. Banjo gaskets are usually .006 and .010 in thickness.

Once the carrier pre-load has been established, disassemble both axle housings from the banjo and set the quantity of gaskets aside. This gasket quantity will be dispersed to the two sides of the banjo on final assembly to establish the back lash.

It is important to have a minimum of at least two .010 banjo gaskets, one for each side, for oil control purposes. If this cannot be achieved, additional shims must be placed under one or both carrier bearings. This will allow for additional gaskets to be added.
