Rear Axle Assembly Overhaul Pictorial

July 2018 by Tom Endy

This is a pictorial of a typical rear axle assembly that has been received for overhaul. It is long and tedious. However, for those who have taken on the task of overhauling a rear axle assembly themselves, the photos and captions may be of help.

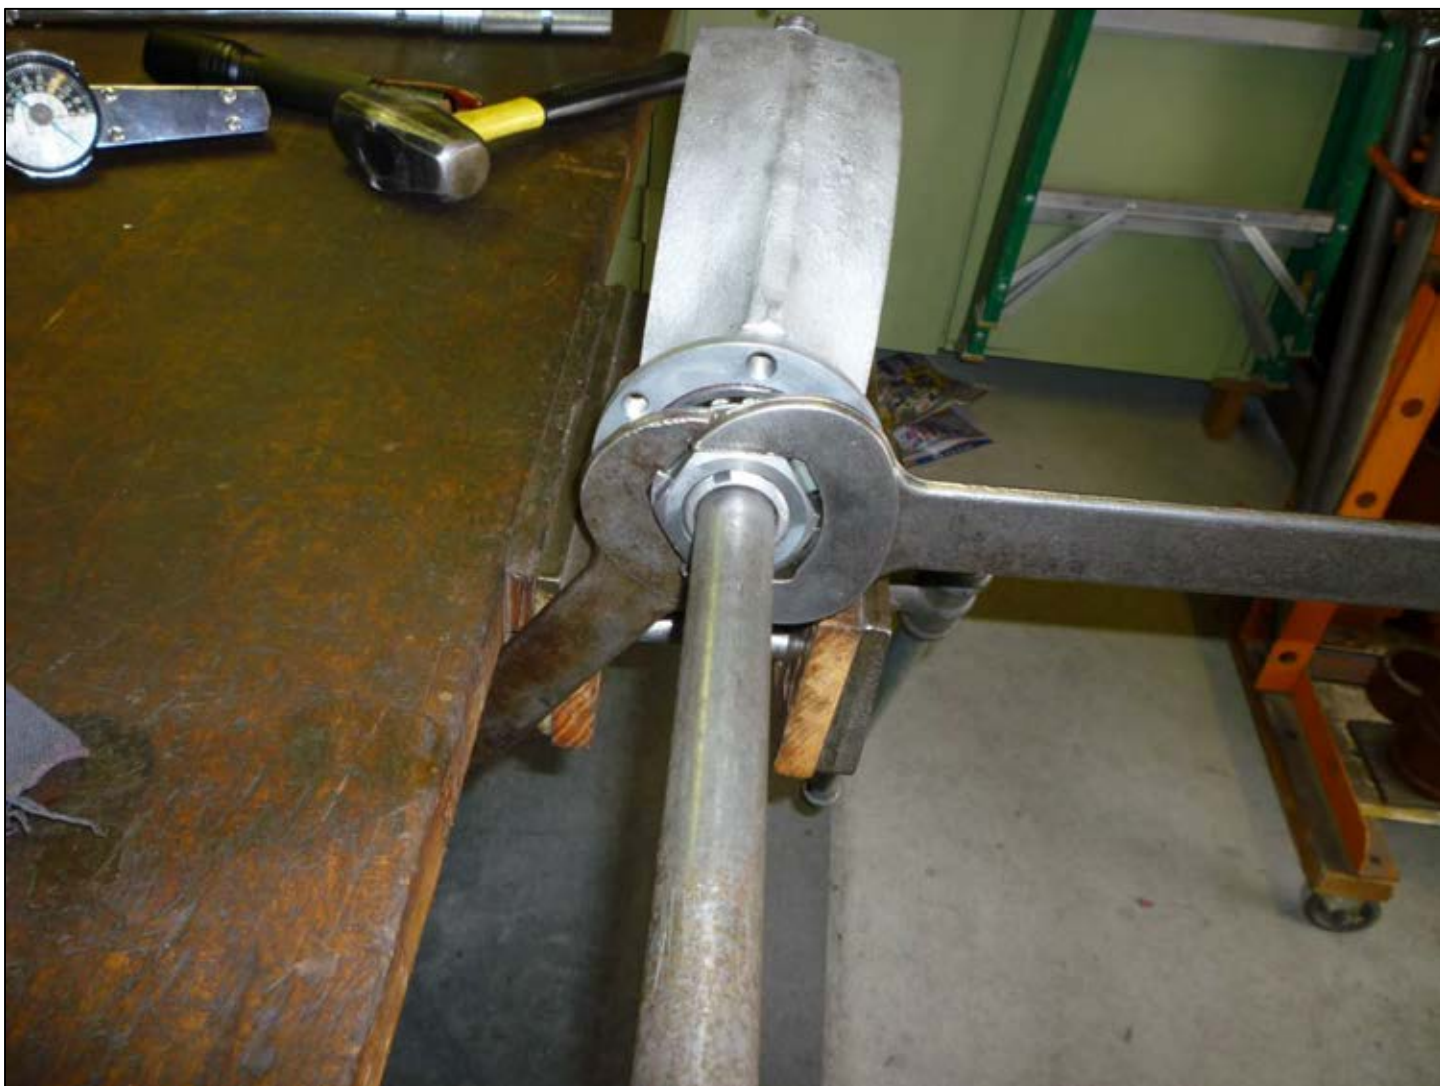
When adjusting the pinion bearing pre-load, the first nut is tightened to make the adjustment, the second nut is tightened to lock the first in place. Easily said, but difficult to do: When tightening the second nut it will affect the setting of the first nut. For this reason I set the pre-load at about 10 in. lbs. with the first nut, and then tighten the second nut.

Note the inboard nut is being held by a wrench that is braced against the work bench. The drive shaft is also held with a pipe wrench to prevent it from turning.

It is important that the two nuts be locked tightly together after the pre-load is set. The Ford factory service bulletin recommends hammering the wrench holding the outer nut.

The pre-load is set at a nominal 20 in. lbs. A setting between 14 and 22 is acceptable.

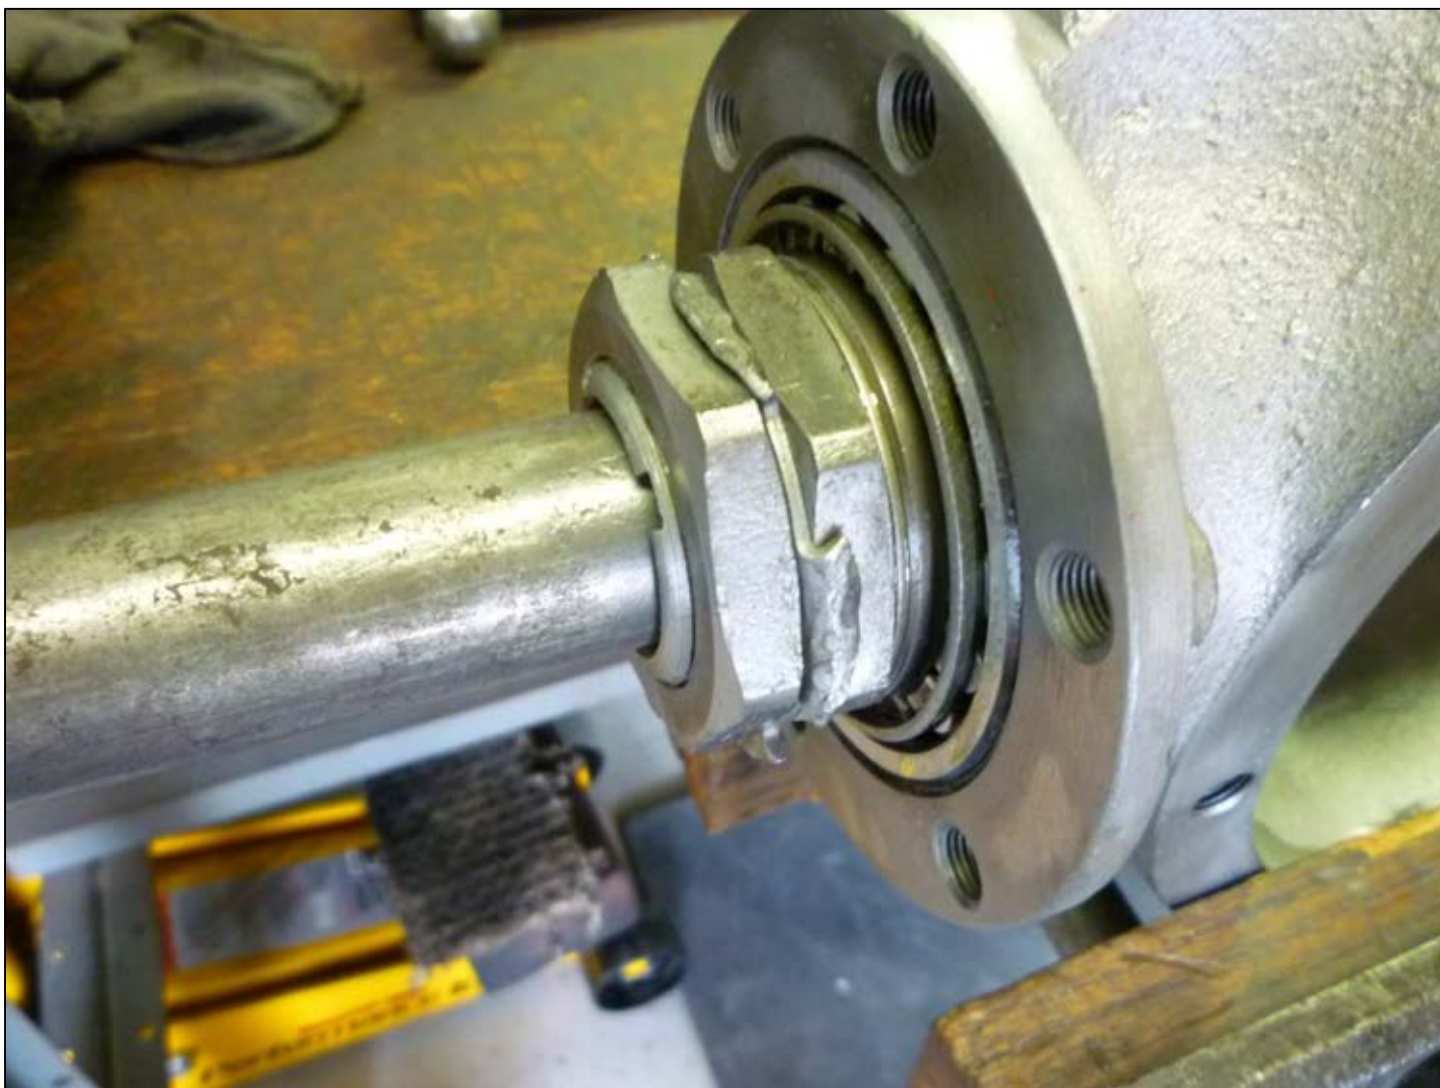
Once the pre-load is set and the two nuts are tight two of the ears of the locking washer are bent over in opposite directions.

Beware of reproduction locking washers. Some have the ears too long and will scrape on the inside of the torque tube. In this case all the ears have to be bent over.

The carrier, still without the spider gears and the two axles is once more assembled with a trial and error placement of the number of banjo gaskets on each side that was selected during the carrier pre-load adjustment.

In this case the number determined were two .010 gaskets. One was placed on either side and the backlash was determined to be only a few thousandths. This is determined by very carefully rotating the drive shaft back and forth and feeling where the teeth on the ring and pinion contact. There should be a slight backlash around the full circumference of the ring gear. There should be no binding.

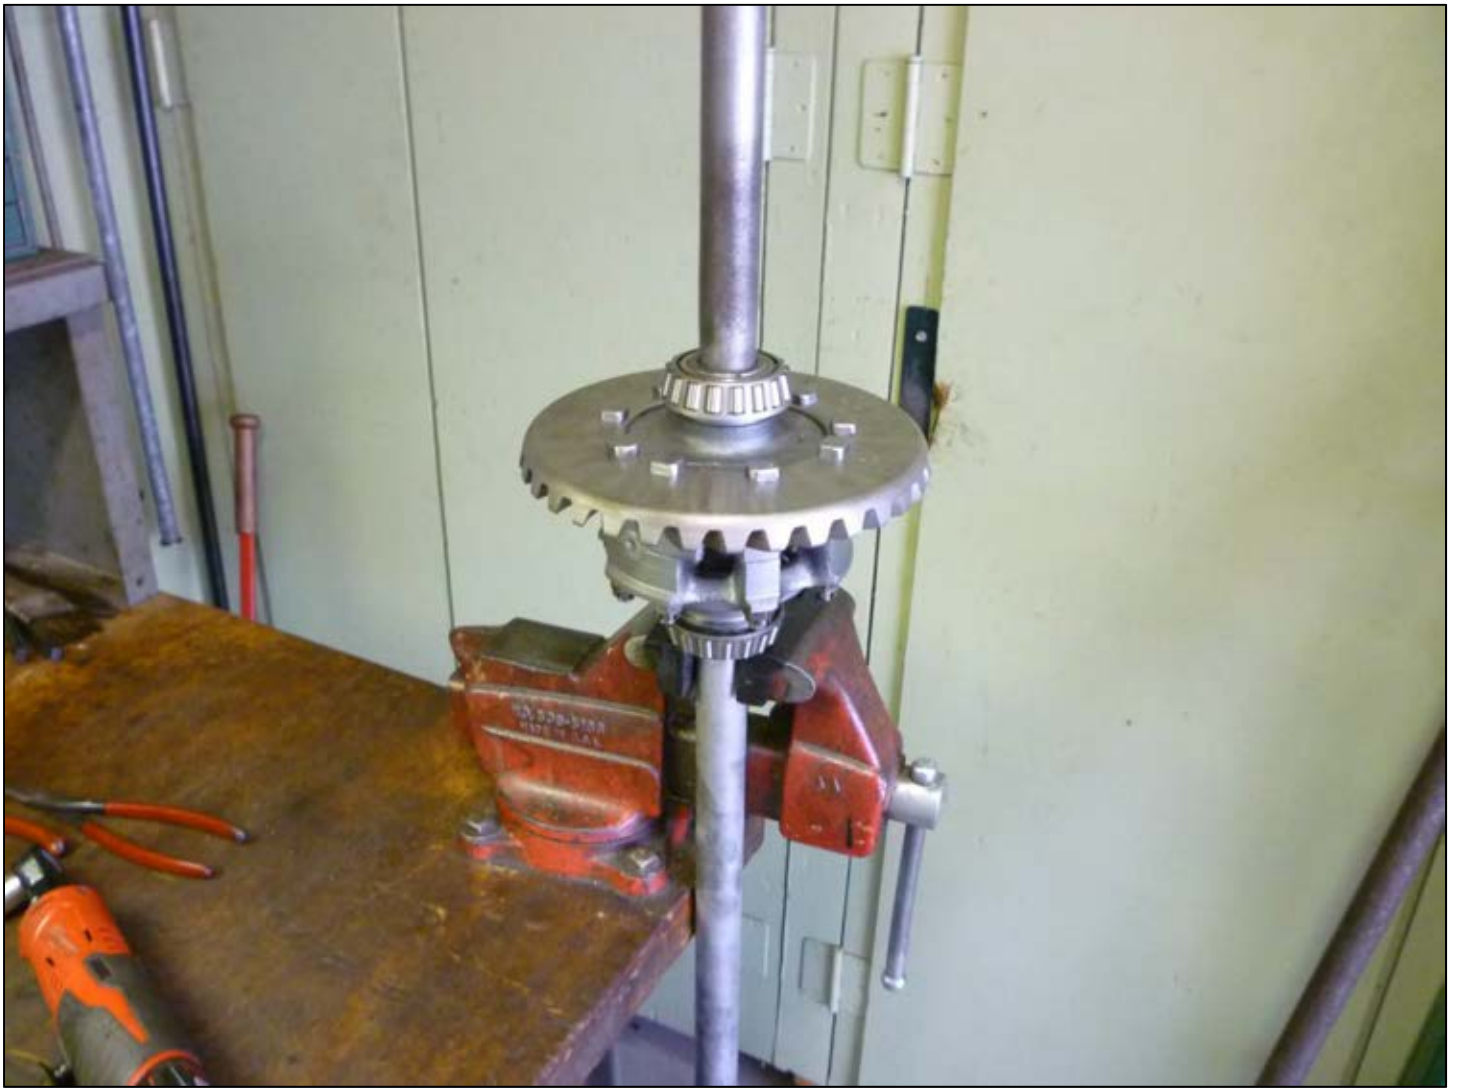
The next task is to prepare the carrier assembly with the two axles and the spider gears. Shown here is the right axle being held in a vice. The pre-load tool was removed and replaced with the spider gear assembly. The two axles were inserted and the nine carrier bolts torqued to 35 ft. lbs.

The damaged right axle shaft was replaced with serviceable original.

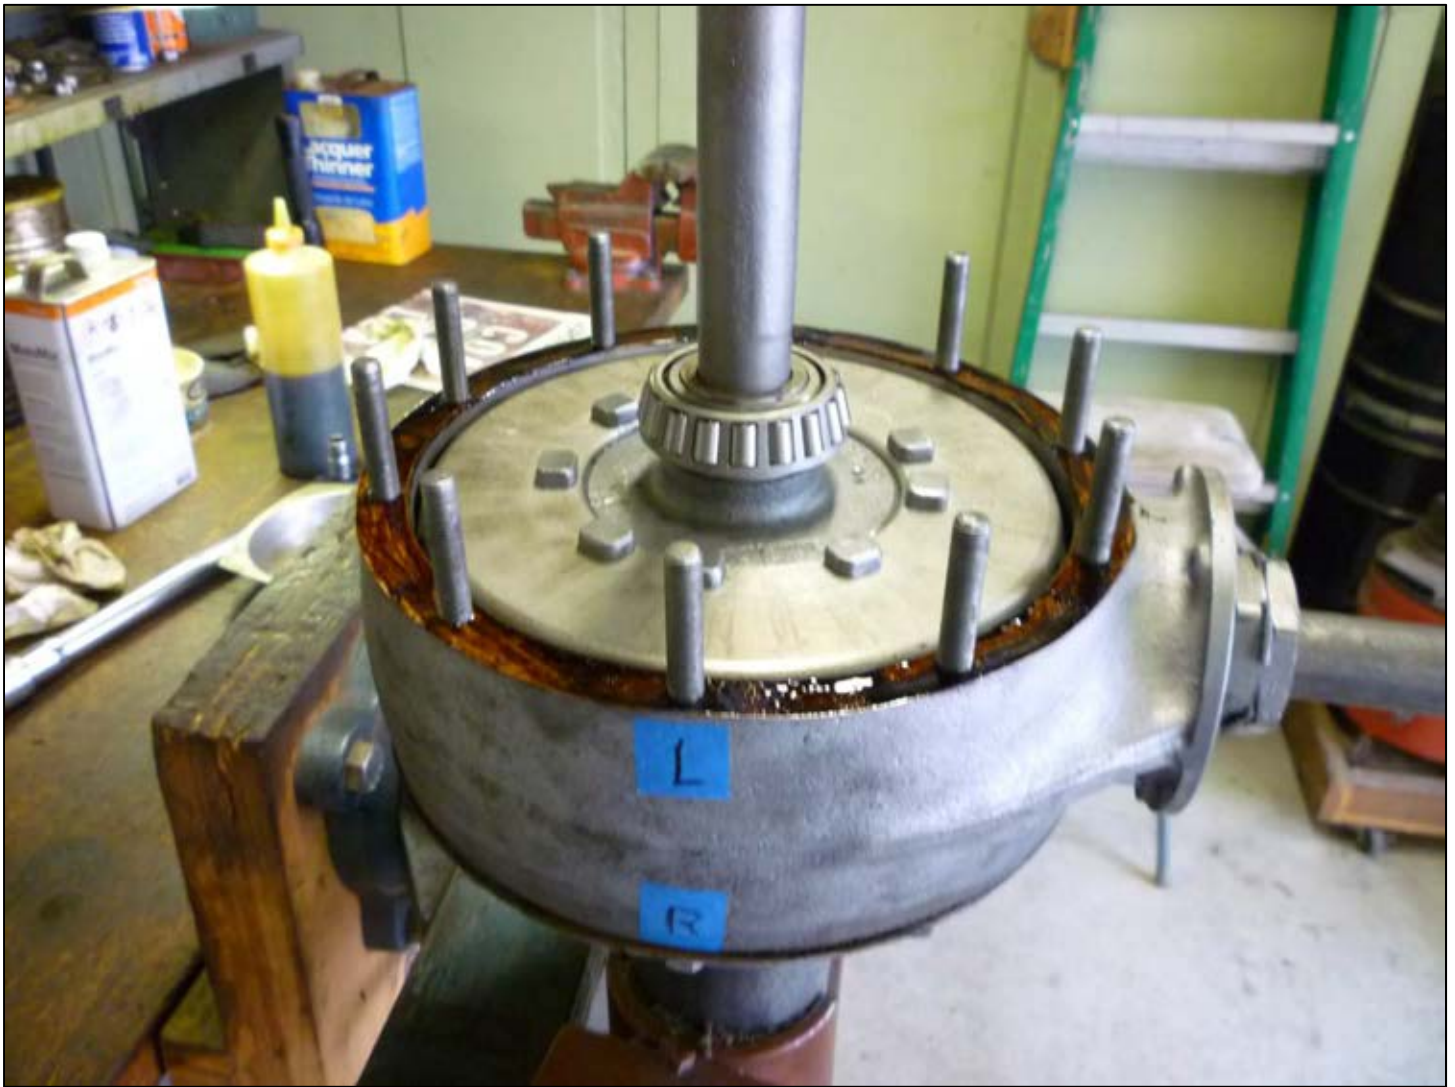
The completed carrier assembly is installed in the axle housings. The gaskets on both sides are coated with Indian Head sealer. All twenty of the banjo bolts are then torqued to 35 ft. lbs.

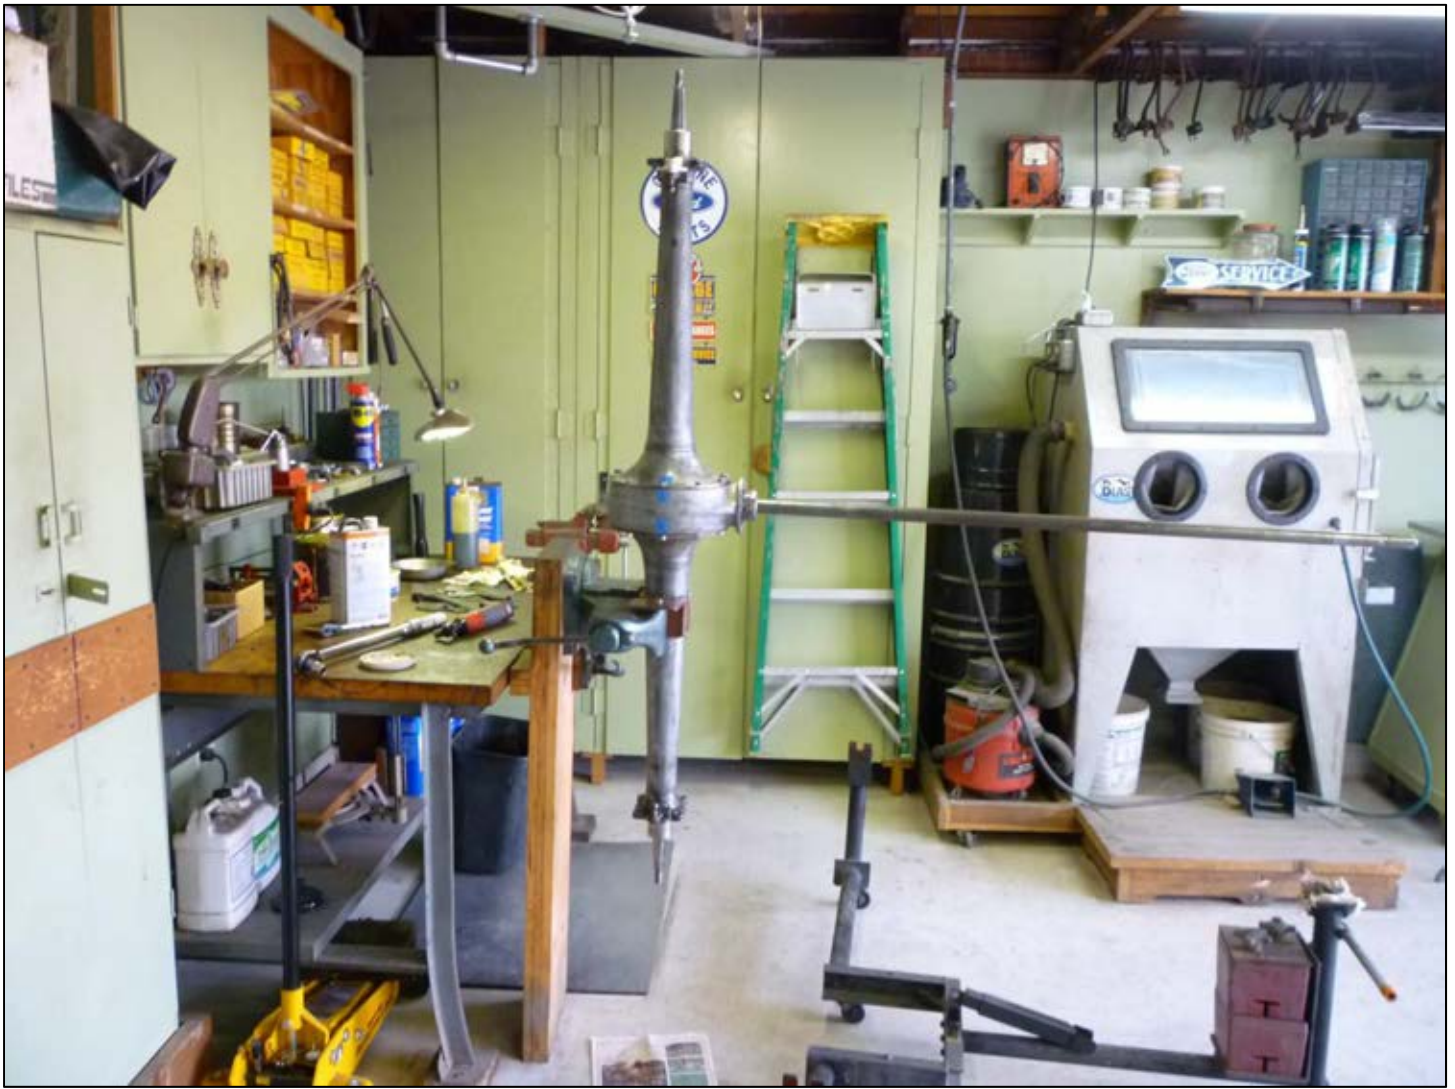
The completely assembled rear axle assembly is shown here still sitting in the assembly jig. The torque tube will be installed once the assembly has been removed from the jig and placed back into the rolling cradle.

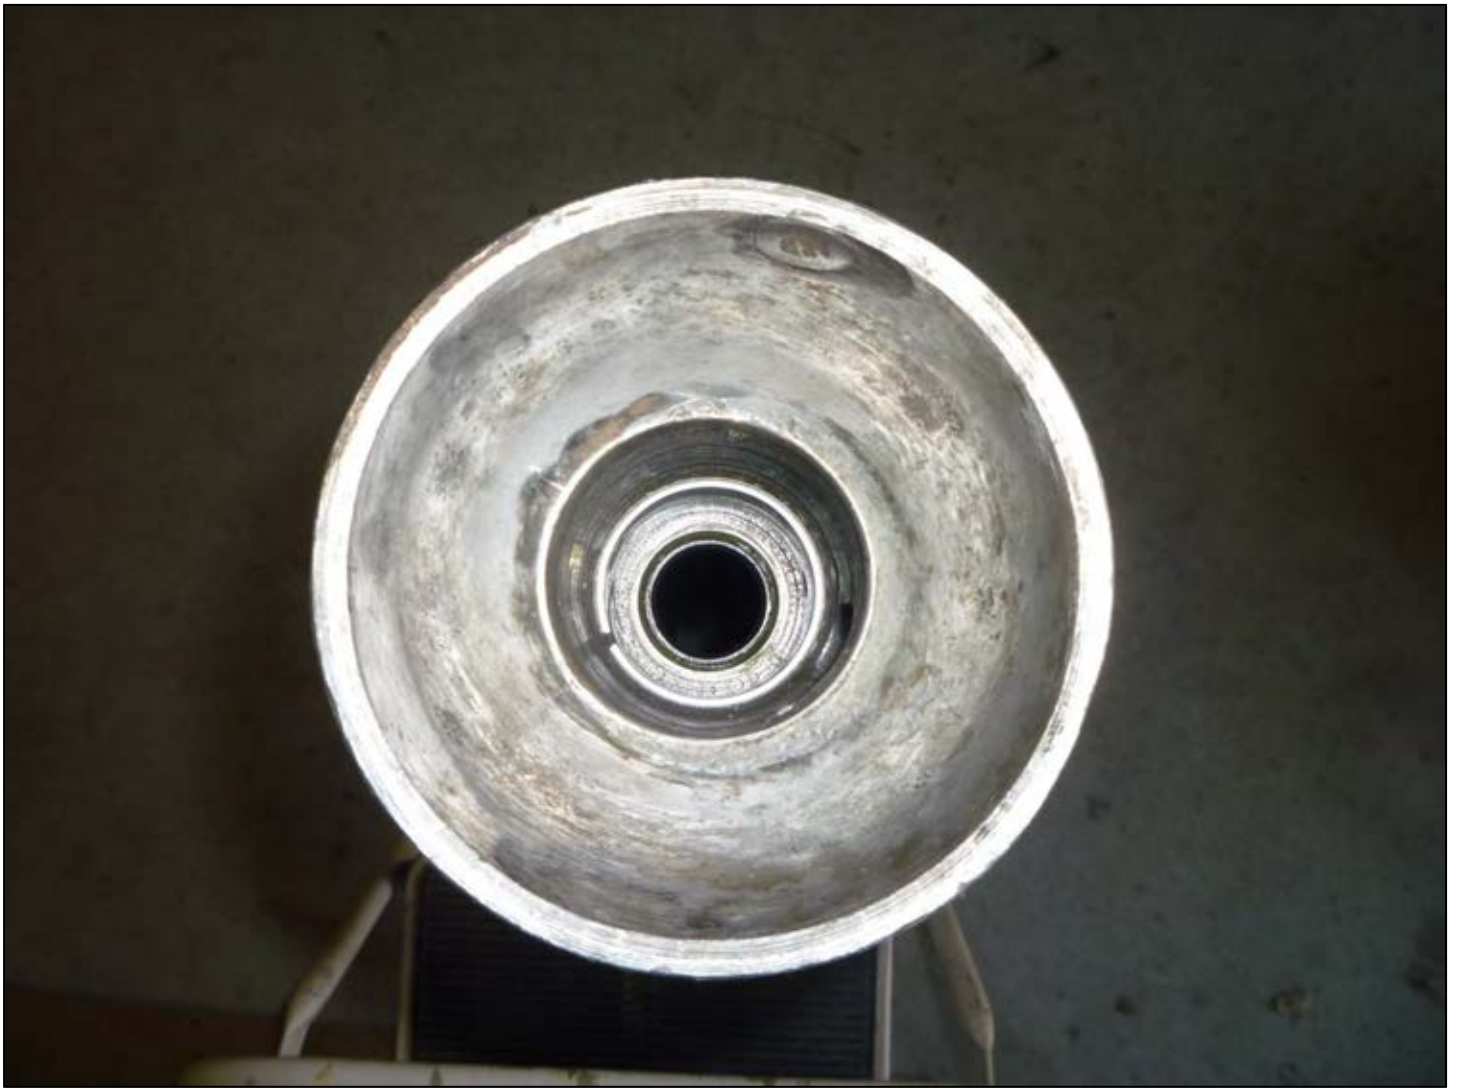
Check that the sleeve is flush against the inner circumference of the torque tube and there are no gaps. The split will also have opened. It is seen located at about the seven o'clock position.

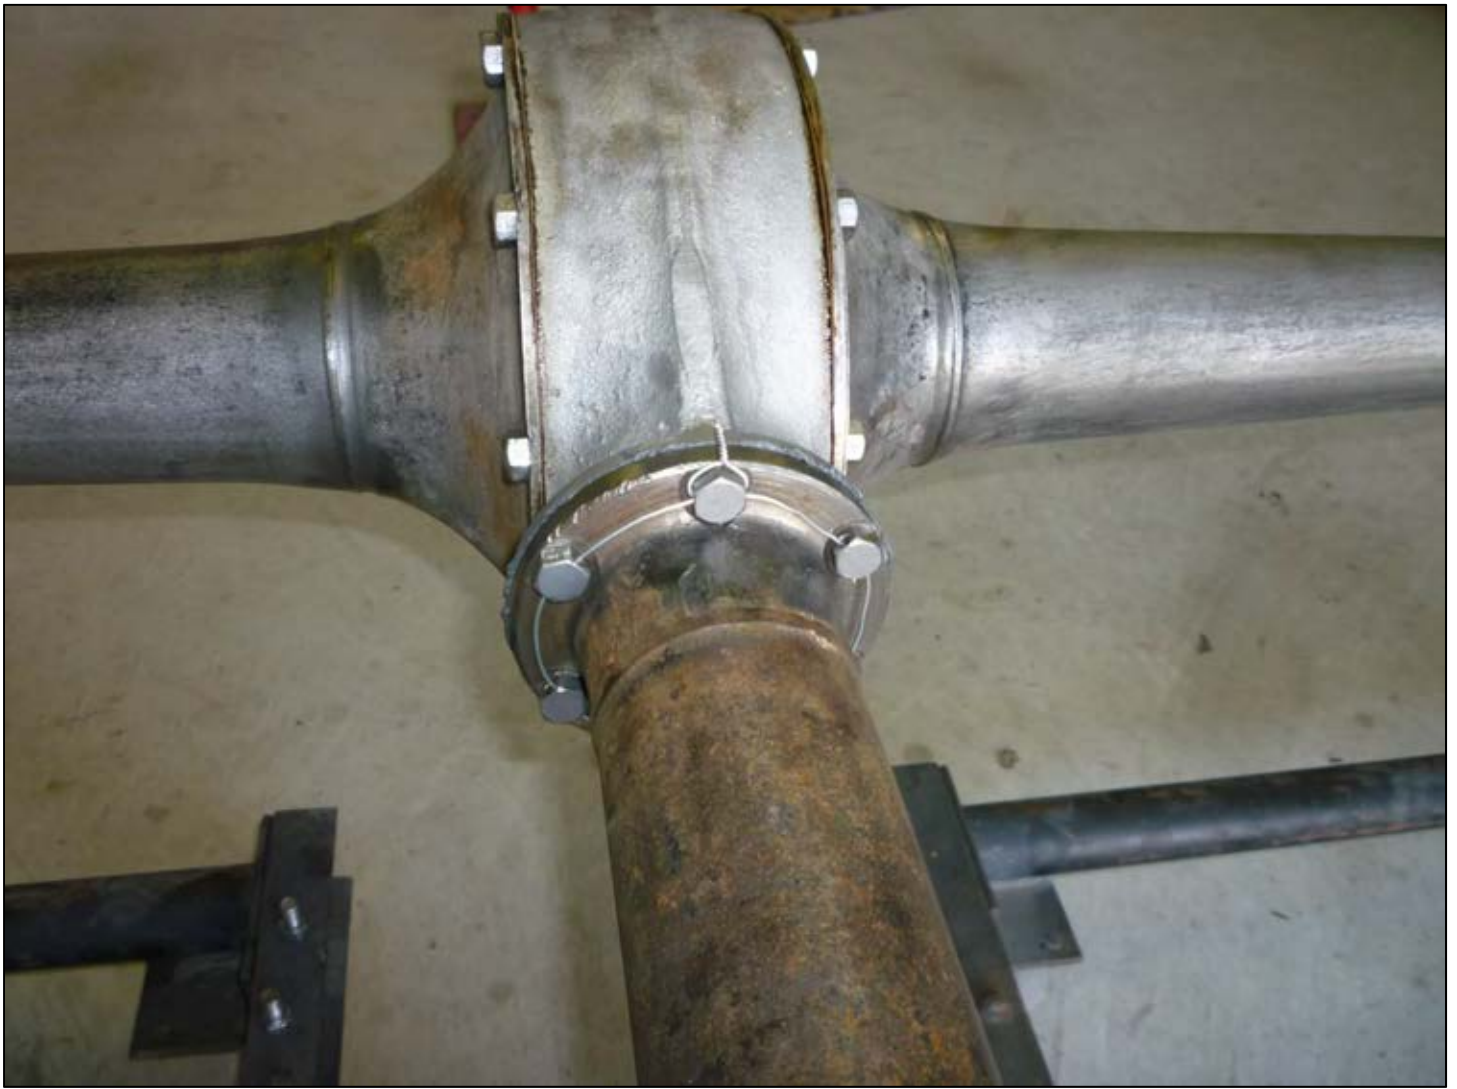
Install the torque tube with a gasket coated on both sides with sealer. Torque the bolts and safety wire them. The torque value is 35 ft. lbs. However, it is difficult to use a torque wrench on this task.

Tighten the bolts tightly with a box wrench. Check to see where the safety wire holes are. Tighten them more to align them parallel to the circumference of the torque tube. If you cannot achieve this, swap the bolts around. I have a box full of original torque tube bolts, so the effort is easier for me.

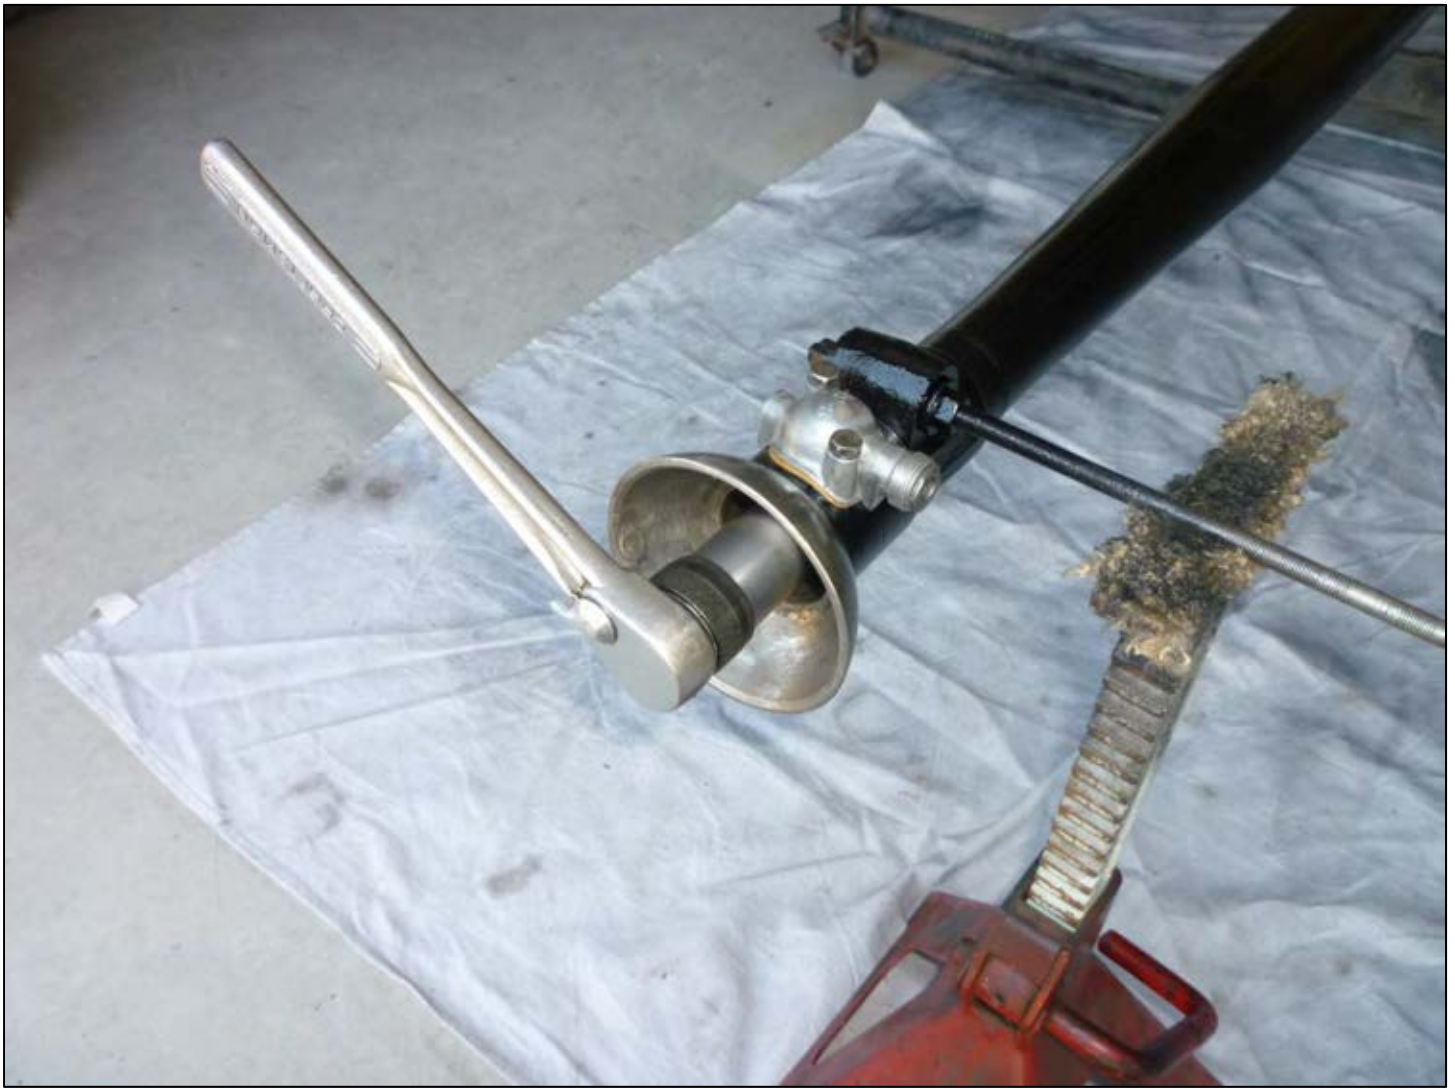
After painting the speedo housing is installed. Care must be taken to make certain the gears are in mesh before installing the bolts; otherwise it can easily crack the speedo housing. The 1&1\16'' six point deep socket is used to crank the drive shaft over before the bolts are installed and tightened to make certain the gears are in mesh.

The two grease fittings have also been installed in each end of the axle housings.

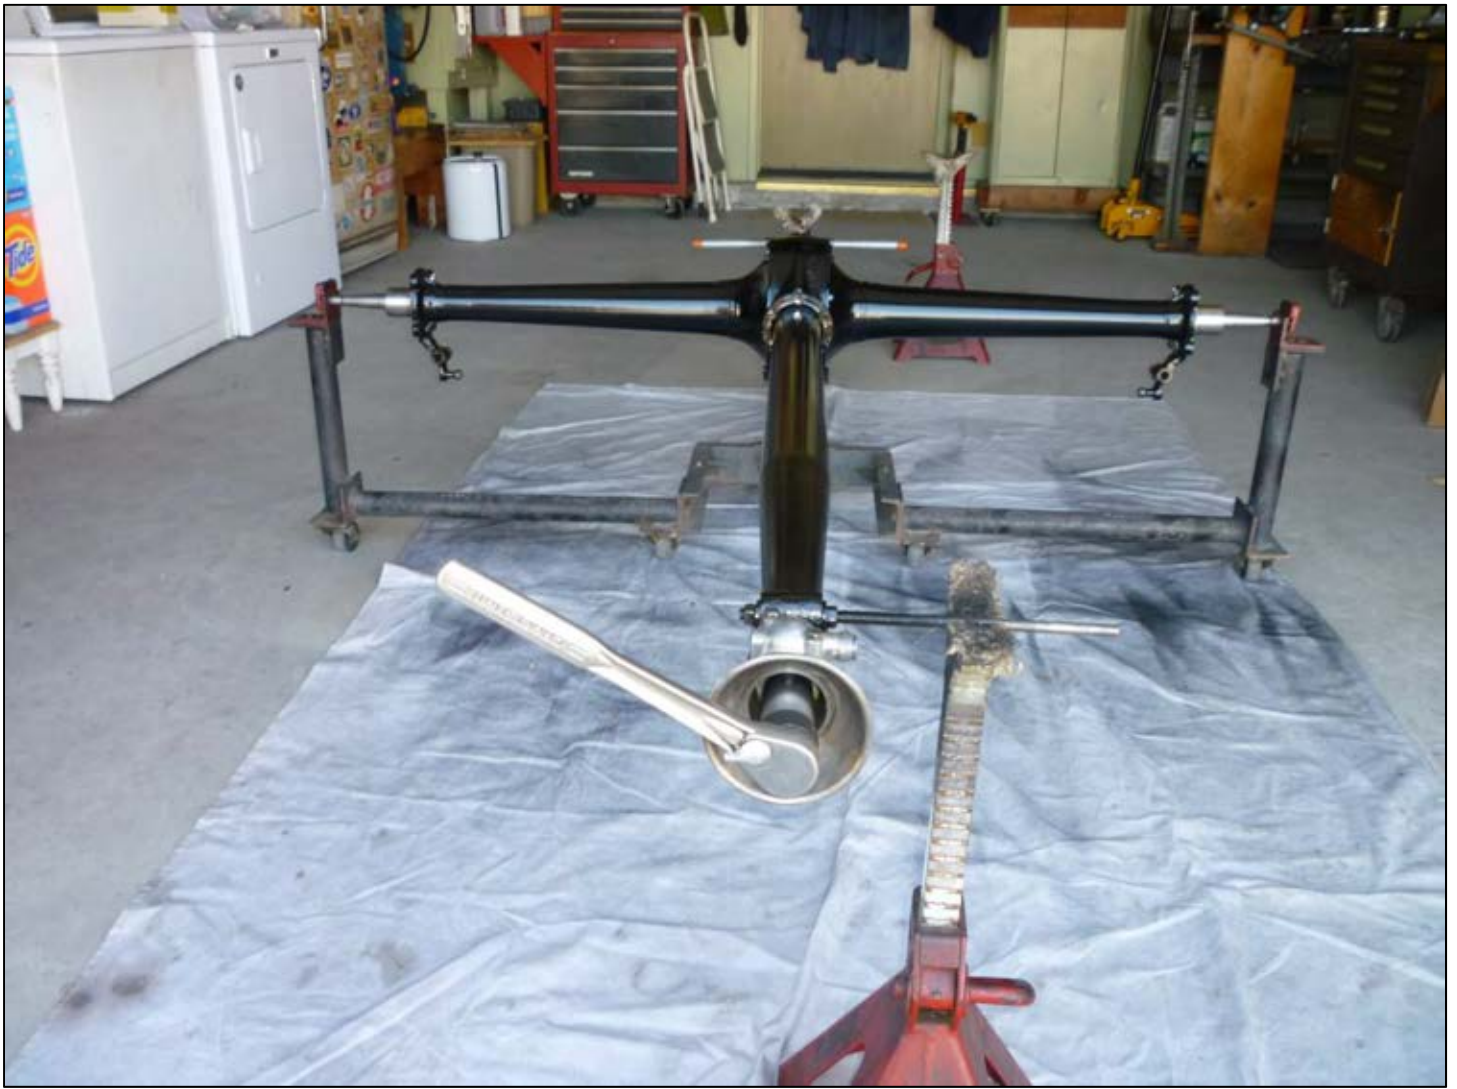
Note the threaded stock in the radius rod bolt hole. This is used so the front of the torque tube can be raised up out of the cradle and set on a jack stand for painting.

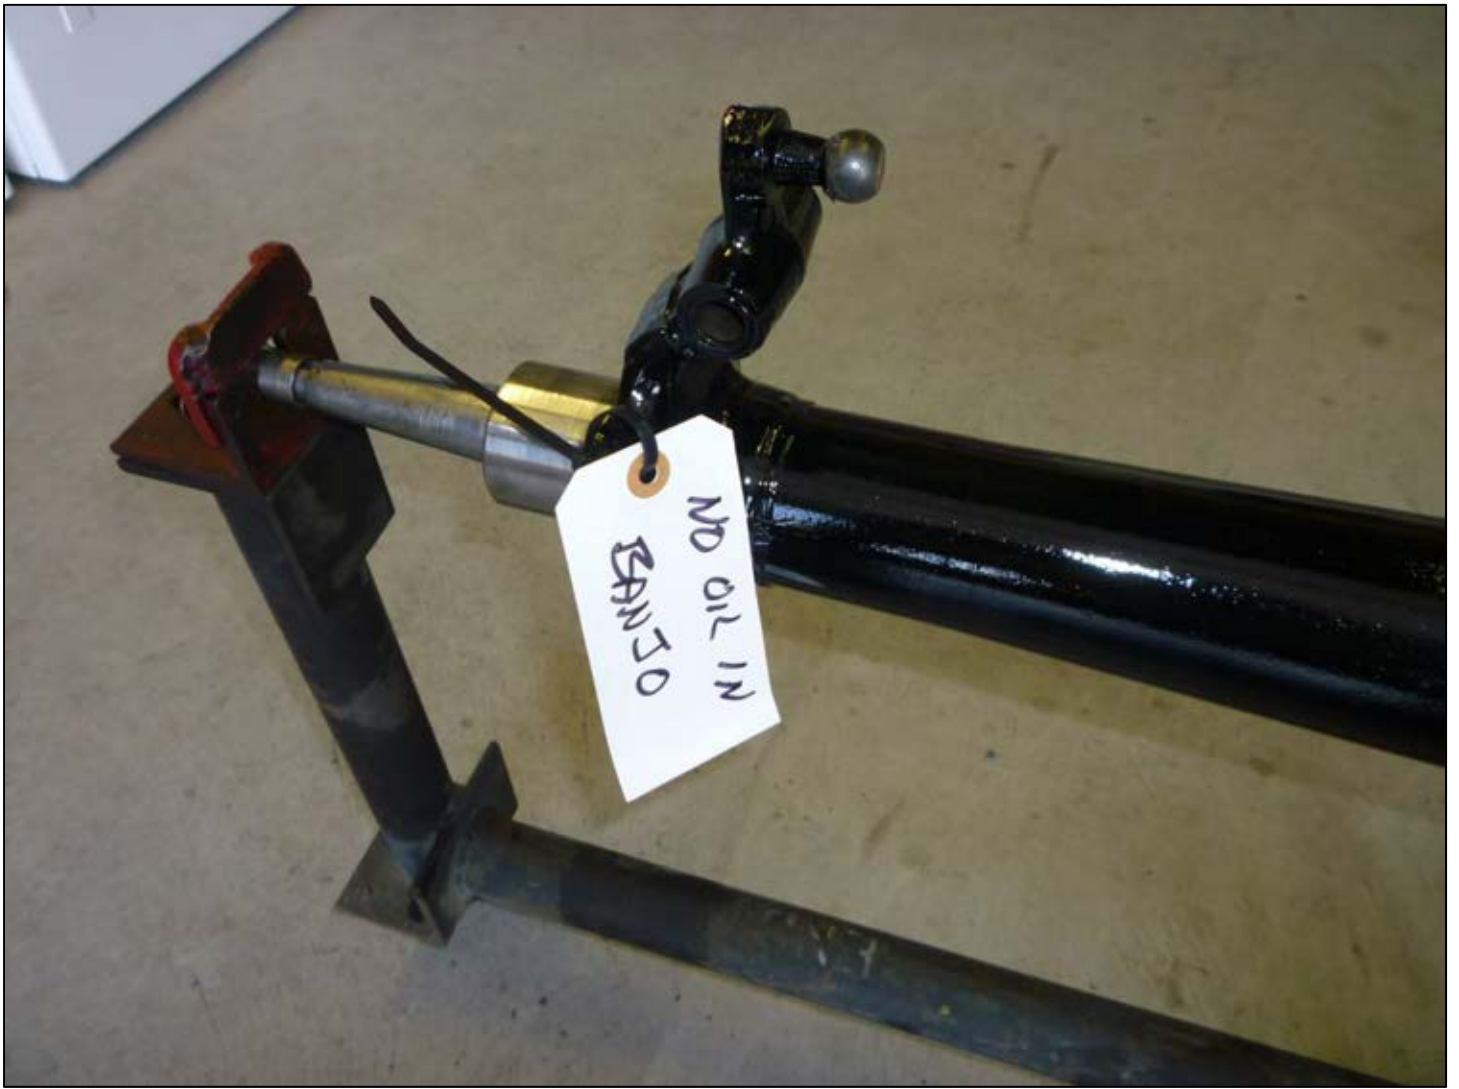
The final touch: Don't forget to put oil in the banjo. Leave the tag in place until you do.
