March 2019 Differential Overhaul

By Tom Endy

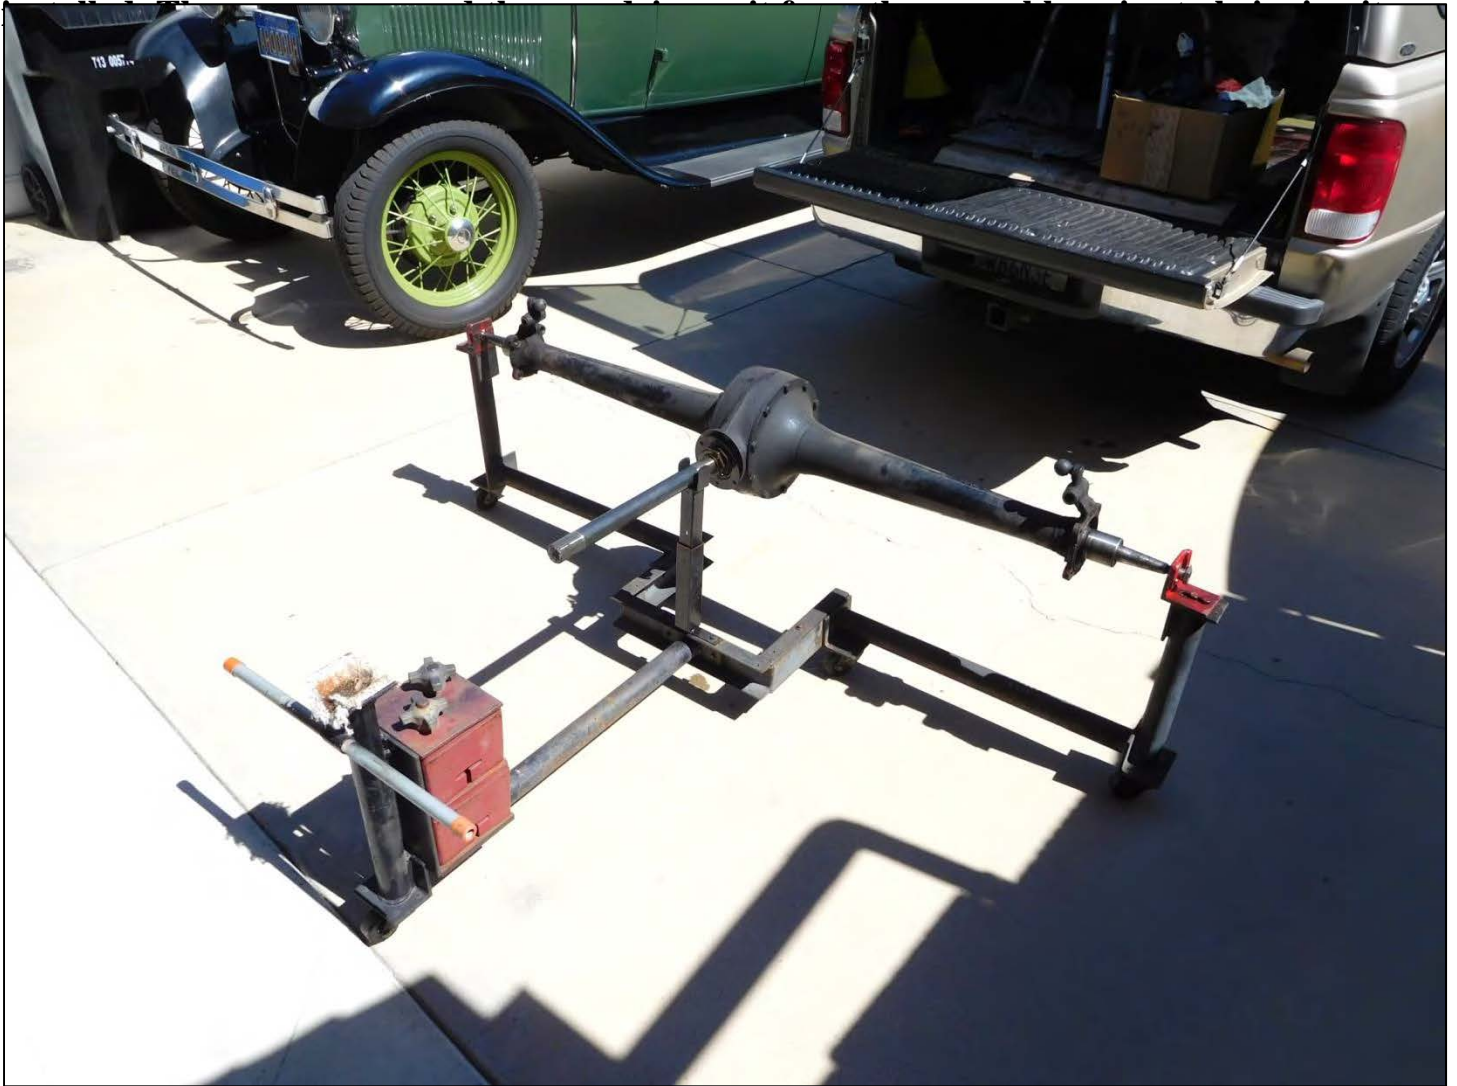
The first job of 2019 came into the shop on March 16. The customer complaint was the ring & pinion gears appear to be jammed. The photo shows the rear axle assembly being unloaded from a pickup truck. Note the unit has a Mitchell overdrive stub shaft

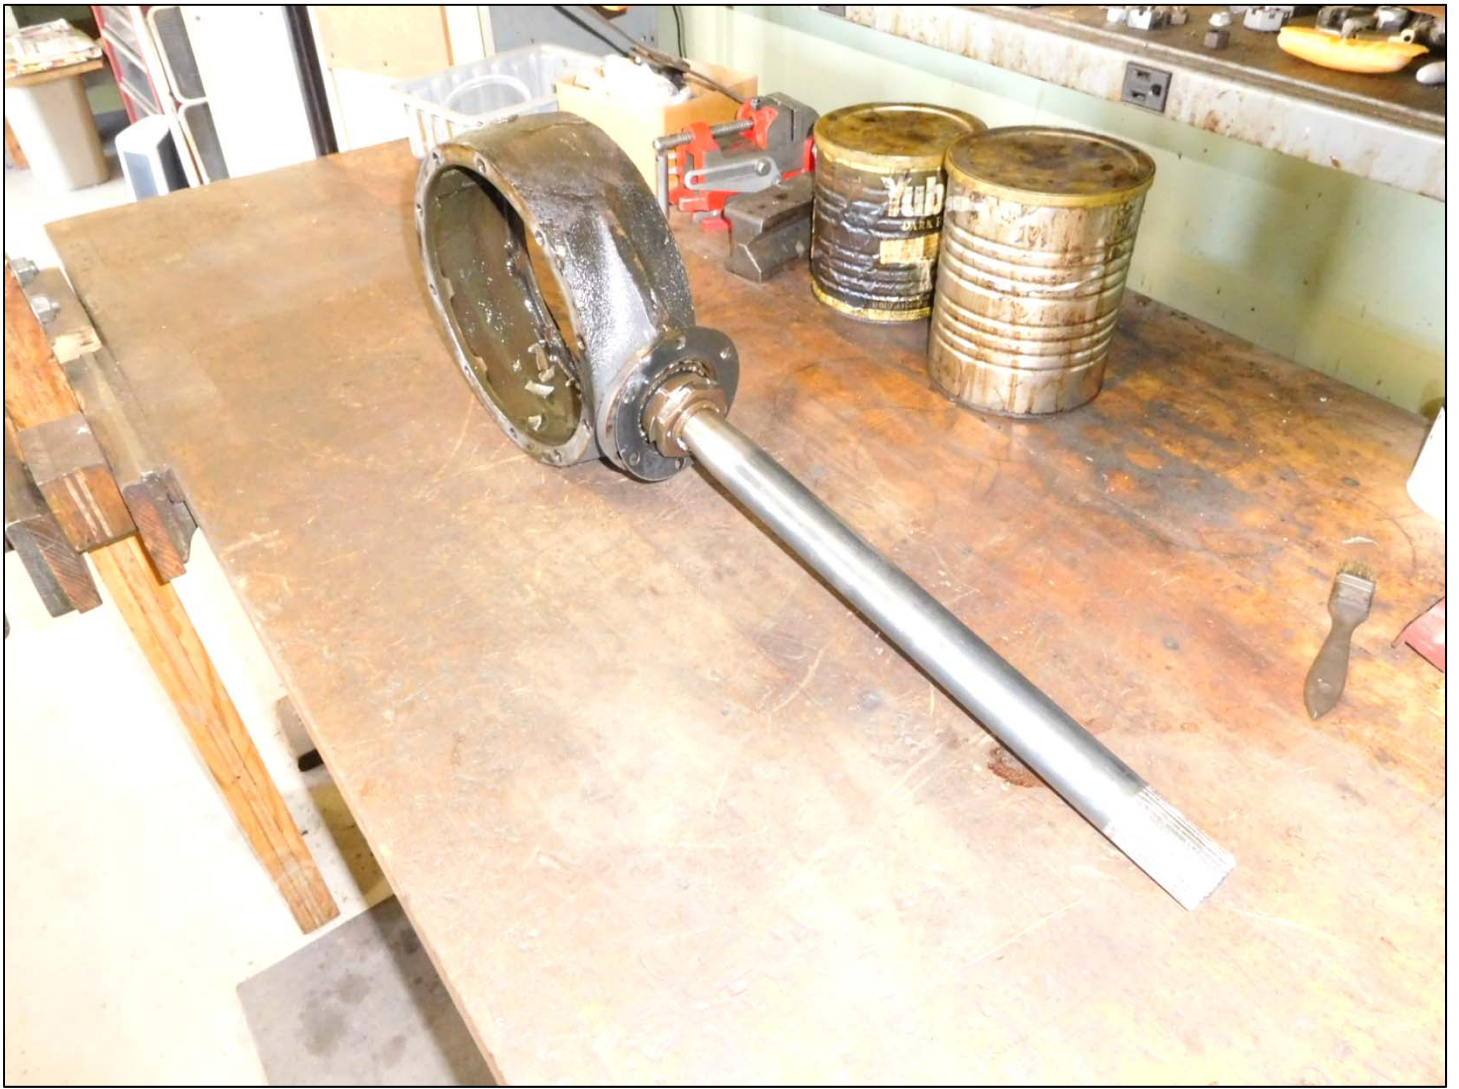
The banjo shown with the Mitchell stub shaft installed. Broken teeth from the ring gear can be seen in the bottom of the banjo.

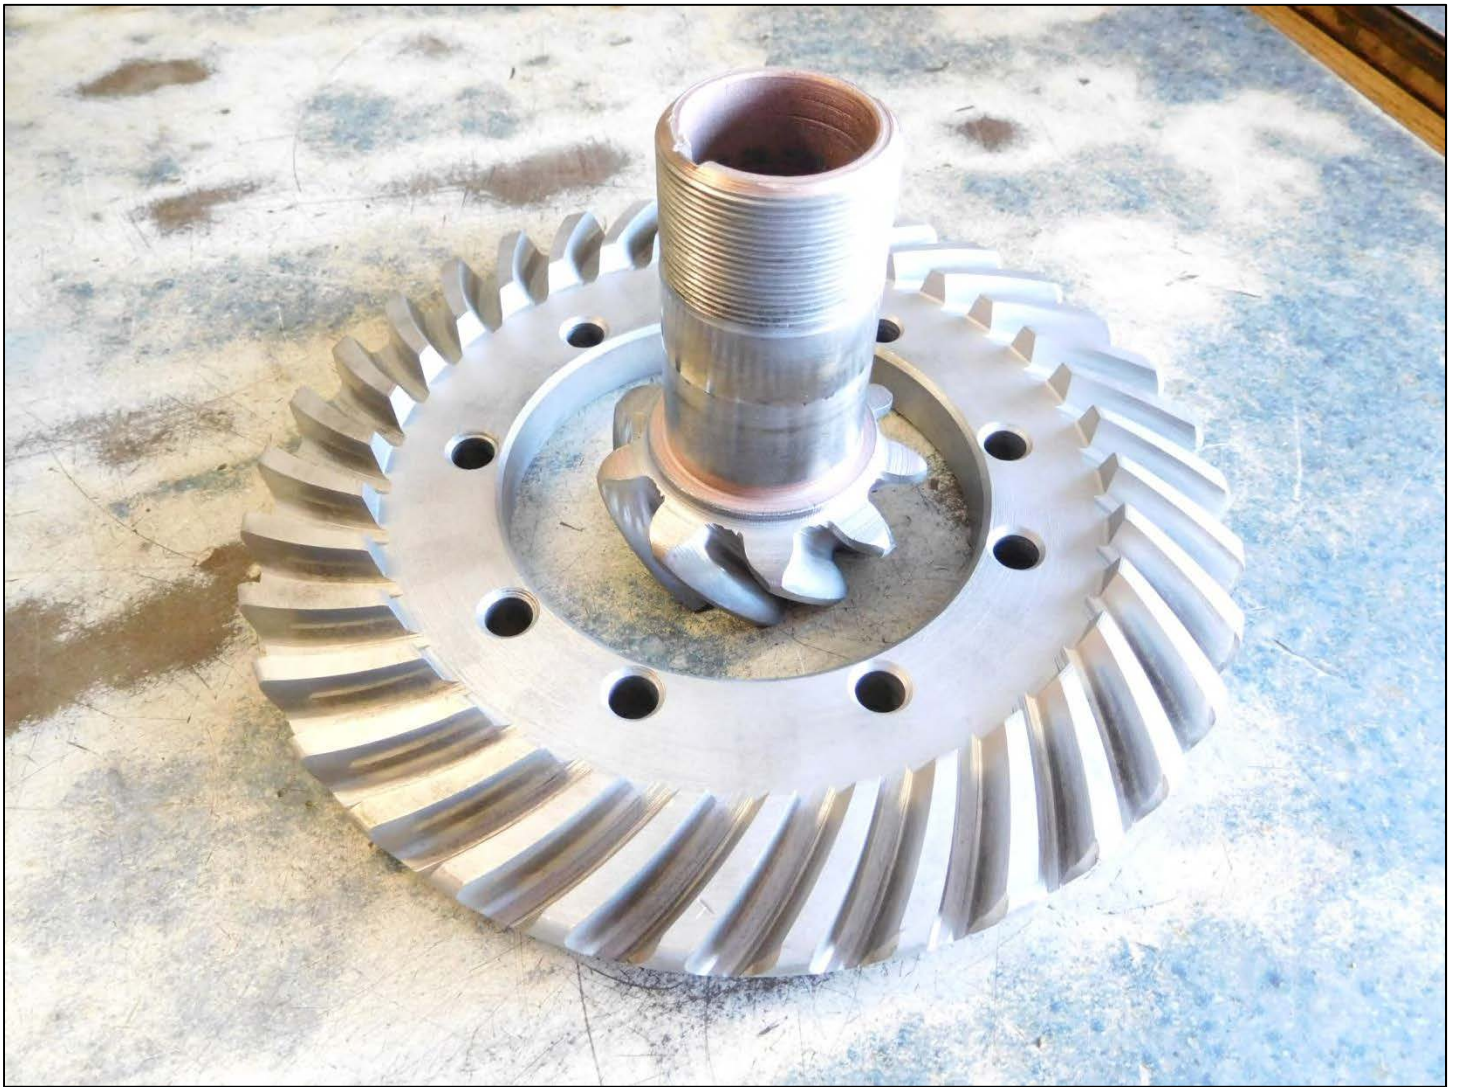
The replacement ring & pinion supplied by the owner is an original 378 (9-34) and in excellent serviceable condition. There are matching numbers (3710) on both components. It is shown here after I bead blasted it.

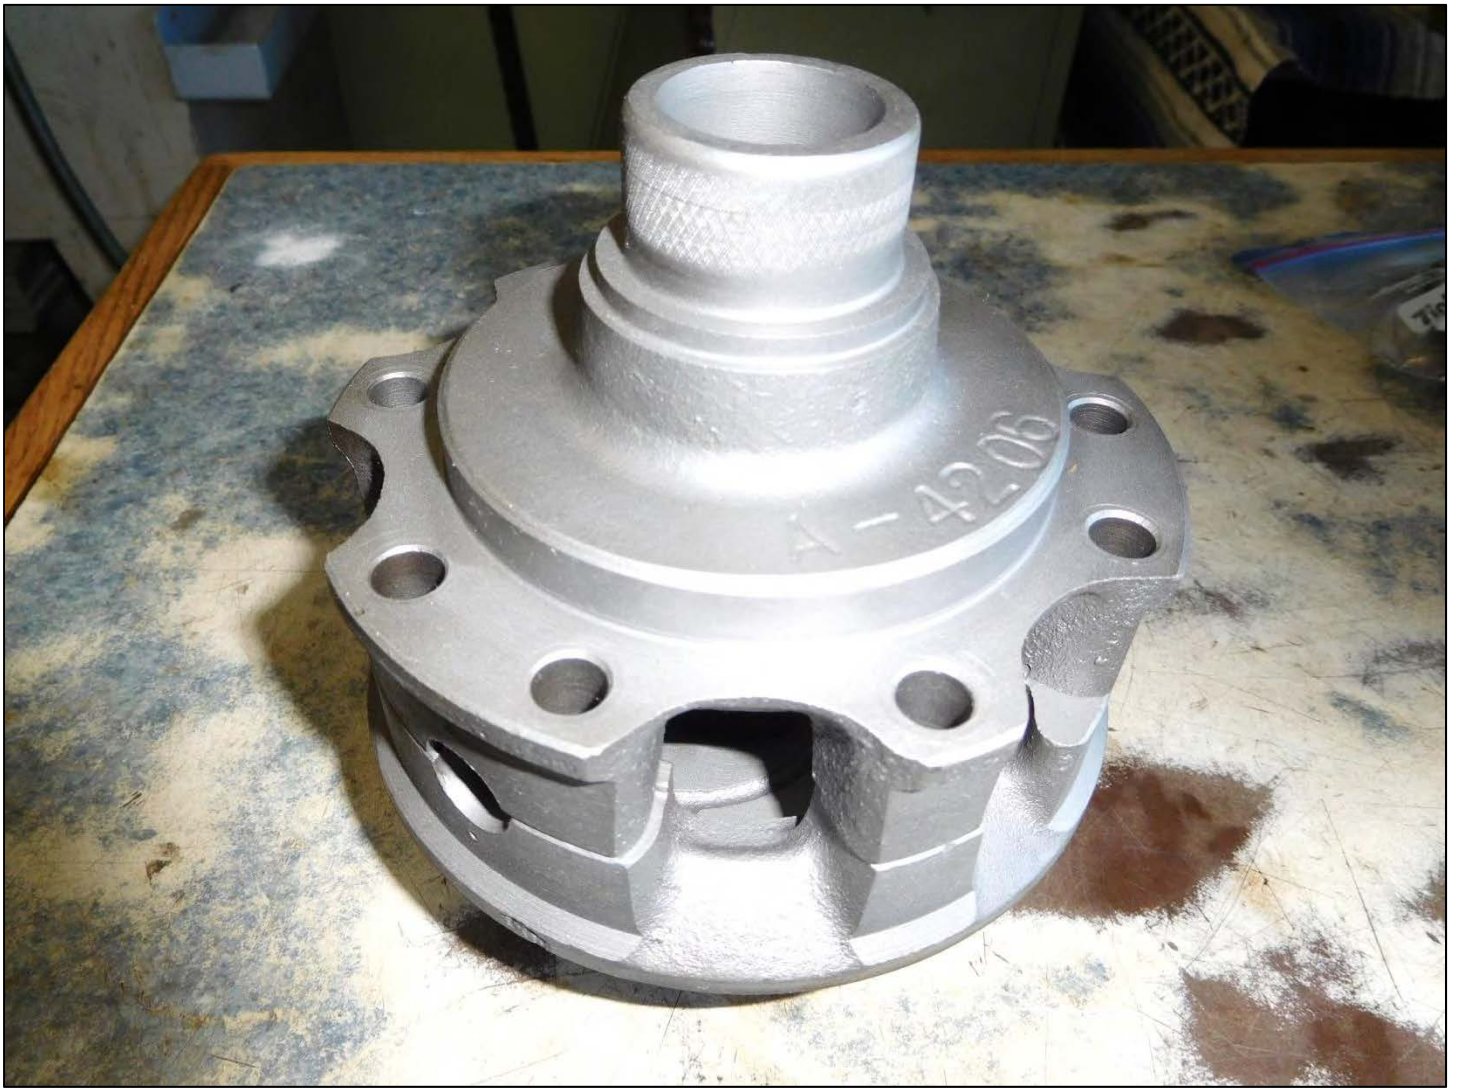
The replacement carrier is shown here. It has had both bearing hubs knurled and has been bead blasted. It is important that both carrier bearings press on tight.

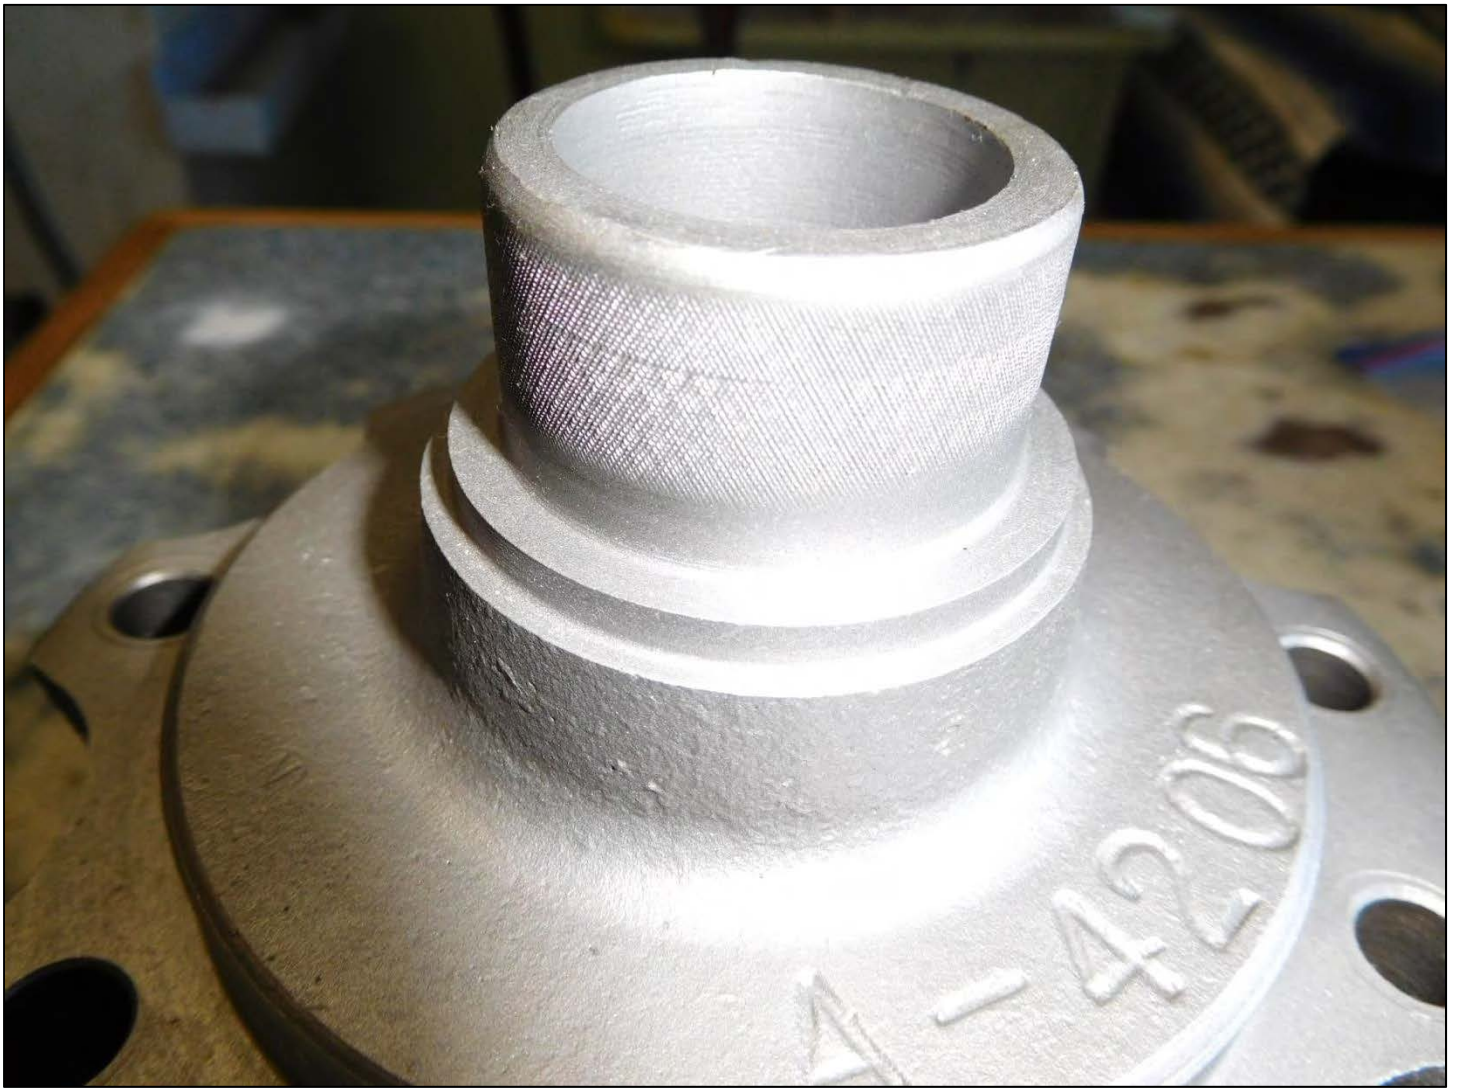
Close up of a knurled hub. Note the bearing stop has been machined to clean it up, .005 was taken off and it will be replaced with a .005 metal shim. A second relief cut was taken below the stop to provide additional room under the bearing if it becomes necessary to remove the bearing to add another shim. The additional room makes it easier to get a removal tool under the bearing to get it off without damaging it.

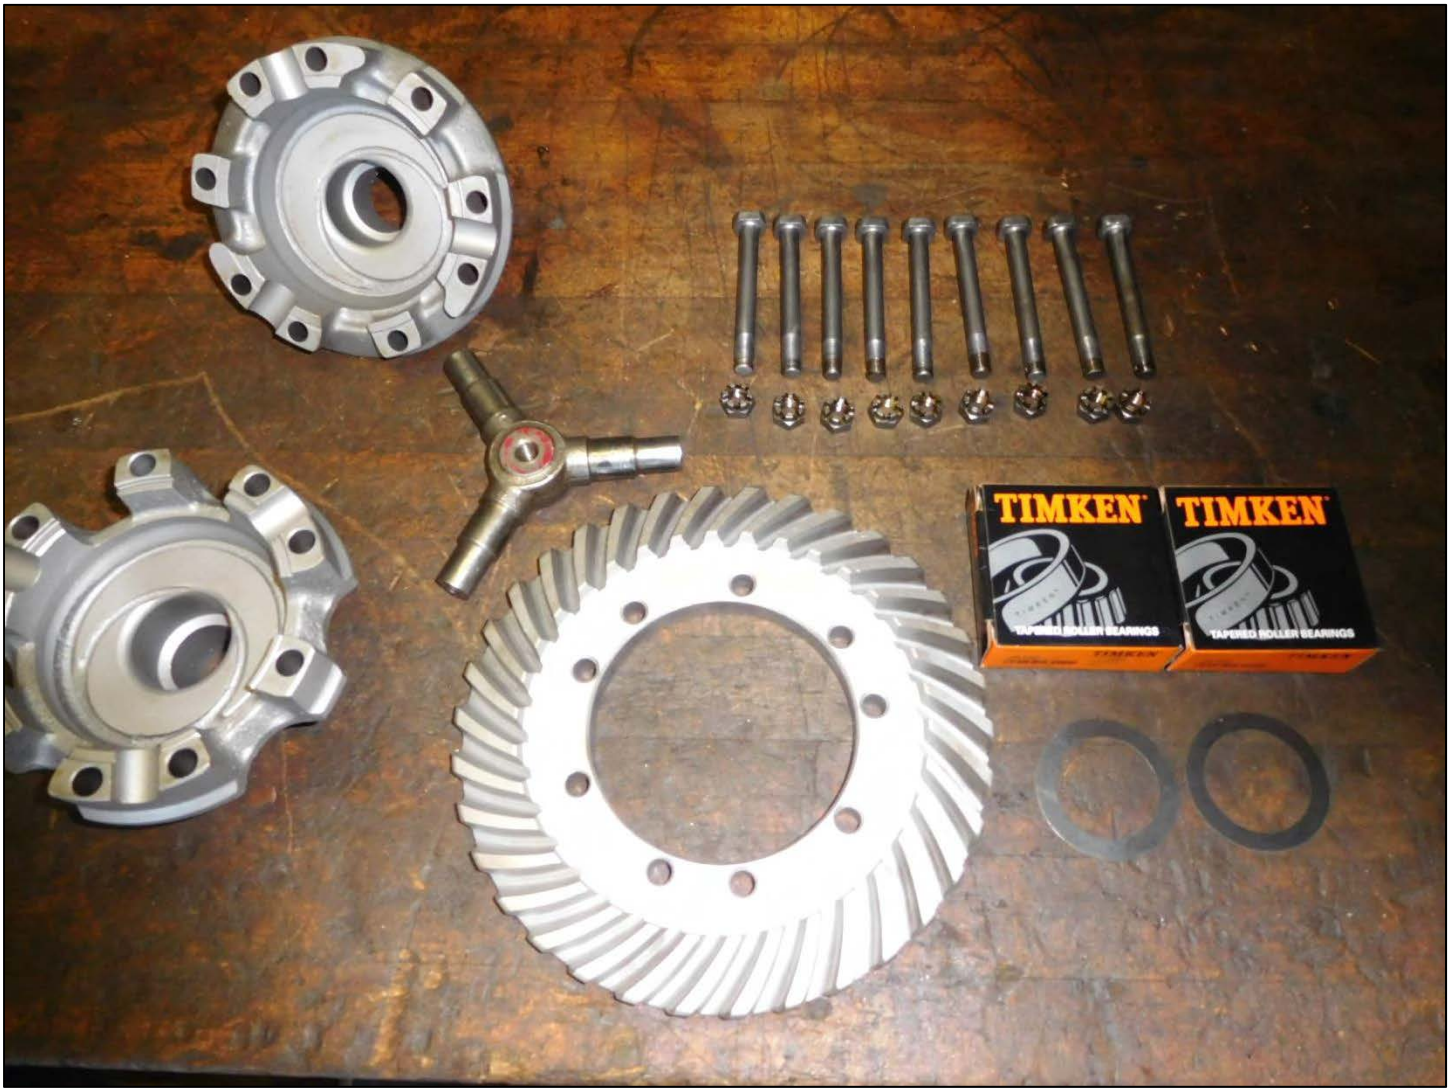
The new carrier is about to have the ring gear and the new bearings installed. In place of the spider gears a modified spider yoke is installed as a tool to enable the setting of the carrier bearing pre-load. Shims will be placed under each bearing to compensate for the material that was removed from the bearing stop to true it up. The nine bolts and nuts that hold the carrier together have been bead blasted and wire wheeled.

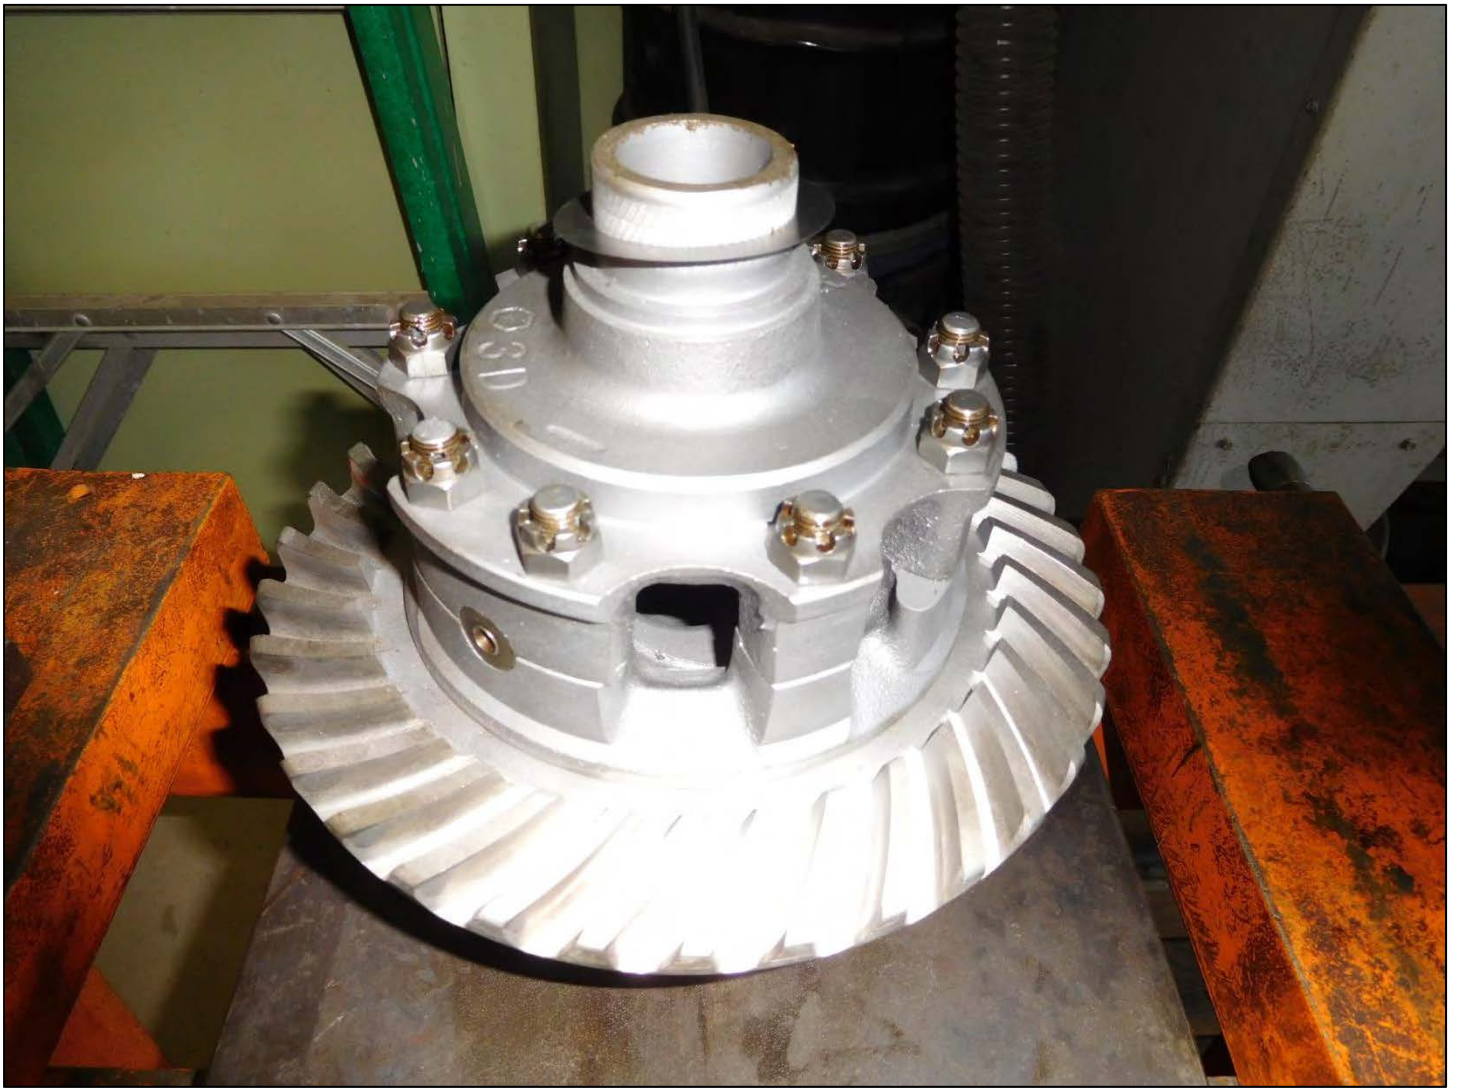
The carrier has been assembled and is about to have a shim installed to one side of the carrier.

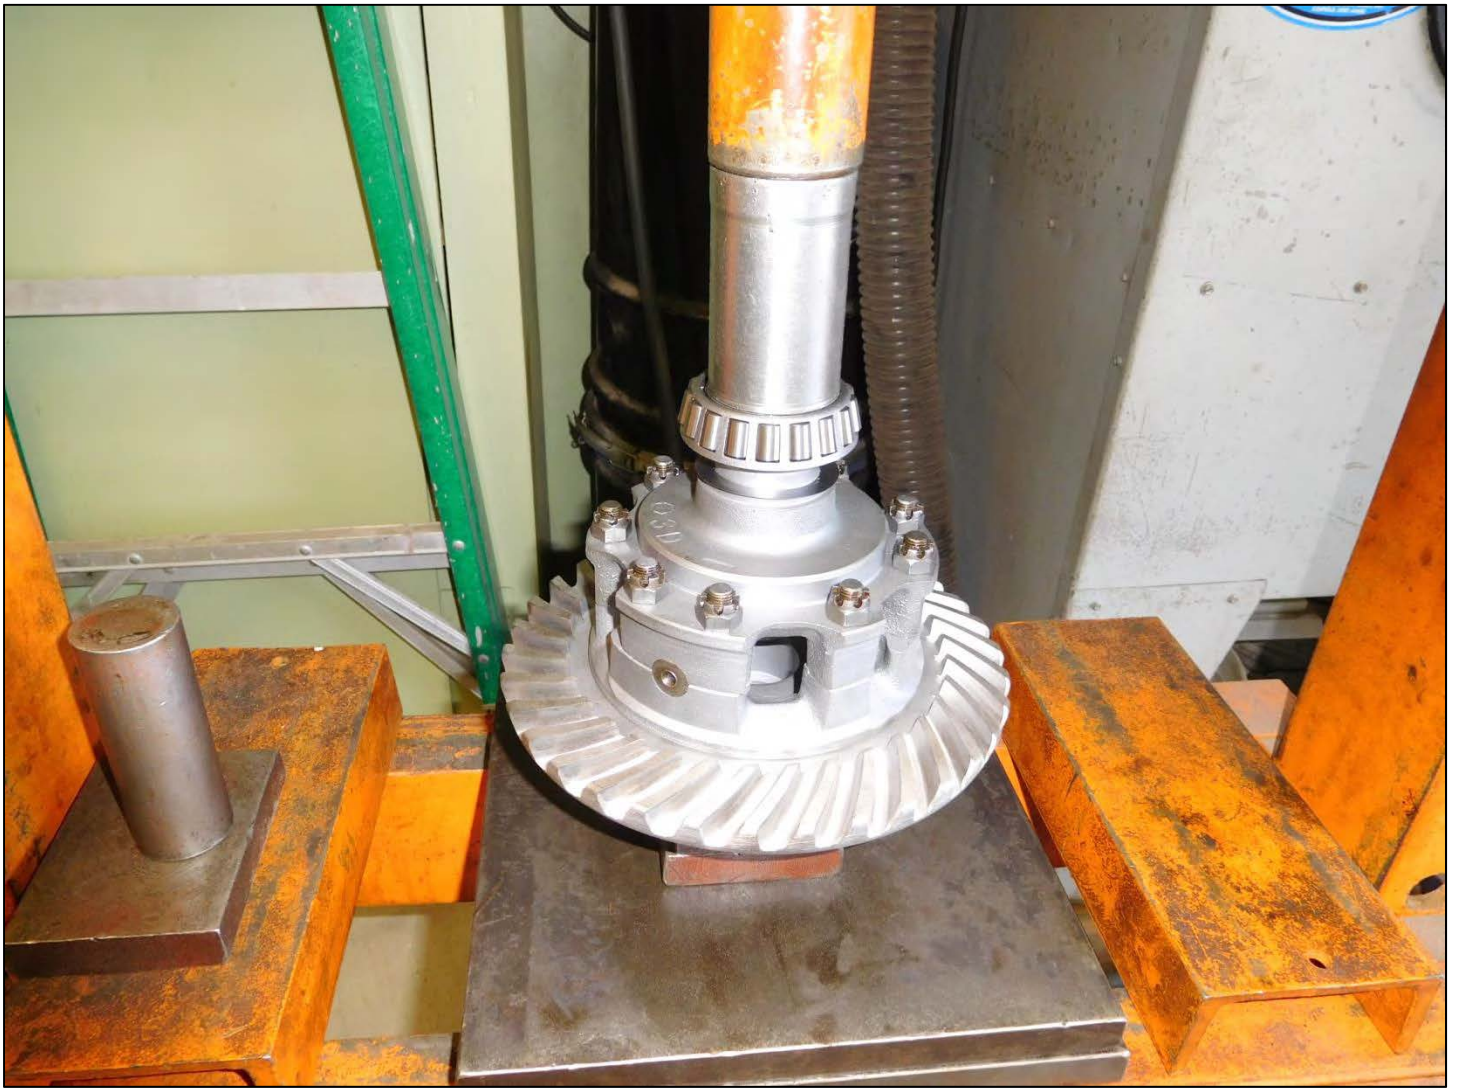
The bearing is being pressed down on top of the shim.

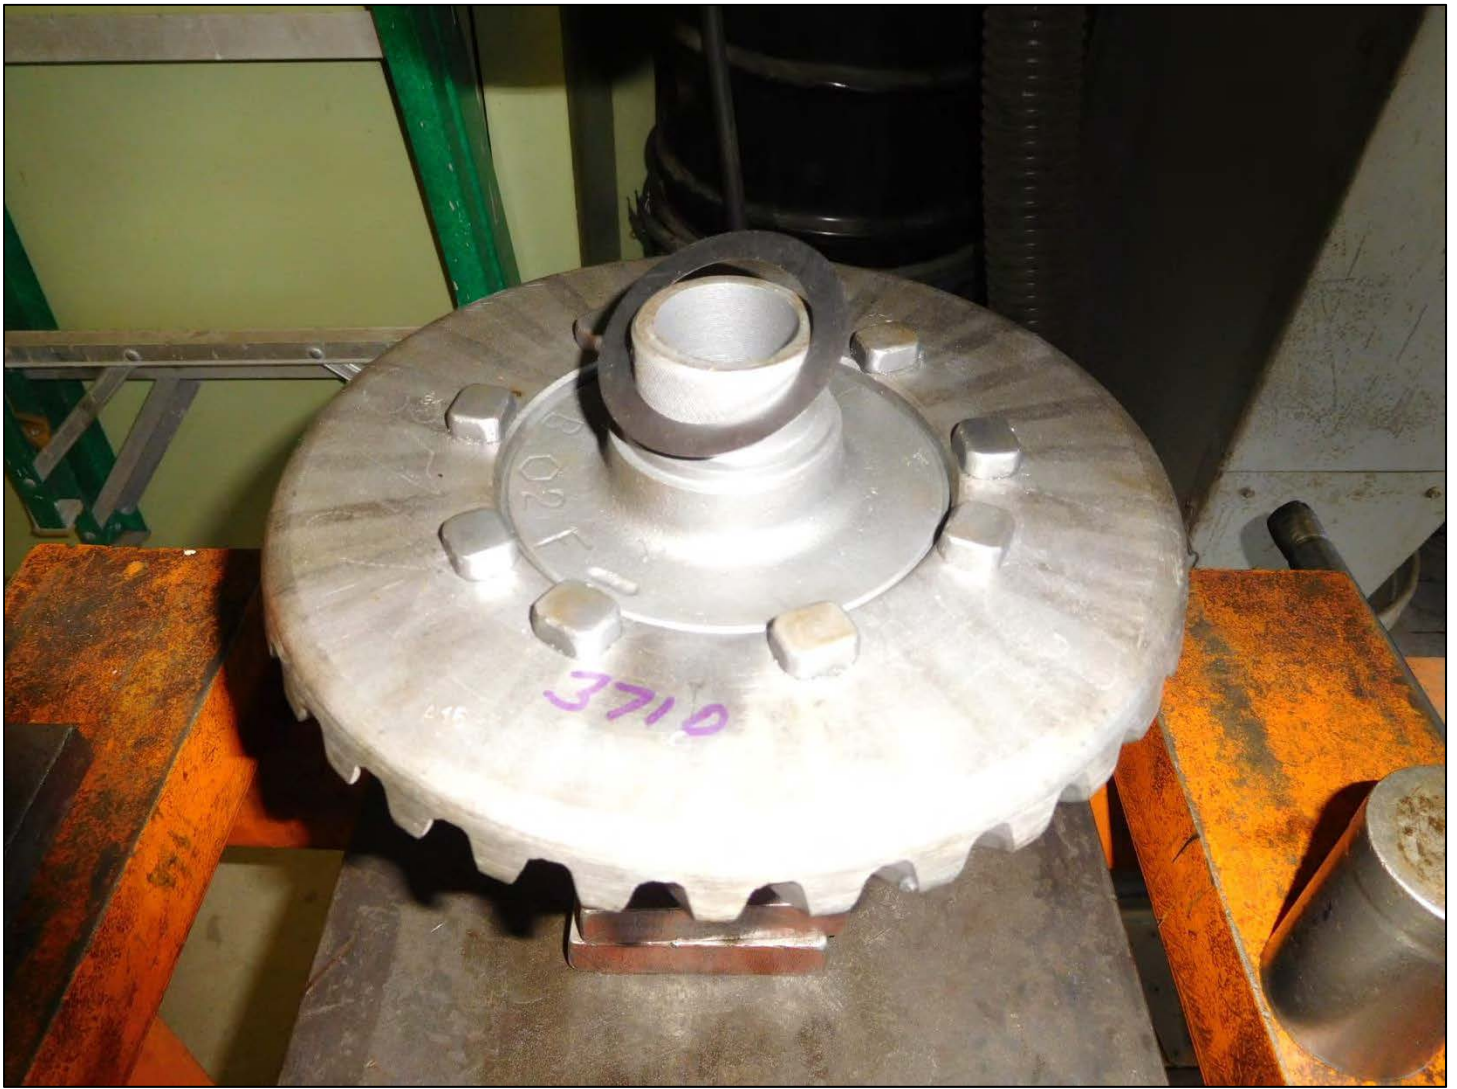
The opposite side of the carrier is having a shim installed.

The number 3710 seen written on the back side of the ring gear was done by me after I found this number stamped on the end of the pinion gear and etched on the back side of the ring gear. This is the matching number.

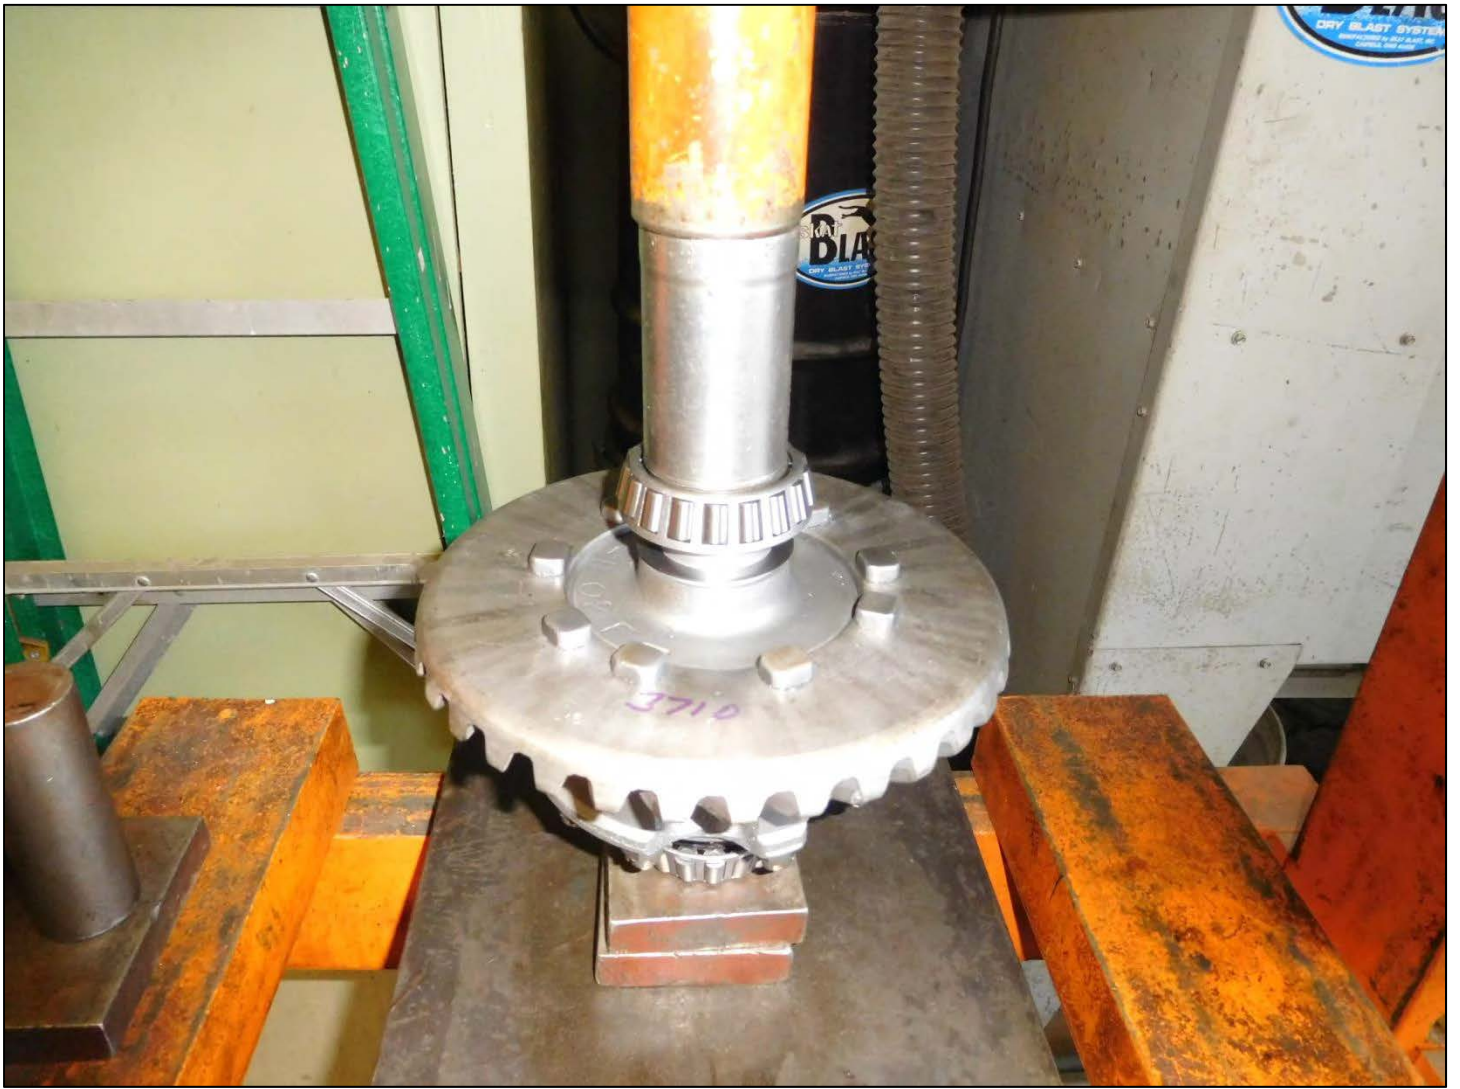
The other bearing is being pressed on.

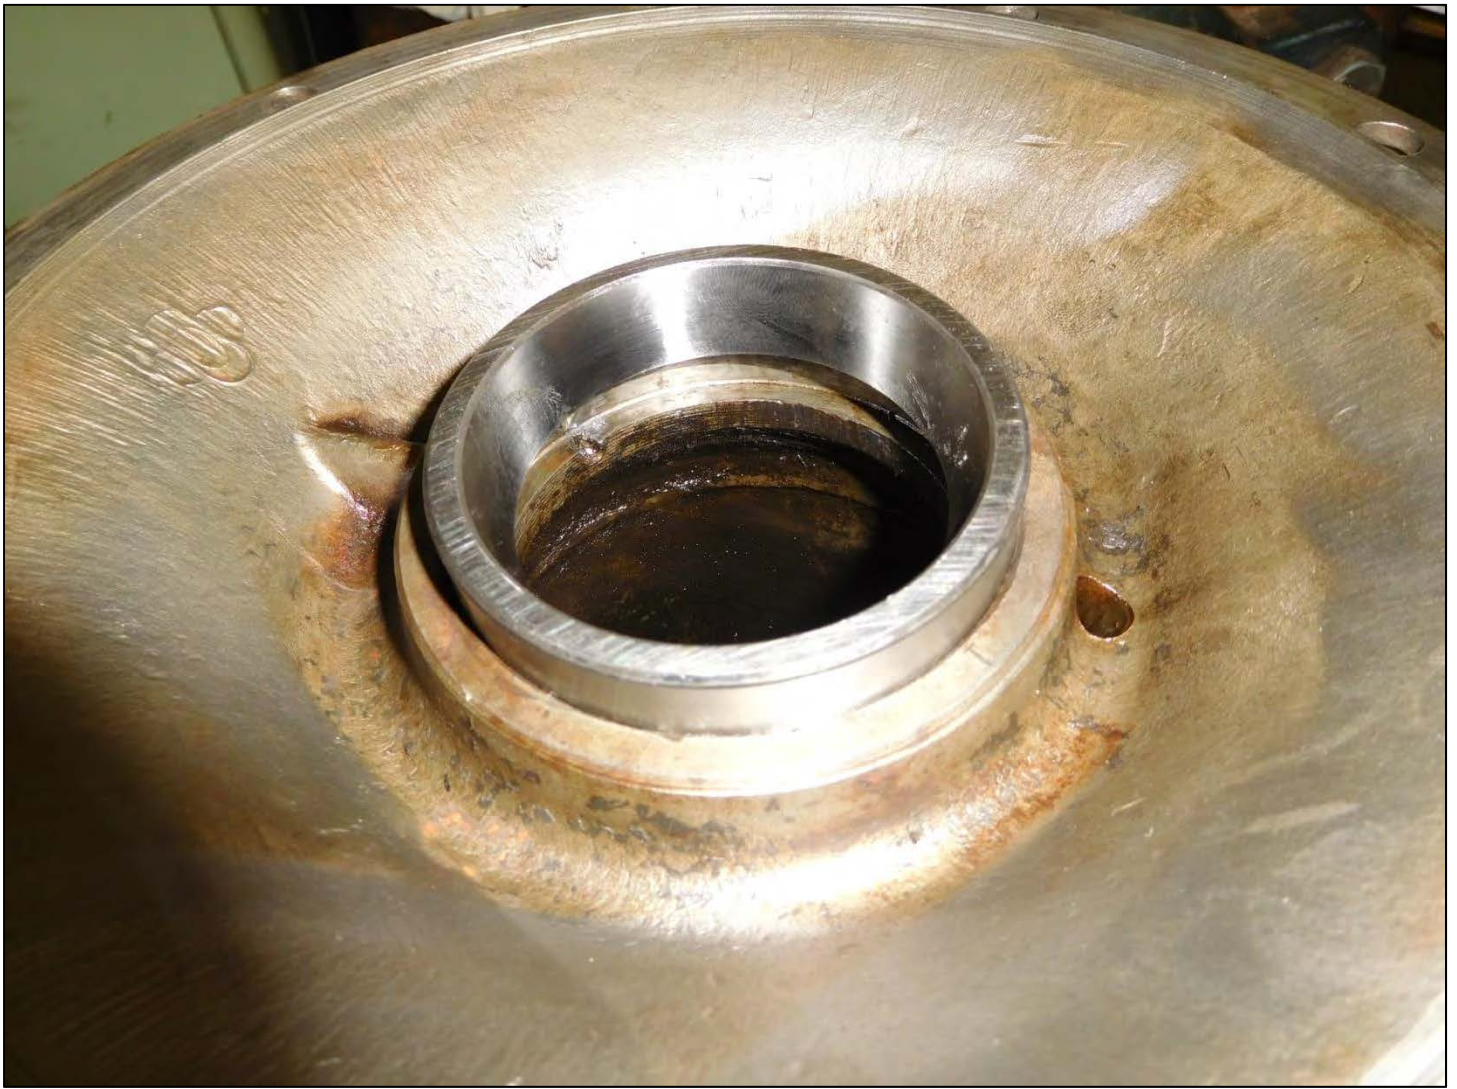
A new race is being installed in the axle housing after it was repaired. It is important that the race is pressed down firmly and evenly on the seat. A dental mirror is used to determine that it was done correctly once the race is seated.

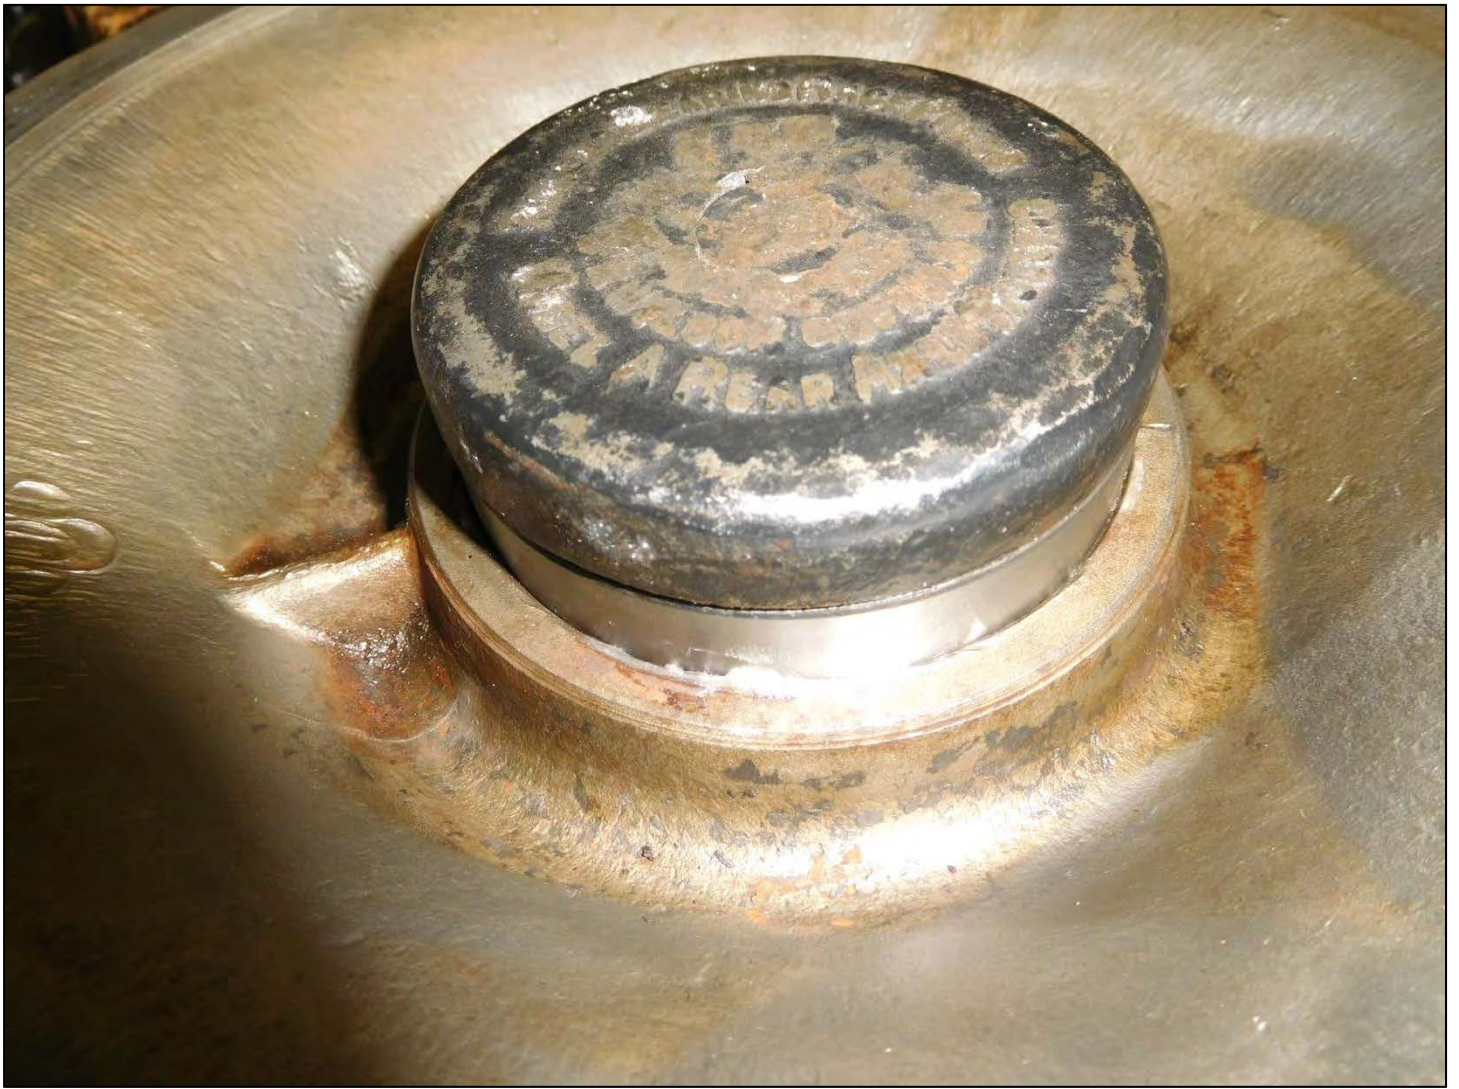
This photo shows a K. R. Wilson tool being used to press the race into place in the axle housing.

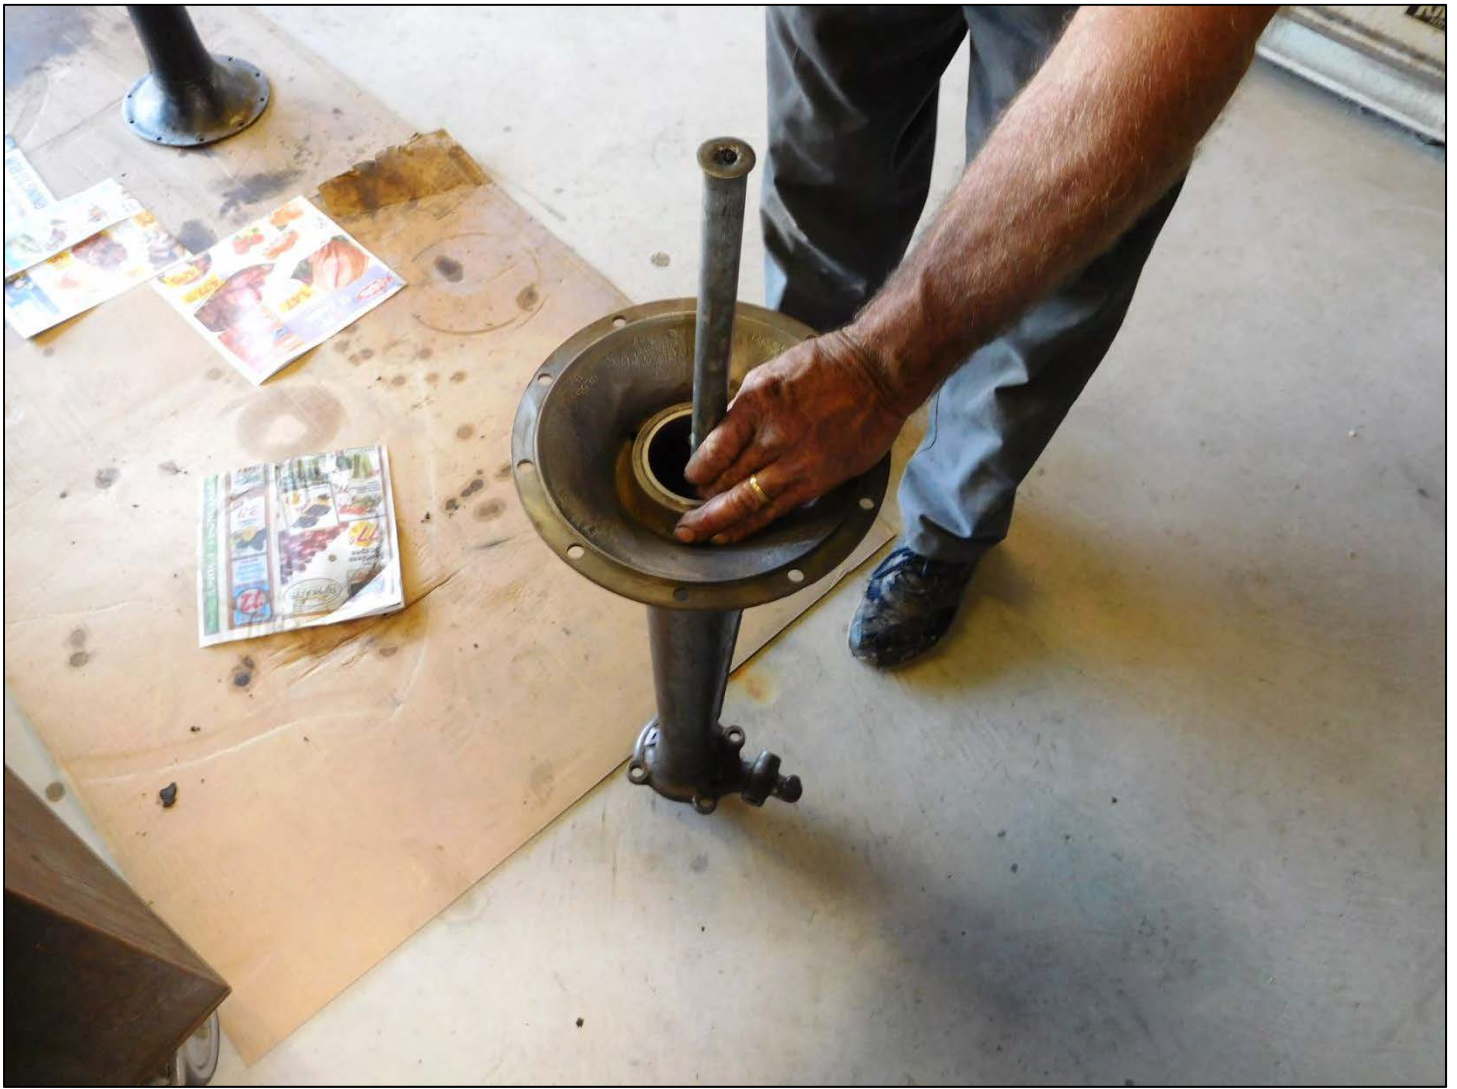
A new grease seal is being installed in one of the axle housing. The seal is placed on the end of an insertion tool and is driven into place with a hammer. The axle housing is set on a concrete floor as is shown. About six or more hammer blows are required to seat it. With each hammer blow there is a clunk sound. When the seal seats the sound changes to a ringing sound.

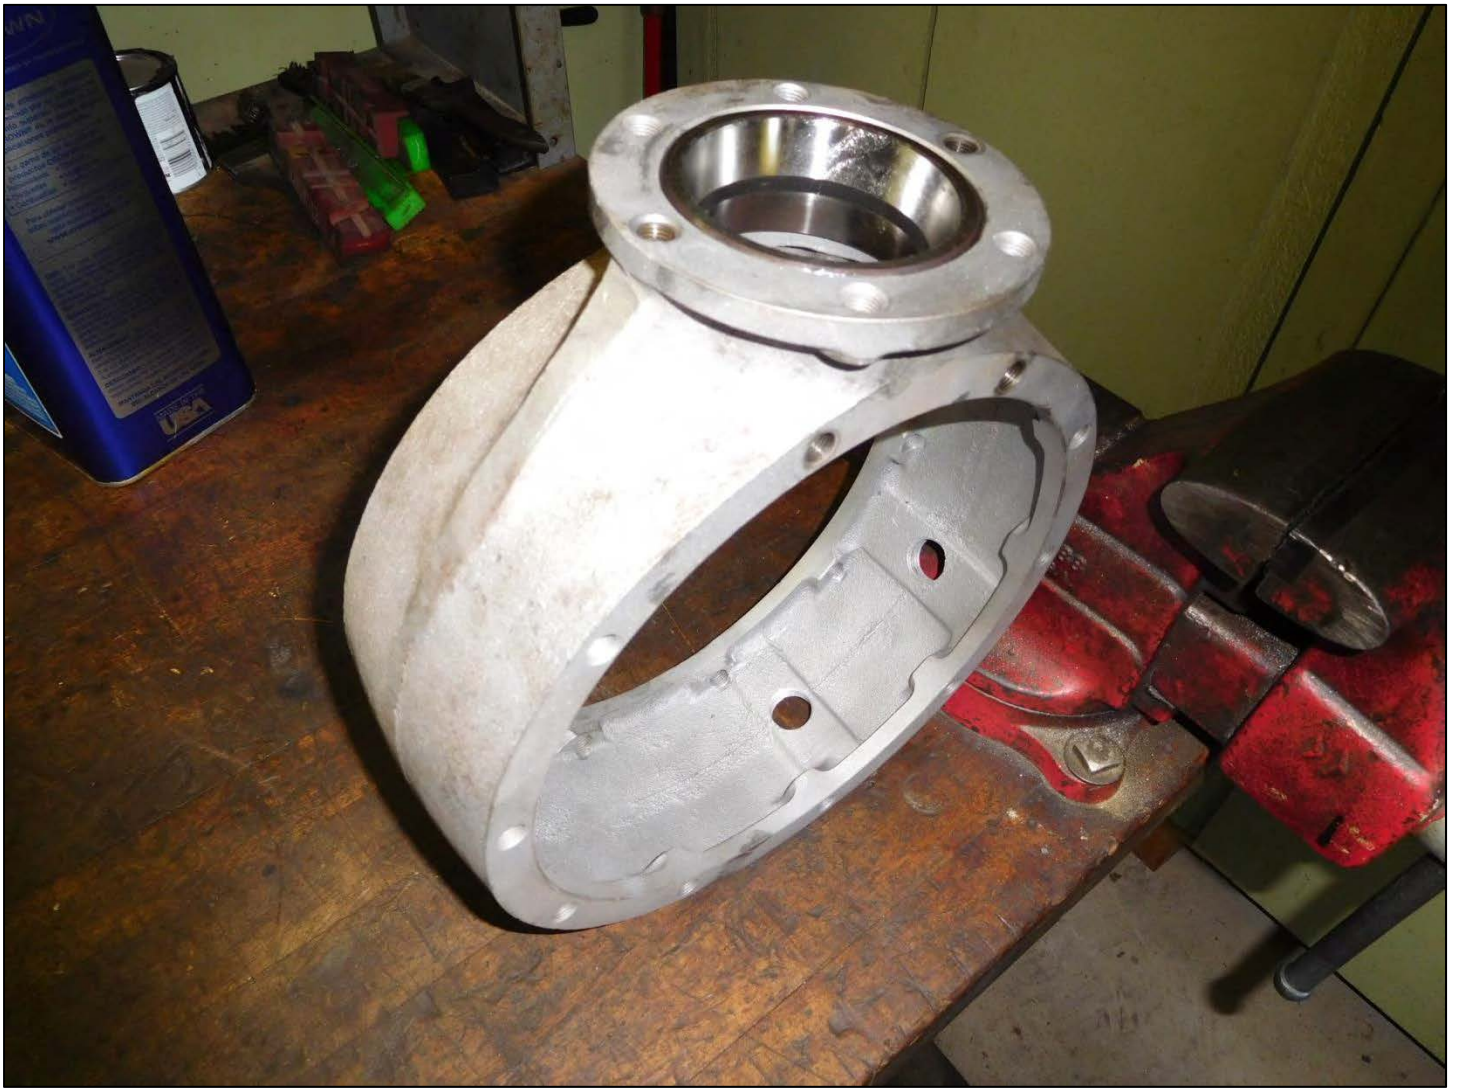
The banjo was degreased and bead blasted. A new double race was pressed into place.
