March 2019 Differential Overhaul

By Tom Endy

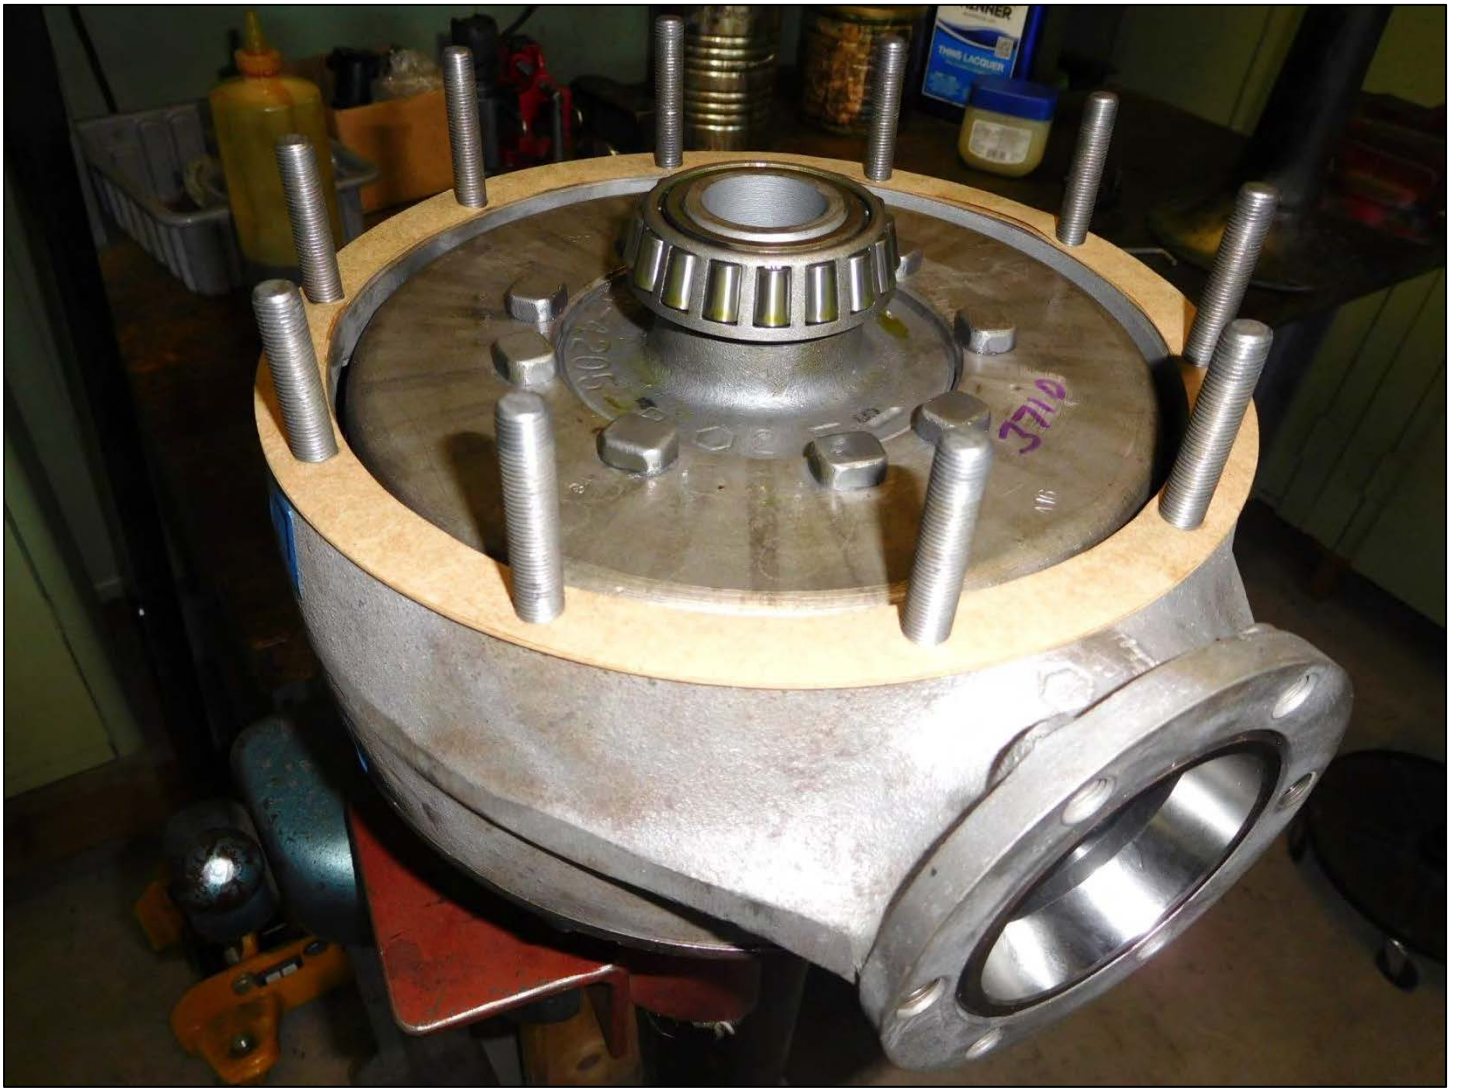
This photo shows the beginning of the carrier bearing pre-load adjustments process. The right axle housing is sitting in the vertical jig with the banjo bolted to it and all the bolts torqued to 35 ft. lbs. The carrier assembly is set down inside. Two .010 banjo gaskets are initially installed. Alignment studs are installed on the left side of the banjo.

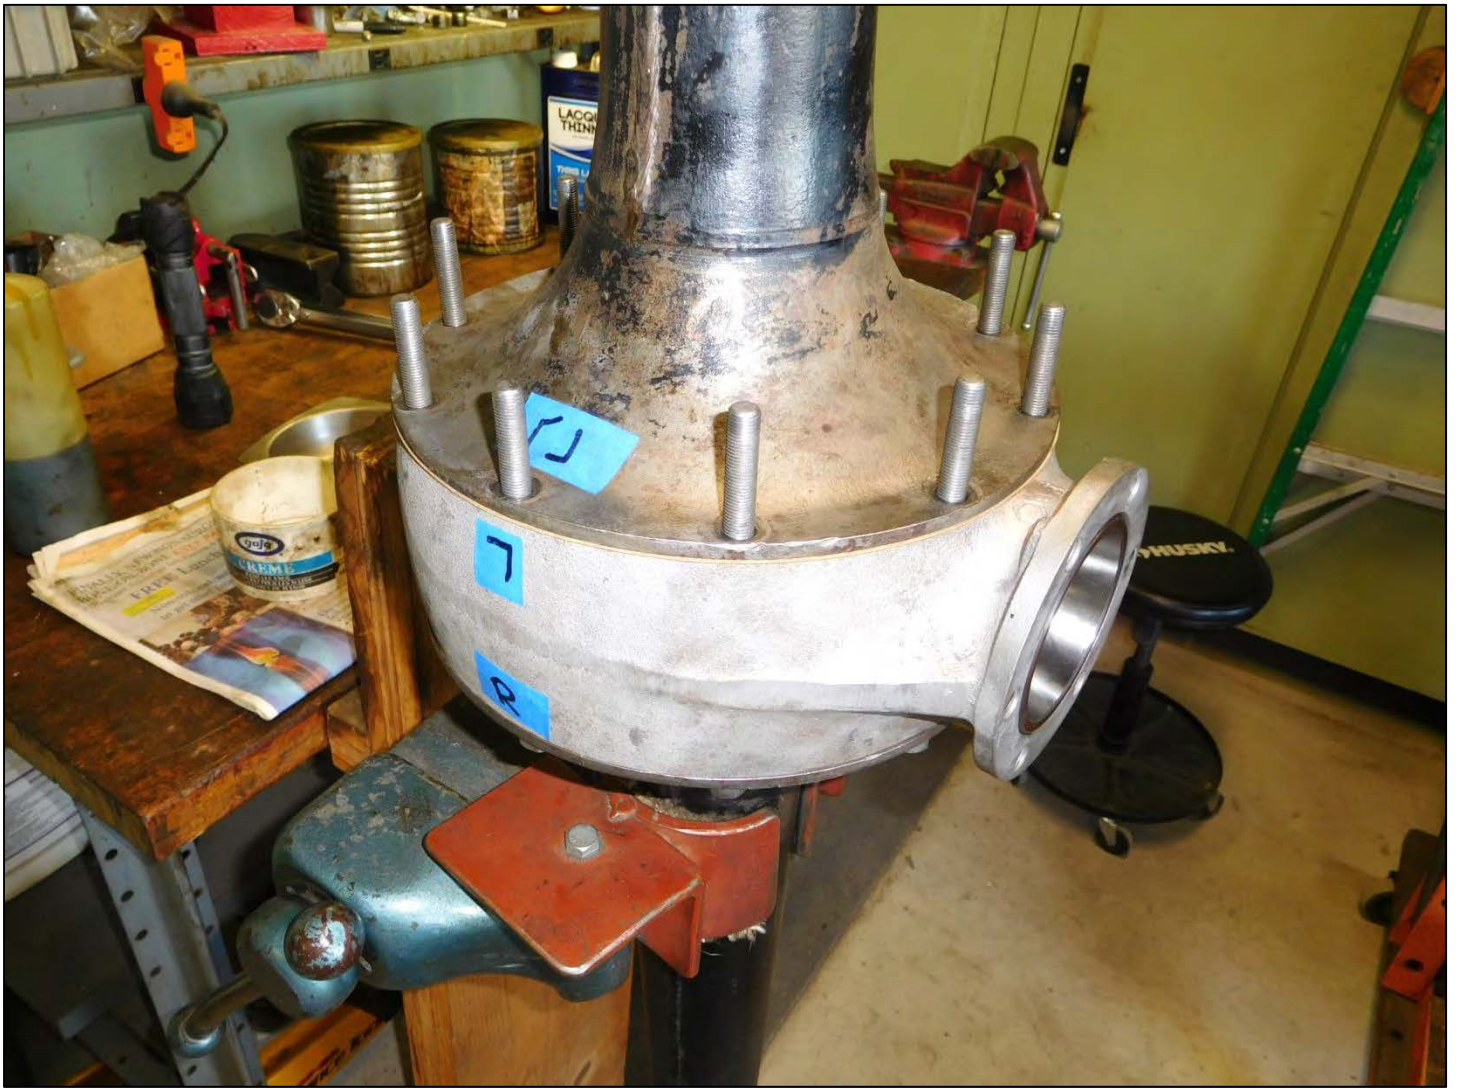
The left axle housing is set down on the left side of the banjo and the studs were replaced with bolts and torqued to 35 ft. lbs. The pre-load was then checked. In this case I had to add an additional .006 gasket to bring it to the desired 20 in. lbs.

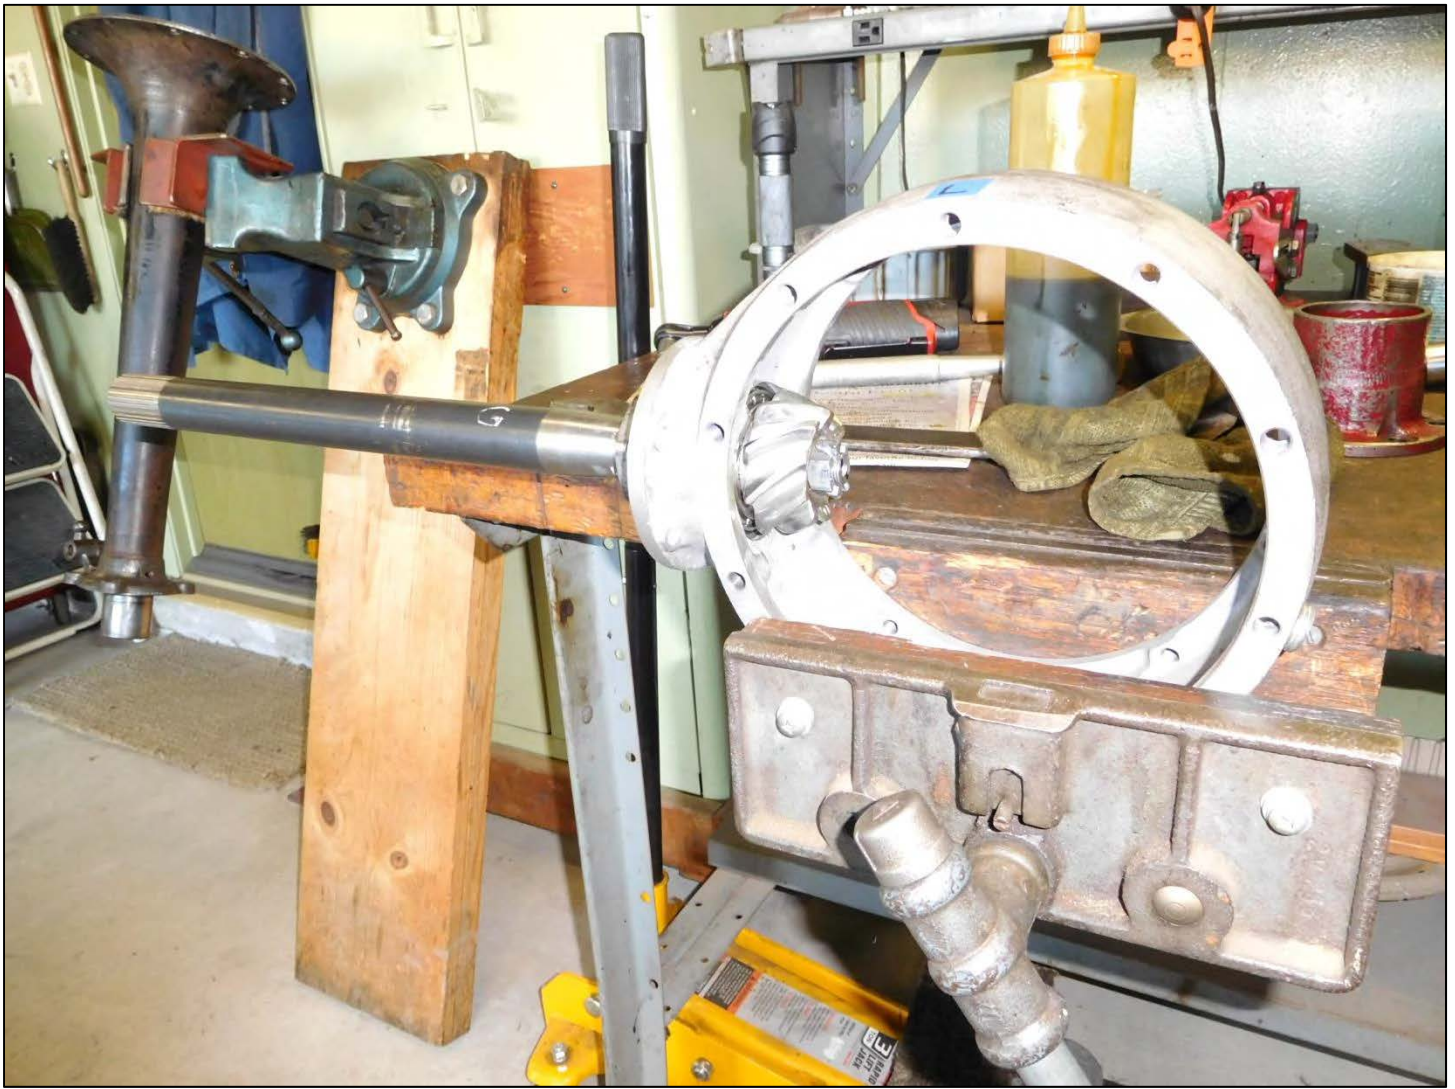
The pinion assembly was installed along with the new Mitchell stud shaft. The pinion bearing pre-load was established by adjusting the two large nuts on the pinion sleeve. The nut on the end of the Mitchell stub shaft was tightened to 100 ft. lbs. The cotter pin legs were bent down along the side of the nut, not over the end of the shaft.

It is prudent to check the clearance between the end of the drive shaft and the carrier. There is a nominal 1\4" clearance, but it can vary, especially with an overdrive installation or aftermarket ring and pinion gears. This can be accomplished during the overhaul process by temporarily setting the carrier upside down on the right axle housing and setting the banjo with the pinion assembly installed down on top. This allows a view of the pinion gear meshed with the ring gear and a clear view of the clearance between the end of the drive shaft and the carrier.

The narrow clearance is the reason the cotter pin on the end of the drive shaft should be bent down along the side of the nut and not over the end of the shaft.

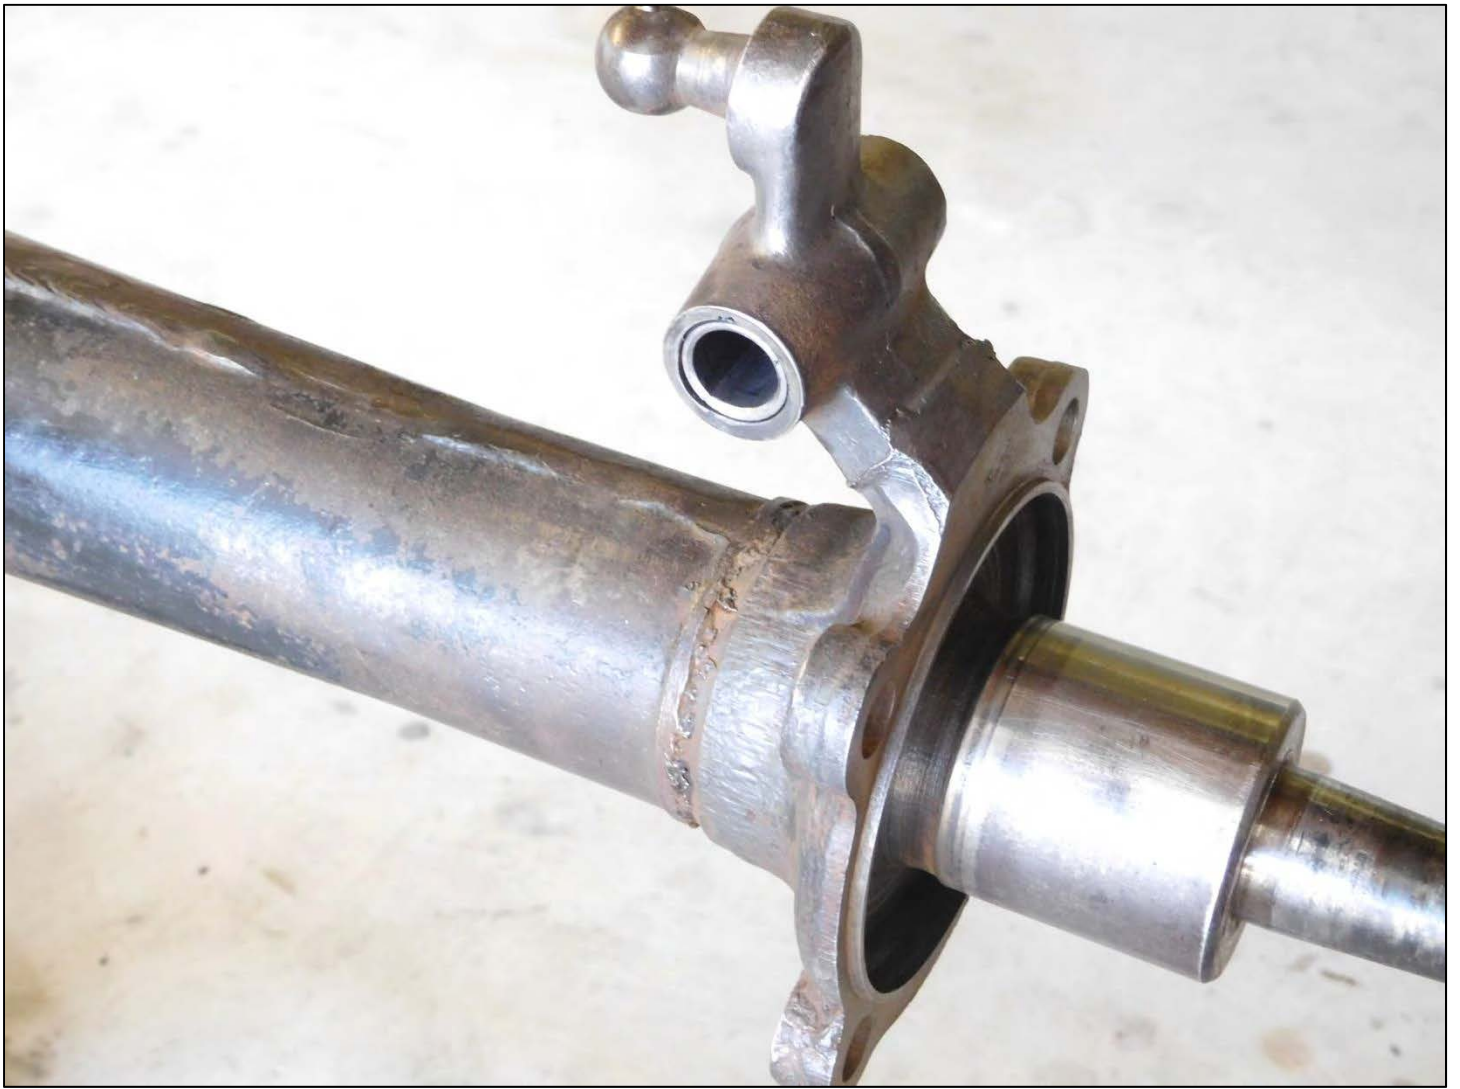
New shackle bushings were installed in both axle housings.

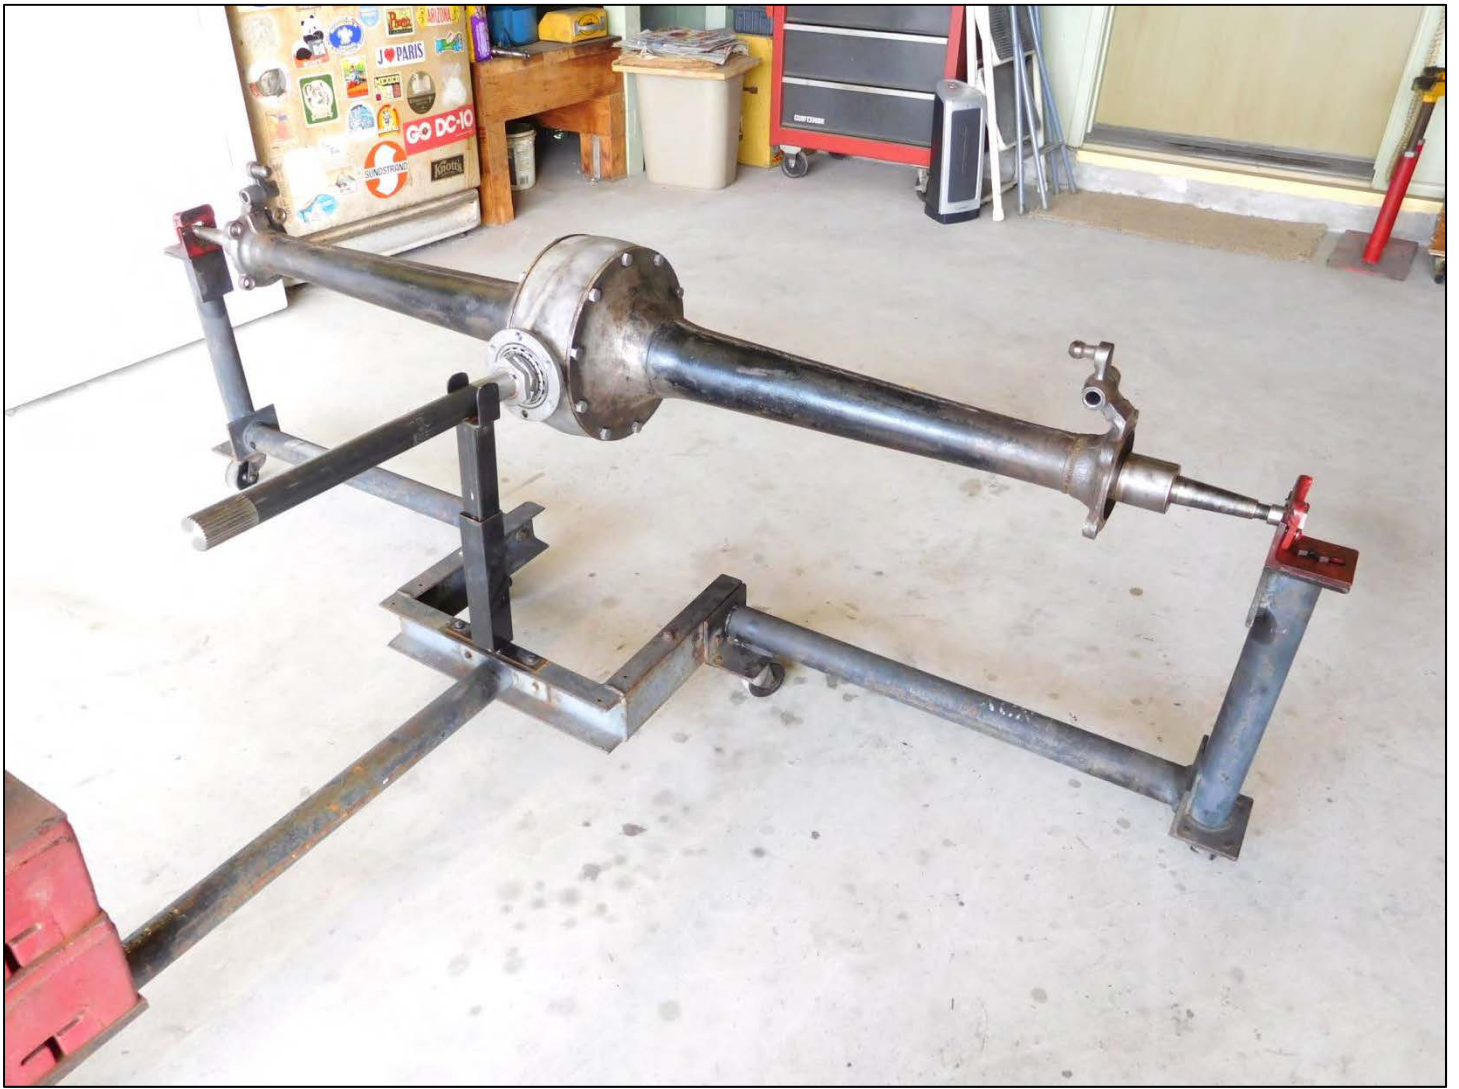
The rear axle assembly is complete and has been put back in the roll around cradle.

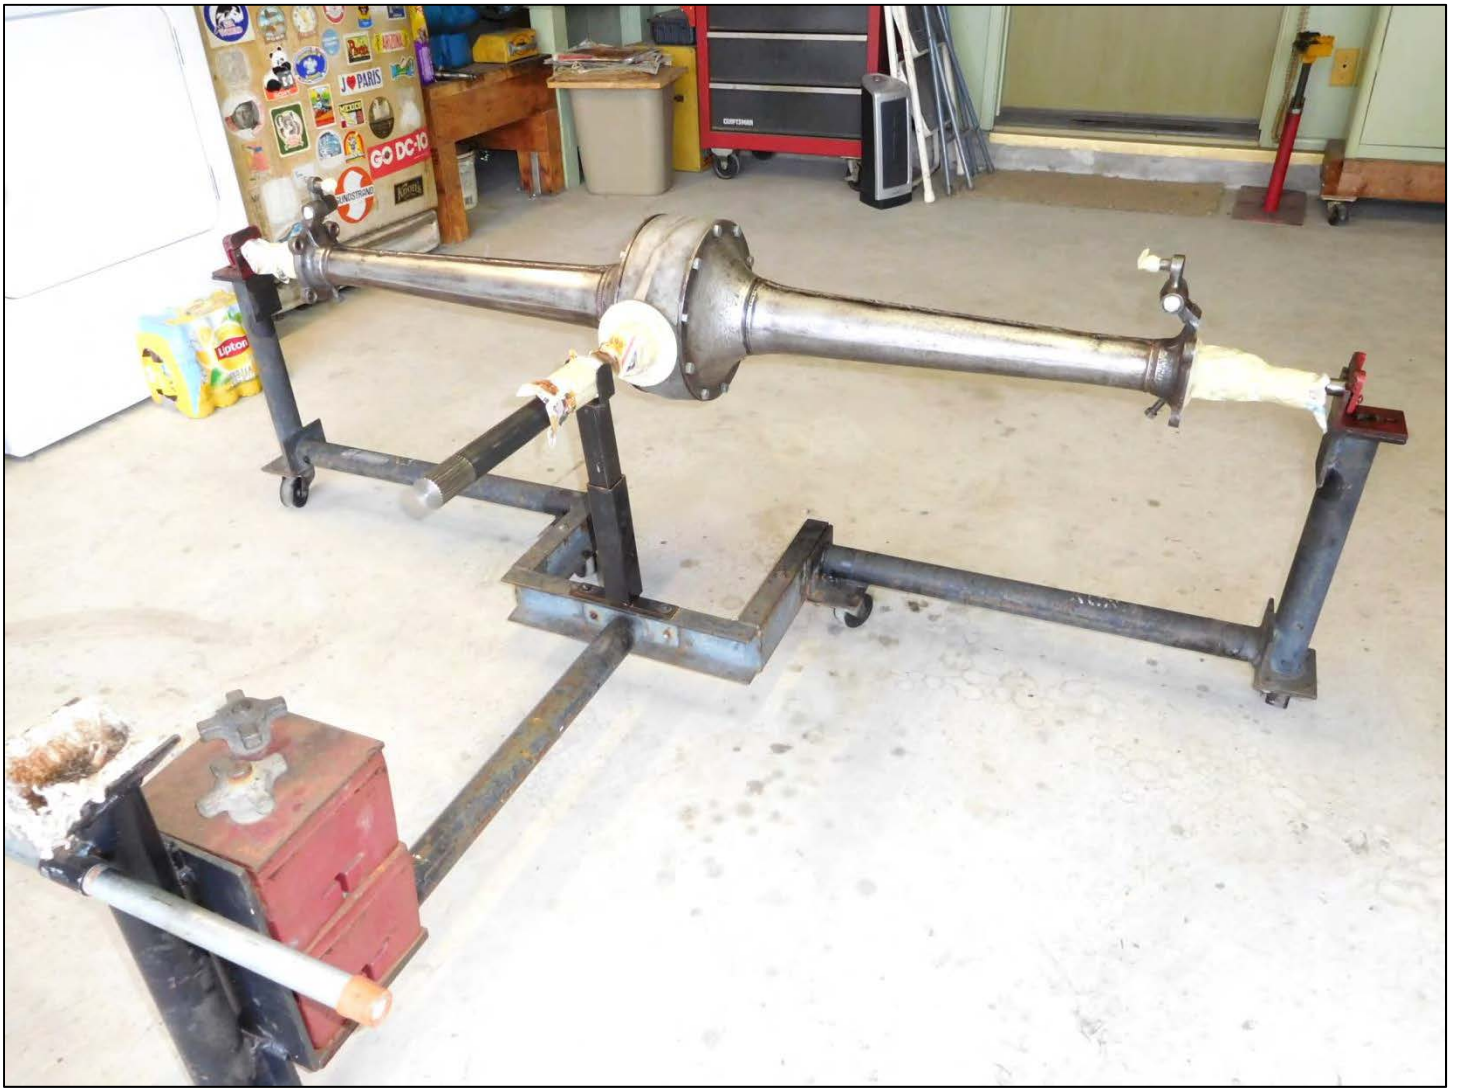
The rear axle assembly has been masked off and sanded and is ready for painting.

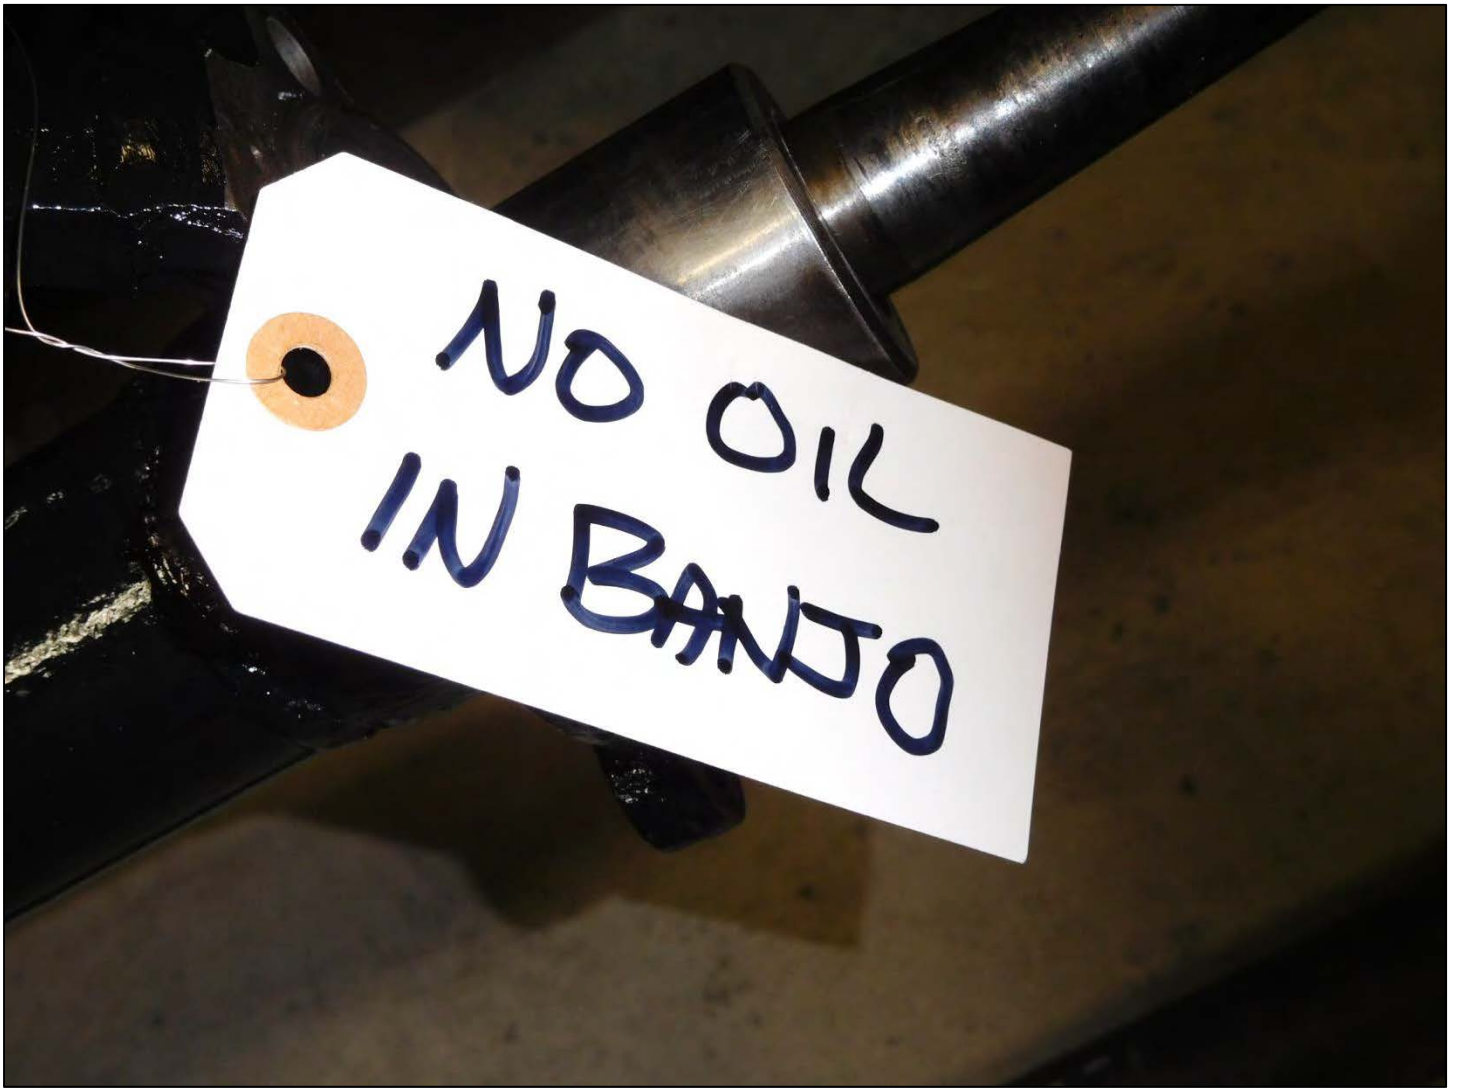
Tag attached to the rear axle housing. Don't forget to put oil in the banjo.
