# Differential Overhaul May 9, 2019 (LB)

by Tom Endy

This rear axle assembly overhaul project arrived in the back of a pick-up truck and will receive a Mitchell overdrive during the overhaul process. In addition, the transmission and bell housing from the project car were also brought and will be overhauled/restored. The project car is a 1929 Tudor. The owner is a member of the Santa Anita A's of Arcadia, California.

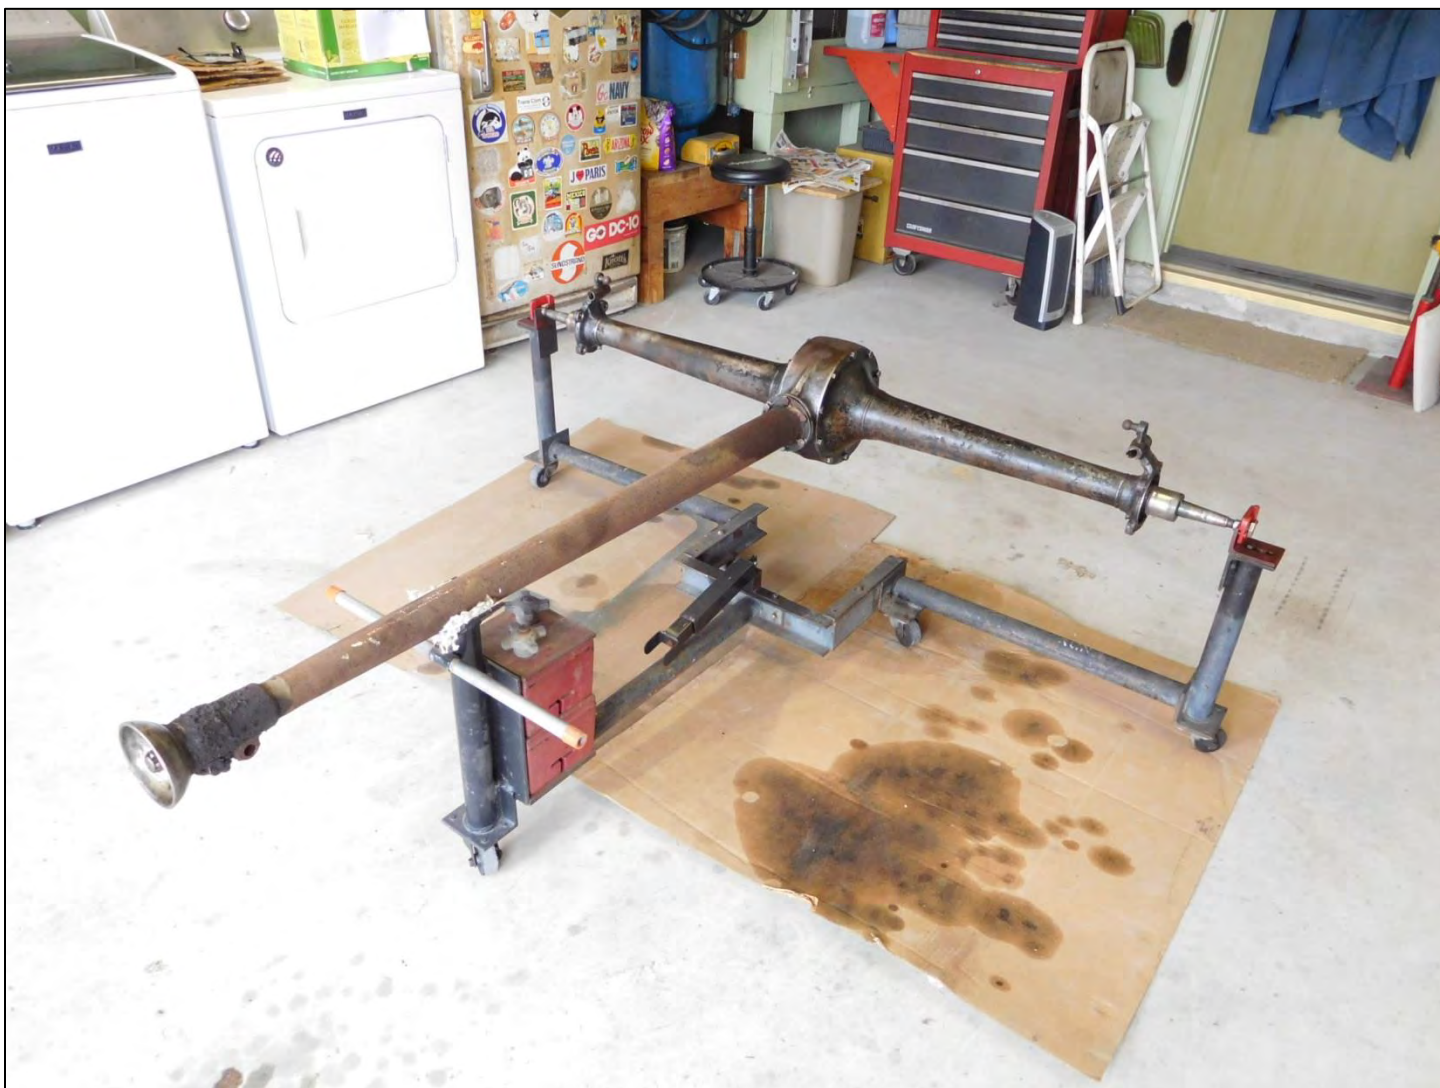
The rear axle assembly was removed from the project car that had been in storage for many years before being transported for overhaul. It is shown here arriving in typical cruddy condition.

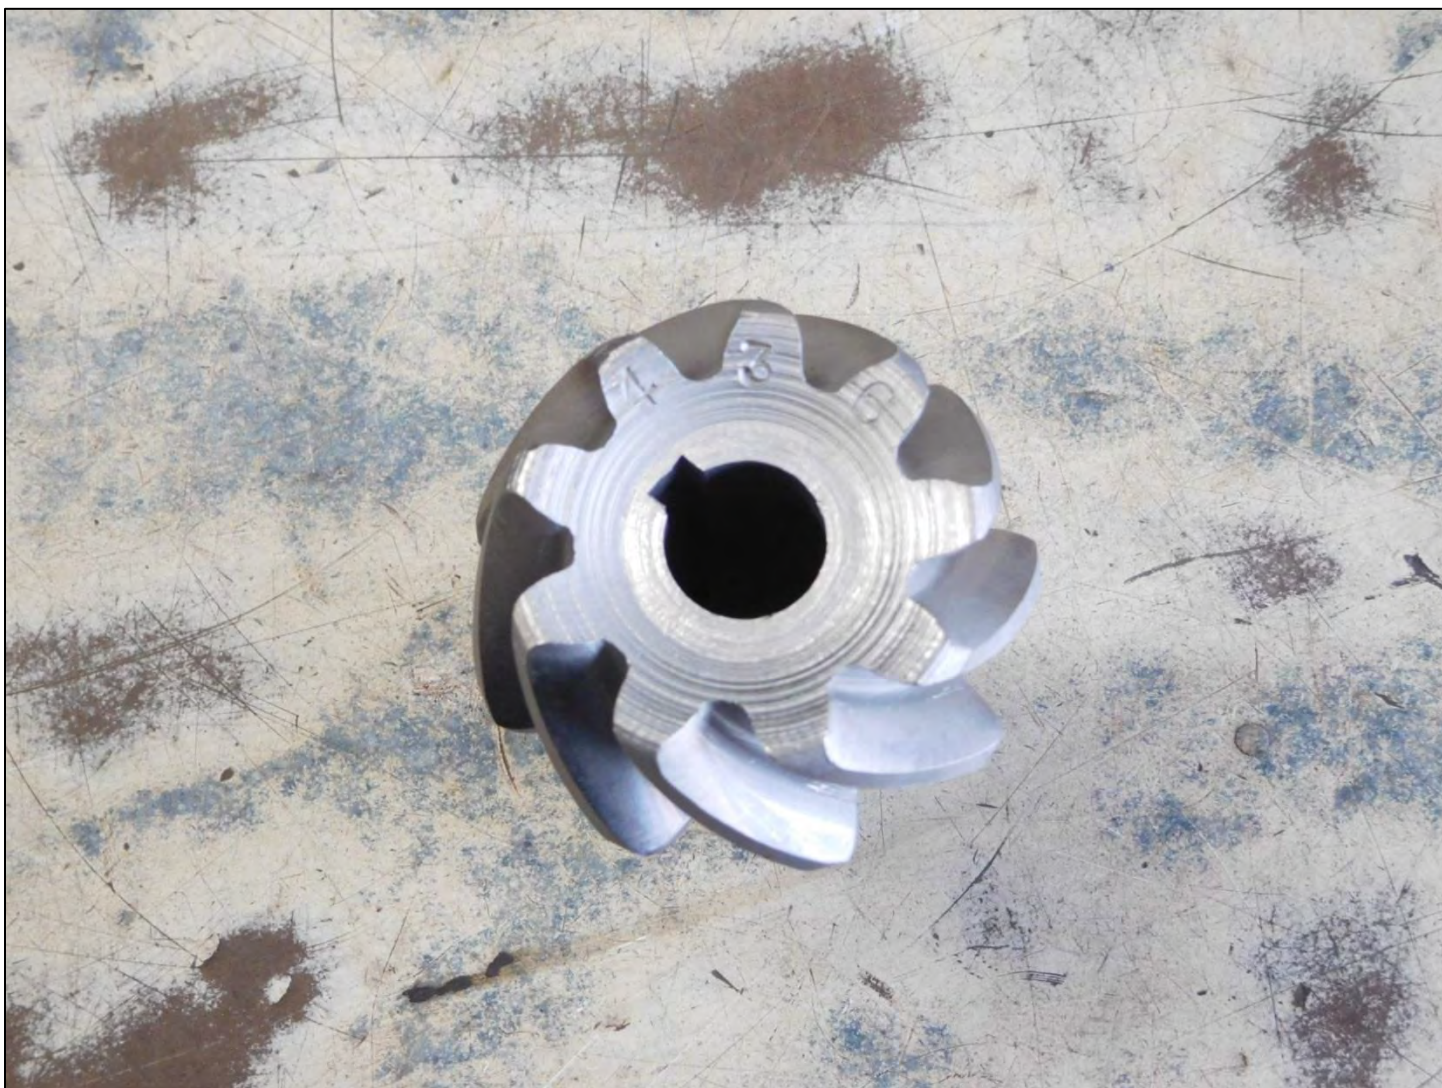
**An original pinion gear will have a number stamped into the end of the gear. In this case the number is 436. During factory assembly it was common practice for a worker to use an etching tool to inscribe the same number on the flat side of the ring gear.**

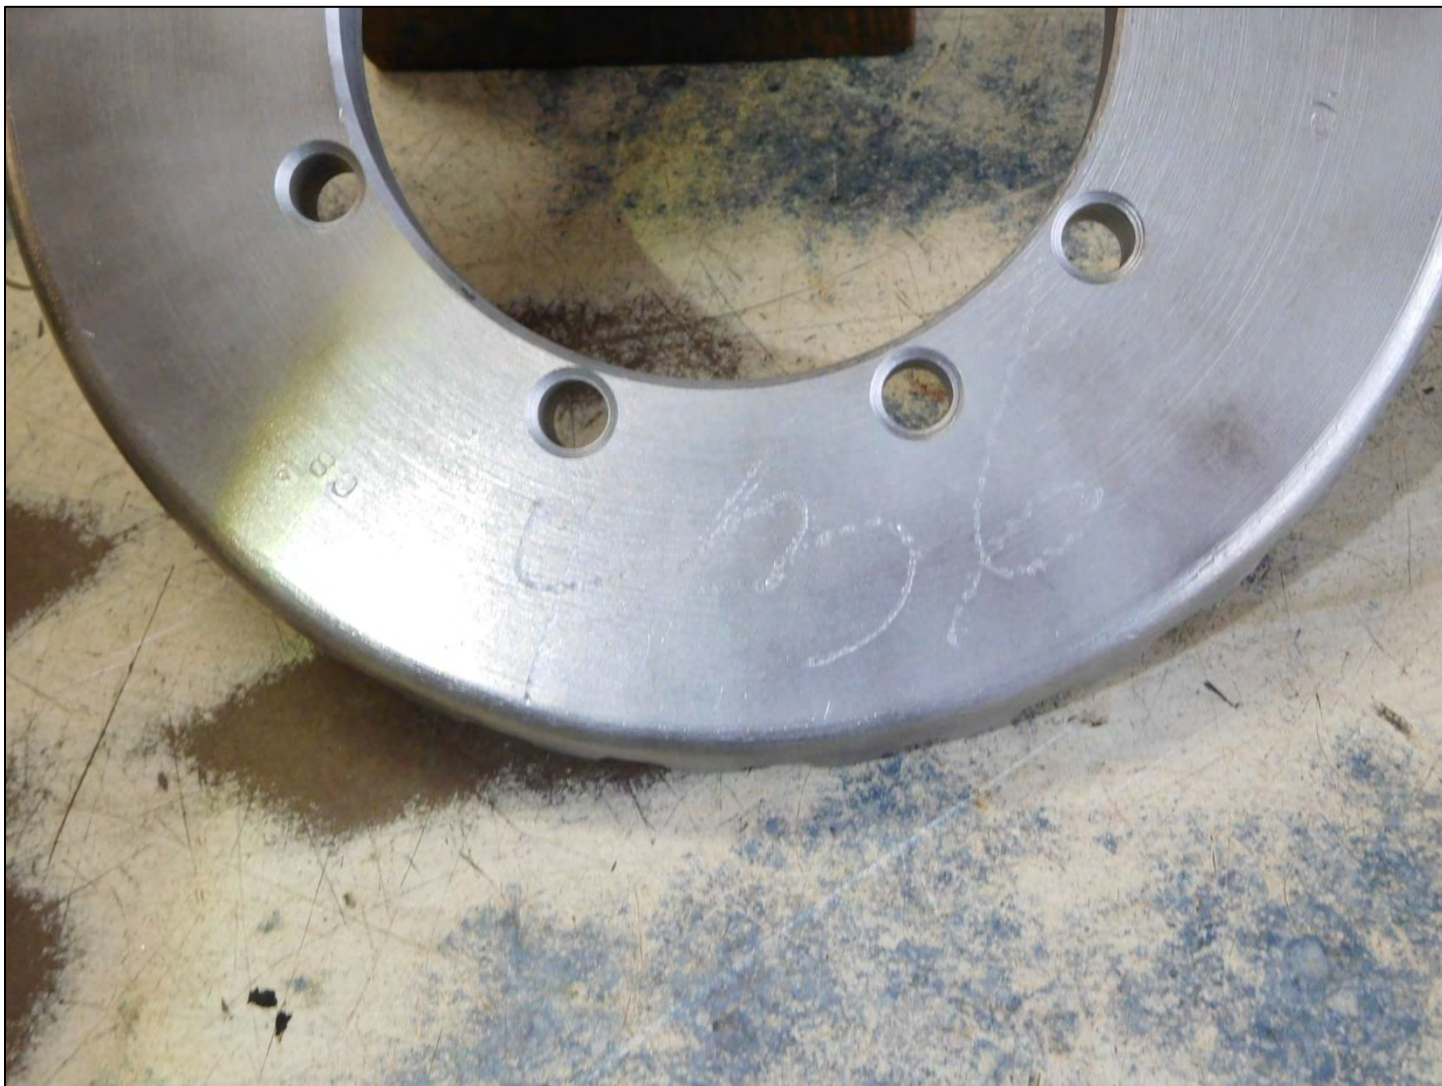
**Shown here is the flat side of the ring gear that shows the corresponding inscribed number 436 that is stamped on the pinion gear.**

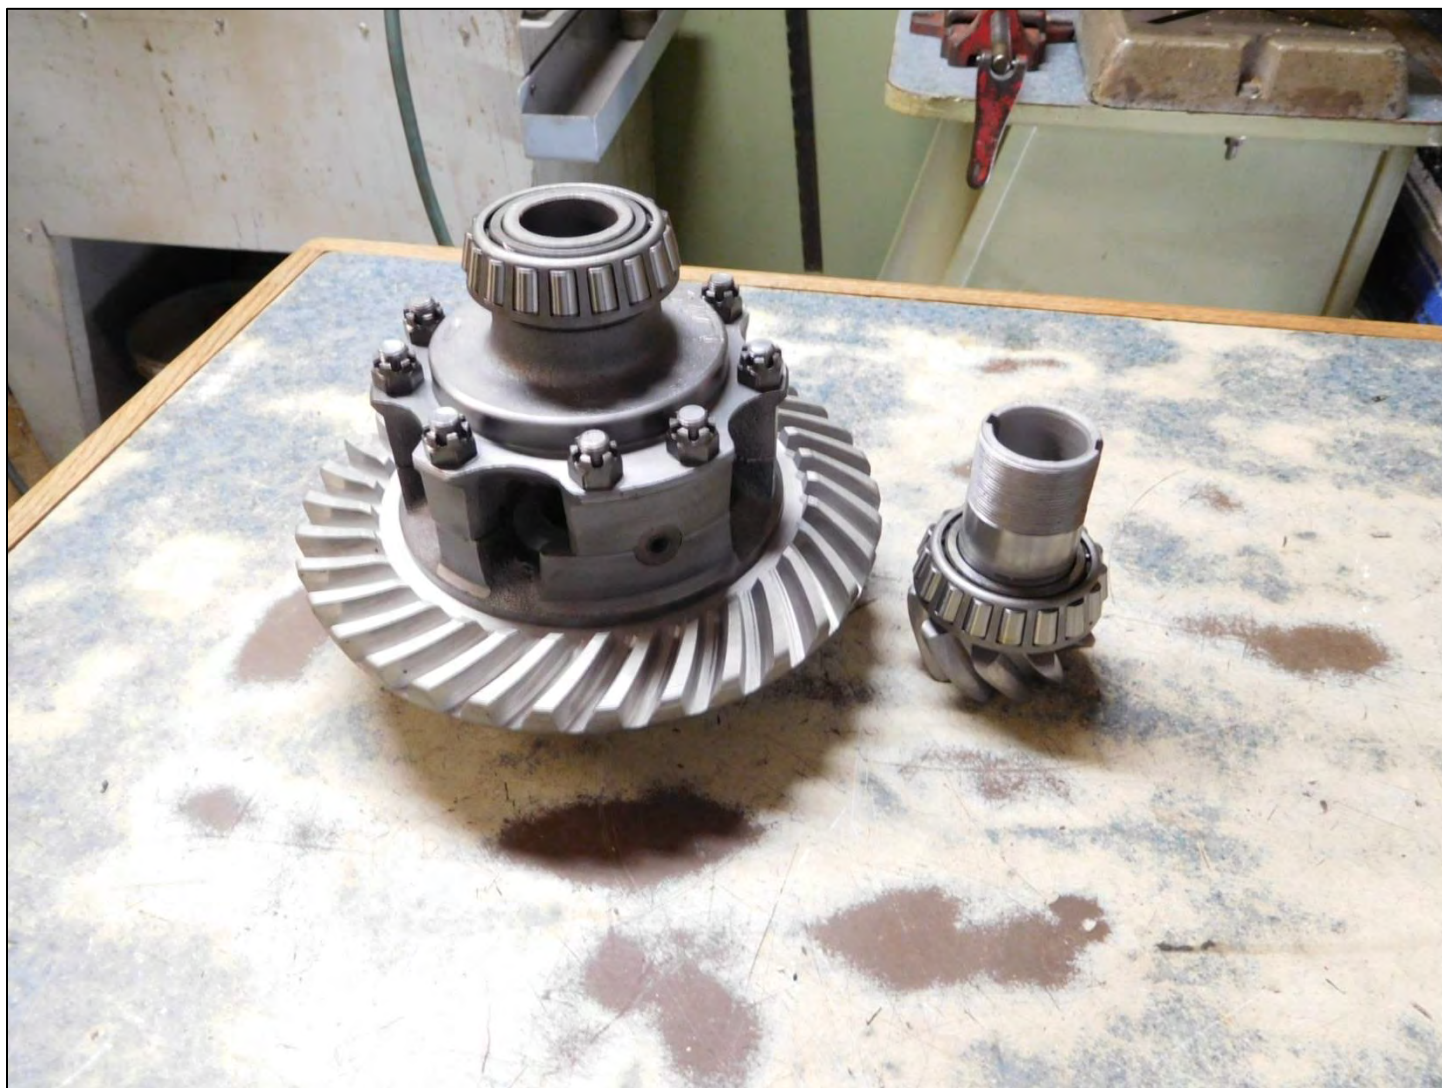
**Shown here is the carrier fully assembled with new bearings installed and the pre-load tool mounted inside. The nine nuts were torqued to 35 ft. lbs. The carrier will later be taken apart to remove the pre-load tool and to install the spider gears and both axle shafts for final assembly.**

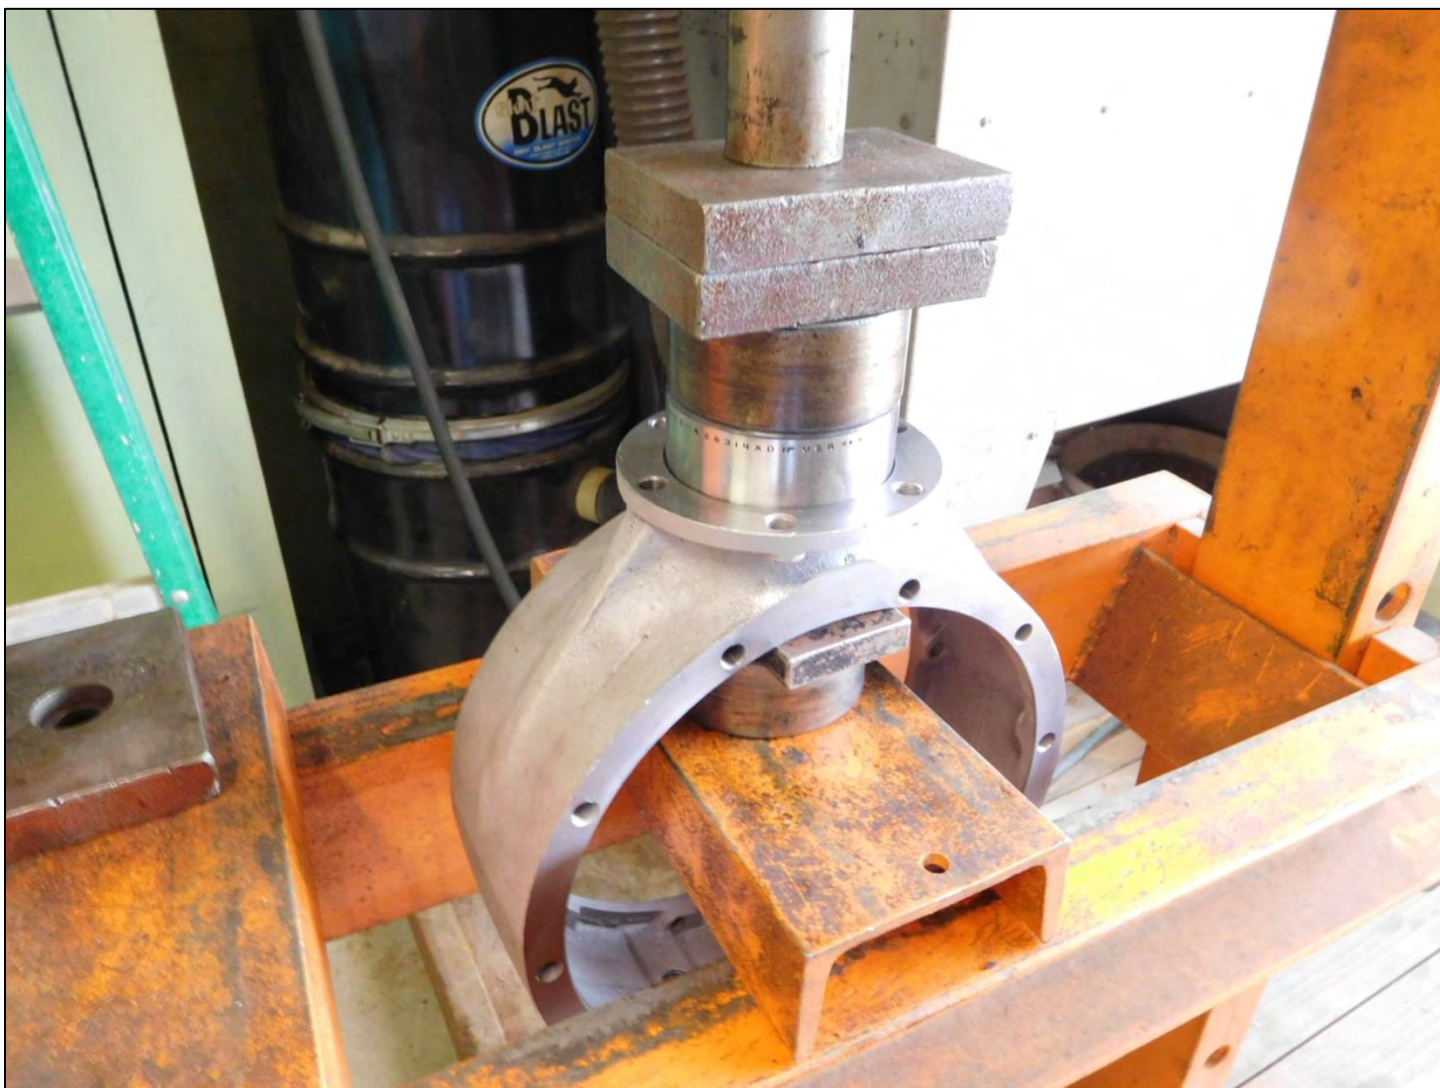
**The banjo has been degreased and bead blasted. The old bearing race has been removed and shown here is a new bearing race being pressed into place.**

**Note how the banjo is placed on the press. You never should place a banjo on a press with the bottom of the banjo resting on the press platform. The force of the press will distort the banjo into the shape of a football.**

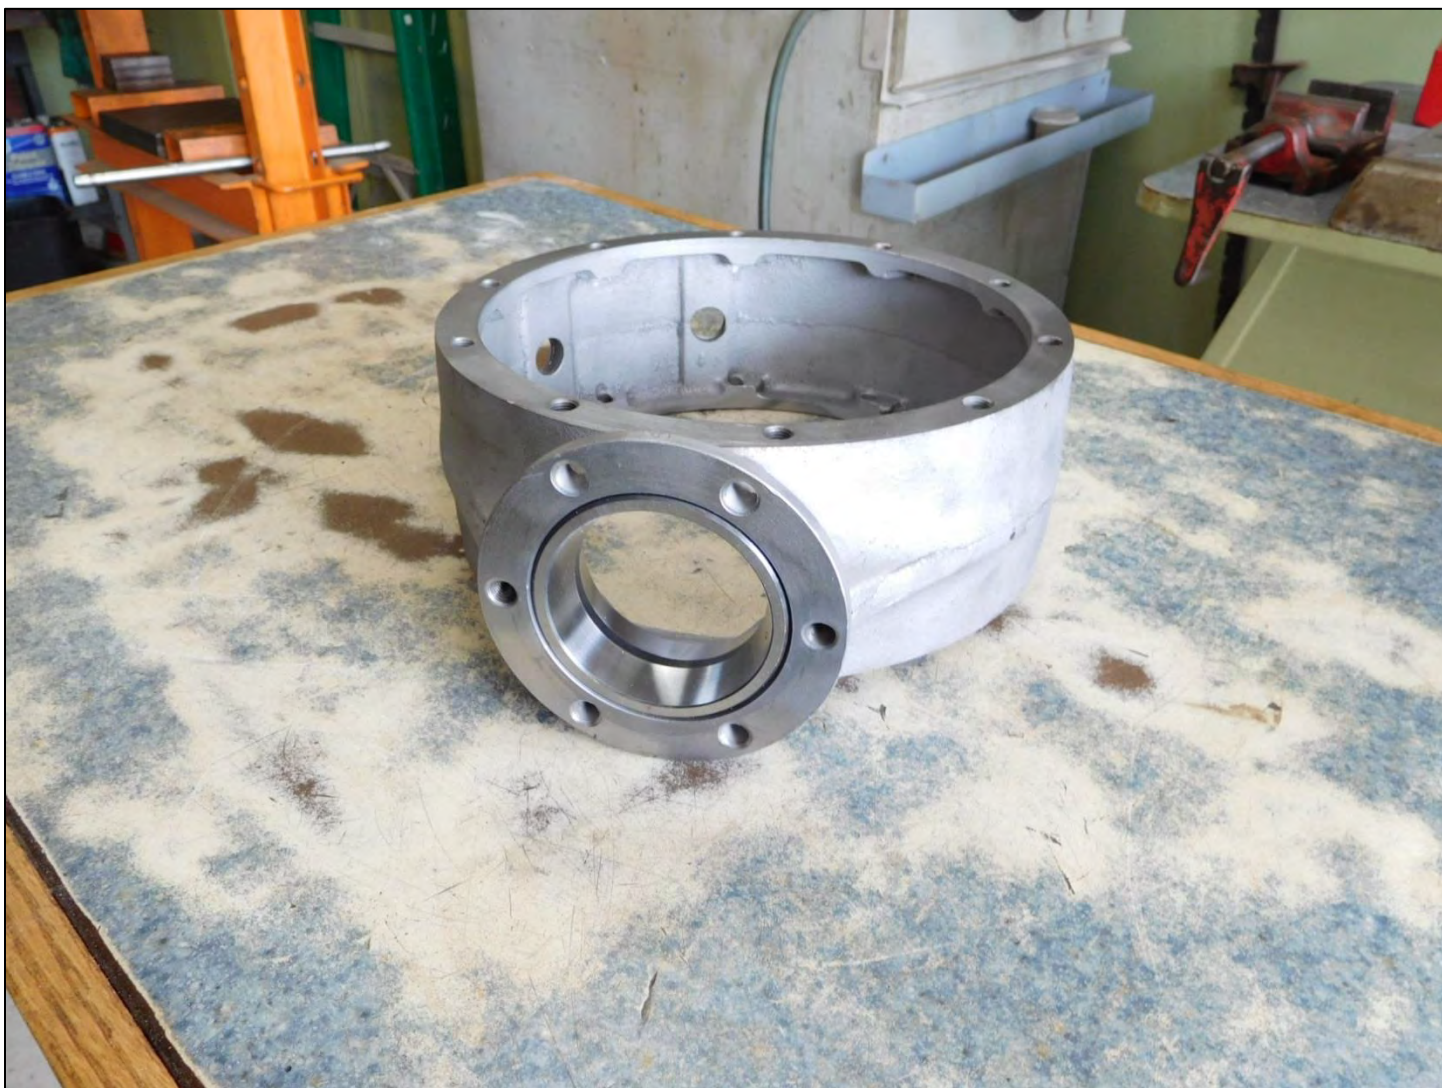
**Shown here is the banjo with a new pinion bearing race pressed into place.**

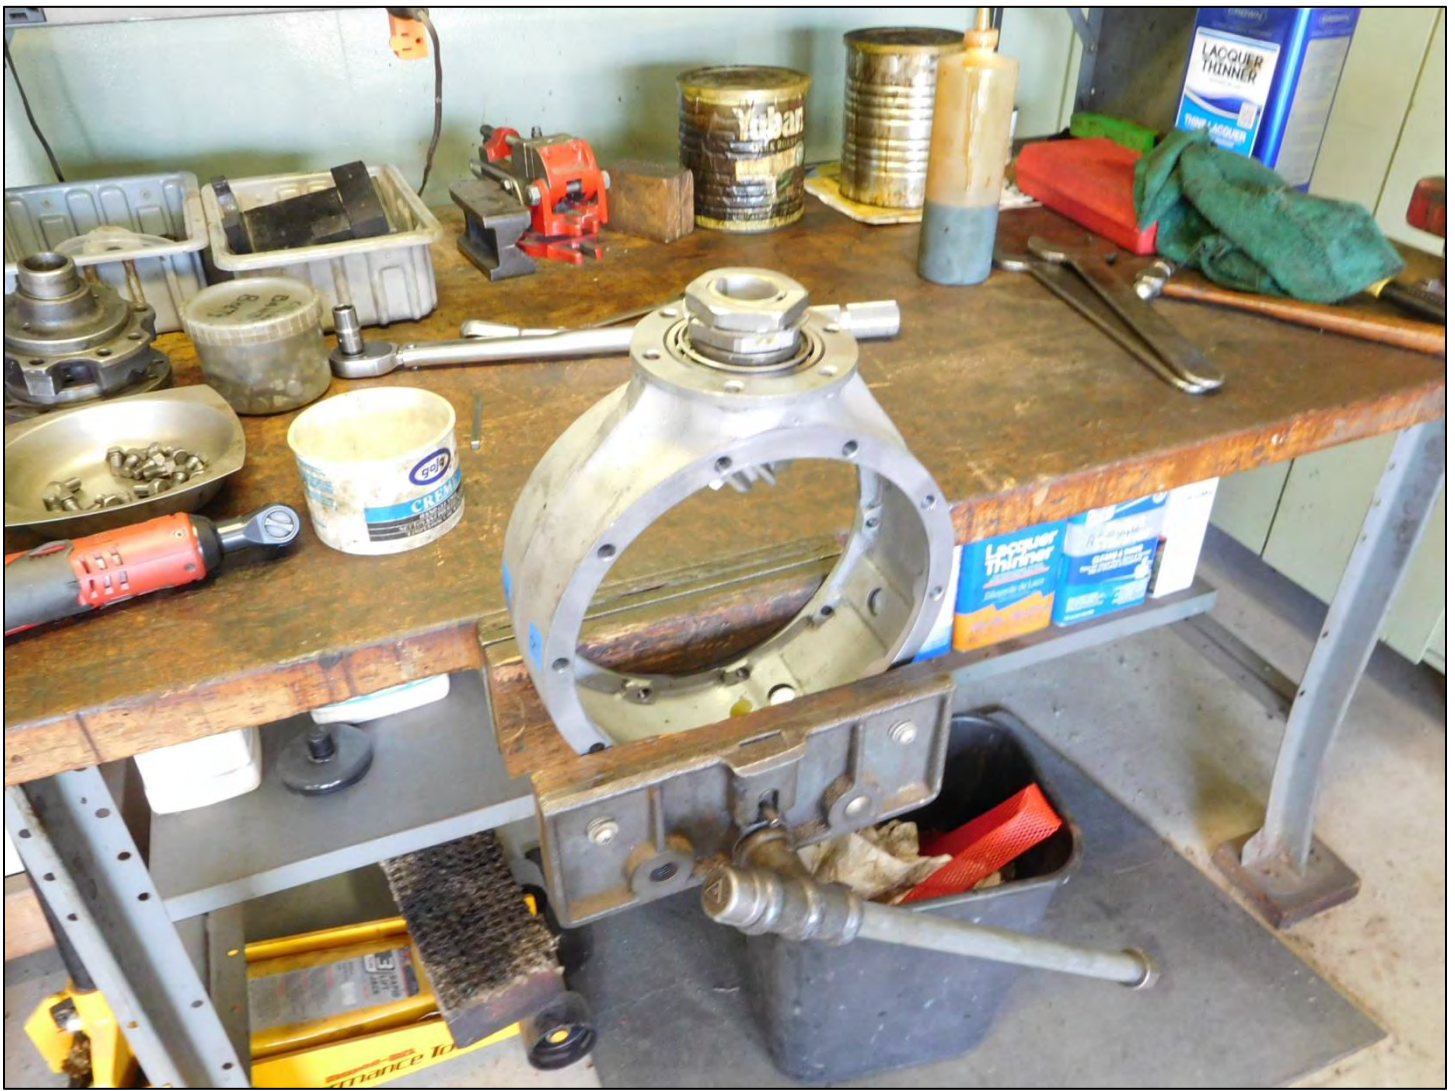
**Once the carrier pre-load is established by the selection of a quantity of banjo gaskets, the housings are disassembled and set aside. The banjo is then clamped in a wood vice and the pinion gear assembly is installed and the pre-load on those bearings is established.**

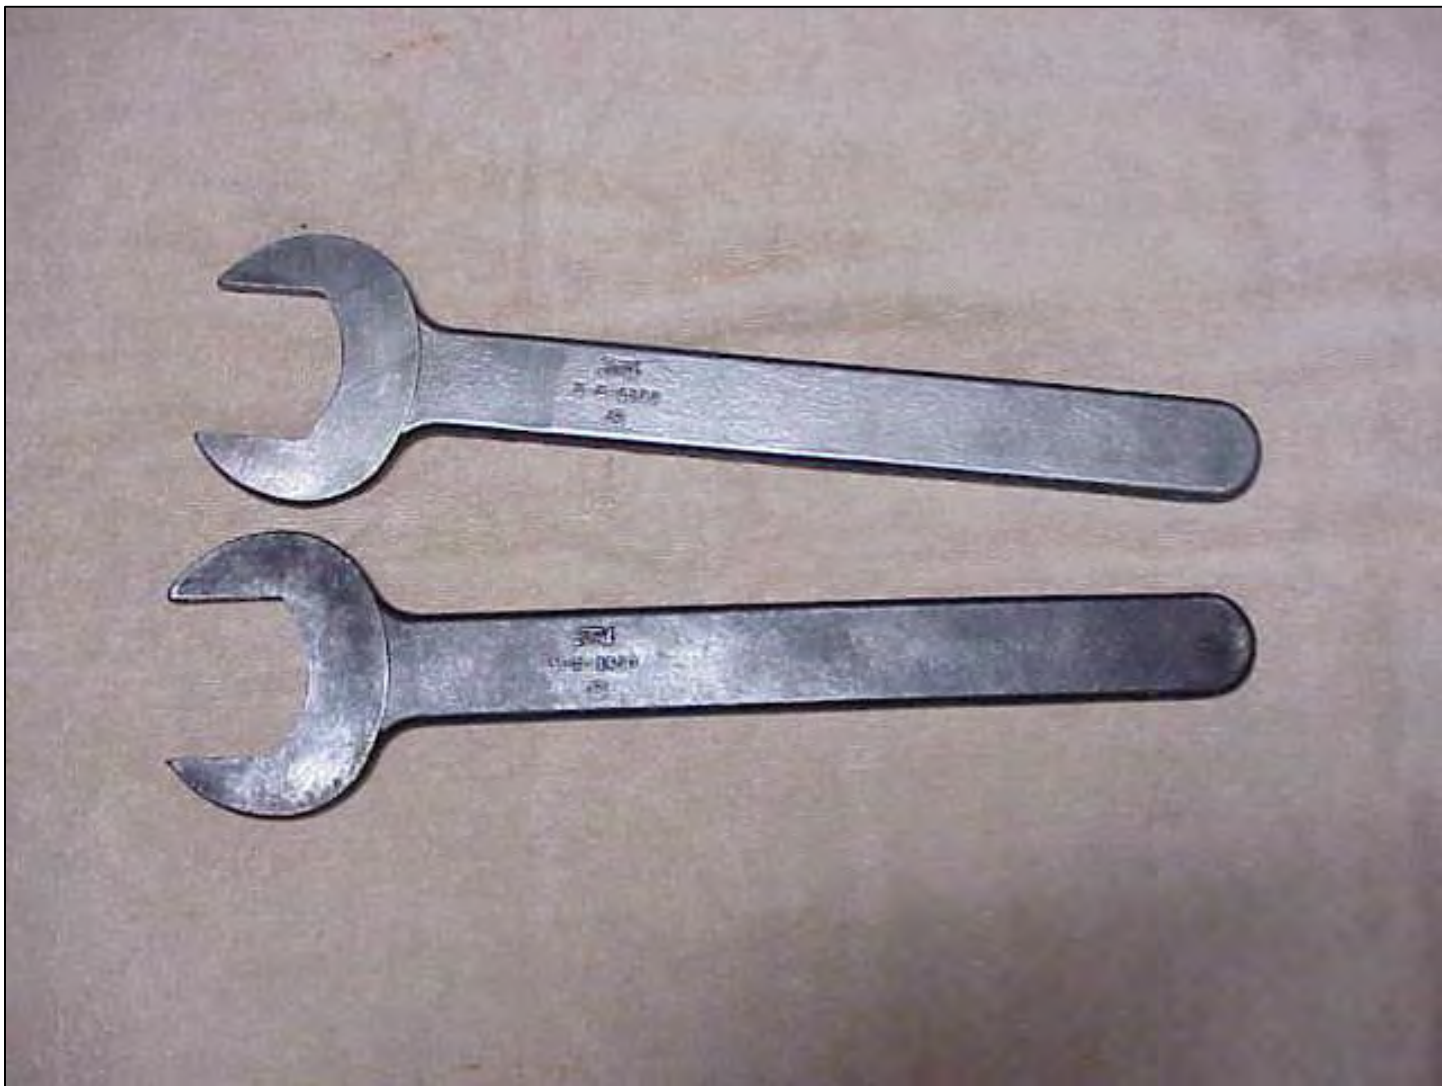
**Shown here are two Ford factory wrenches used on the two large pinion assembly nuts to establish pinion bearing pre-load and to tighten the two nuts tight against each other.**

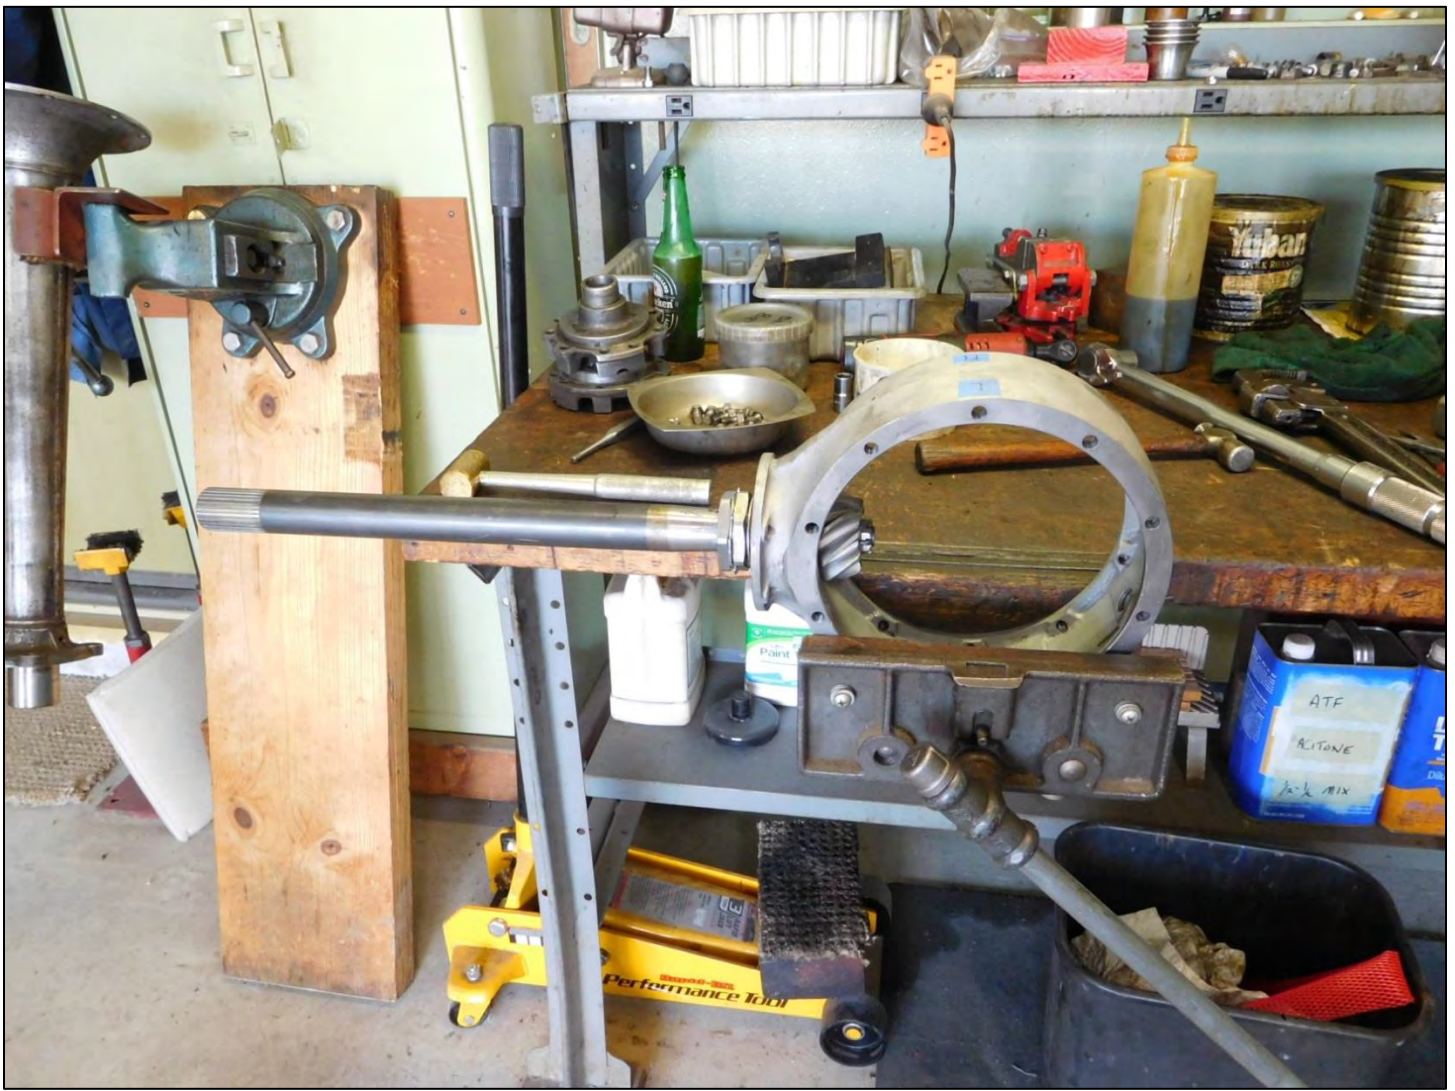
The Mithcell stub shaft, which is part of the Mitchell overdrive, is shown here insatalled in the pinion assembly. Once the stub shaft nut has been torqued to a nominal 100 ft. lbs. the pinion bearing pre-load is established by the adjustment of the two large nuts that are part of the pinon gear assembly. The first nut esablishes the pre-load, the second nut locks the first in place. This is not a straight foraward proceedure as the tightening of the second nut will often over-tighten the pre-load. The end objective is to have the pre-load correct and the two nuts extrememly tight against each other. The Ford service bullitens say to use a hammer against the Ford factory wrench for the final tightening.

The target pre-loead value is 20 inch pounds, the same as the carrier bearing pre-load; my acceptable window is between 14 and 22.

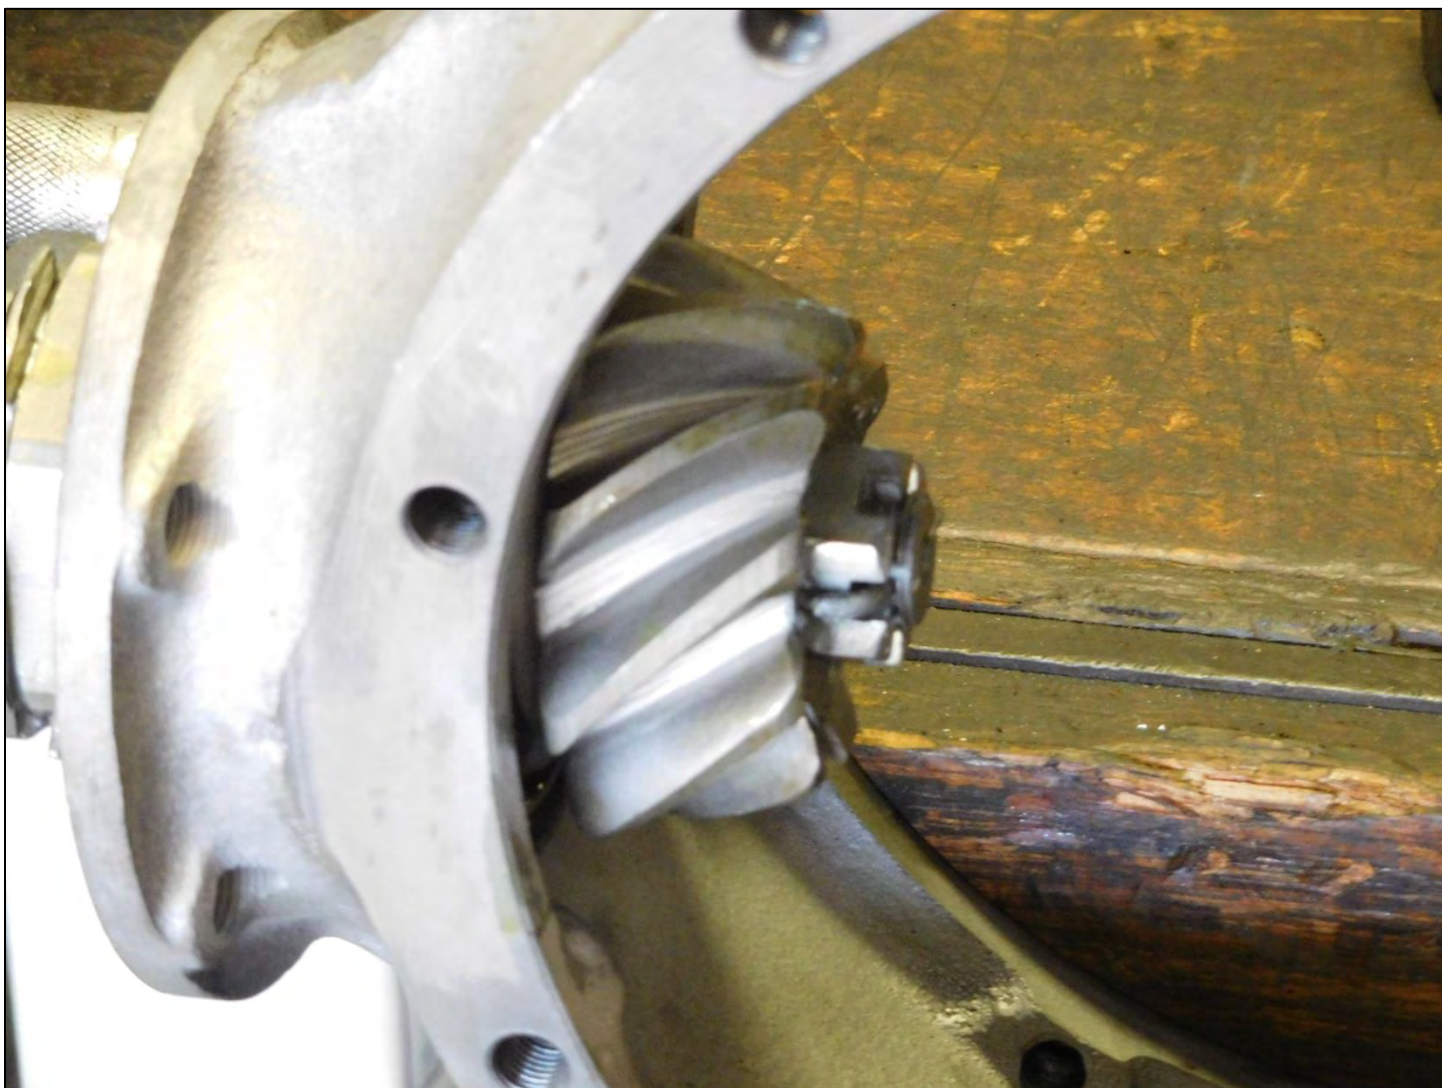
**The nut on the end the Mitchell stub shaft is torqued to a nominal 100 foot pounds before the preload on the pinion bearings is established. A cotter pin is inserted into the end of the stub shaft and the legs are bent down the side of the nut. Never bend them over the end of the shaft as they can conflict with the rotating carrier.**

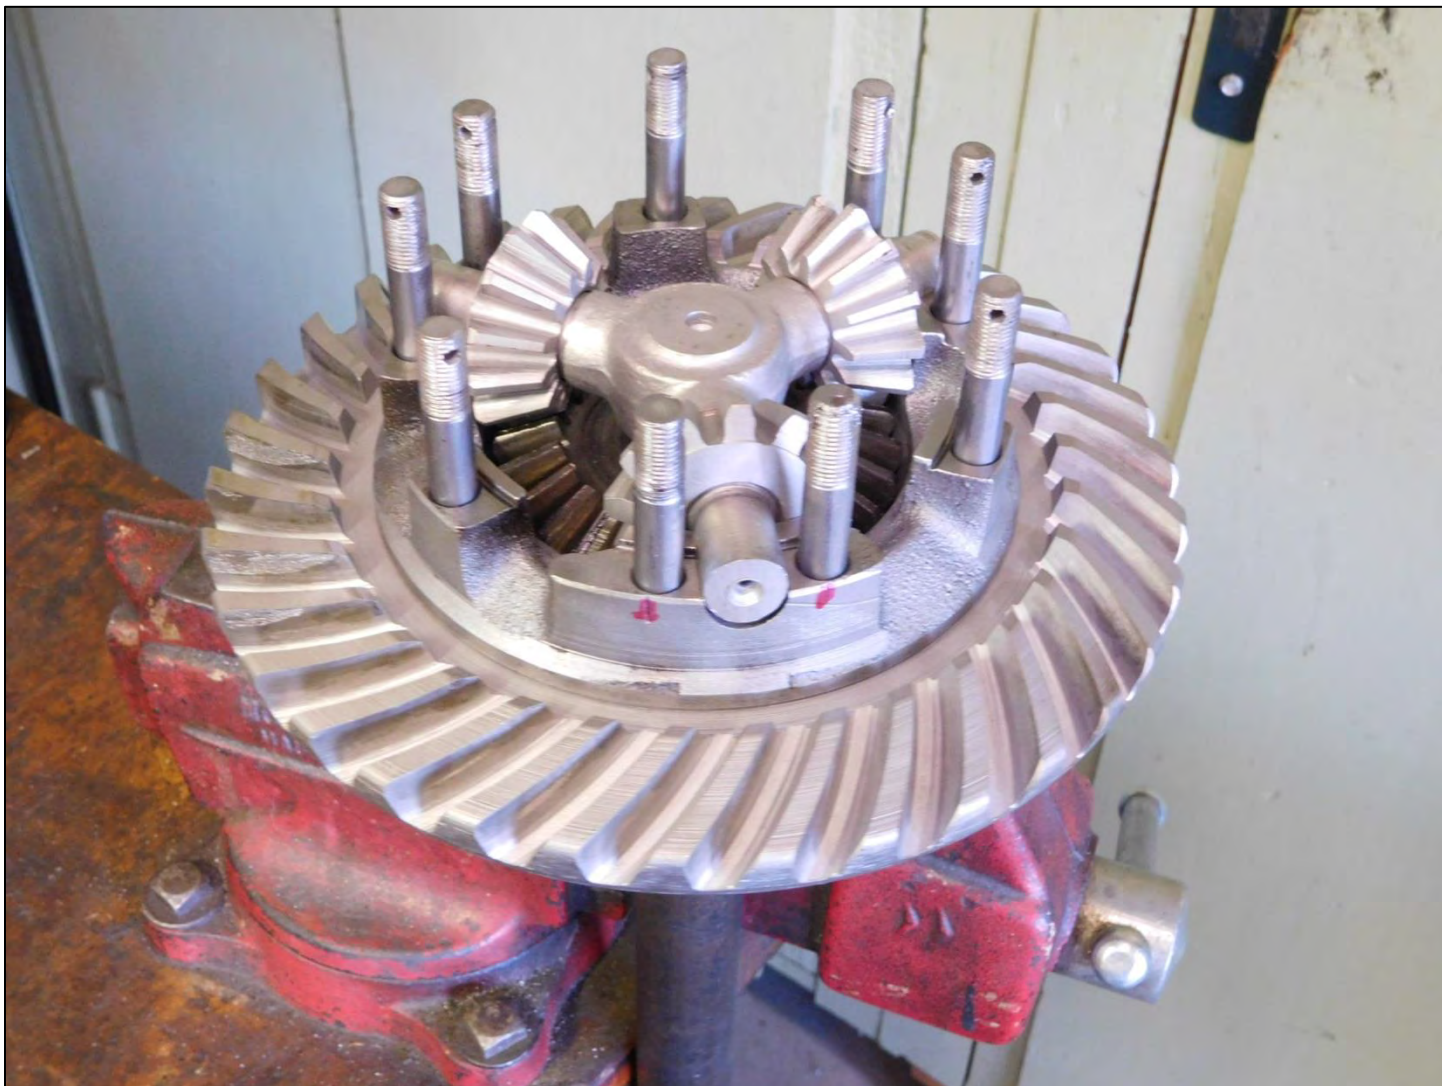
**The carrier has been taken apart and the pre-load tool removed. Shown here is one of the axle shafts installed in the left carrier half. The spider gear assembly has been installed. The right carrier half will be installed, along with the other axle shaft, over the extended carrier bolts. The two carrier halves will be lined up with the red reference marks that were applied when the carrier was initially disassembled.**

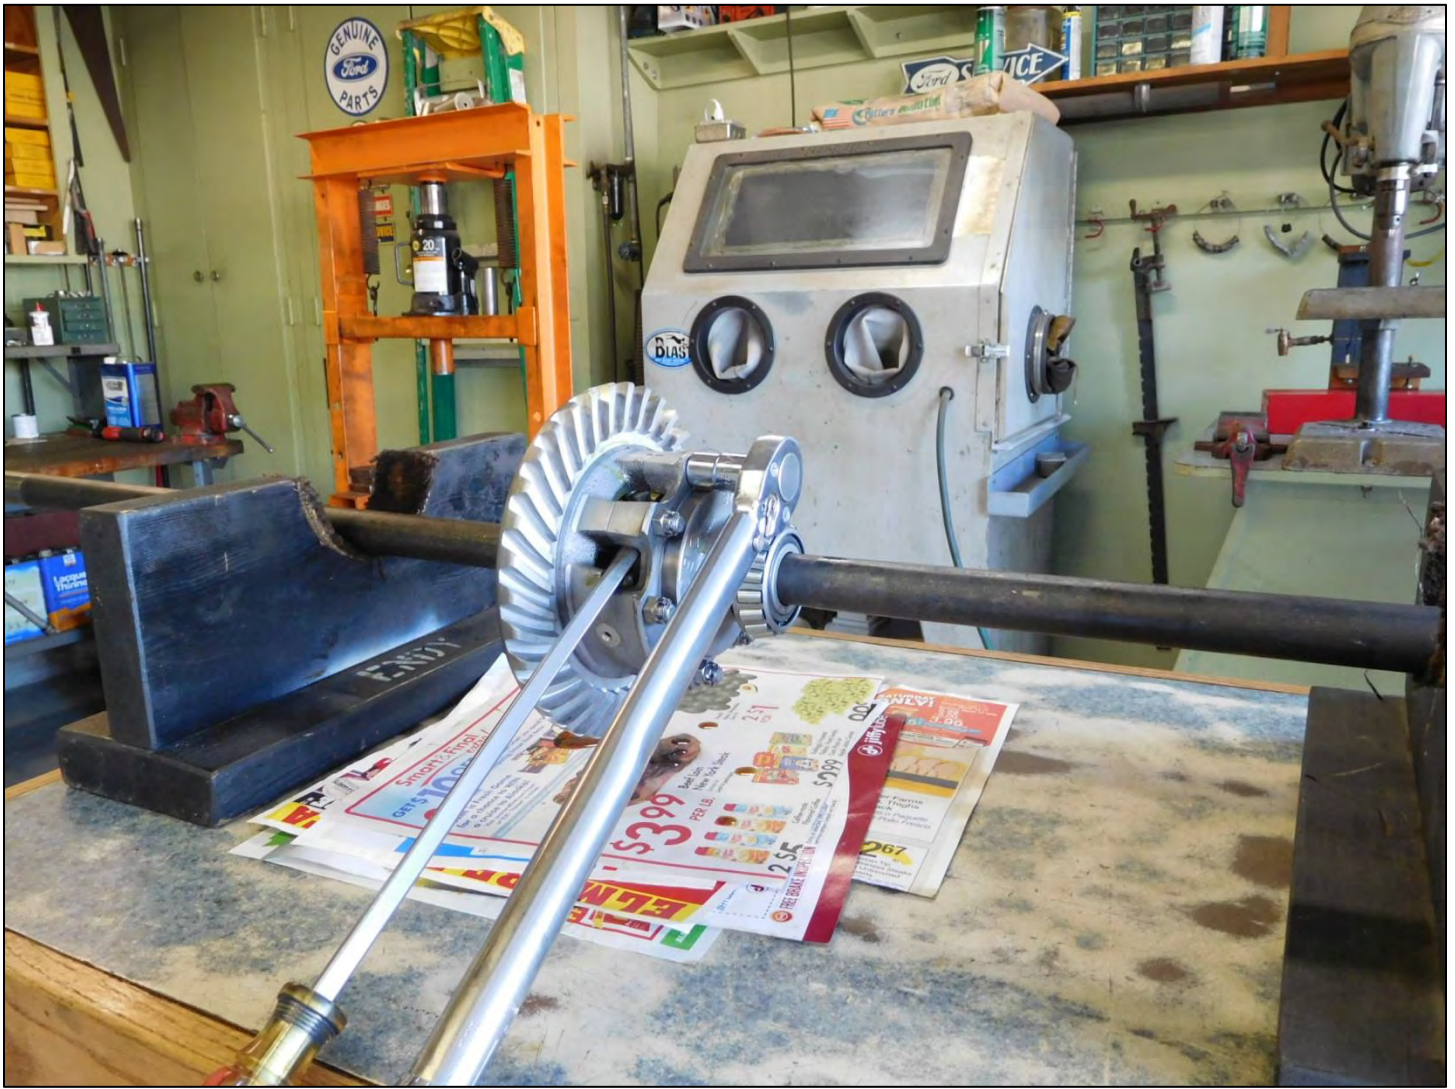
**The carrier has been fully assembled with both axles and is shown here with the nine carrier bolts being torqued to 35 ft. lbs. To facilitate the torquing the carrier is held in place with a large screwdriver placed into an opening in the side of the carrier.**

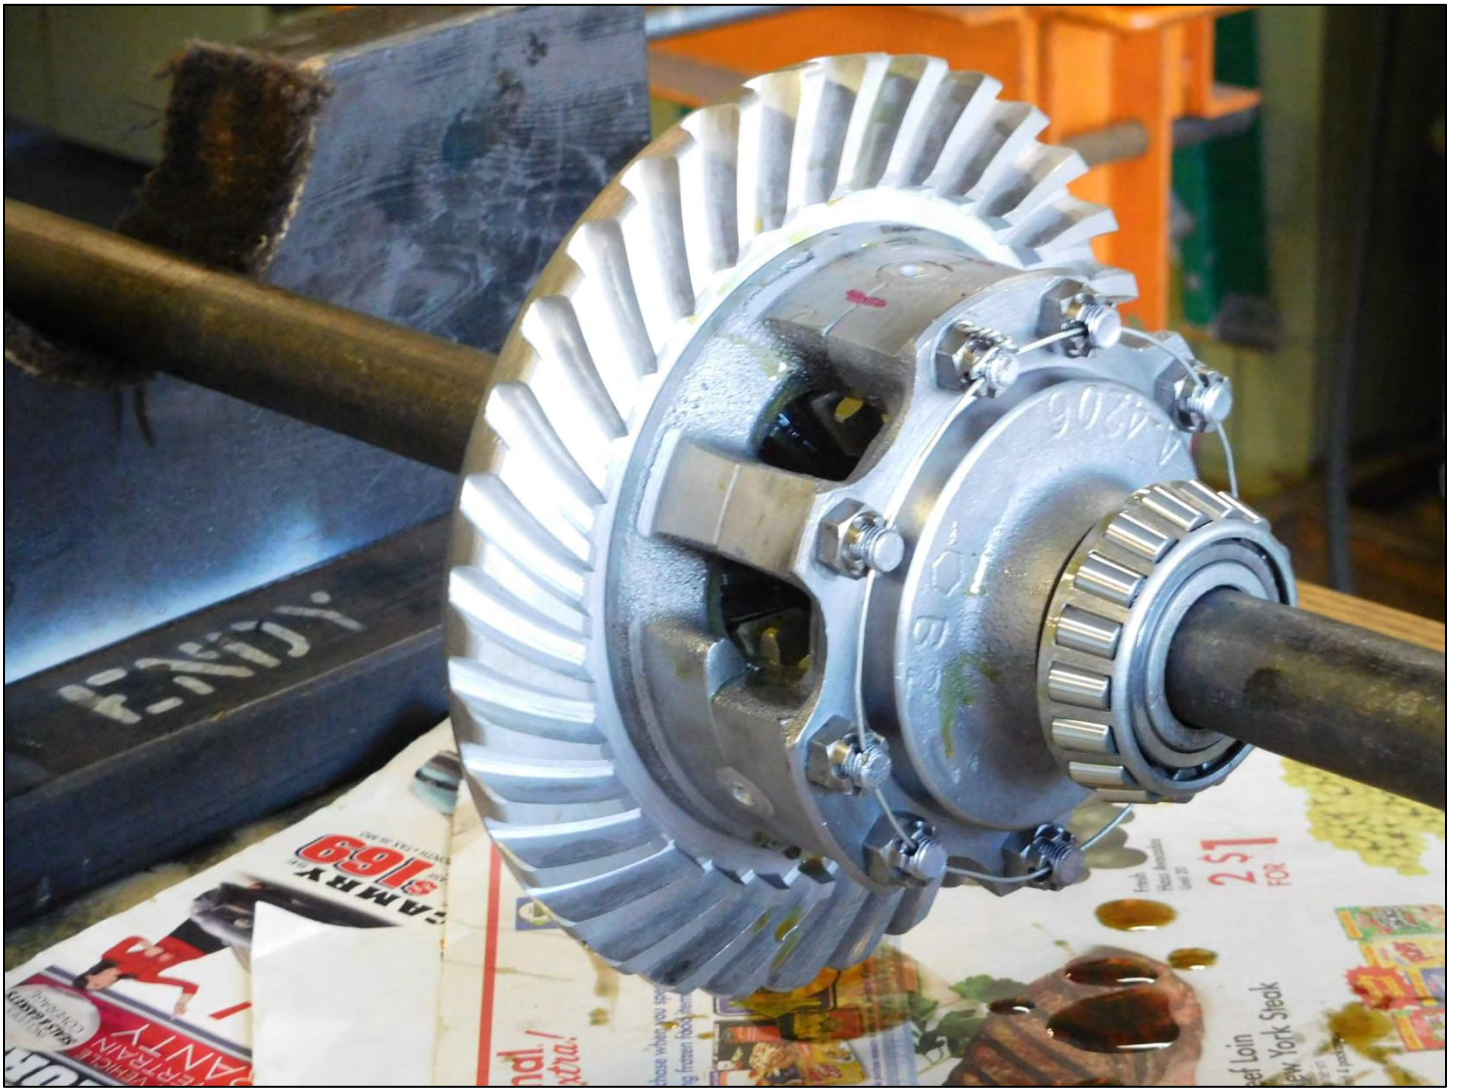
Once the nine bolts have been torqued they are secured with safety wire. Shown here is my trademark style of safety wiring in a perfect circle.
