# Differential Overhaul May 9, 2019 (LB)

by Tom Endy

This rear axle assembly overhaul project arrived in the back of a pick-up truck and will receive a Mitchell overdrive during the overhaul process. In addition, the transmission and bell housing from the project car were also brought and will be overhauled/restored. The project car is a 1929 Tudor. The owner is a member of the Santa Anita A's of Arcadia, California.

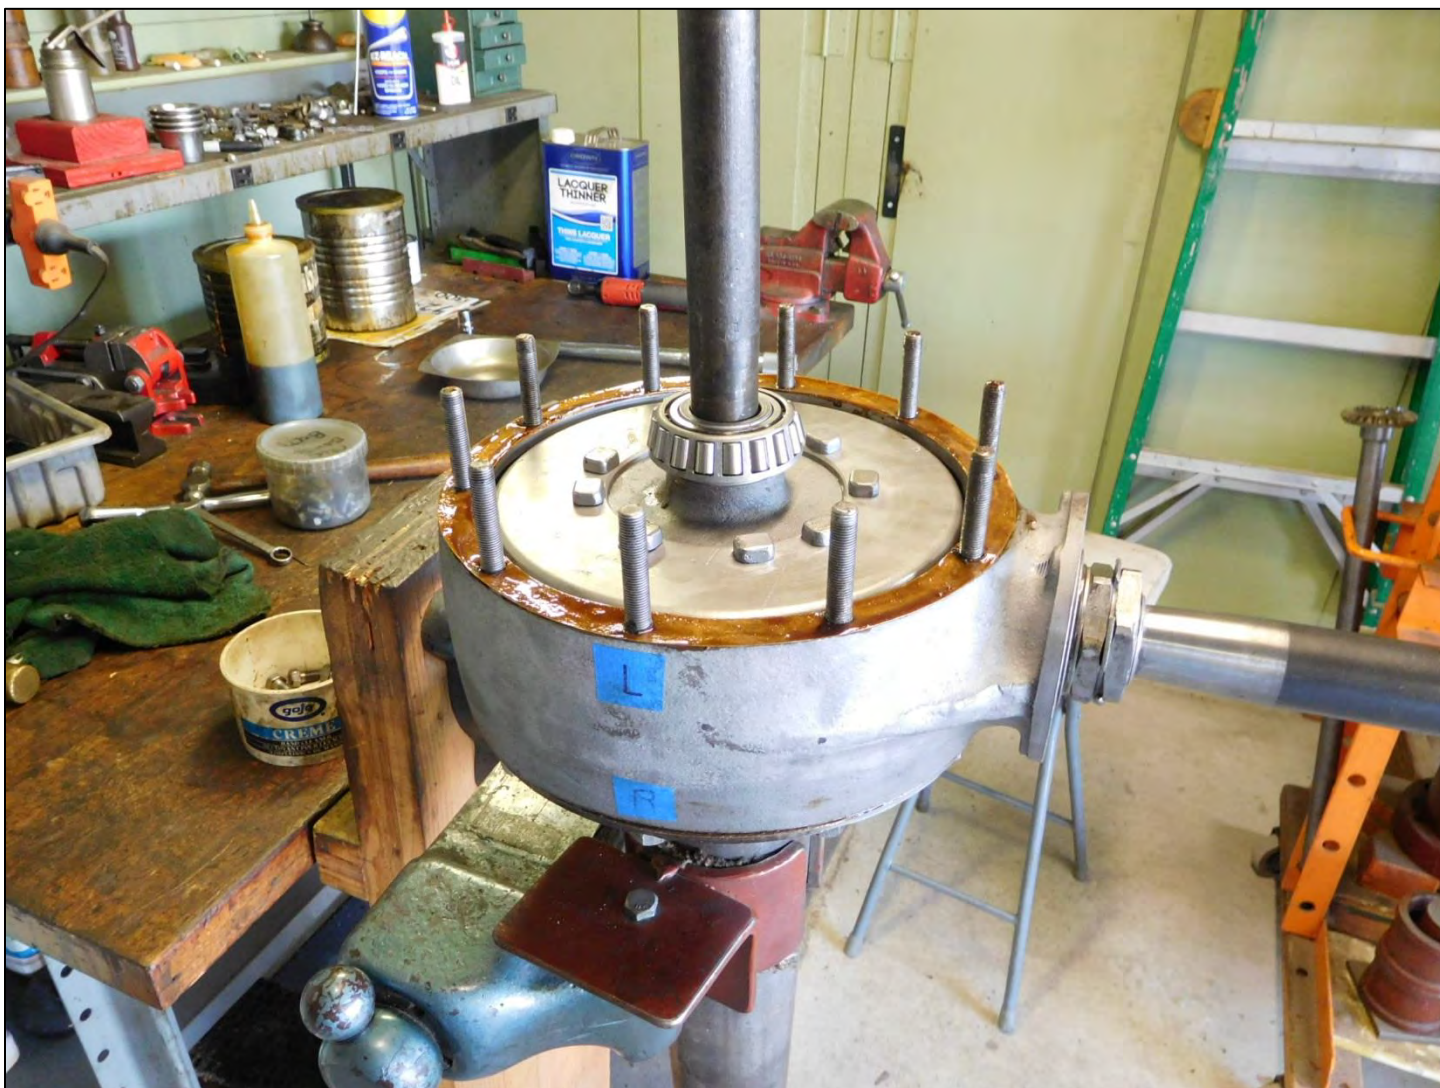
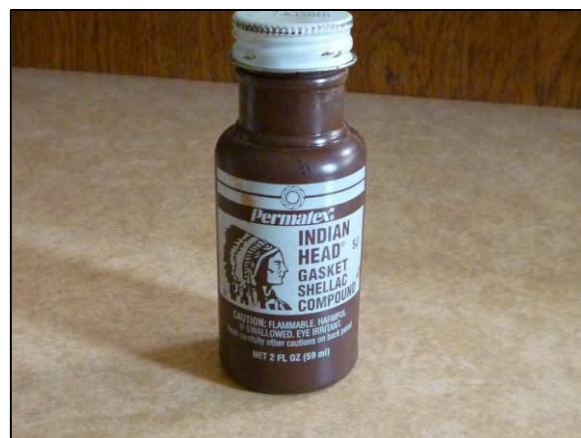
The carrier assembly has been inserted down into the right axle housing. The pre-determined banjo gaskets were previously installed on the right side. Seen here are the banjo gaskets for the left side. They have been coated with sealer and are ready for the left axle housing to be installed down over the 10 alignment studs screwed into the left side of the banjo.

The sealer used is Indian head gasket sealer.

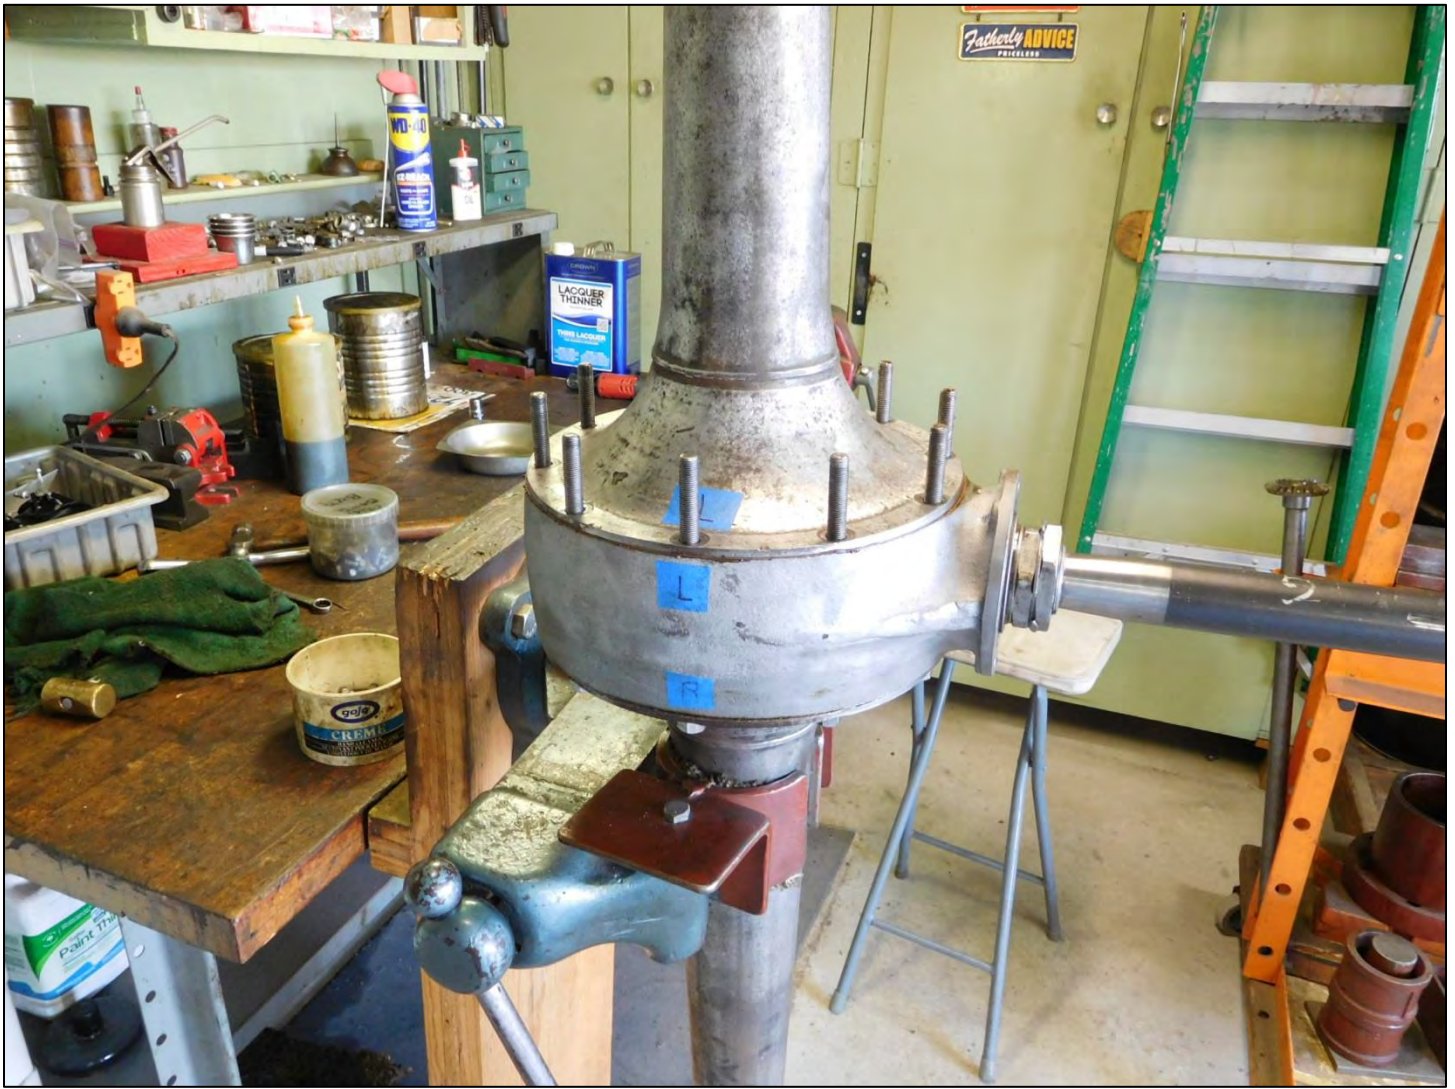
**The left axle housing has been placed down over the ten alignment studs screwed into the left side of the banjo.**

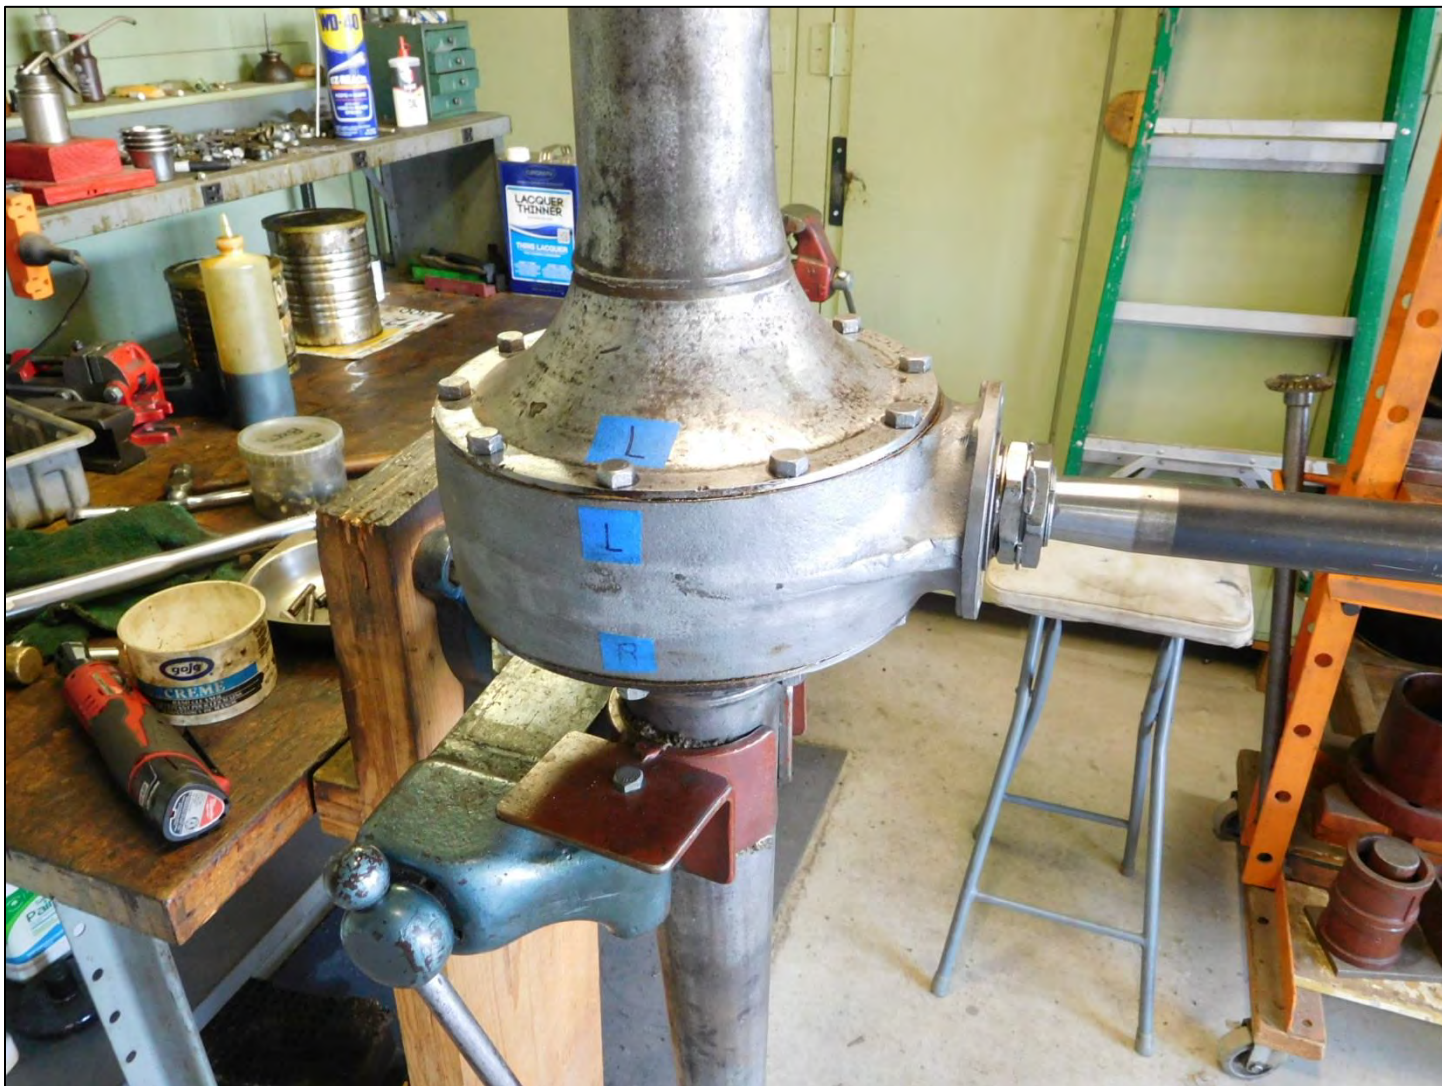
**The ten axle housing bolts have been installed and torqued to 35 ft. lbs.**

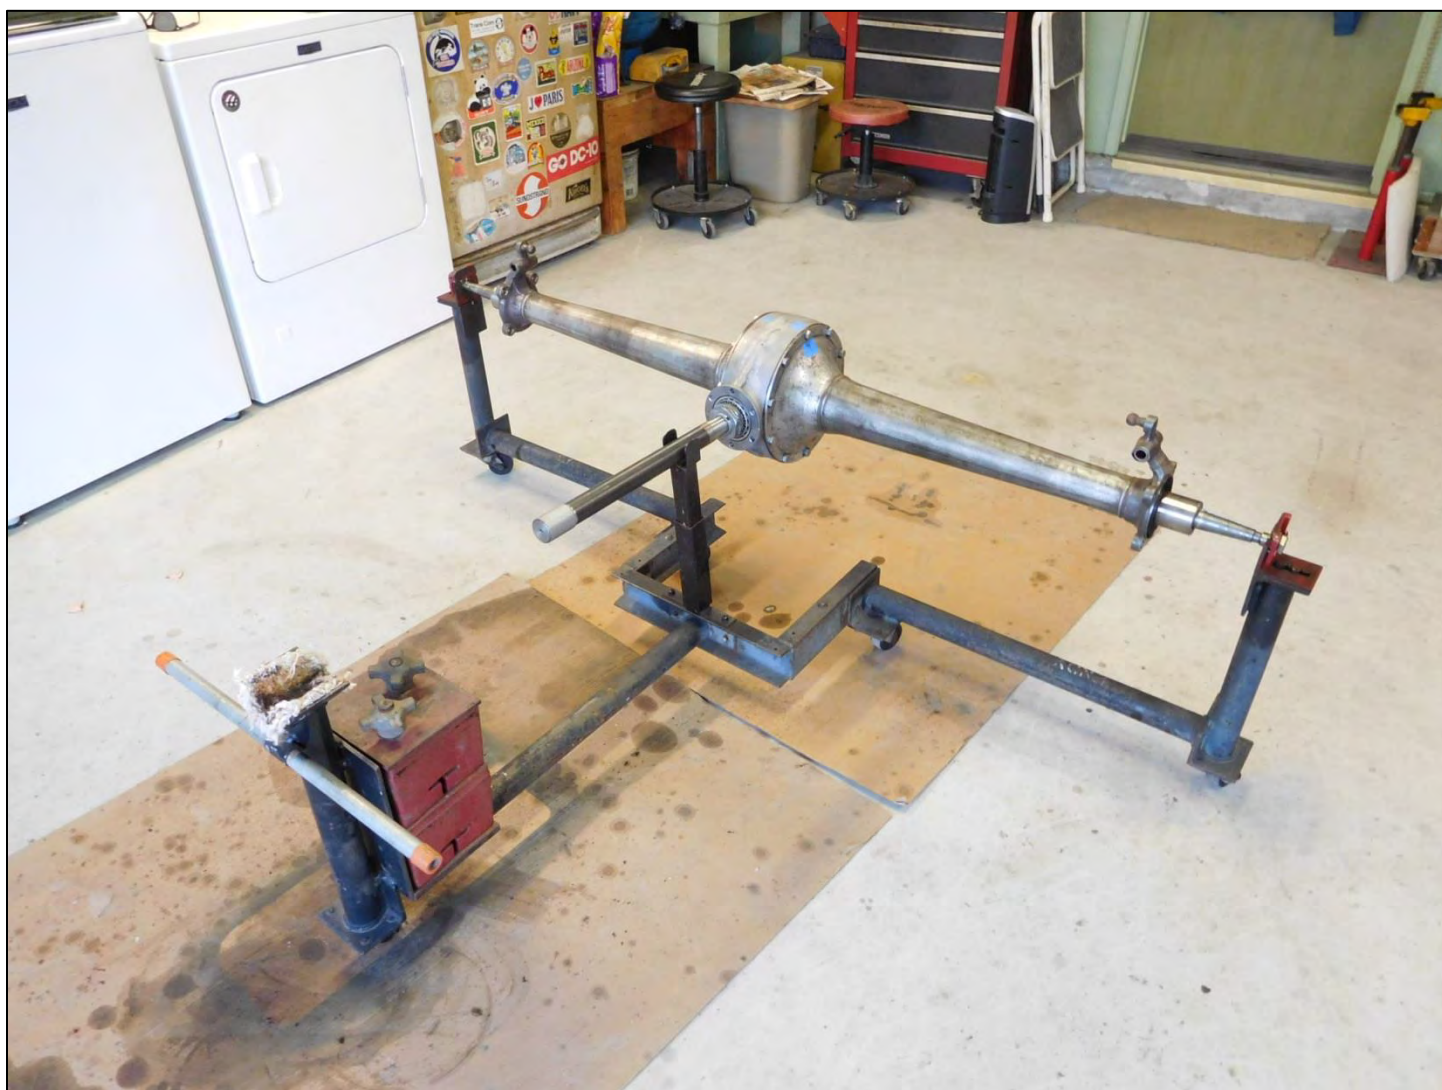
**The assembly of the rear axle assembly is complete and it has been moved back into the roll around cradle. The next step is to mask off the machined surfaces and paint it with black enamel.**

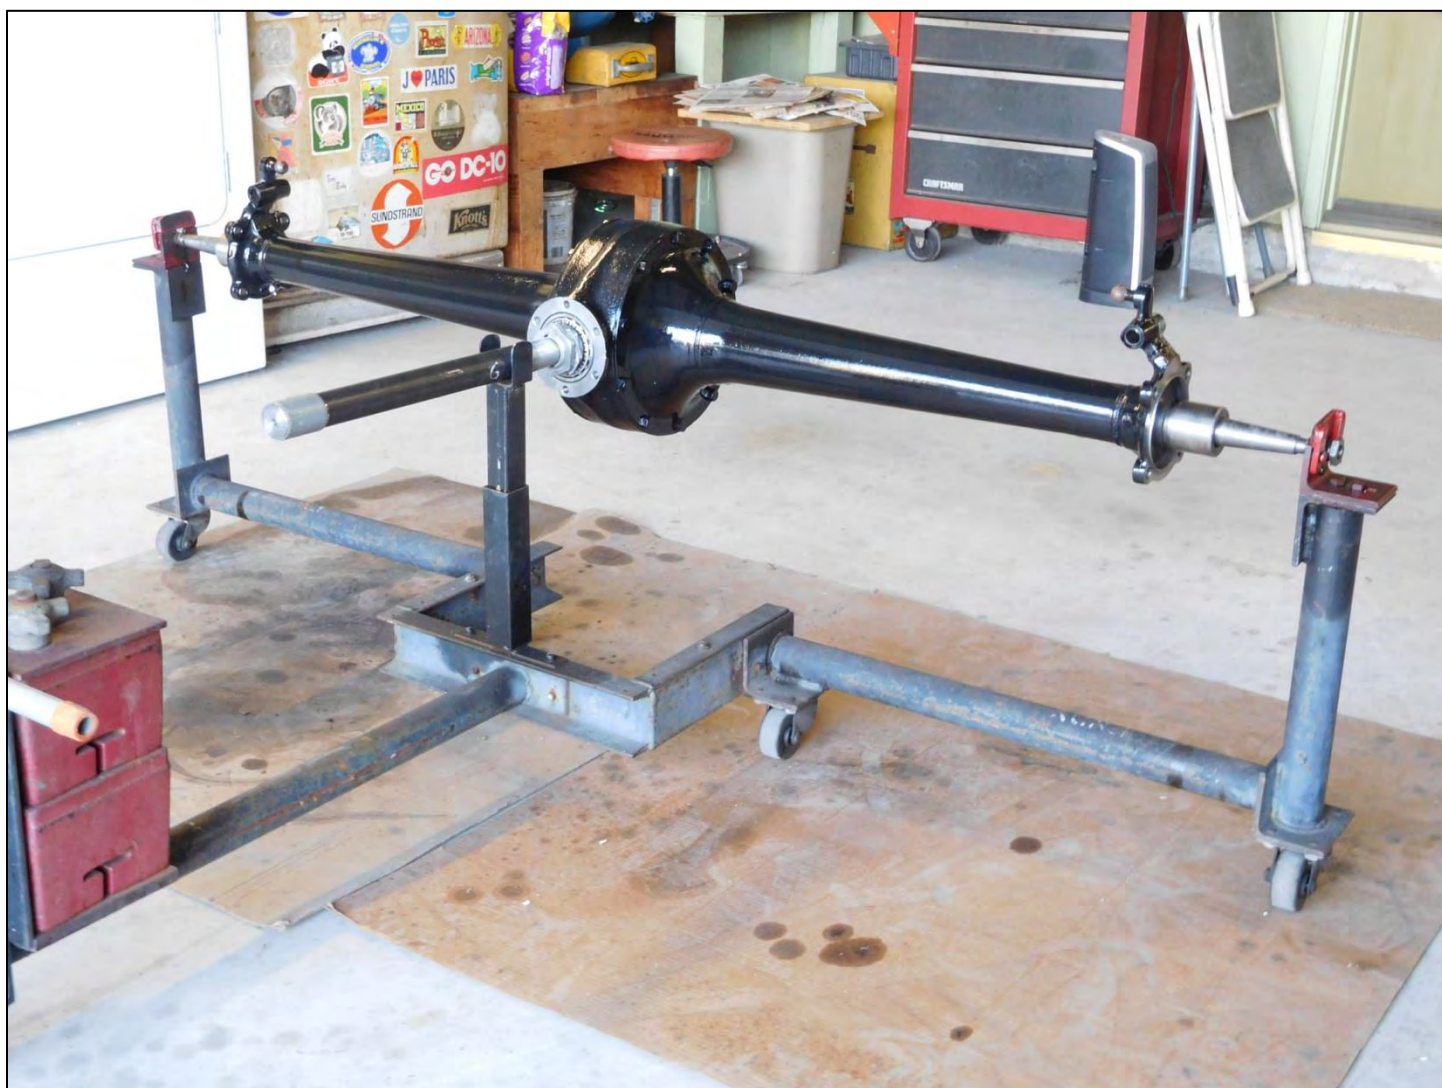
**The rear axle assembly has been painted and it will be stored away awaiting the delivery of the Mitchell overdrive. When it arrives, it is an easy task to slide the overdrive on over the stub shaft and install the six securing bolts to the banjo flange.**

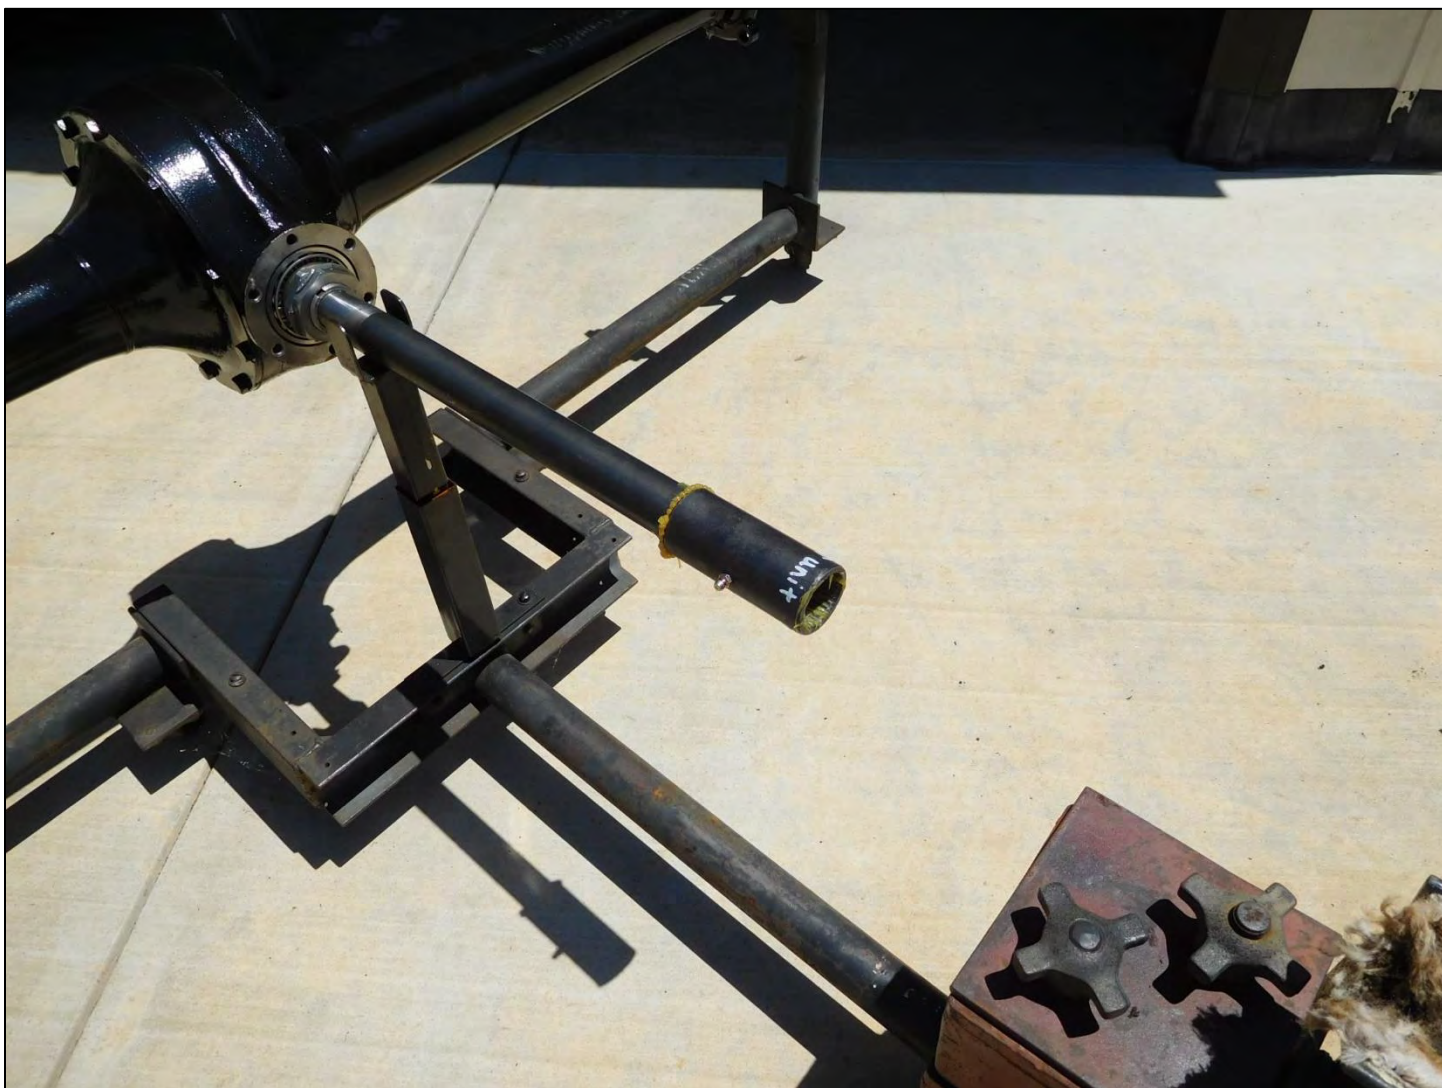
**The spline coupler has been greased and installed on the stub shaft. The other end of the coupler will slide onto a mating shaft inside the overdrive.**

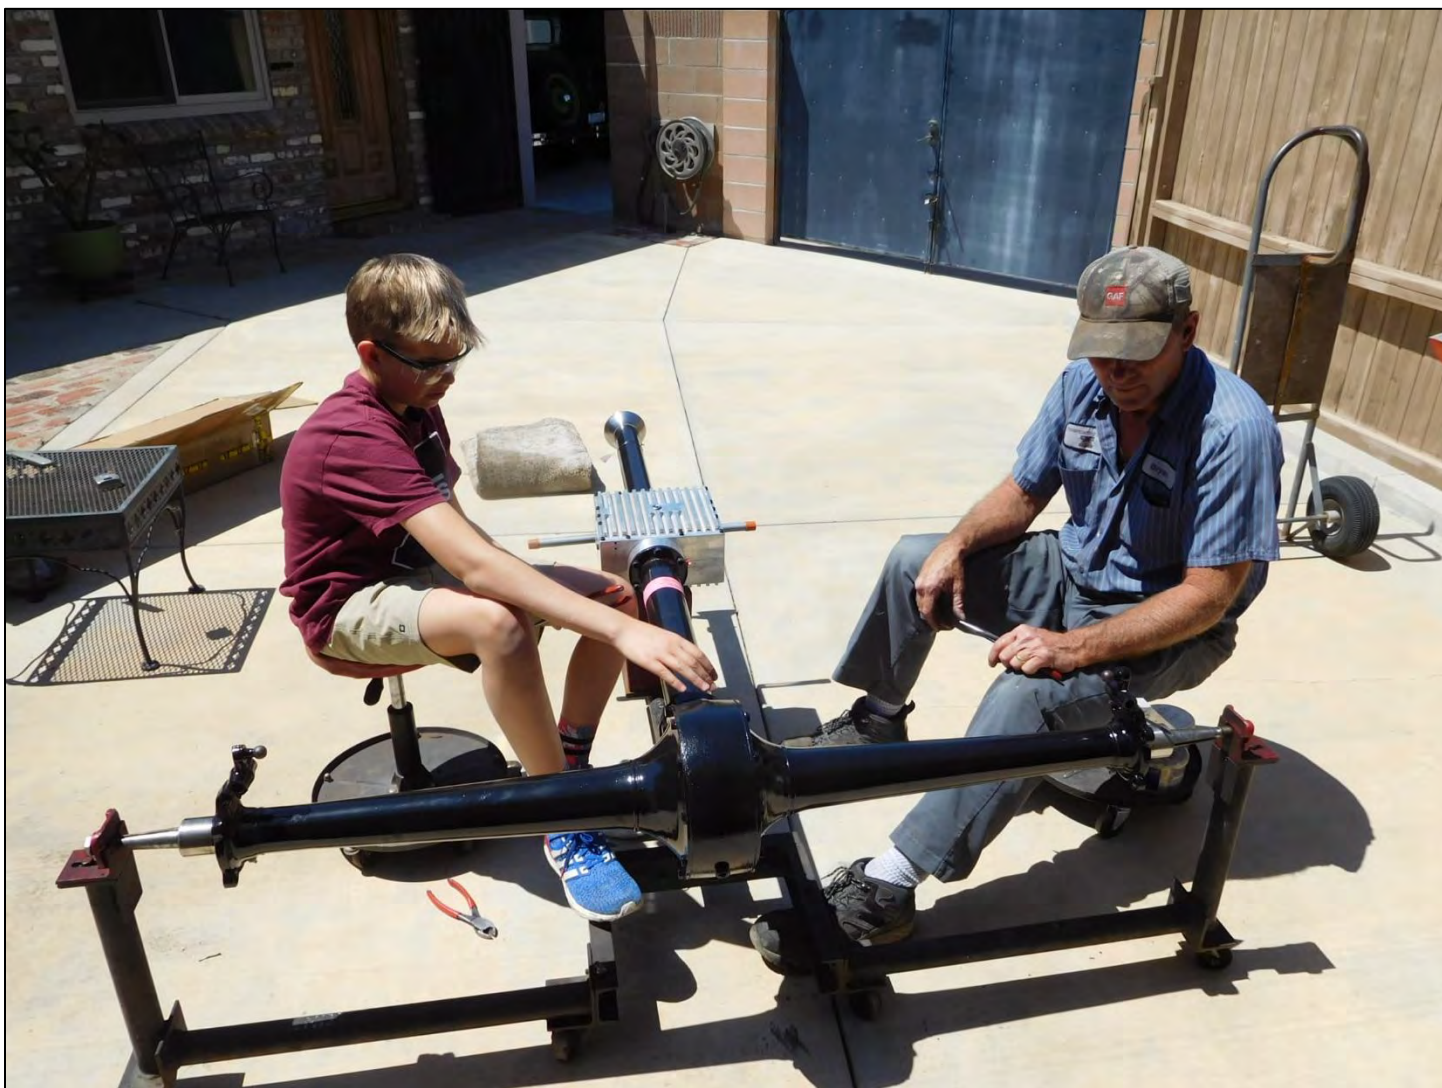
**Ben and Bryan have installed the overdrive onto the rear axle assembly.**

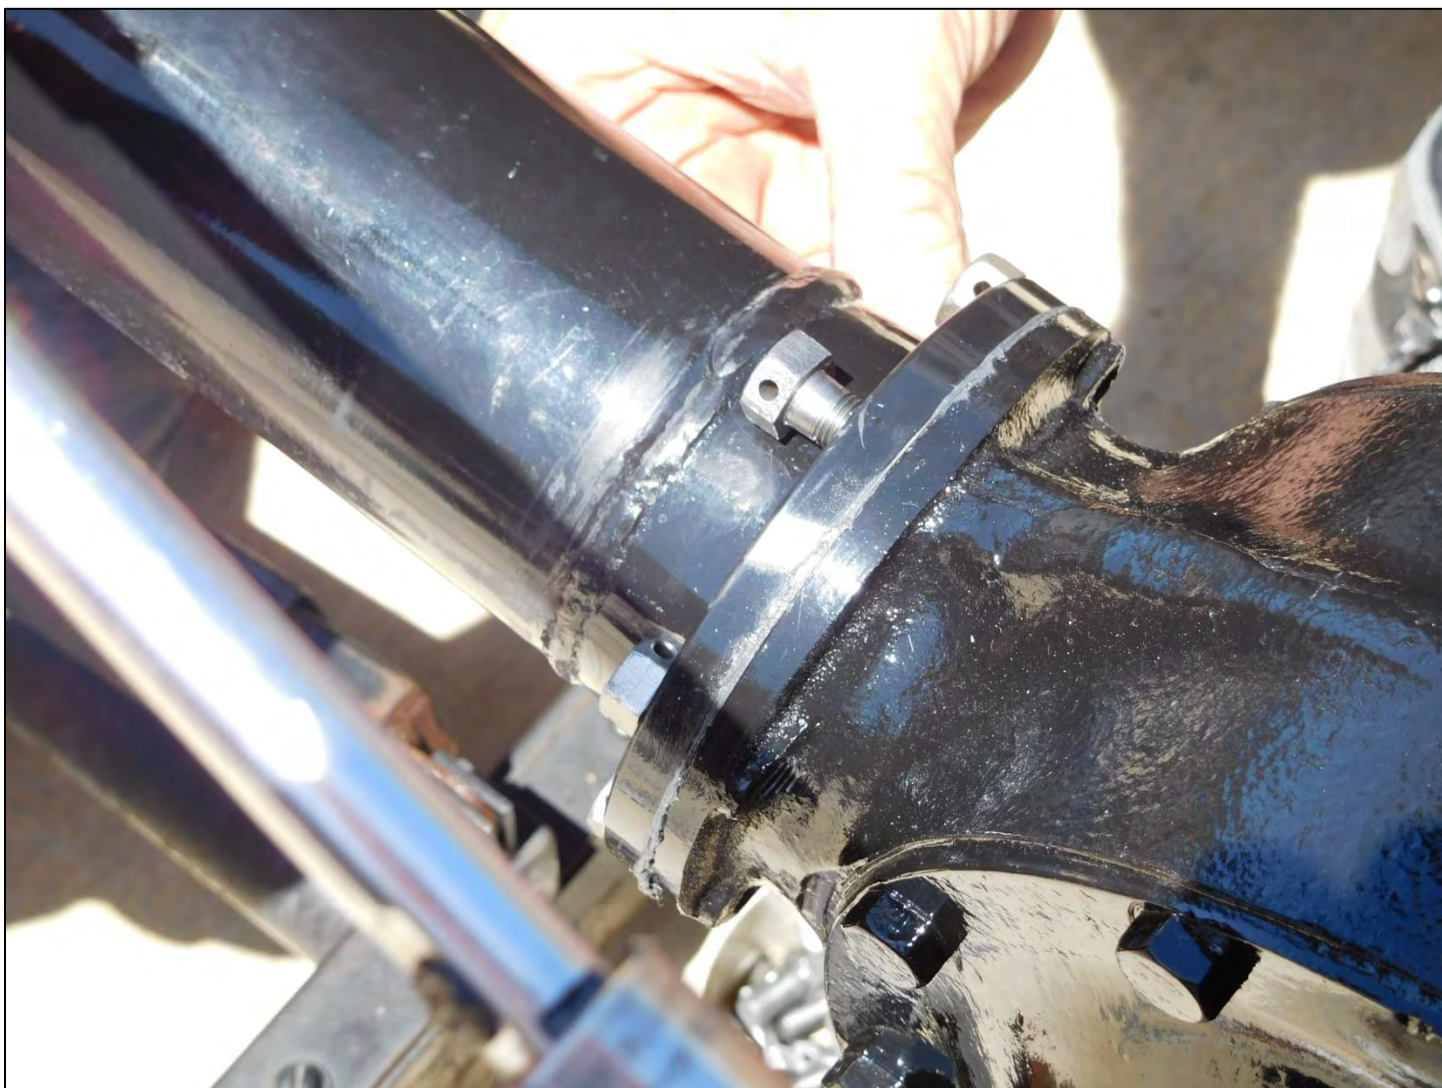
**The six mounting bolts secure the overdrive to the banjo and are safety wired.**

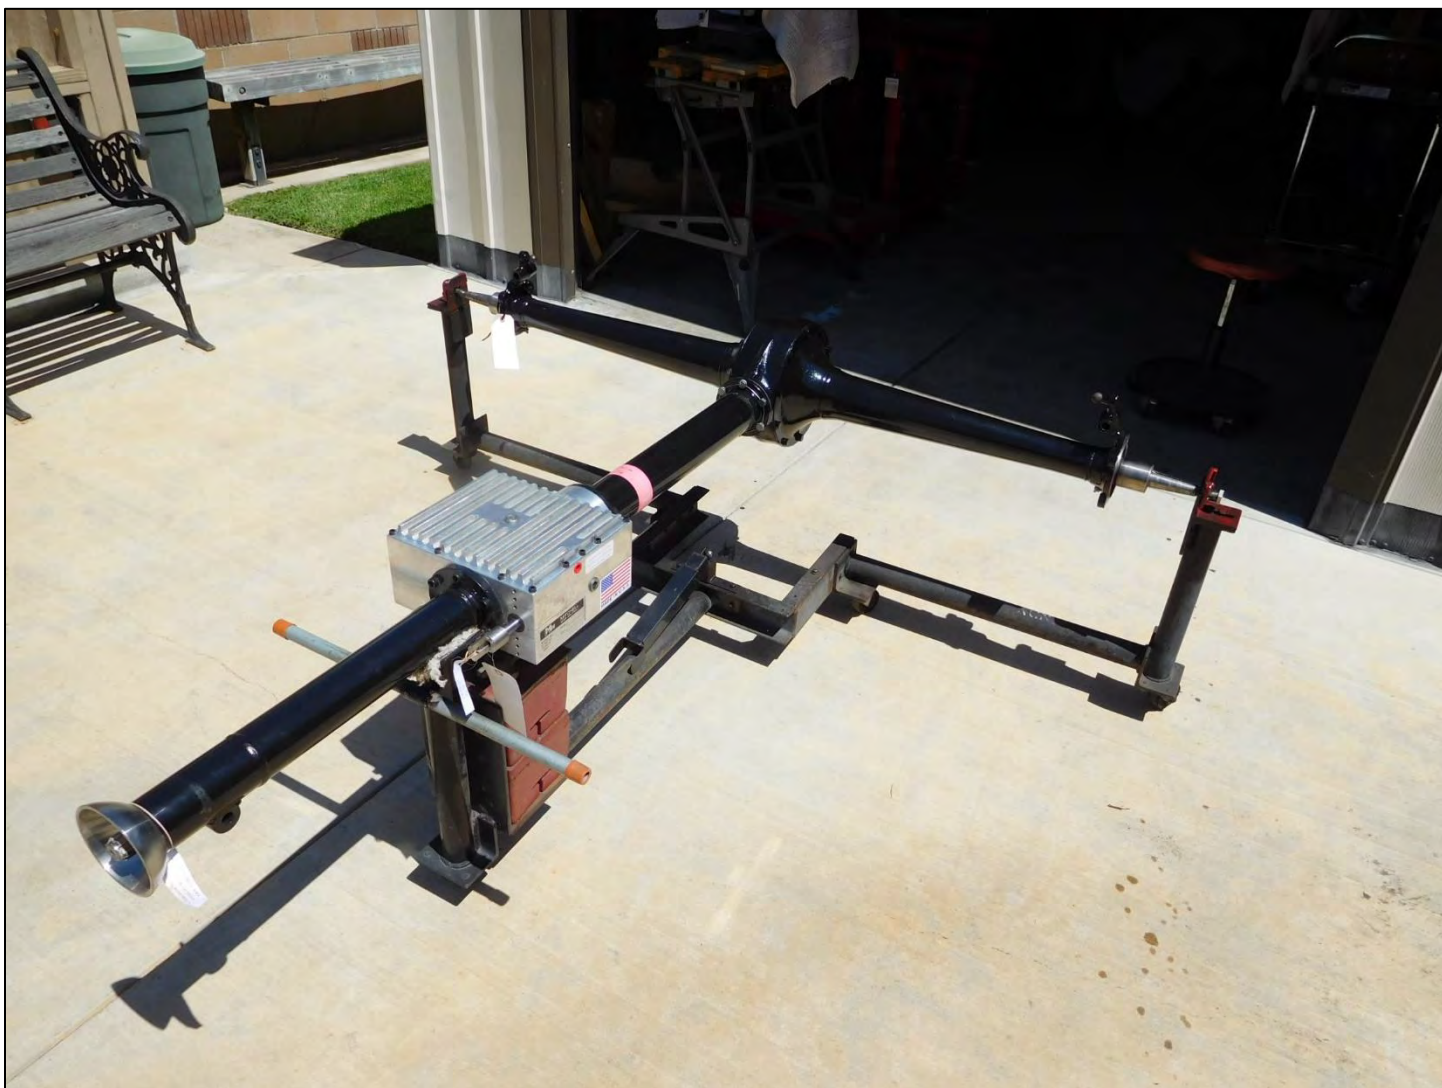
**The overdrive and the rear axle assembly are fully assembled and the unit is ready for installation into the car.**

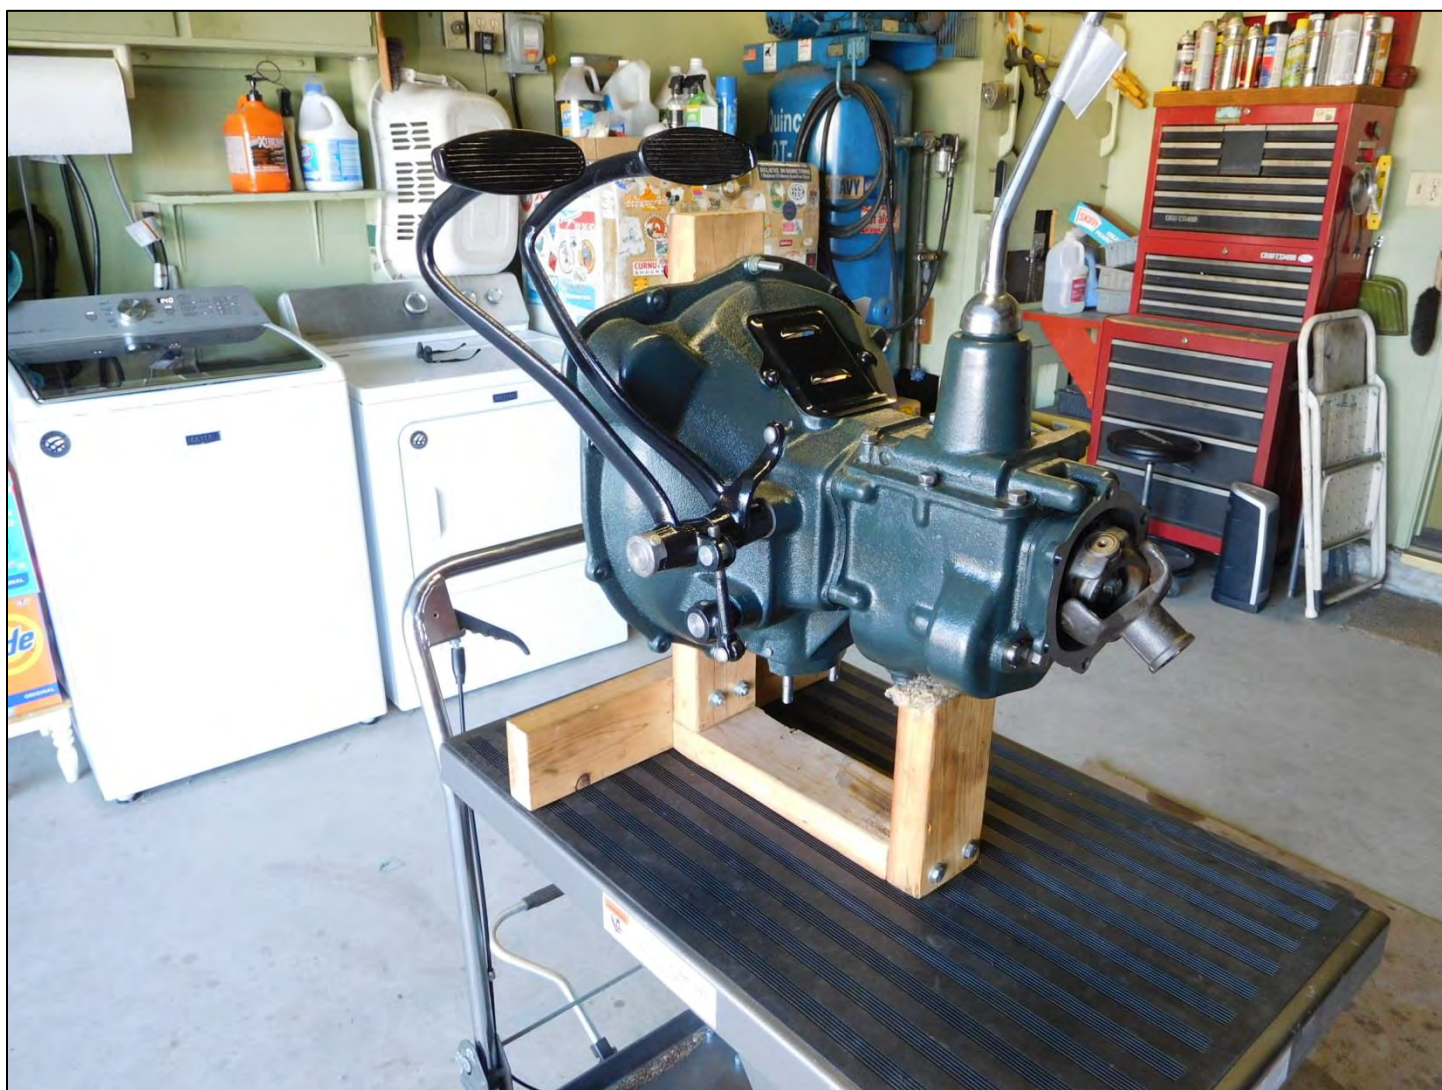
**The transmission and bell housing were also overhauled.**

**The bell housing was degreased, bead blasted and painted. The clutch shaft and pedal shaft were replaced. New bushings were installed.**

**The transmission housing was degreased, bead blasted, and painted. The gears were found to be in good condition and were degreased and bead blasted. The input shaft was found to have a deep groove worn into the nose where it inserts into the flywheel bearing. The shaft was exchanged for one that has had the nose machined and a sleeve pressed on. All five bearings were replaced with new; the two ball bearings incorporate oil seals. The cluster shaft and the reverse idler shaft were replaced with new that are modified with O-rings for oil control. A new throw-out bearing was installed.**

**Both pedals were bead blasted and painted. New bushings were installed. A new trunnion nut was installed in the clutch pedal.**

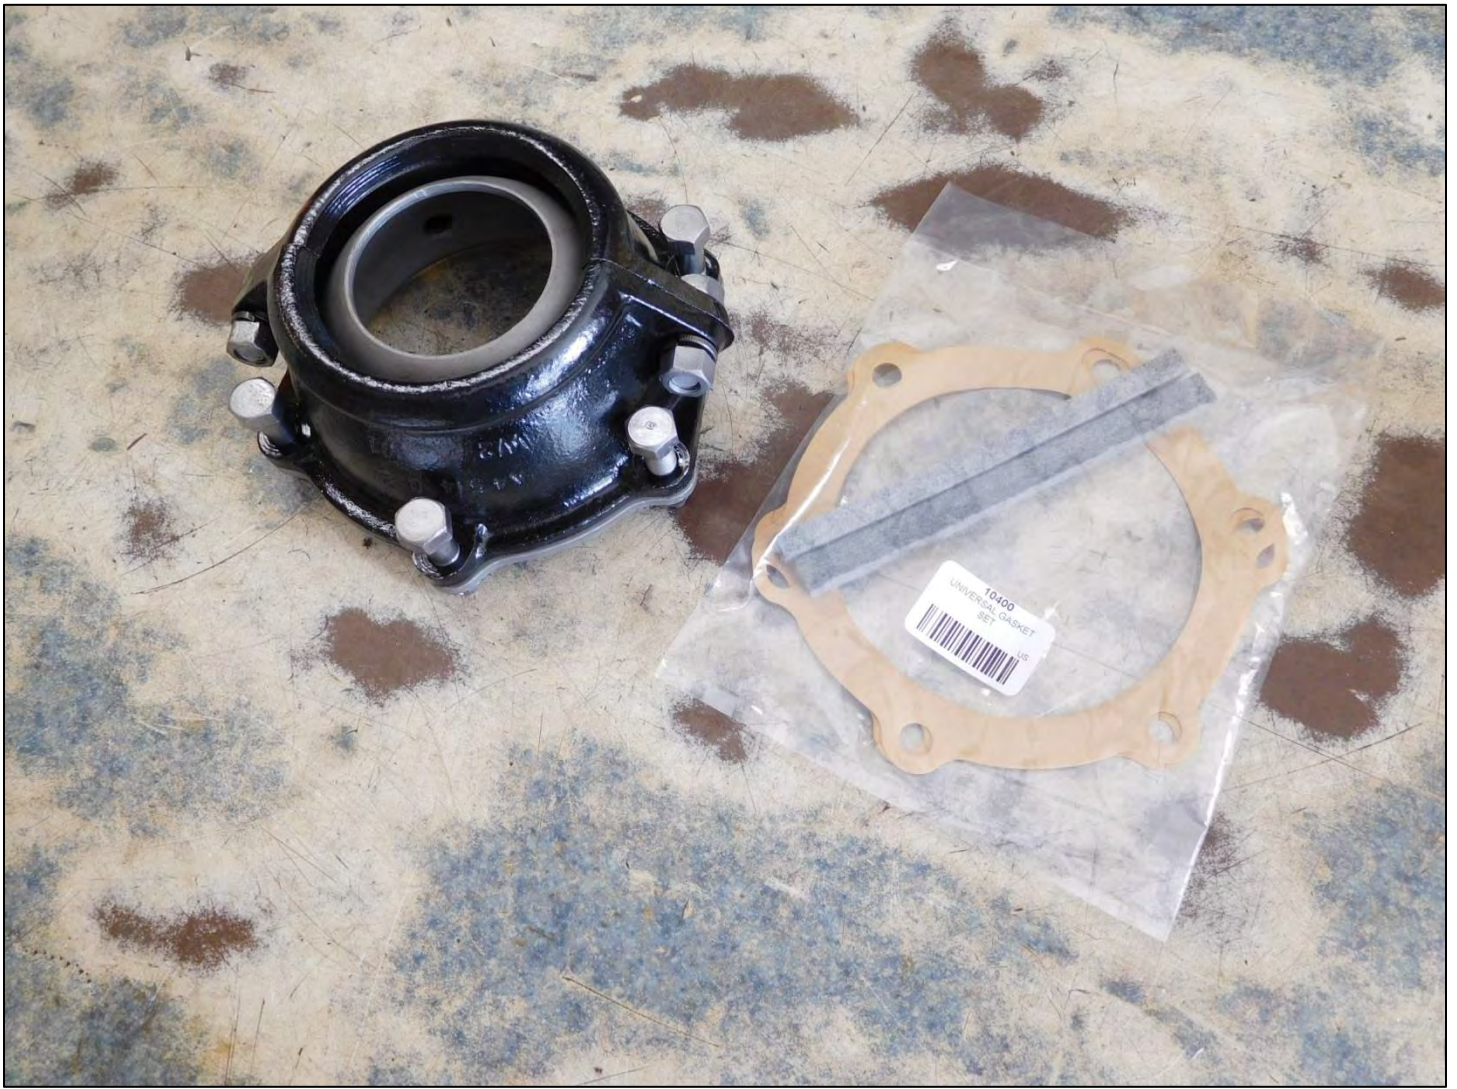
**The U-joint housing assembly has been bead blasted and painted and is ready for installation.**
