# Differential Overhaul August 27, 2019

by Tom Endy

Another early 1932 rear axle assembly has arrived for overhaul and the installation of a 354:1 ring and pinion gear set. This one is out of a 1932 model B car with a four-cylinder engine. It is seen here ready for disassembly.

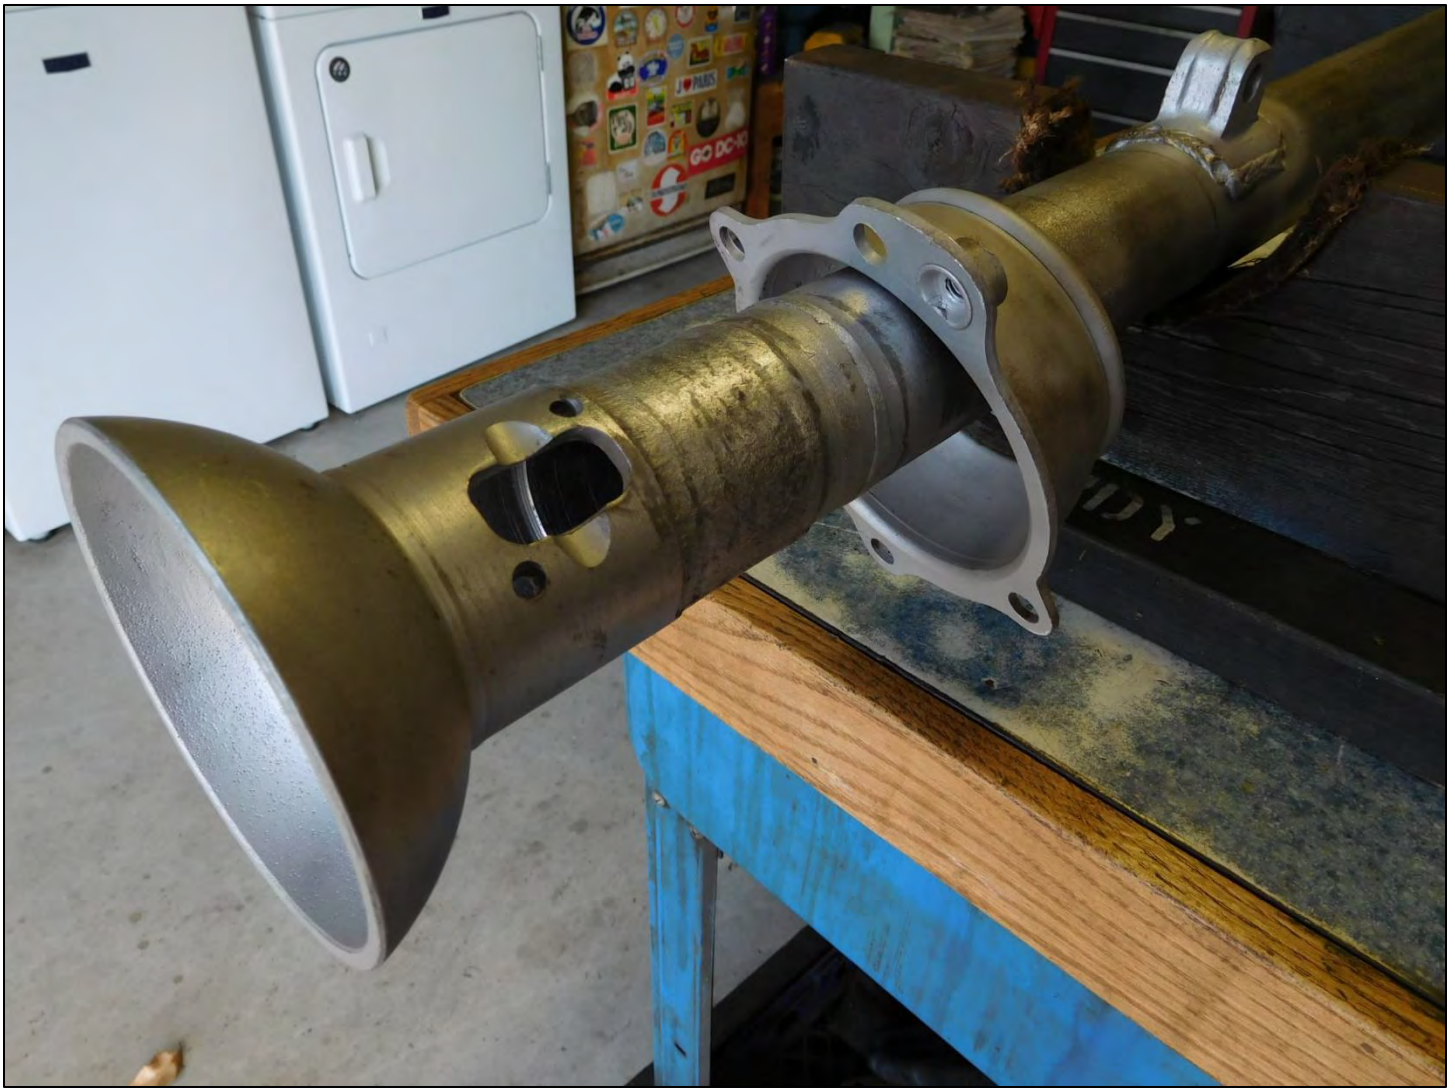
**The torque tube has been cleaned up? The front end was put in the bead blaster to remove the rust and crud from the bell and the U-joint housing.**

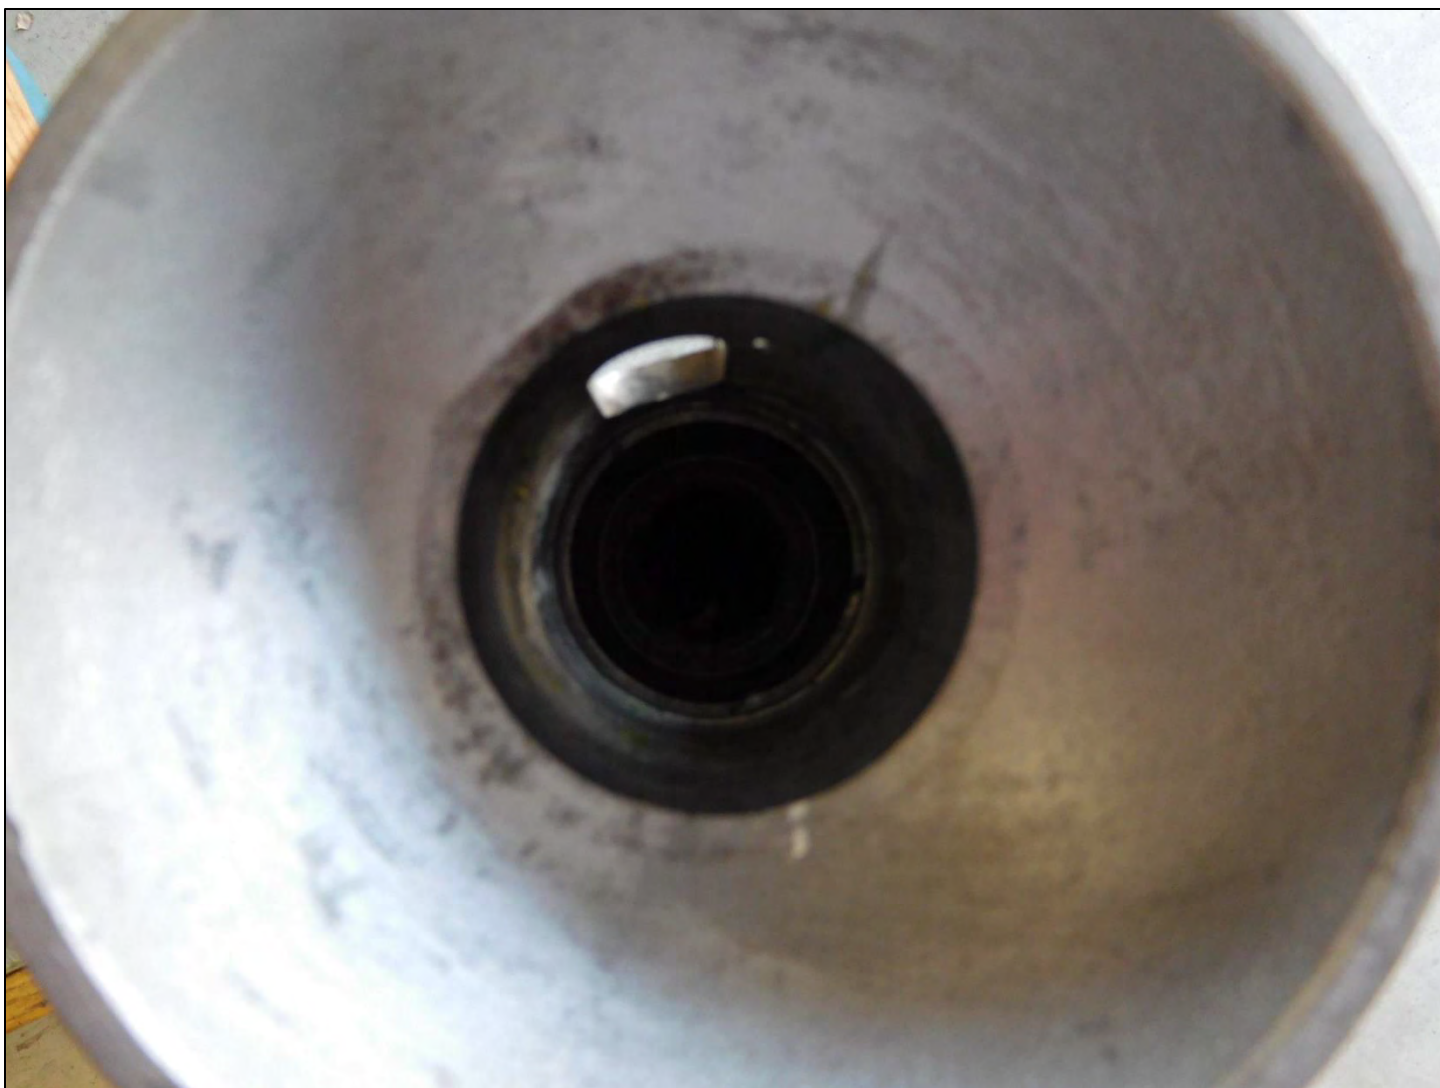
**A new grease seal was driven into place. It must be installed before the bearing race is installed. Shown here is the race being installed. It is driven into place using the back side of a 36 mm socket.**

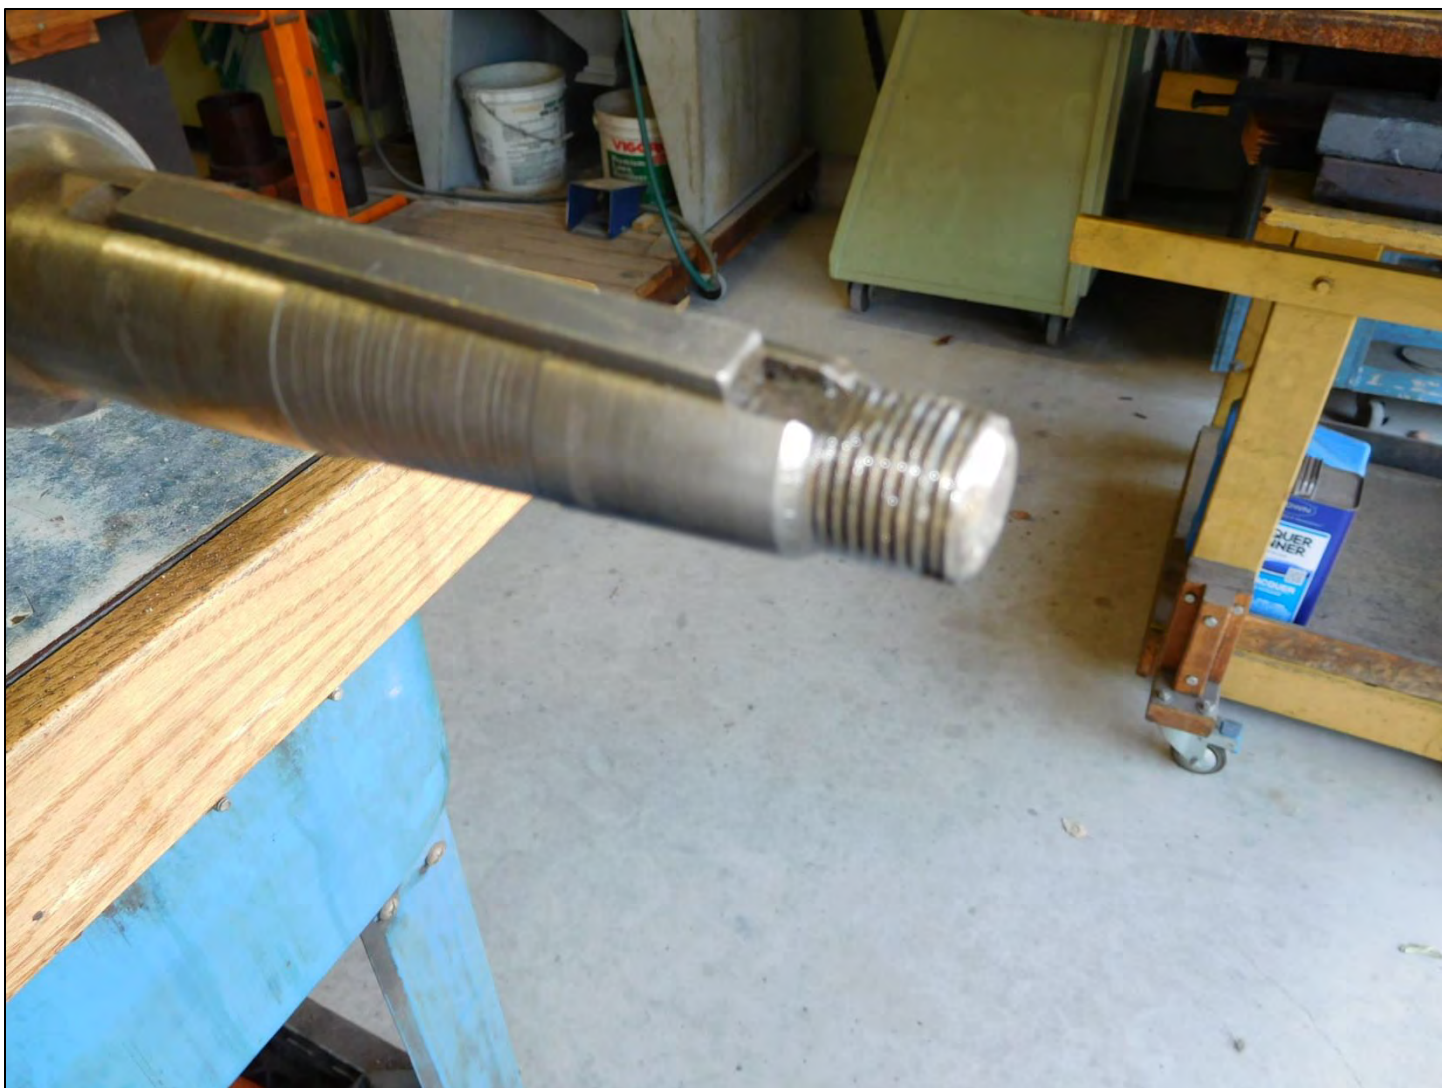
**The replacement early 1932 driveshaft has arrived and is in excellent condition.**

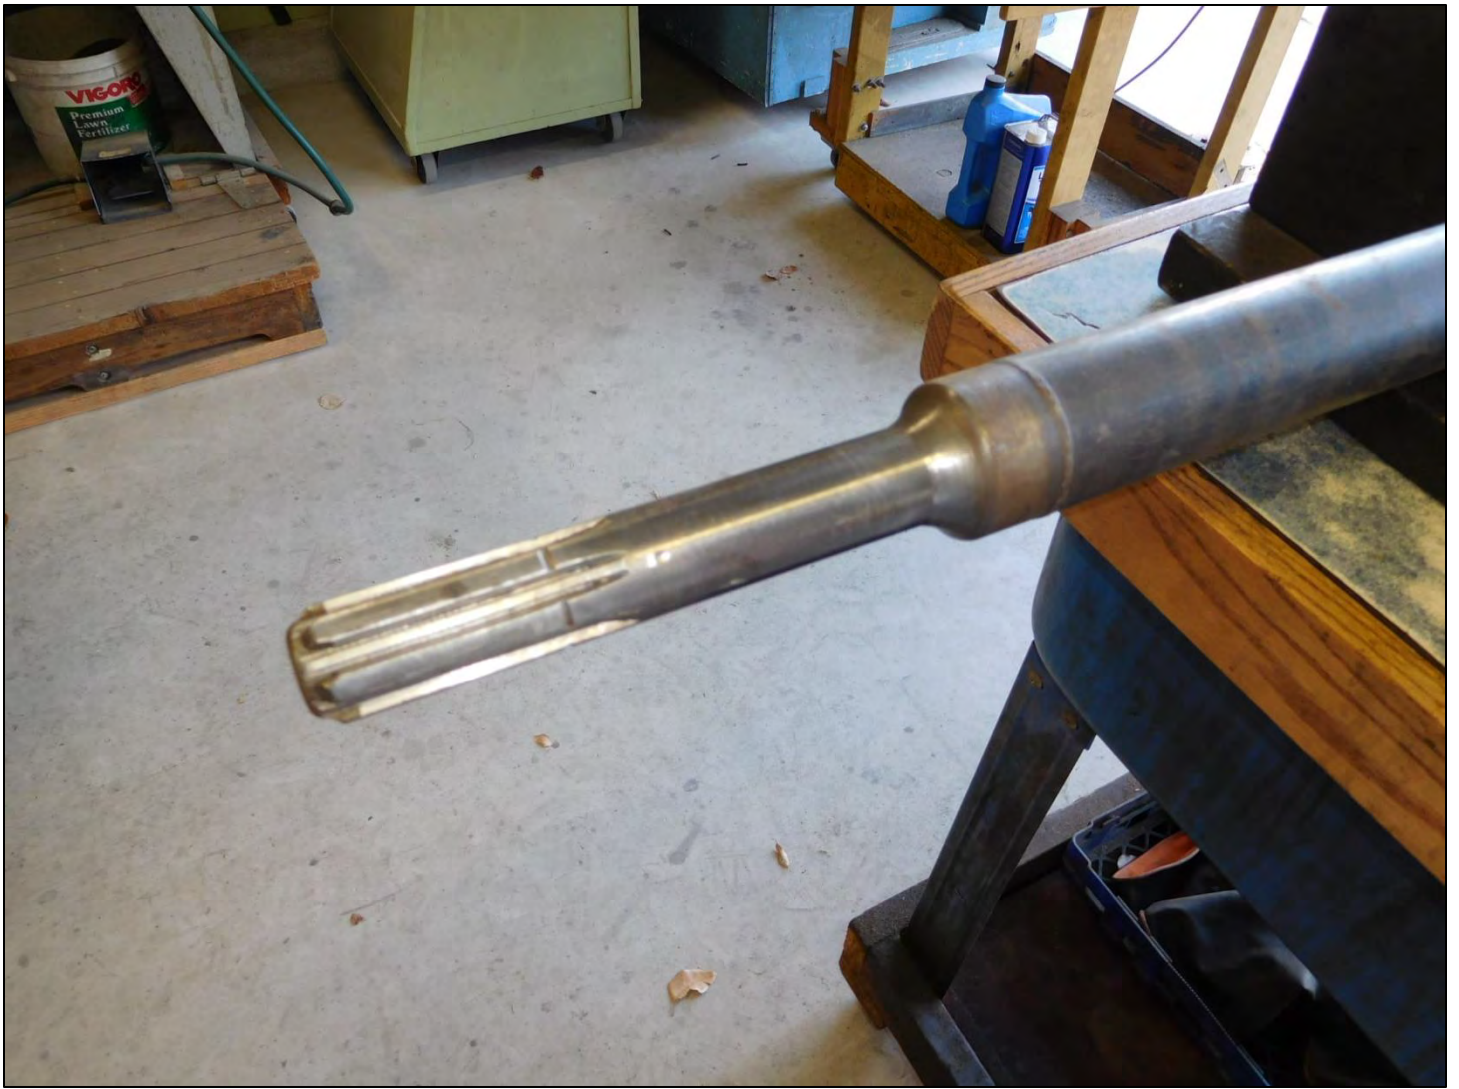
**The threaded end of the drive shaft is in excellent condition.**

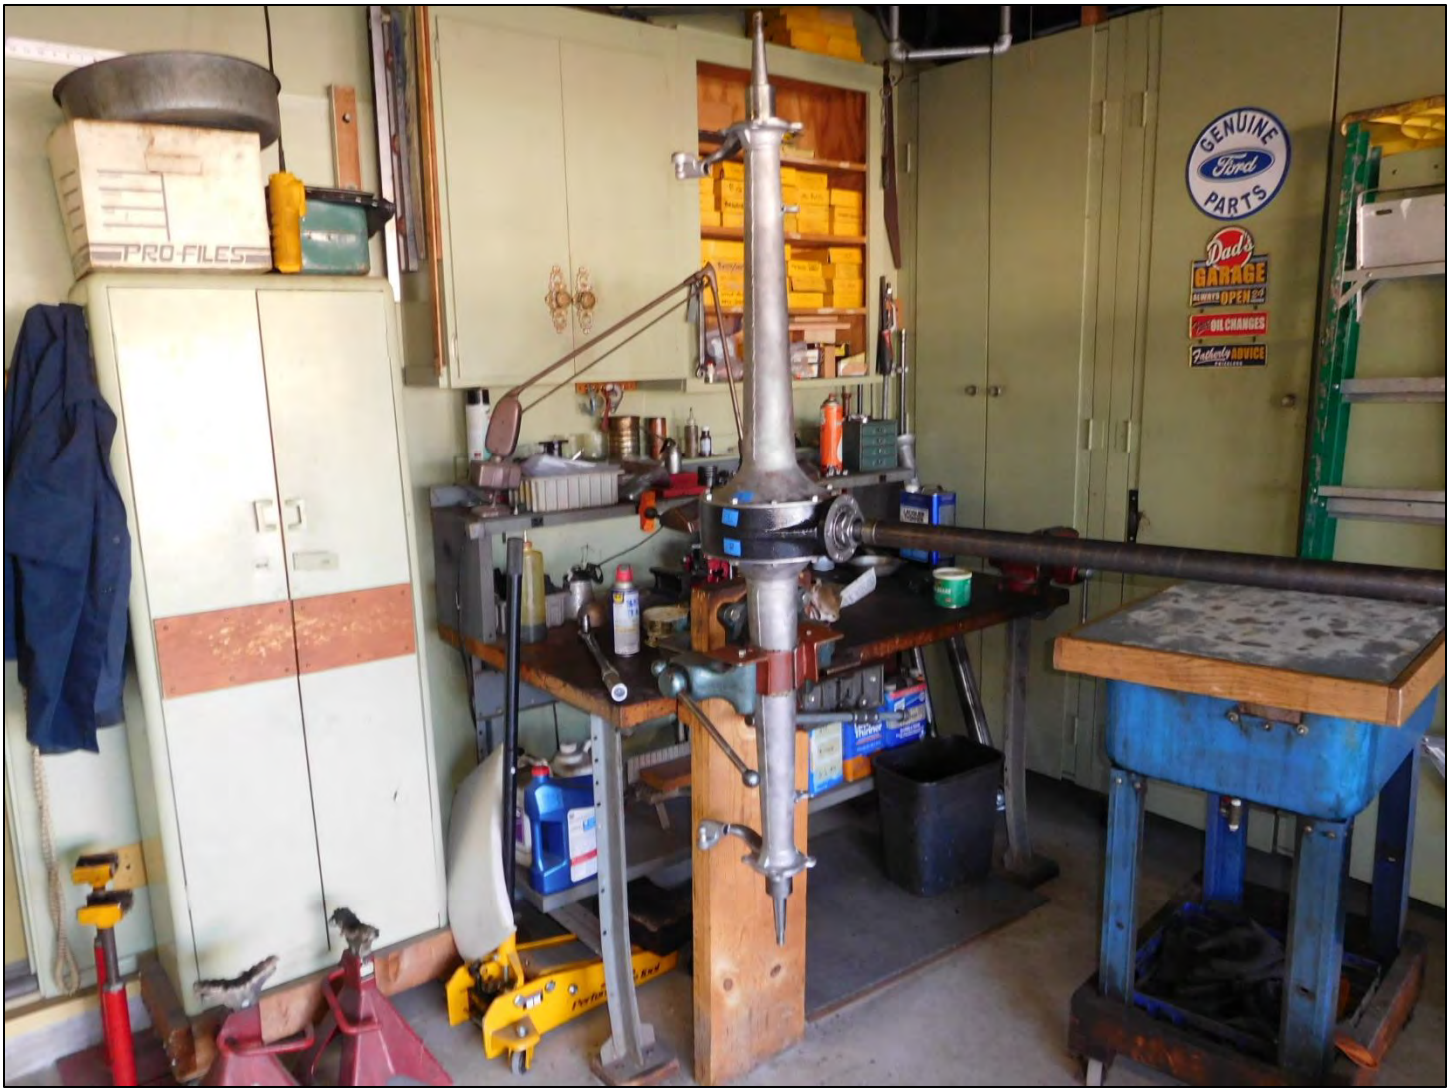
**Shown here is Bryan installing the carrier assembly into the right side of the banjo, this will put the ring gear on the left side.**

**The ring gear must be installed such that it is on the left. It is possible to install it on the right; however, you will then have one speed forward and three in reverse.**

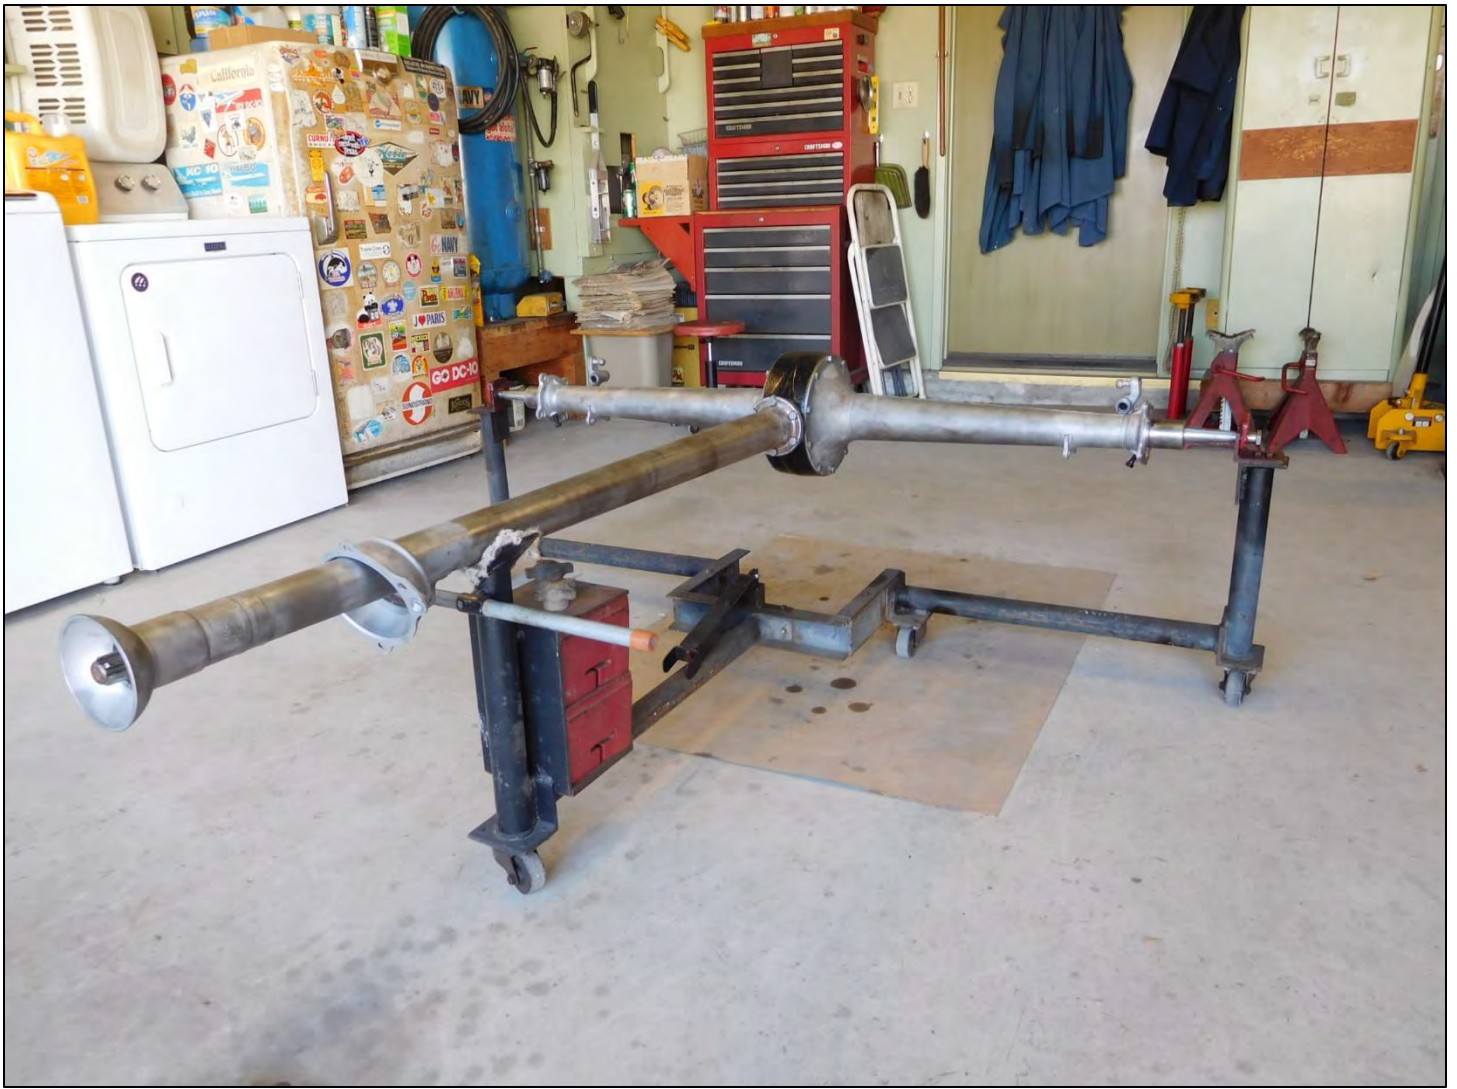
**The rear axle assembly is fully assembled minus the torque tube. The backlash has been set by adjusting banjo gaskets right and left.**

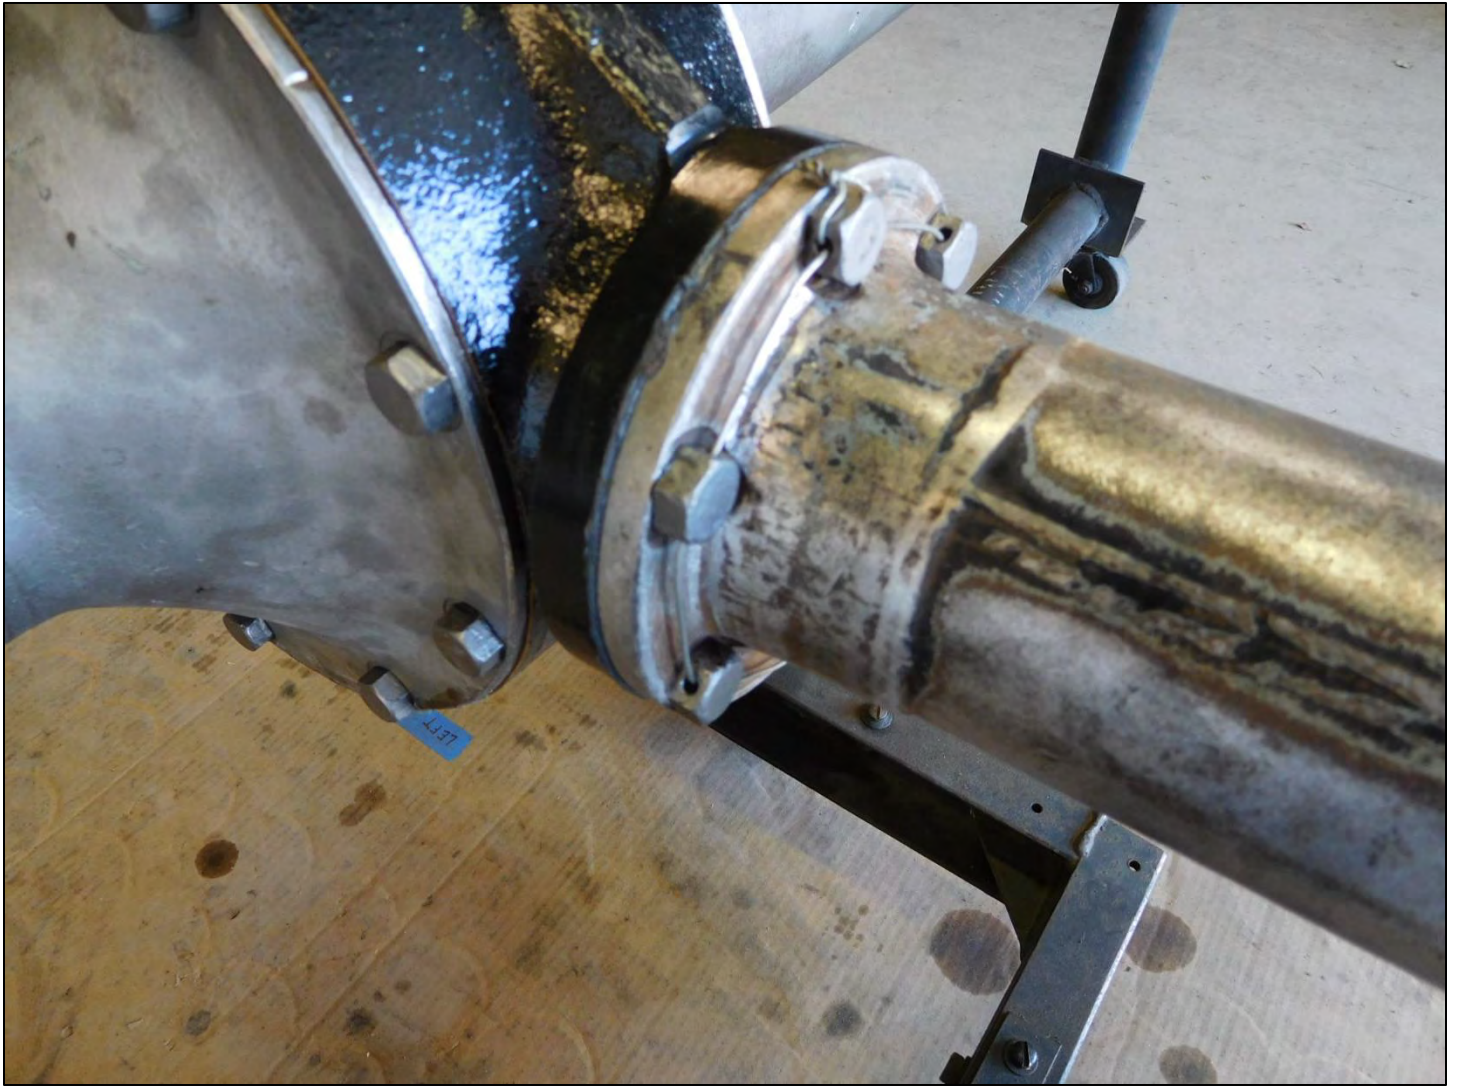
**The assembled rear axle assembly has been moved to the roll around cradle and the torque tube has been installed.**
