# 1928 Transmission

by Tom Endy

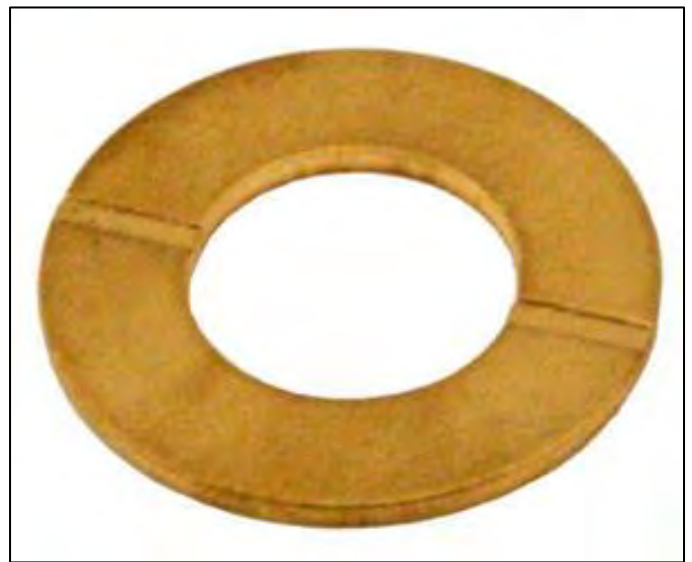
**The photo at right is of a cut-away Model A transmission. The cluster gear is the gear at the bottom of the housing. The 1928 transmissions had a bronze thrust washer inserted between the case and at each end of the cluster gear. The rear of the transmission is to the left.**
