EARLY

Ring & Pinion

By Tom Endy, Westminster, California

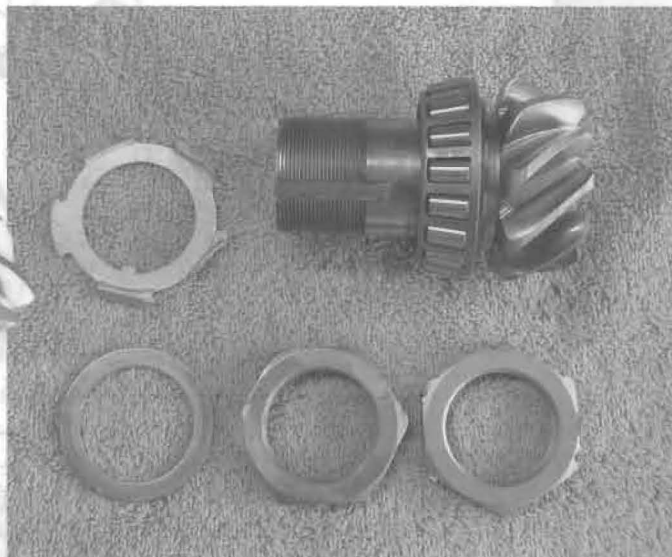
The early ring gear looks the same as the later, however the pinion gear is very different. Note the pinion gear sleeve does not have threads on it for the two large nuts used to set the pre-load. The early pinion nuts are smaller than the later, as is the tab washer. The pinion gear is also installed on the drive shaft with a woodruff key instead of a locking key.

A service bulletin was issued in March 1929 to accommodate replacement parts for the early cars. The gear ratio of the early pinion gear was changed from 3.70 to 3.78 (from 10 teeth to 9 teeth) so it could be mated up to the later style 34-tooth ring gear. I have personally encountered both 3.70 and 3.78 ring and pinion ratios of the early style. The photos in this article are of the early style replacement 3.78 ratio ring and pinion gear set.

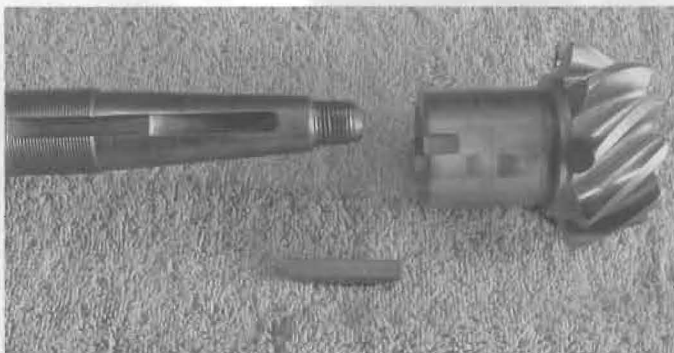
The early drive shaft is threaded to accommodate the two pre-load nuts. The nuts and tab washer must first be installed on the drive shaft before the pinion gear and bearing assembly are installed. Note the drive shaft is machined for a woodruff key instead of a locking key.

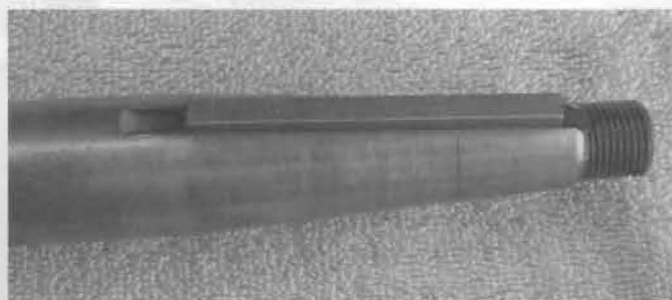
The later pinion gear has a longer sleeve and has the threads, the two pre-load nuts and the tab washer install on. The later pinion gear also uses a thrust washer inserted between the front bearing and the first nut. Note the later nuts and washers are much larger than the early. The later drive shaft does not have threads on it and is machined for a locking key.

Drive shaft used with the later style pinion gear.

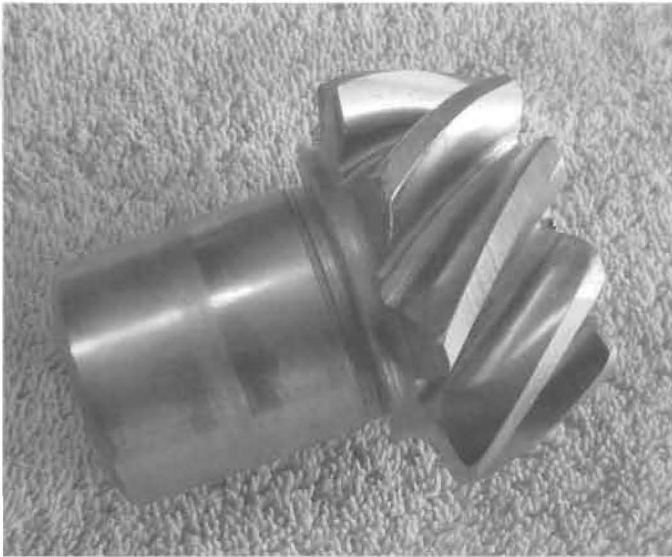
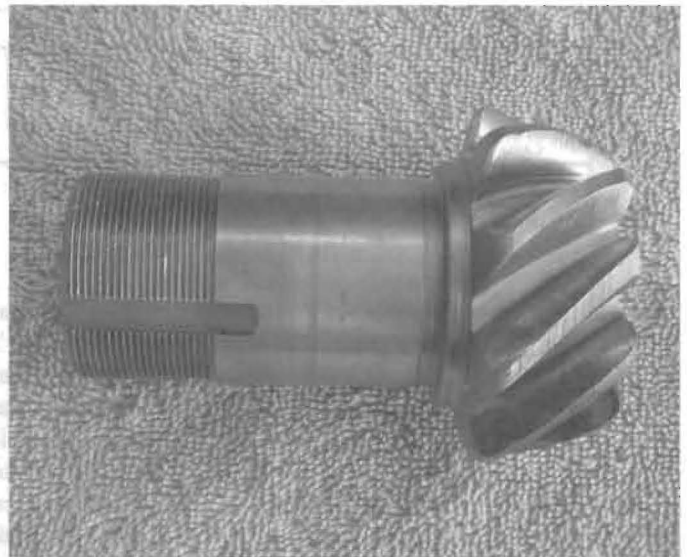
Comparison of early and late pinion gears. Early on the left – late on the right.

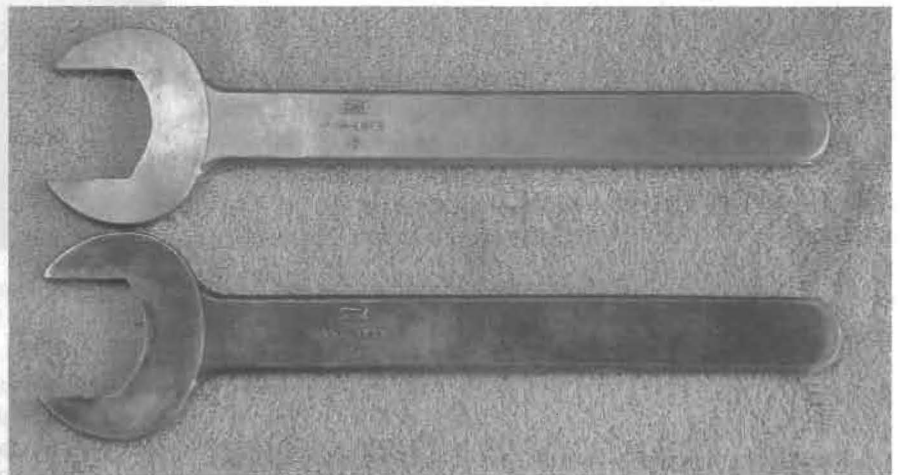
Ford factory wrenches used to set the pre-load on the later pinion gear assemblies that use the larger pinion nuts.

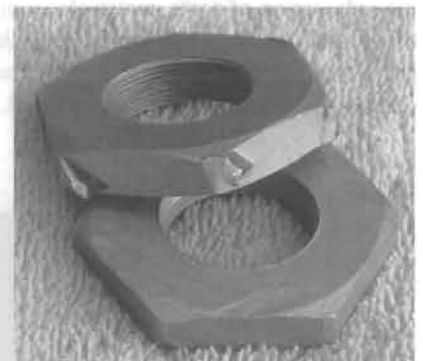
Though the late and early pinion pre-load nuts differed in size, they had one thing in common. Most seem to have been molested with a chisel over the years by people attempting to set the pre-load without using the proper wrenches.

Early chisel molested pinion nuts.

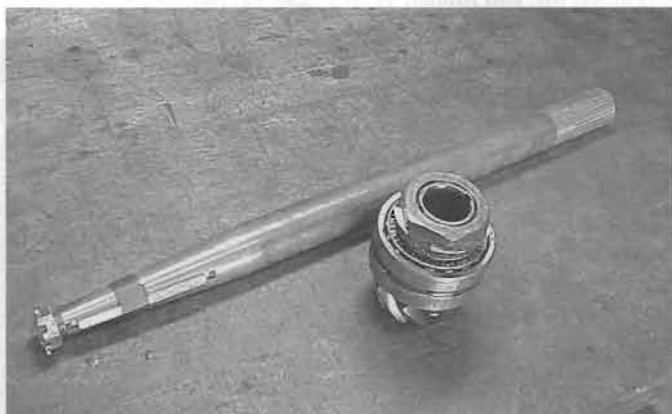
Mitchell overdrive stub shaft with later pinion gear assembly.

The Mitchell overdrive stub shaft is not compatible with the early pinion gear. When encountering one of these early cars, it becomes necessary to replace the ring and pinion with that of the later configuration in order to install the overdrive.
