Early Ring & Pinion

by Tom Endy

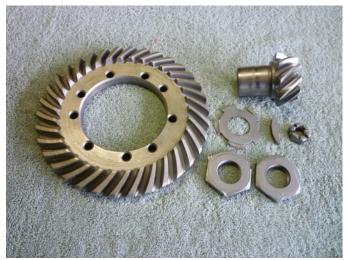
The early ring gear looks the same as the later; however, the pinion gear is very much different. Note the pinion gear sleeve does not have threads on it for the two large nuts used to set the pre-load. The early pinion nuts are smaller than the later, as is the tab washer. The pinion gear is also installed on the drive shaft with a woodruff key instead of a locking key.

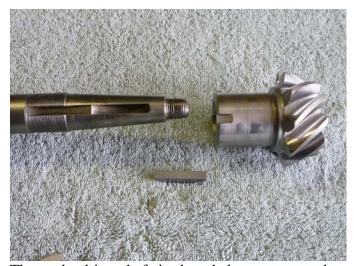
The early drive shaft is threaded to accommodate the two pre-load nuts. The nuts and tab washer must first be installed on the drive shaft before the pinion gear and bearing assembly are installed. Note the drive shaft is machined for a woodruff key instead of a locking key.

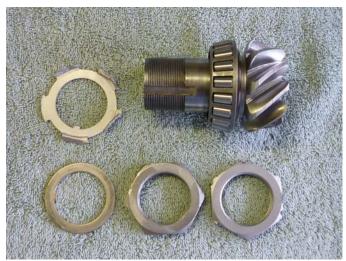
The later pinion gear has a longer sleeve and has the threads the two pre-load nuts and the tab washer install on. The later pinion gear also uses a thrust washer inserted between the front bearing and the first nut. Note the later nuts and washers are much larger than the early. The later drive shaft does not have threads on it and is machined for a locking key.

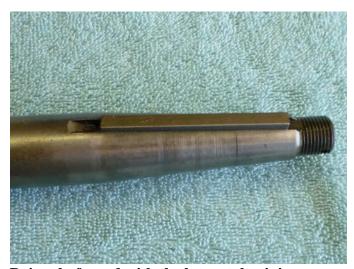
Drive shaft used with the later style pinion gear.

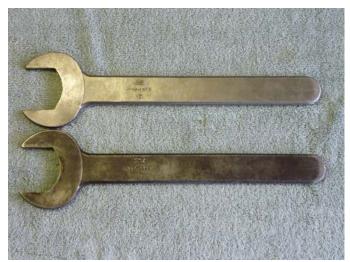
Ford factory wrenches used to set the pre-load on the later pinion gear assemblies that use the larger pinion nuts.

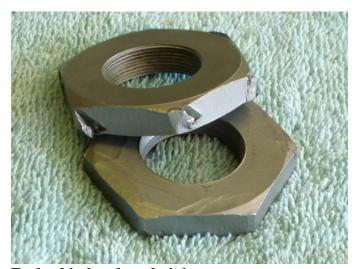
Early chisel molested pinion nuts.

Though the late and early pinion pre-load nuts differed in size, they had one thing in common. Most seem to have been molested with a chisel over the years by people attempting to set the pre-load without using the proper wrenches.
