Torque Tube Race & Seal

by Tom Endy

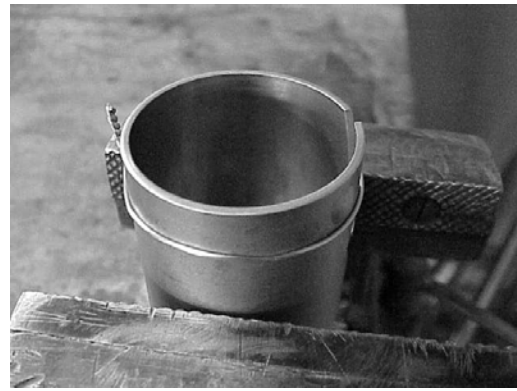
**Safety wire wrapped on A4655 sleeve
(Dimple on right side just above safety wire)**

Place the A4655 sleeve in a bench vice with the end with the dimple facing up and tighten the vice until the split in the sleeve is almost closed. Wrap a piece of safety wire (.040) around the sleeve just below the dimple. Twist the safety wire together 7 or 8 turns on the opposite side from the dimple. Cut and bend the twisted end straight up. Place a chalk mark on the top edge of the sleeve right above the dimple. Remove the sleeve from the vice. The split will open up some, but it is not a problem.

Stand the torque tube on the floor in a vertical position with the forward end up. Reach through the speedometer gear-housing opening and clean out any debris that is in the dimple recess. Place a chalk mark inside the torque tube directly above the dimple recess. Place the safety wired sleeve inside the torque tube with the chalk mark end up. Align the chalk mark on the sleeve with the chalk mark on the torque tube. It is important to accurately align the two chalk marks. Place a 36mm 1 $\frac{1}{2}$ " drive socket on an extension up side down. Place the flat side of the socket against the sleeve and with a hammer gently tap the sleeve down into the torque tube. As the sleeve goes into place the safety wire will be pushed up and over the dimple and will exit the top of the sleeve. If the two chalk marks were aligned correctly the dimple on the sleeve will snap into the dimple recess in the torque tube. Place a punch in through the speedometer gear-housing opening in the torque tube and into the dimple and gently tap it to insure the sleeve has seated fully. Check that the circumference of the sleeve is snug against the inside diameter of the torque tube. There should be no visible space between the two; otherwise you will not be able to install the roller bearing when the drive shaft is in place. The split in the sleeve will have also opened up.
