Emergency Brake Cross Shaft Change

by Tom Endy

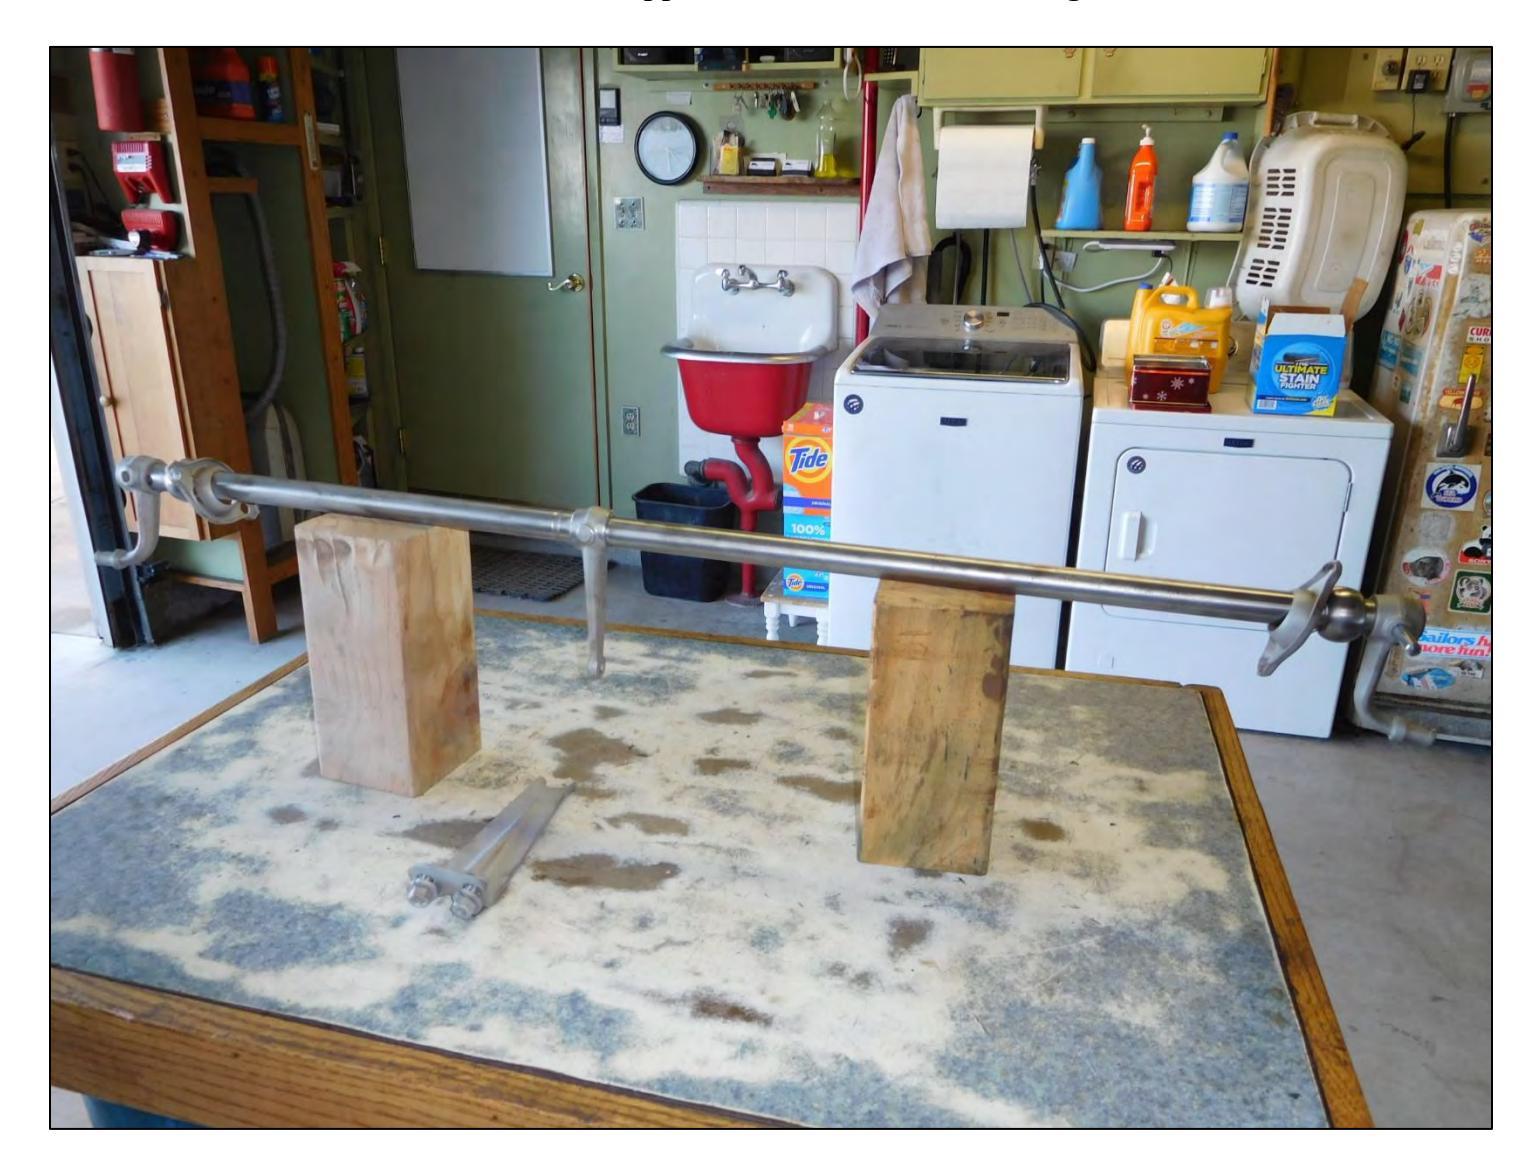
This photo shows the later E-brake cross shaft removed from a 1930 Tudor. Each end of the shaft protrudes through a hole in the frame on each side. The hole is beveled on the inside of the frame in the shape of the bearing and provides one half of the bearing race.

E-brake shafts see little wear and are largely ignored when a Model A is restored. Most just sit there and get rusty and cruddy, but see little wear to the parts because of the short duty cycle. The one in the photo was extremely cruddy before it was bead blasted and it was found in excellent condition. The only parts that have to be replaced are the two tapered pins that hold the two lever arms to the shaft at each end. The pin is Ford part number A-23830. Bratton part number 4160 (for the E-brake) or 11260 (for the clutch release shaft) they are both the same pin.

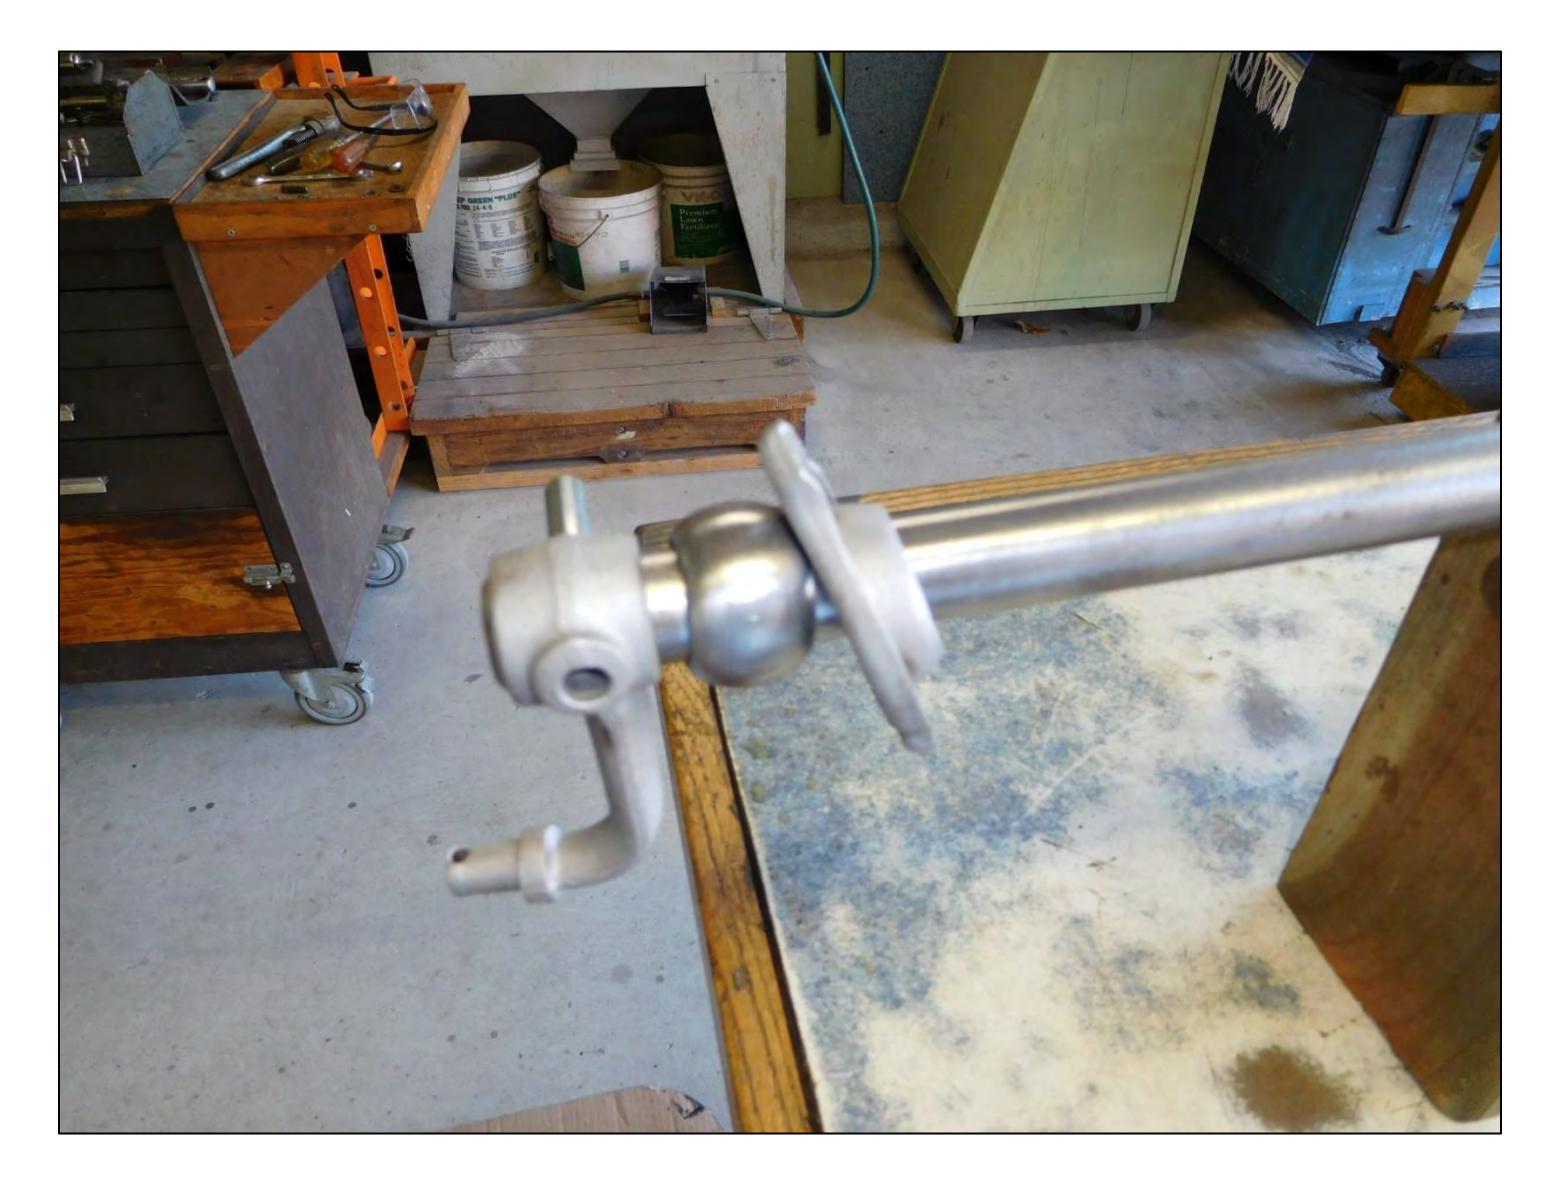
Shown in the photo is one end of the shaft showing how the lever mounts to the shaft. A tapered pin is driven into the hole in the lever and shaft. A new pin can be seen protruding from the far side of the lever. The frame hole is beveled on one side to provide half of the bearing race. The bracket on the right is the other half of the bearing race, and bolts to the frame with two mounting bolts. The other end of the shaft has the same assembly, except the two levers are a left and a right. When installed each must point outward toward the rear of the car. On the bottom of each lever is where the E-brake rods that attach to the brake levers on the rear backing plates attach.

The section of frame with the hole in it will be positioned between the lever and the round shaped bearing.

The tapered pin is the same used in the assembly of the clutch release shaft in the bell housing. It is described as being 5\16X1&1\4". Ford part number A-23830.

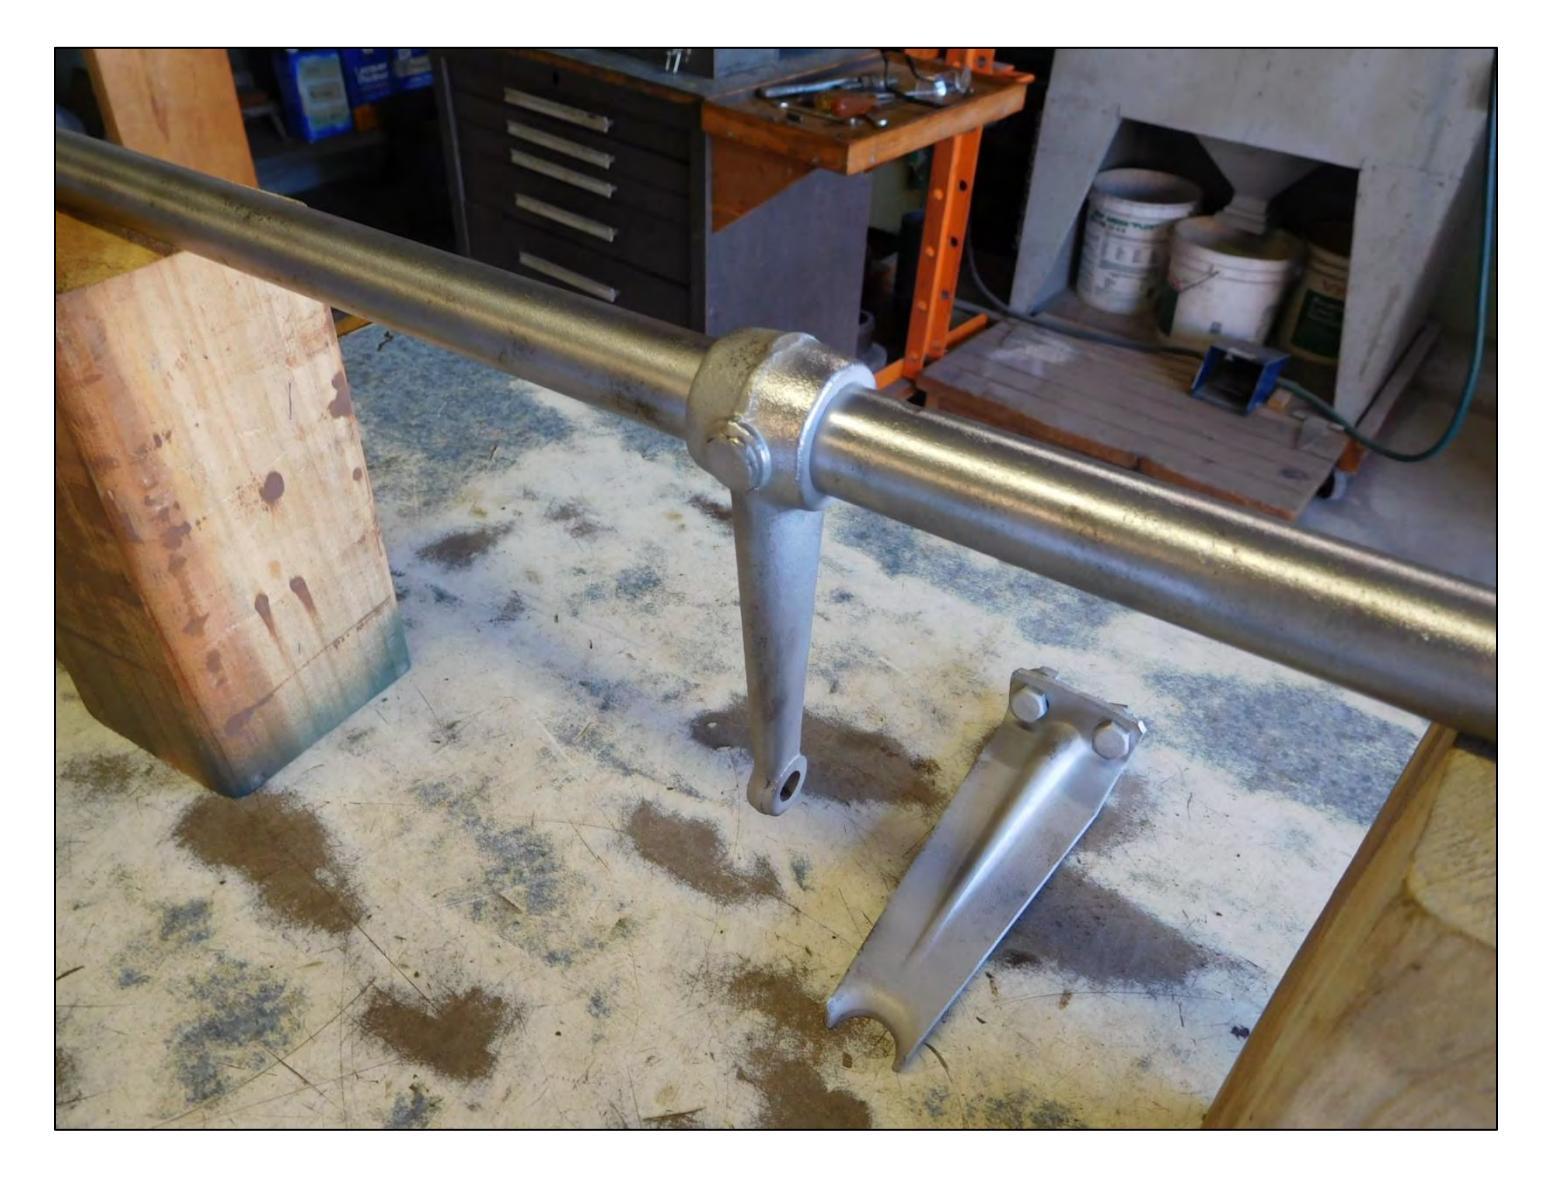
The bracket seen laying on the table below the shaft is called a cross-shaft support. It bolts to a section of frame forward of the shaft and parallel to it. The curved end rides on the shaft and provides stabilization at the center. The lever hanging down attaches to a short brake rod that attaches to the E-brake handle. It is off-set to the right when installed correctly in the car.

In order to remove the later E-brake cross shaft from the car the tapered pin in each lever must be driven out first. Next remove the two mounting bolt that attach the bracket on each side. The shaft can then be slid out of the frame. The two bearings then just slide off the shaft. The cross-shaft support bracket does not have to be removed in order to remove the cross-shaft. Removal of the cross-shaft support is optional and only if it is to be cleaned and painted.
