30 Tudor Seat Belts

by Tom Endy 2021

During the recent restoration of a 1930 Tudor for my grandson Ben seat belts were certainly going to be included in the restoration. When we obtained the car there were seat belts installed, but only attached to the sheet metal. These were removed and discarded. Much thought has been given about how we were going to properly secure the new seat belts to the car.

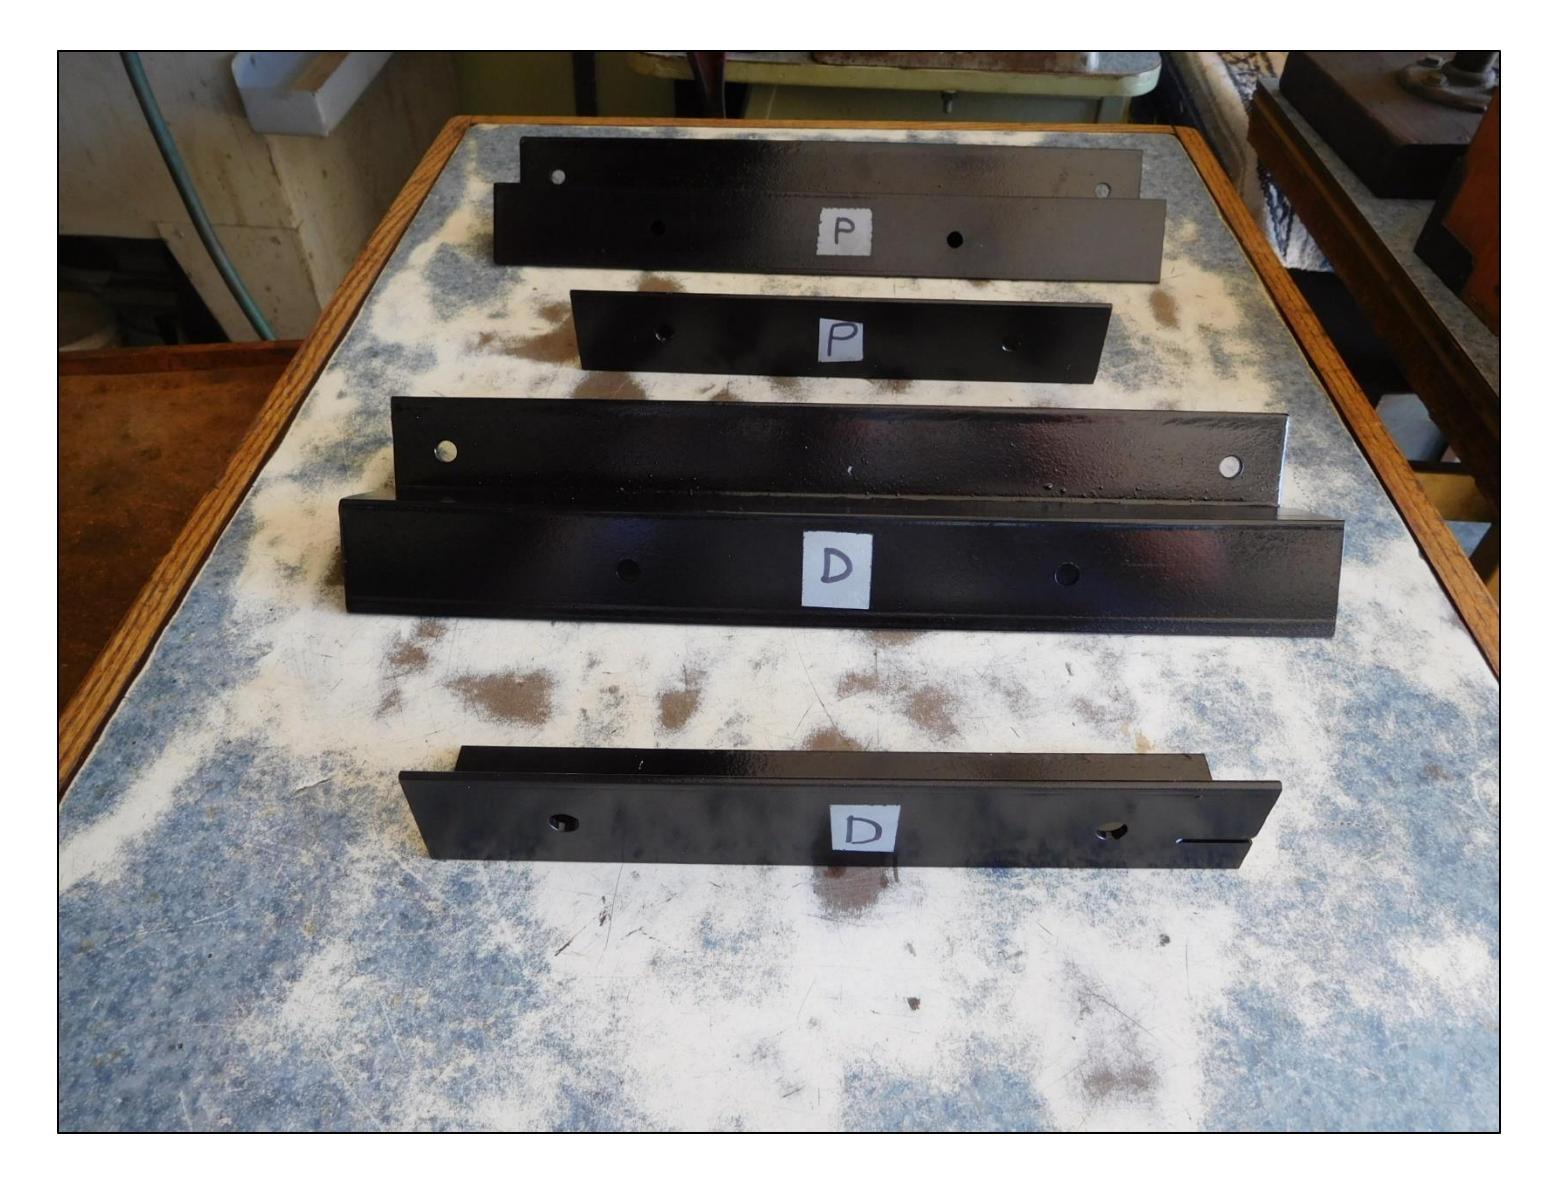
These are the support brackets that attach to the rear seat rails on the 1930 Tudor. The D and the P indicate driver and passenger sides so that all the bolt holes in the seat rail will line up. The two larger pieces are the "Z" brackets that fit under the rear seat rail structure. The shorter pieces attach to the front of the seat rail to add additional support to the seat rail structure. Each section bolts to the seat rail with two $3\8"$ grade-8 bolts and nuts.

The rear seat belts were secured by fabricating two lengths of 2X2 inch by 1/8" thick angle iron. These were welded together longitudinally to form a "Z" shape. The "Z" was stood on its side so that one of the legs was vertical. Two separate pieces were fabricated and neatly fitted behind and under each side of the rail for the back seat lower cushion and bolted to it with a series of bolts. Four 7/16" holes were drilled into the vertical of the "Z" to attach the seat belts to with 7/16" grade-8 bolts and nuts.

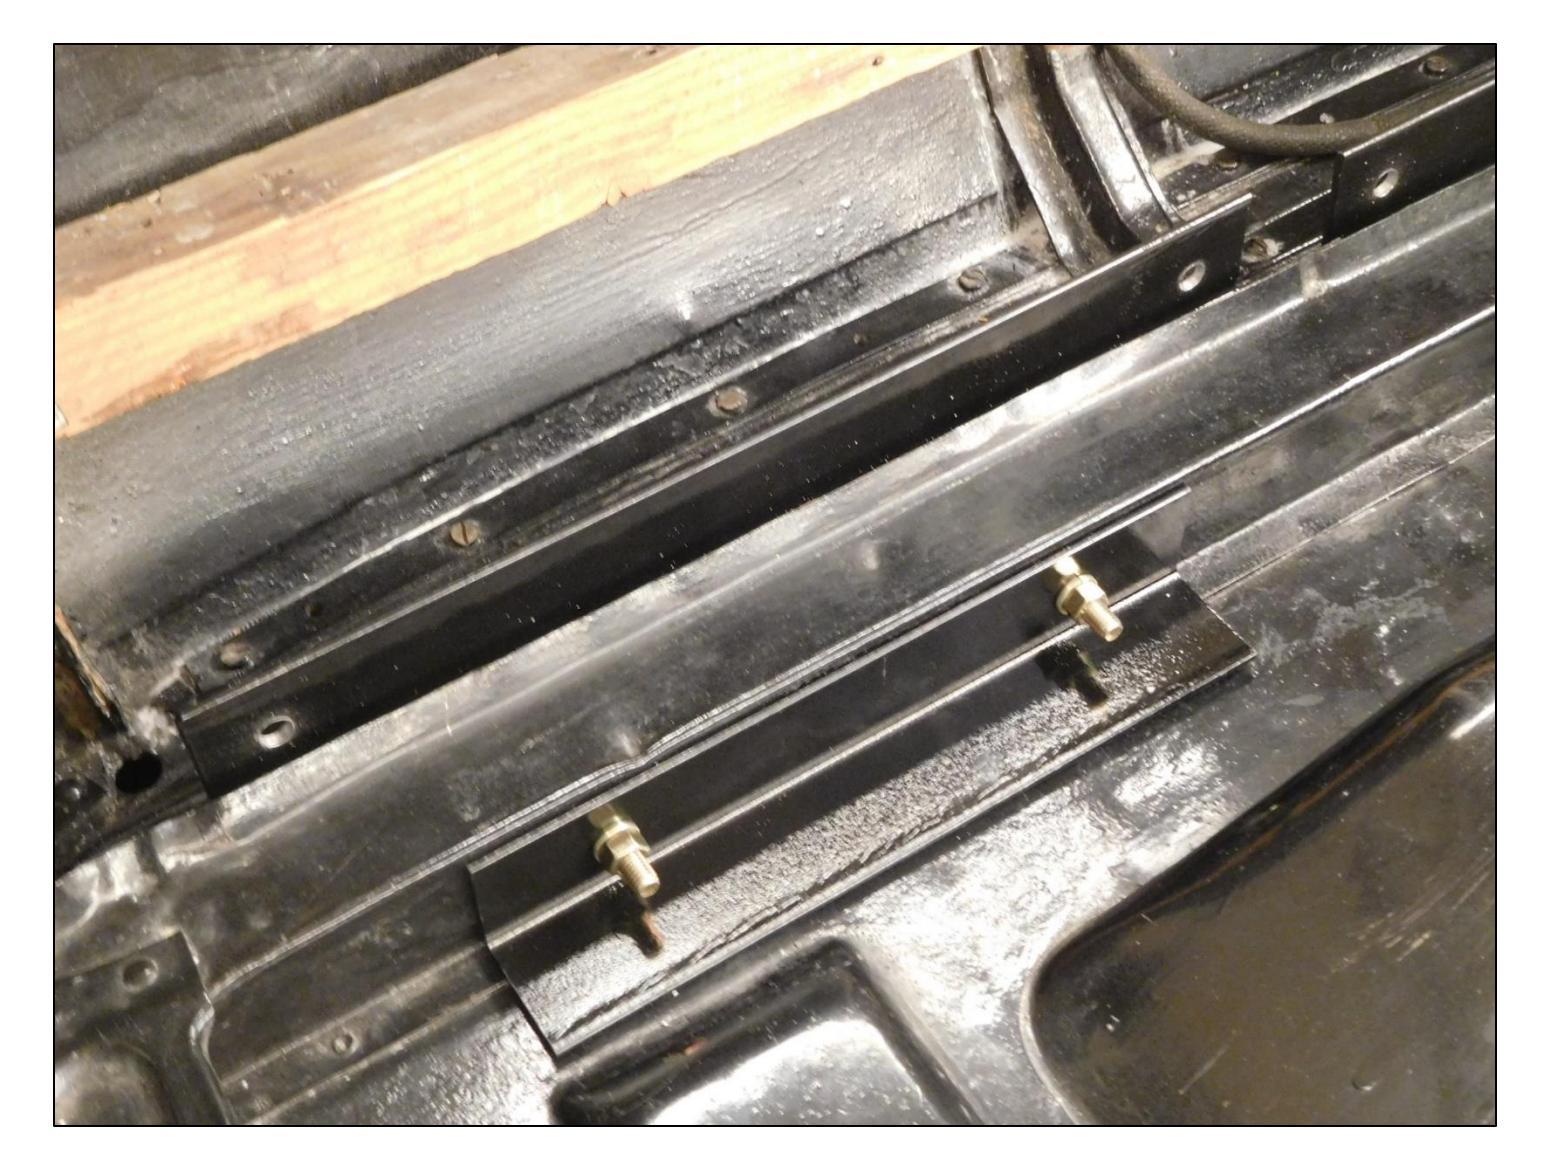
This photo shows the right side rear seat belt support brackets installed on the passenger side. The "Z" section has two 7\16" holes in the vertical section where the seat belts will bolt to with 7\16" grade-8 bolts and nuts. The short front section is bolted to the "Z" structure through the rear section of the seat rail structure with two 3\8" grade-8 bolts and nuts.

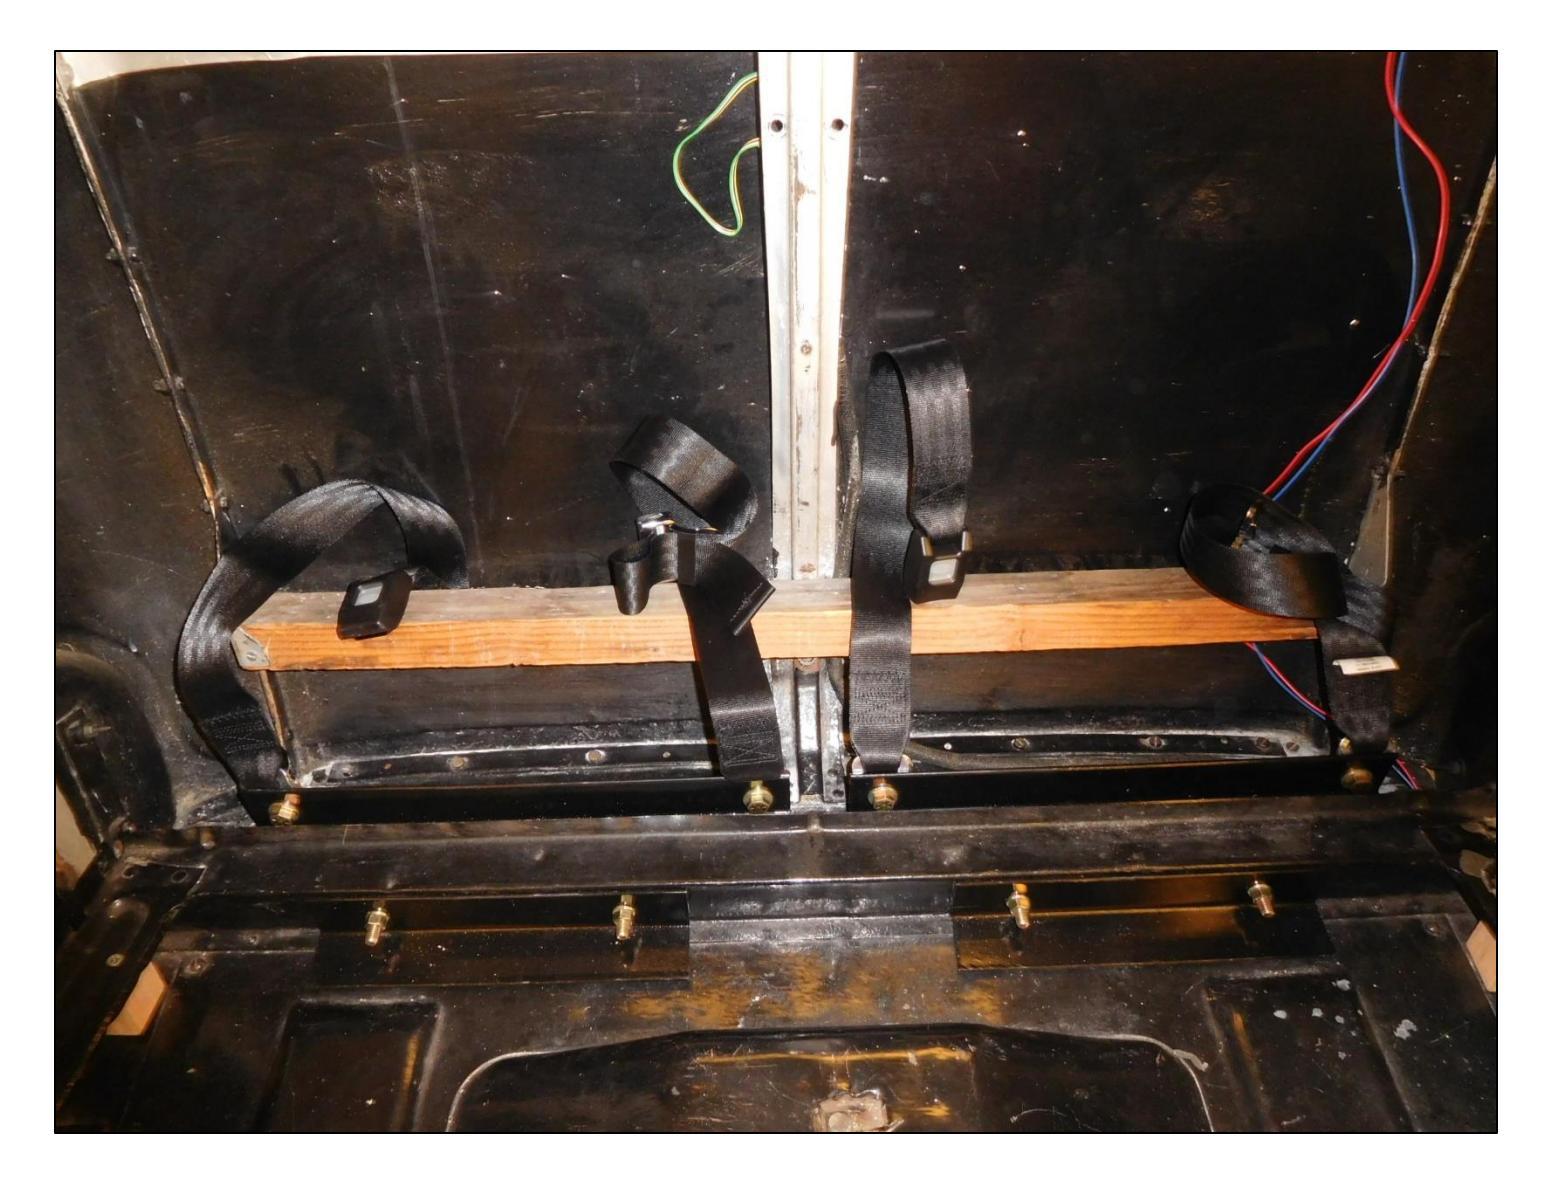
This photo shows the two rear seat belts installed to the support brackets.

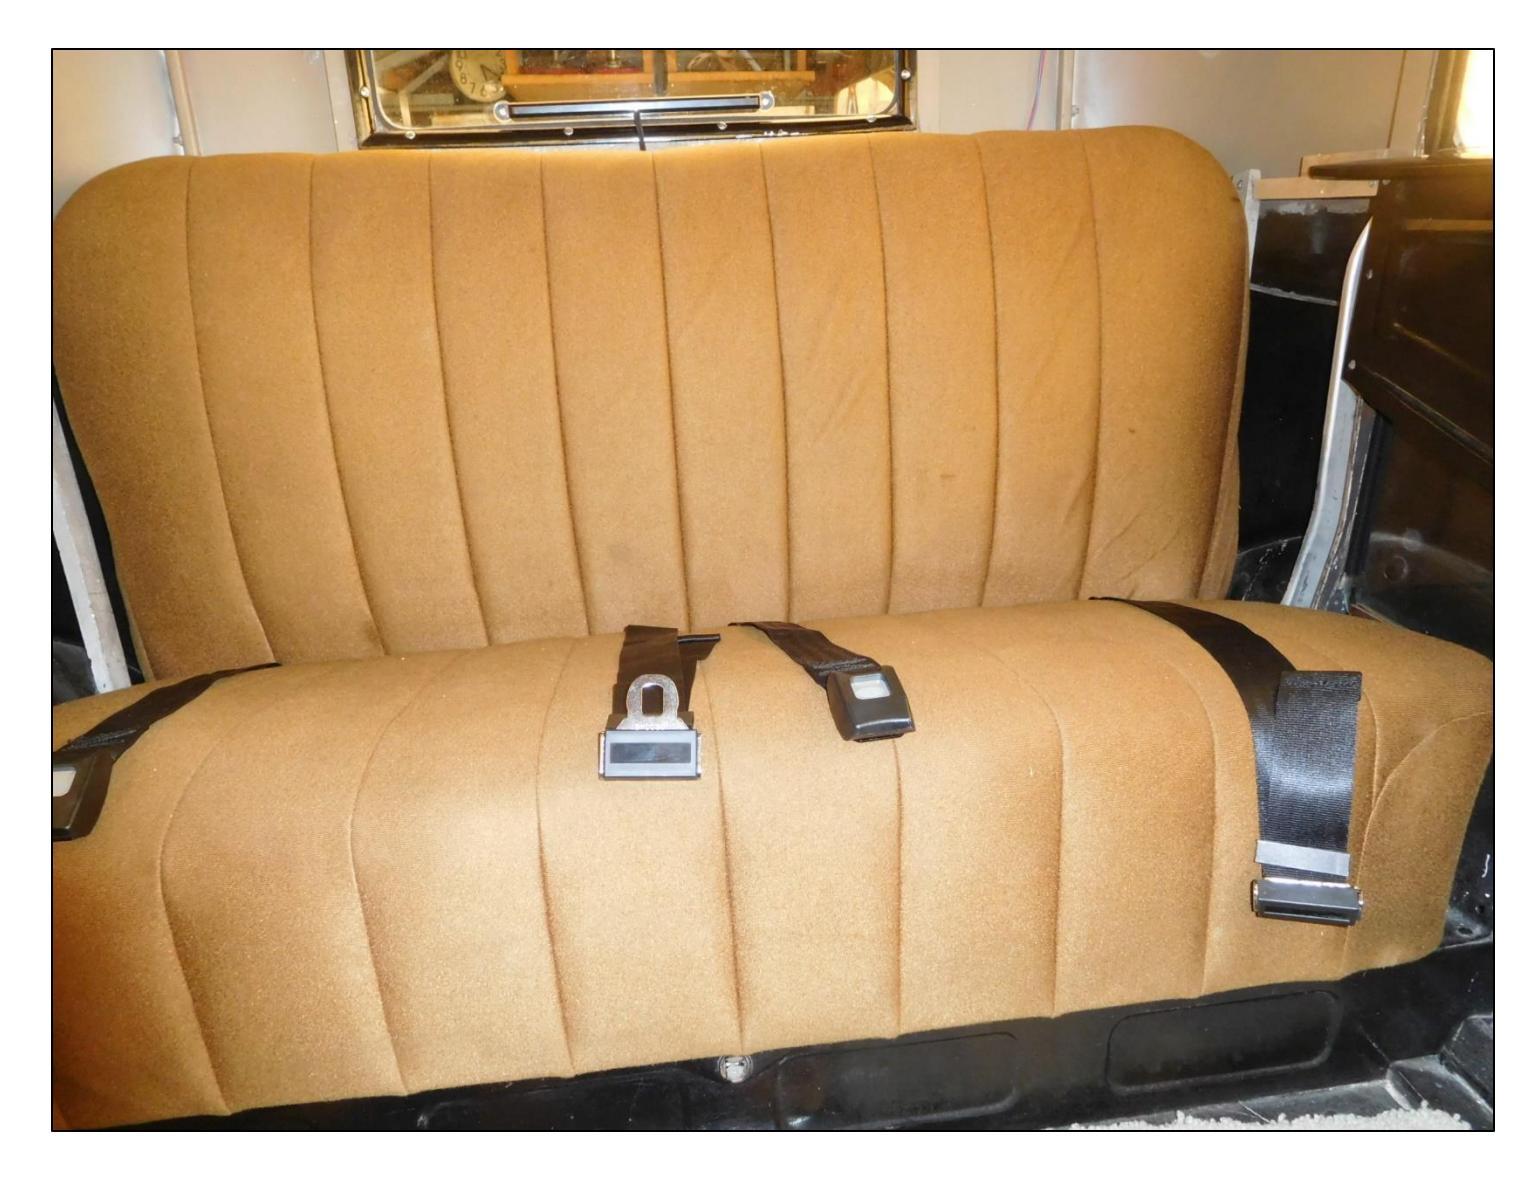
The rear seat belts protrude out between the two seat cushions and are safely secured to the car.

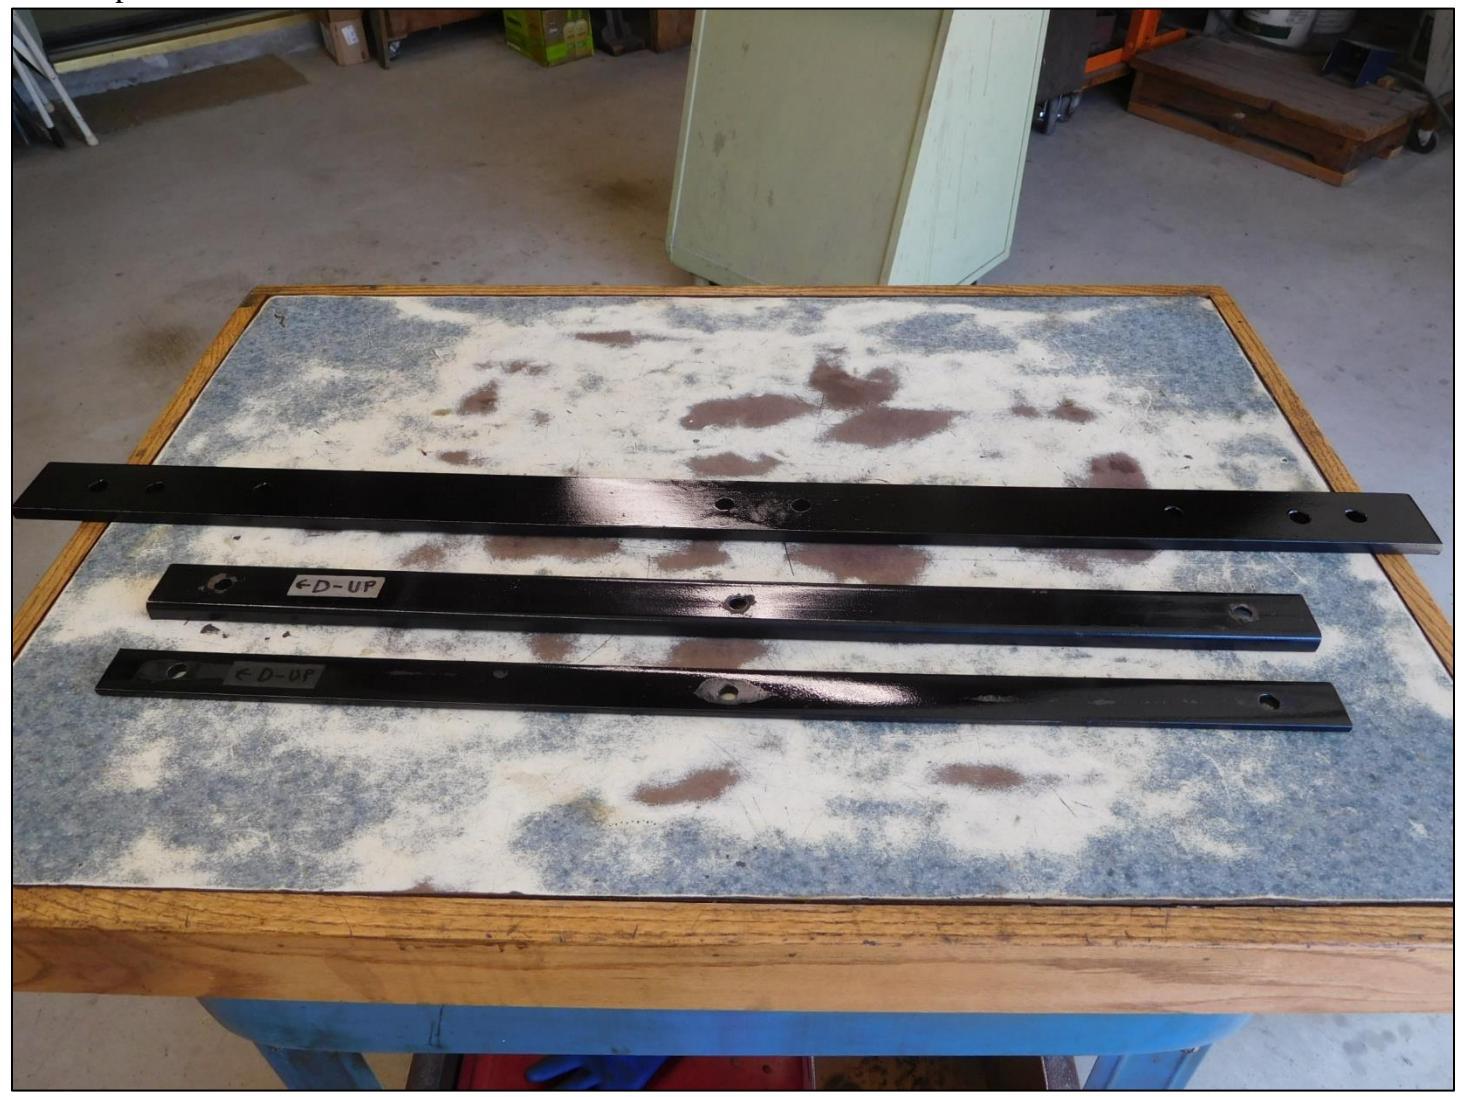
This photo shows the steel supports that were attached to the cross piece. The bottom two fit inside each other and fit up under the cross pieces. The top support lays on top of the cross piece and it is all bolted together with grade -8 bolts and nuts.

The front seat belts were secured to the cross piece channel that supports the front and rear floor boards. But first it had to be strengthened. To do this two pieces of steel were added below the channel. The first was a U-shaped channel $1\4$ " thick, the second was a flat piece of steel $1\4$ " thick that fit inside the U-channel. Both pieces were bolted underneath the floorboard channel with grade-8 bolts. An additional length of flat steel 2" wide and $1\4$ " thick and the length of the floorboard cross piece was bolted to the top. The outboard bolts that anchor the outboard seat belts go down through the frame of the car and are grade 8 bolts. The bolt next to it on the cross piece anchors the top two inch wide steel to the frame. The inboard belts are attached to the two inch wide steel at the center of the ross piece.

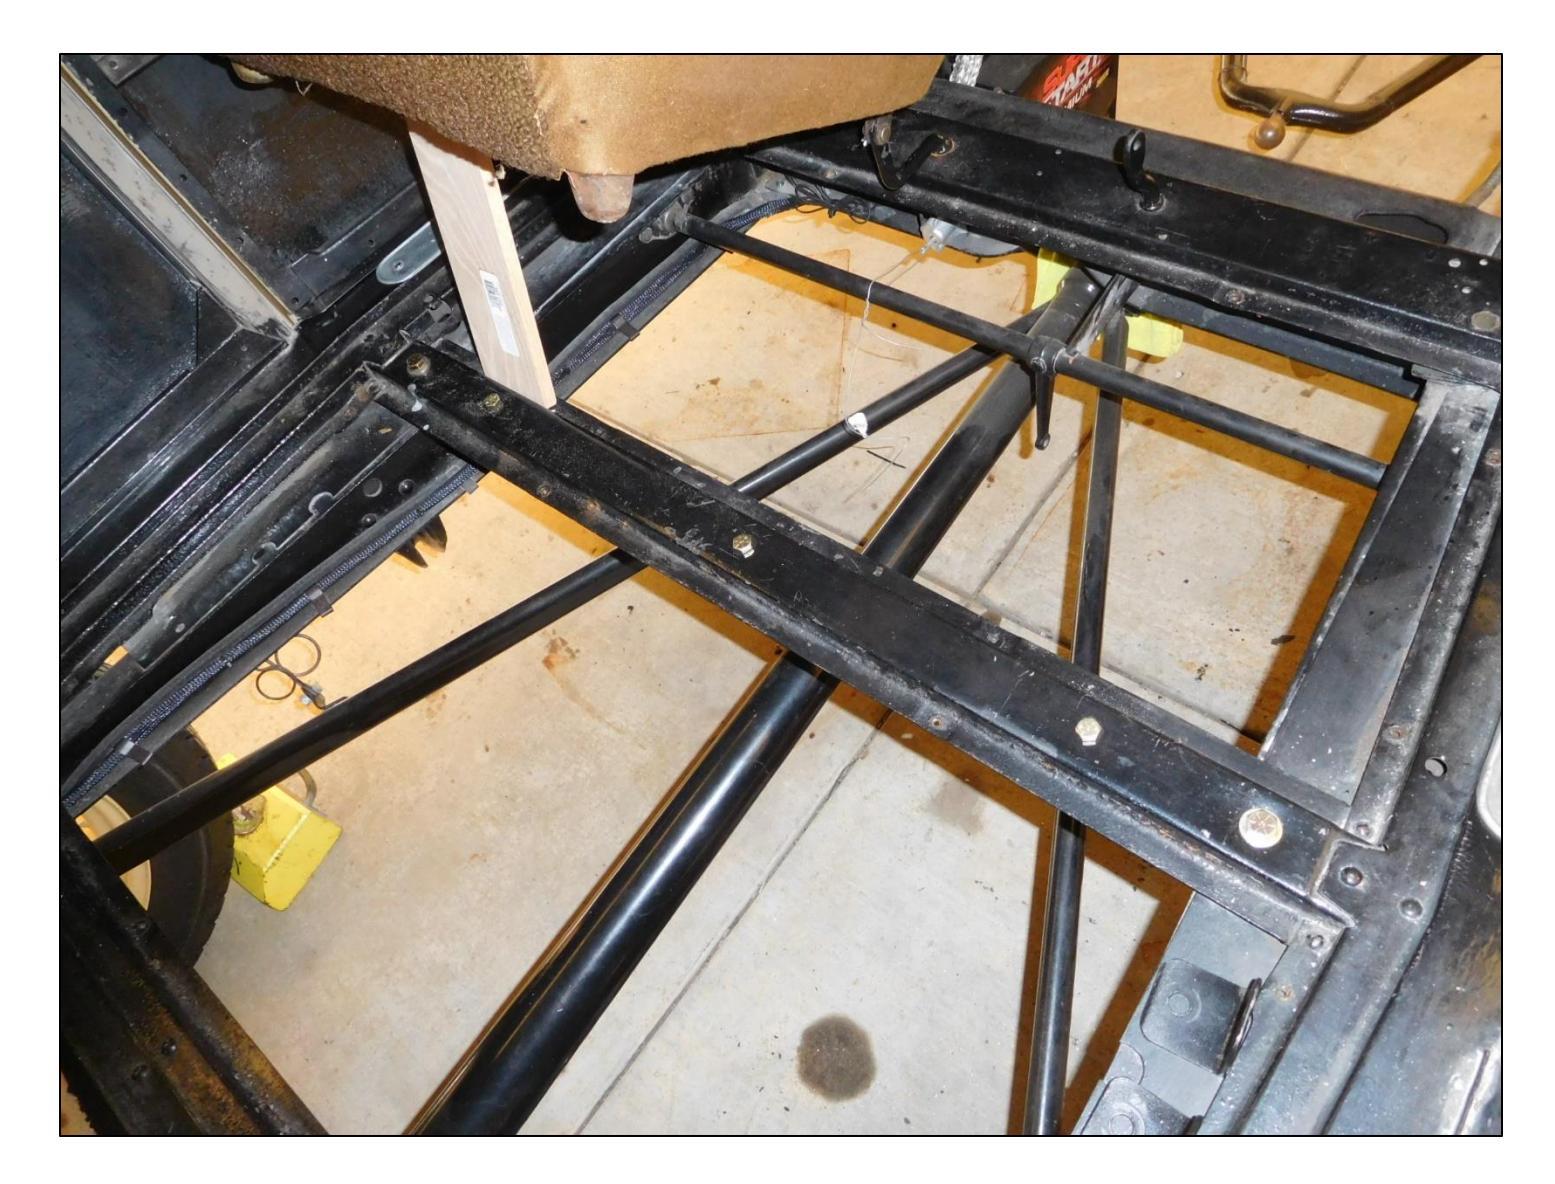
The front seat belts will bolt to the inverted U-shaped cross piece on the 1930 Tudor that provides structure to support the two rear floor boards and the back legs of the two front seats. Under the U-shaped cross piece we attached a solid piece of steel up inside the U and is held in place with three $3\8"$ grade-8 bolts and nuts. The cross piece is also bolted to the frame on each side with $7\16"$ grade-8 bolts and nuts. Both front seat belts will bolt to this cross piece with $7\16"$ grade-8 bolts and nuts. A two inch wide $1\4"$ thick length of steel was attached to the top across the full width with the outboard bolts going down through the frame of the car.

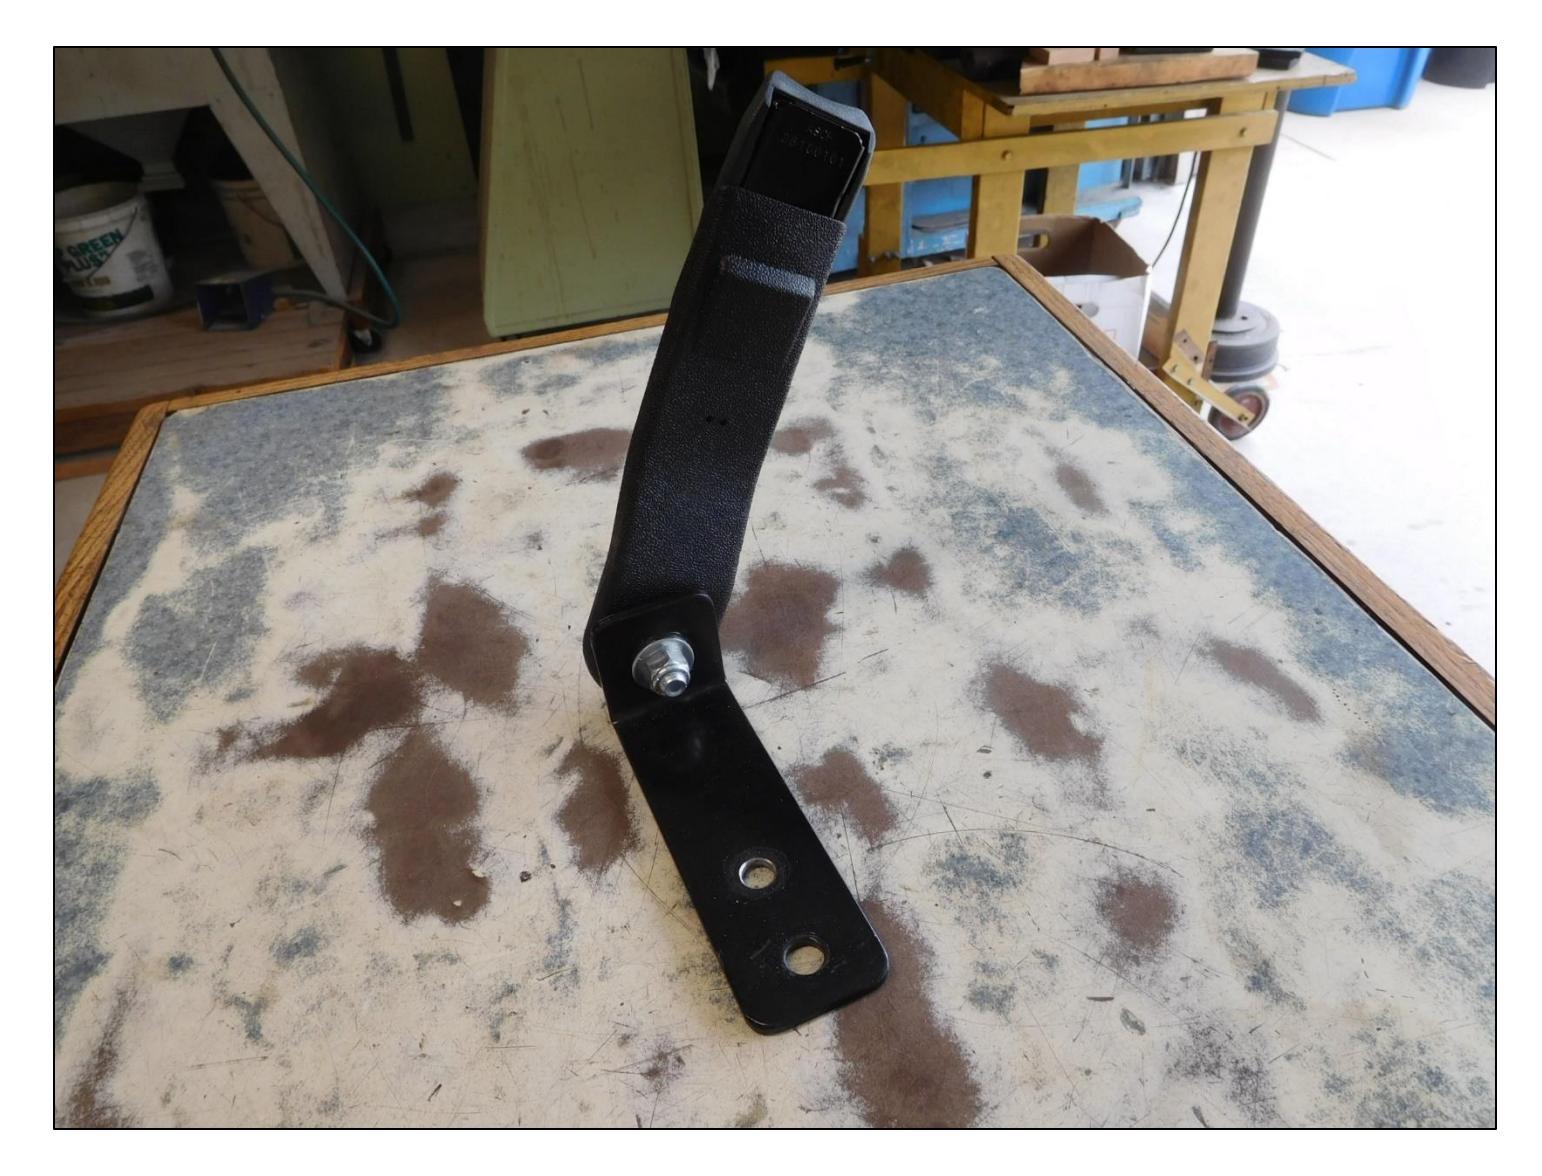
The two long L-brackets and belt receptacles were purchased from Buckle Up.

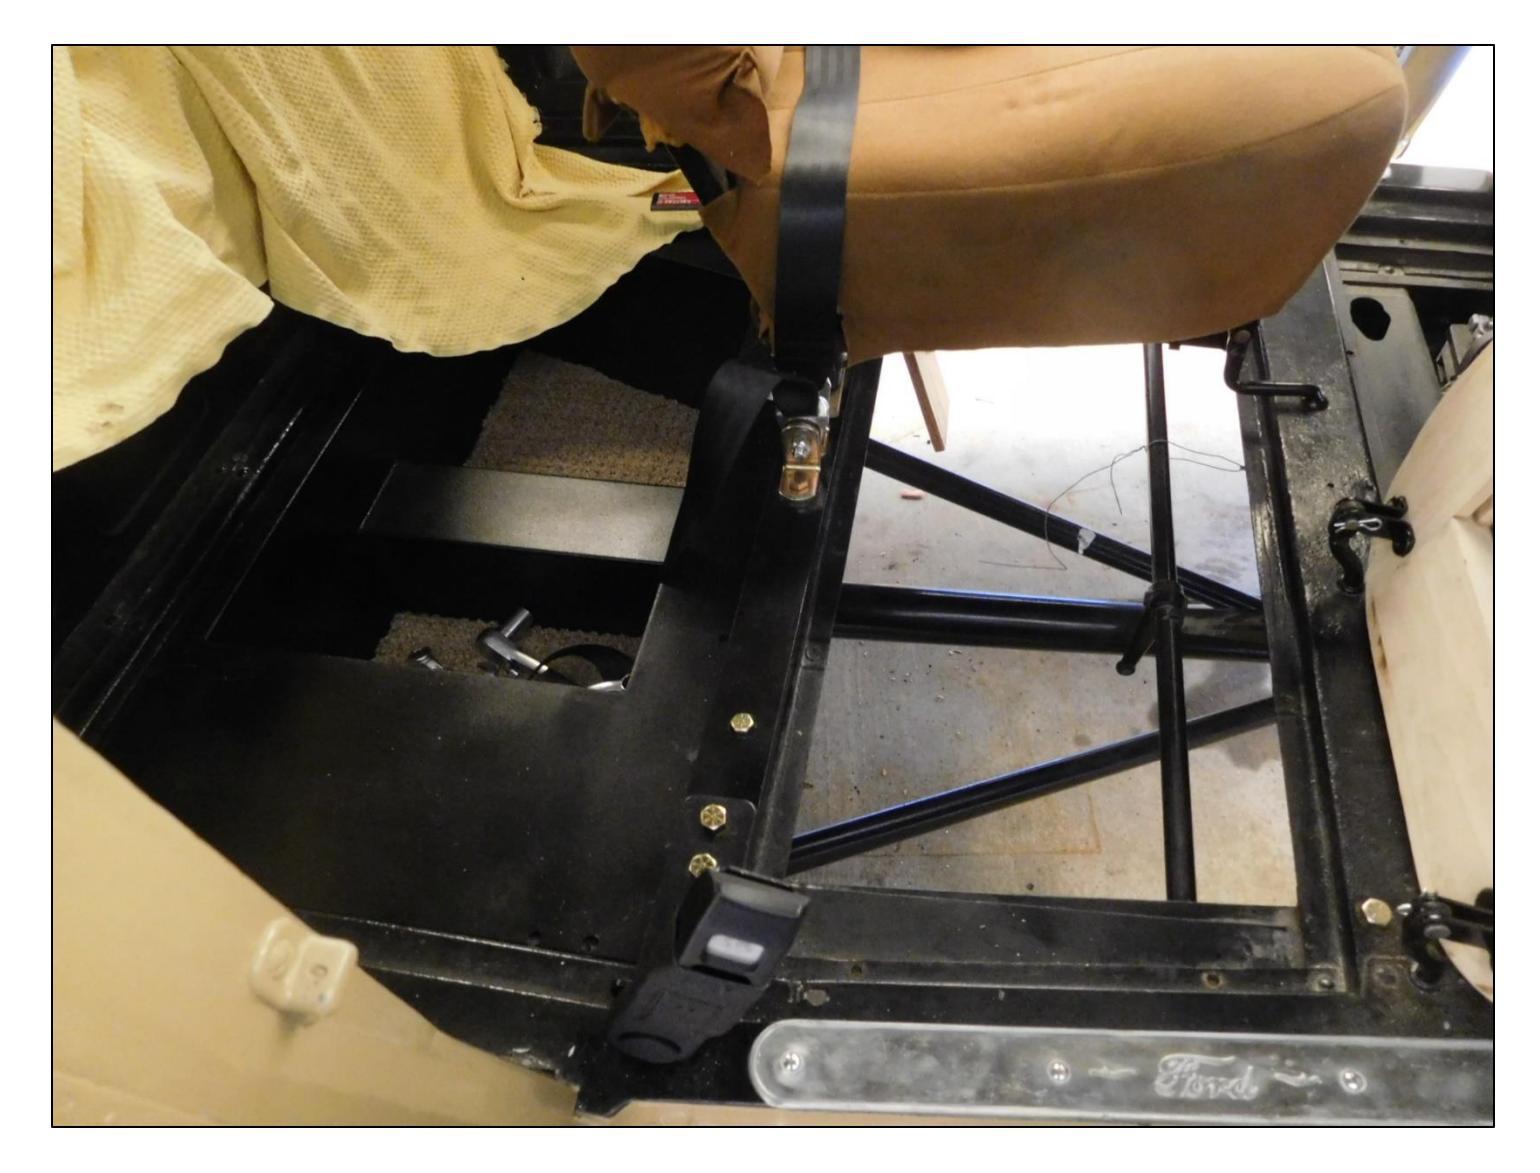
All three cross piece supports have been installed. The two long L-brackets mount the belt receptacles that are on the outboard side of each front seat. The two short L-brackets at the center mount the seat belts.

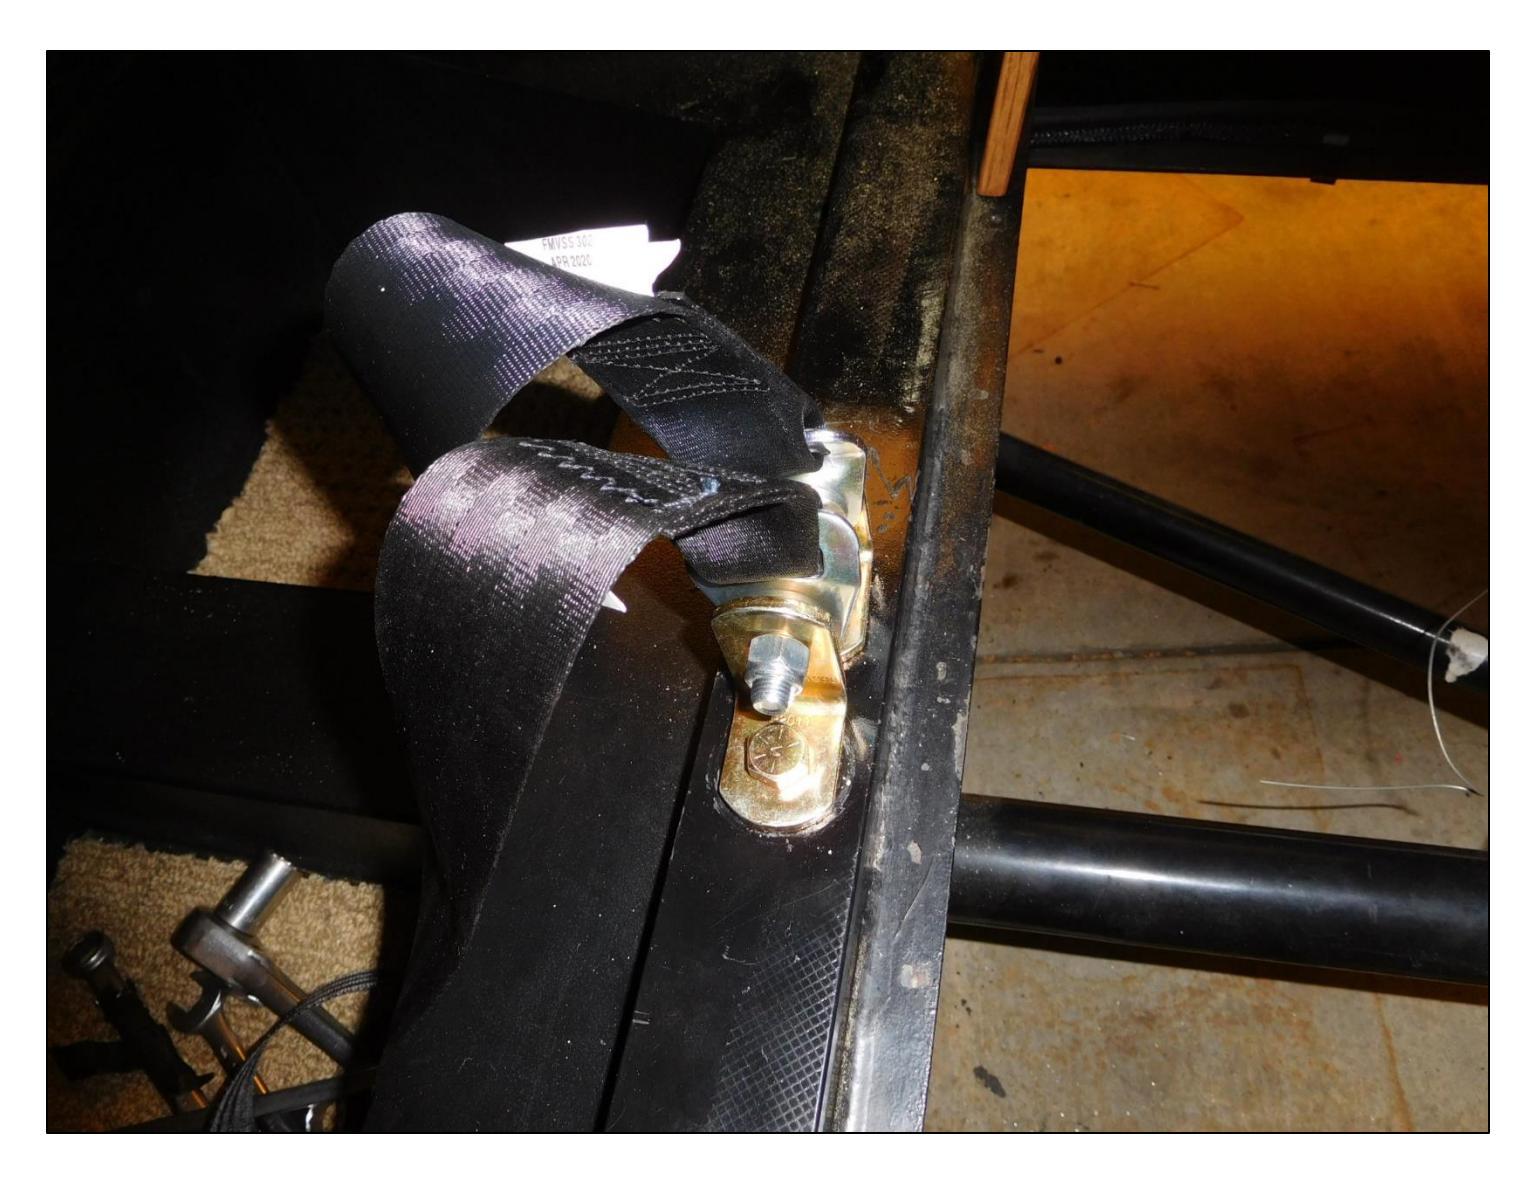
The short L-brackets are attached with 716" grade-8 bolts. They go through the cross piece and all three supports.

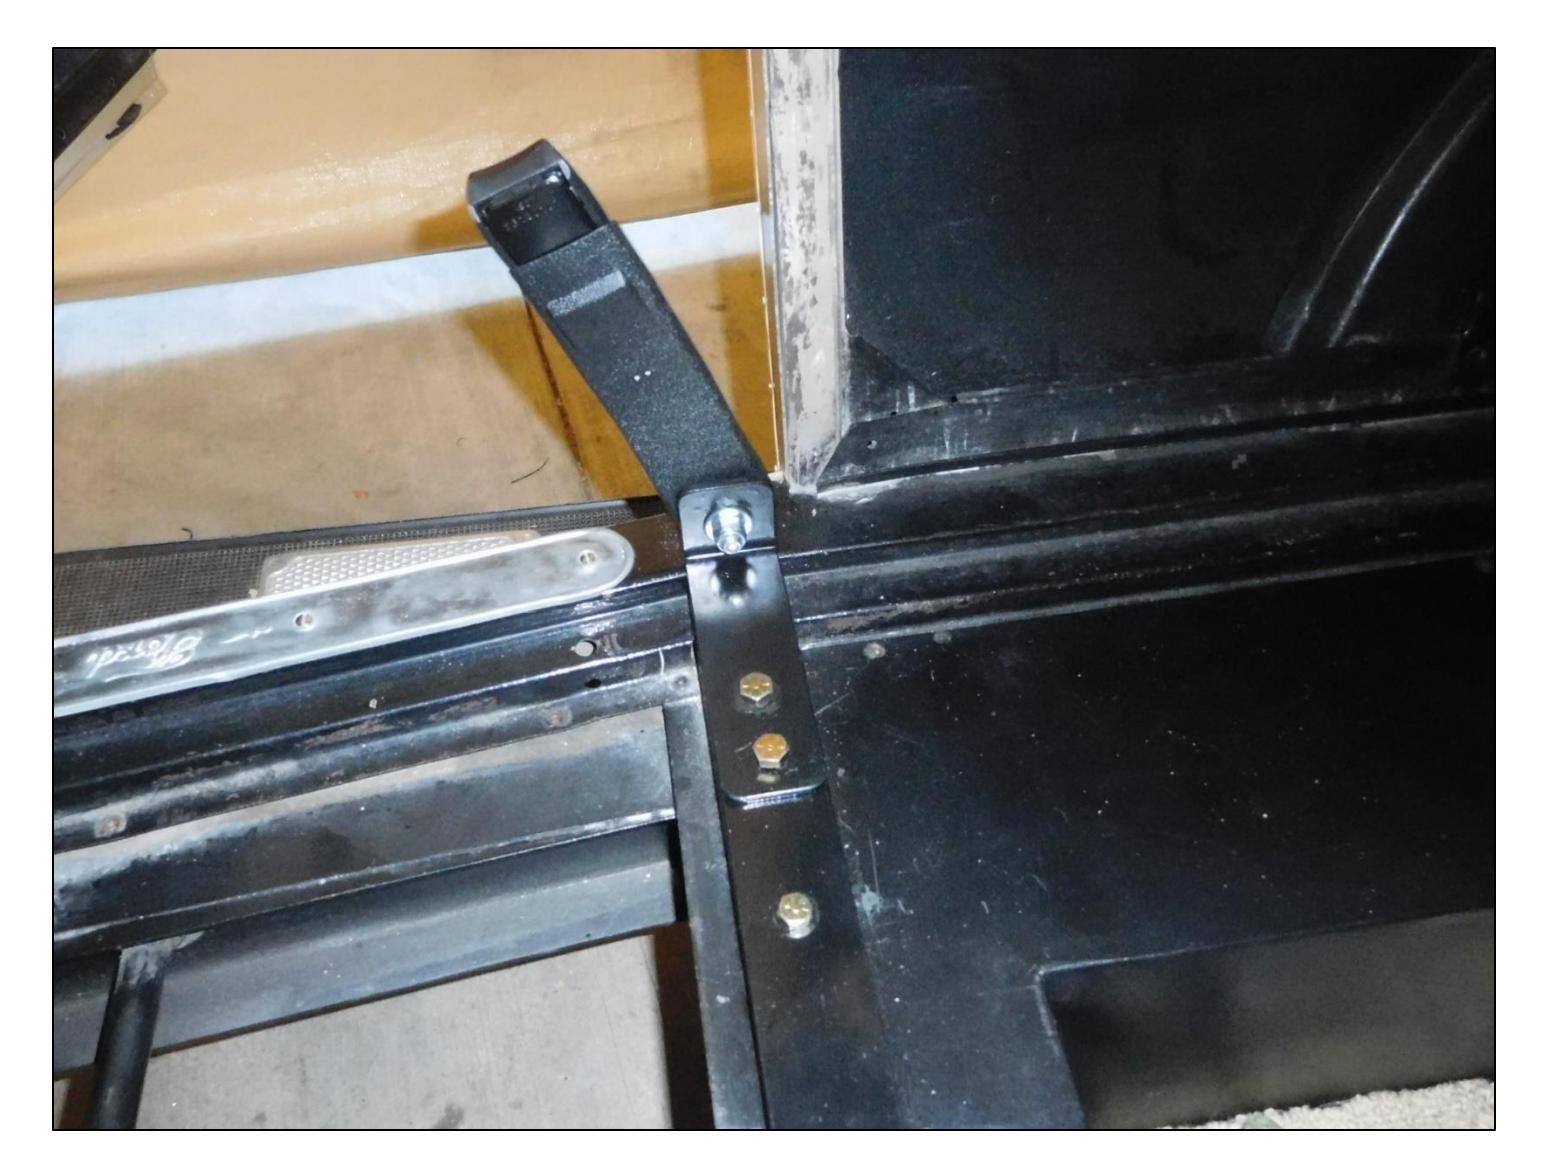
The outboard long L-brackets for the belt receptacles are attached to the cross piece with two grade-8 bolts each. The bolt closest to the receptacle goes down through the frame. A steel spacer had to be added under both outboard long L-brackets to raise them up to the level of the door sills.

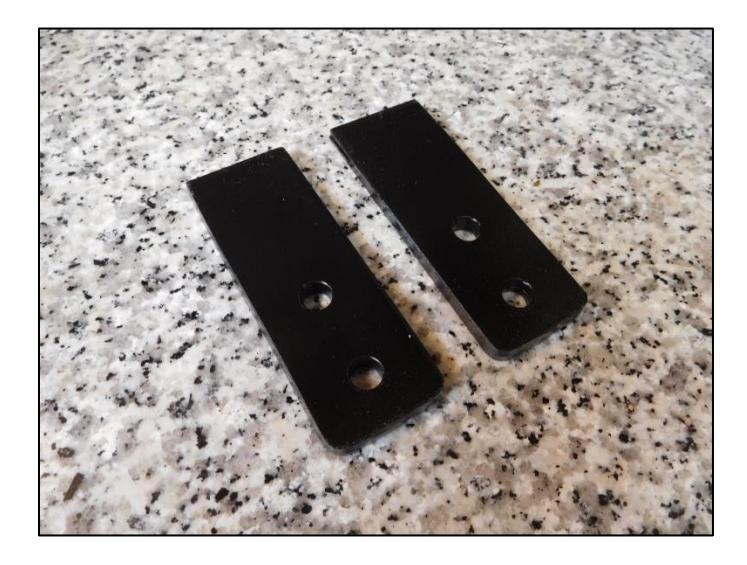
The spacers are 5\16" thick and one fits under each Long L-bracket.

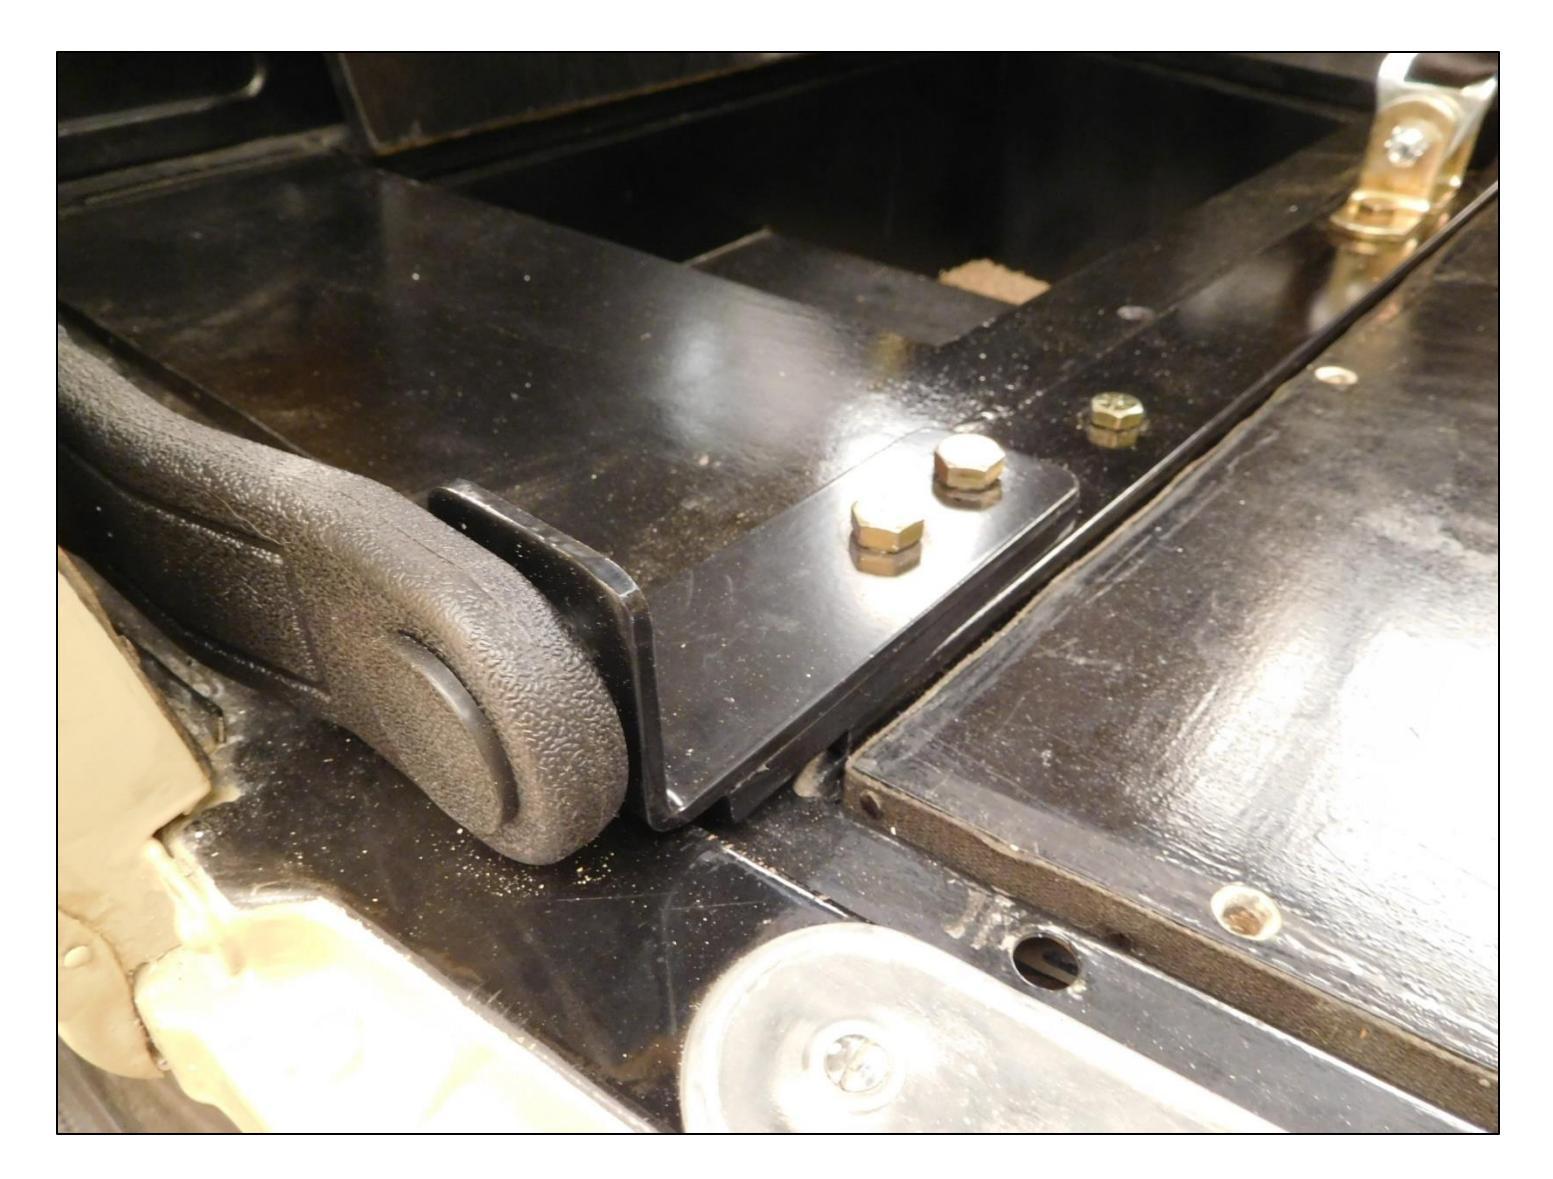
The belt receptacles can pivot both fore and aft to allow them to be folded down and out of the way when entering and exiting the car.

The hole seen in the lower right corner of the photo was where a seat belt was previously attached when the car was procured.
