30 Tudor Seat Belts

by Tom Endy 2021

During the recent restoration of a 1930 Tudor for my grandson Ben seat belts were certainly going to be included in the restoration. When we obtained the car there were seat belts installed, but only attached to the sheet metal. These were removed and discarded. Much thought has been given about how we were going to properly secure the new seat belts to the car.

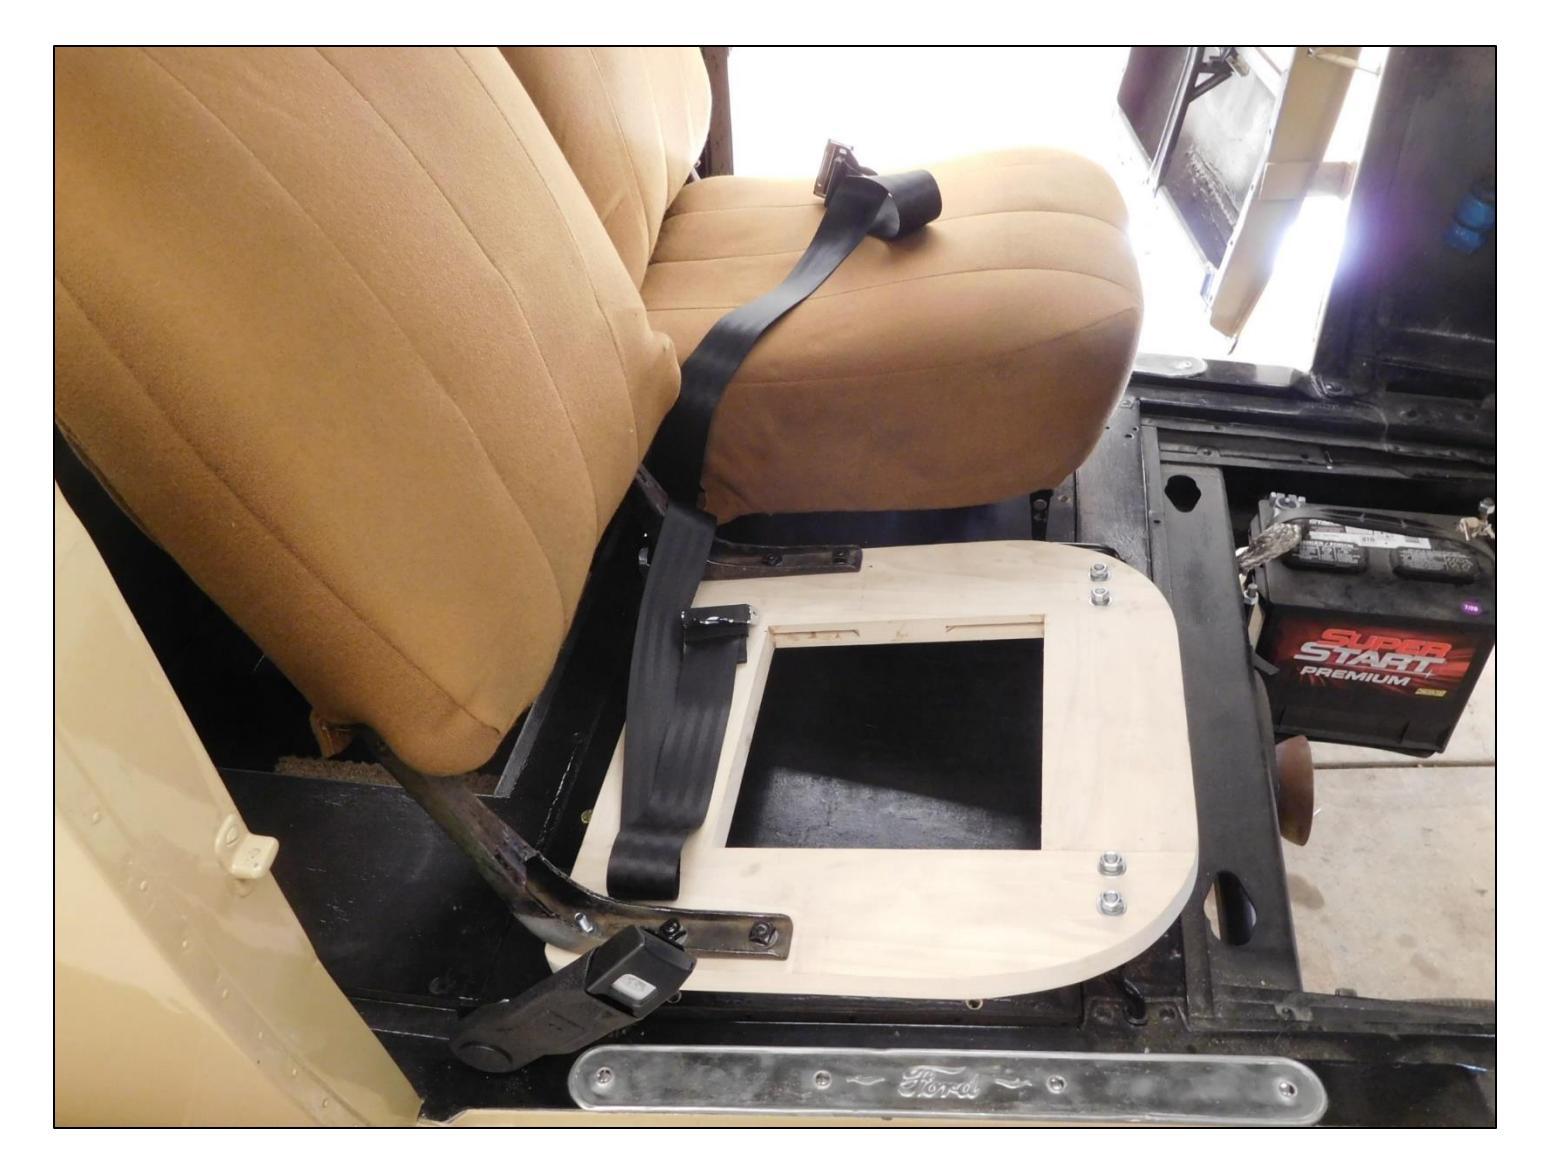
The inboard seat belts will lay on the floor when not in use. By using belt receptacles for the outboard belts there is not the problem of a belt falling out on the running board and scratching paint or having the door closed on a belt.

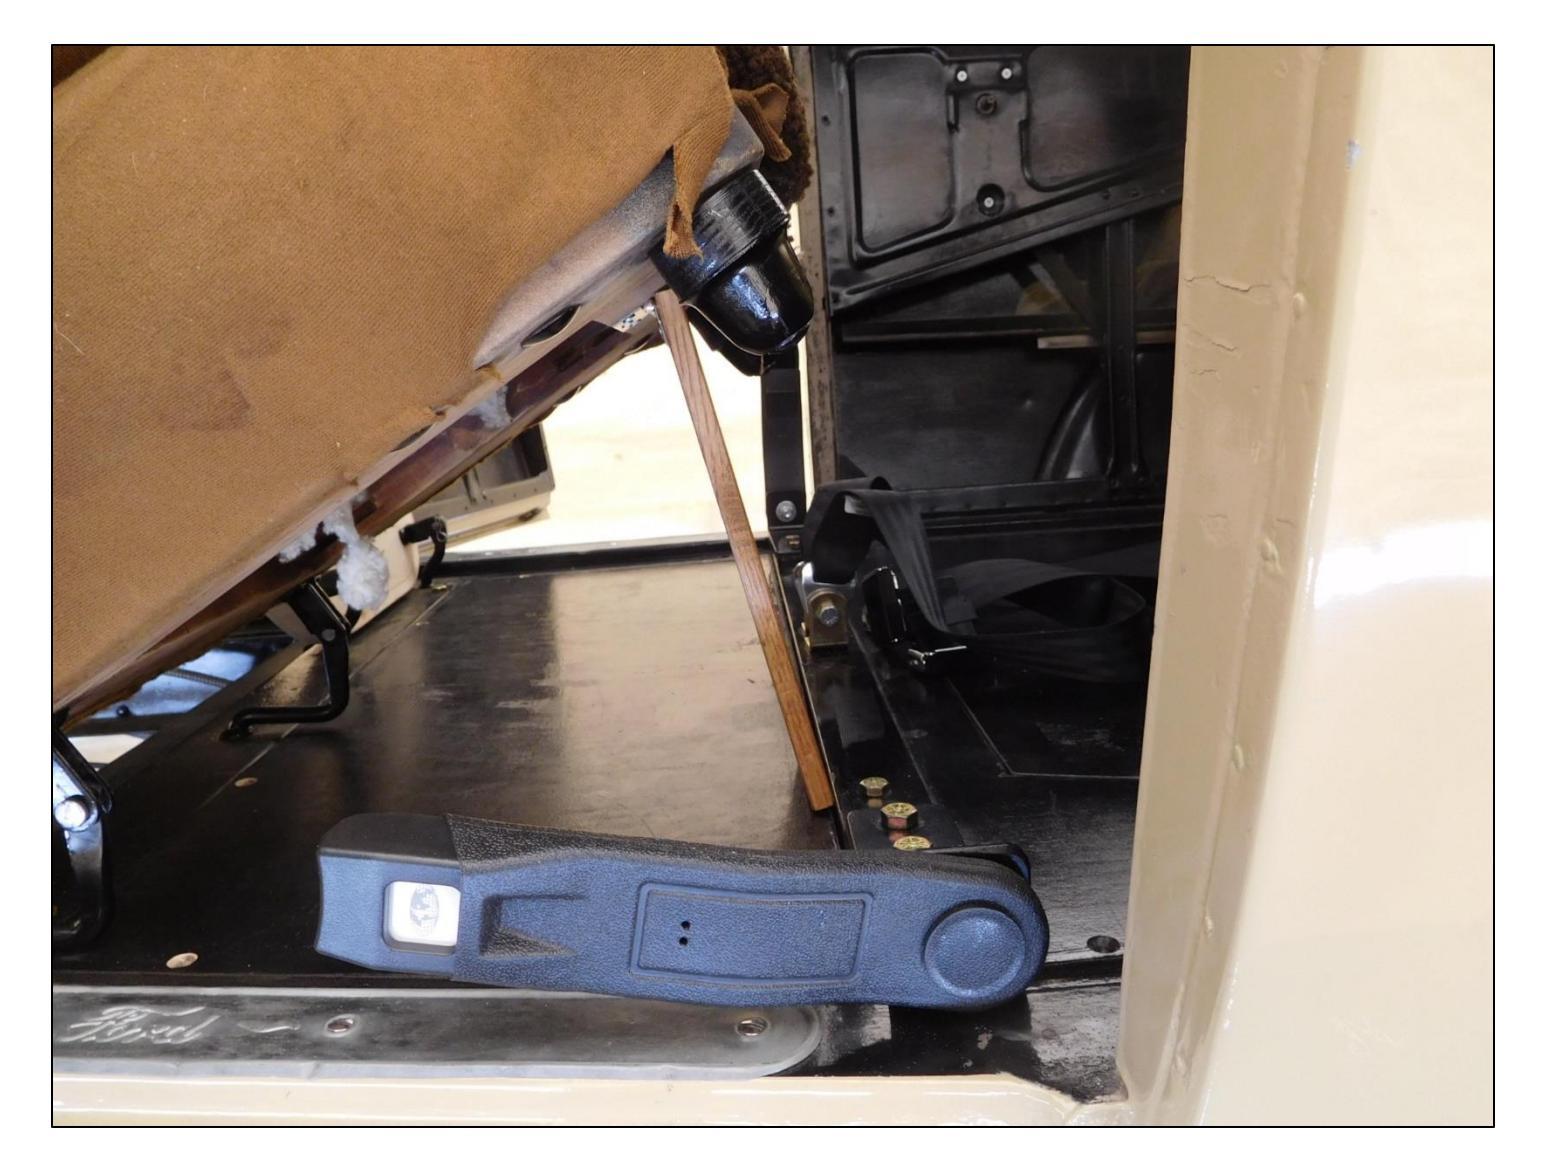
The driver's side belt receptacle is shown here folded forward. The passenger side is folded back.

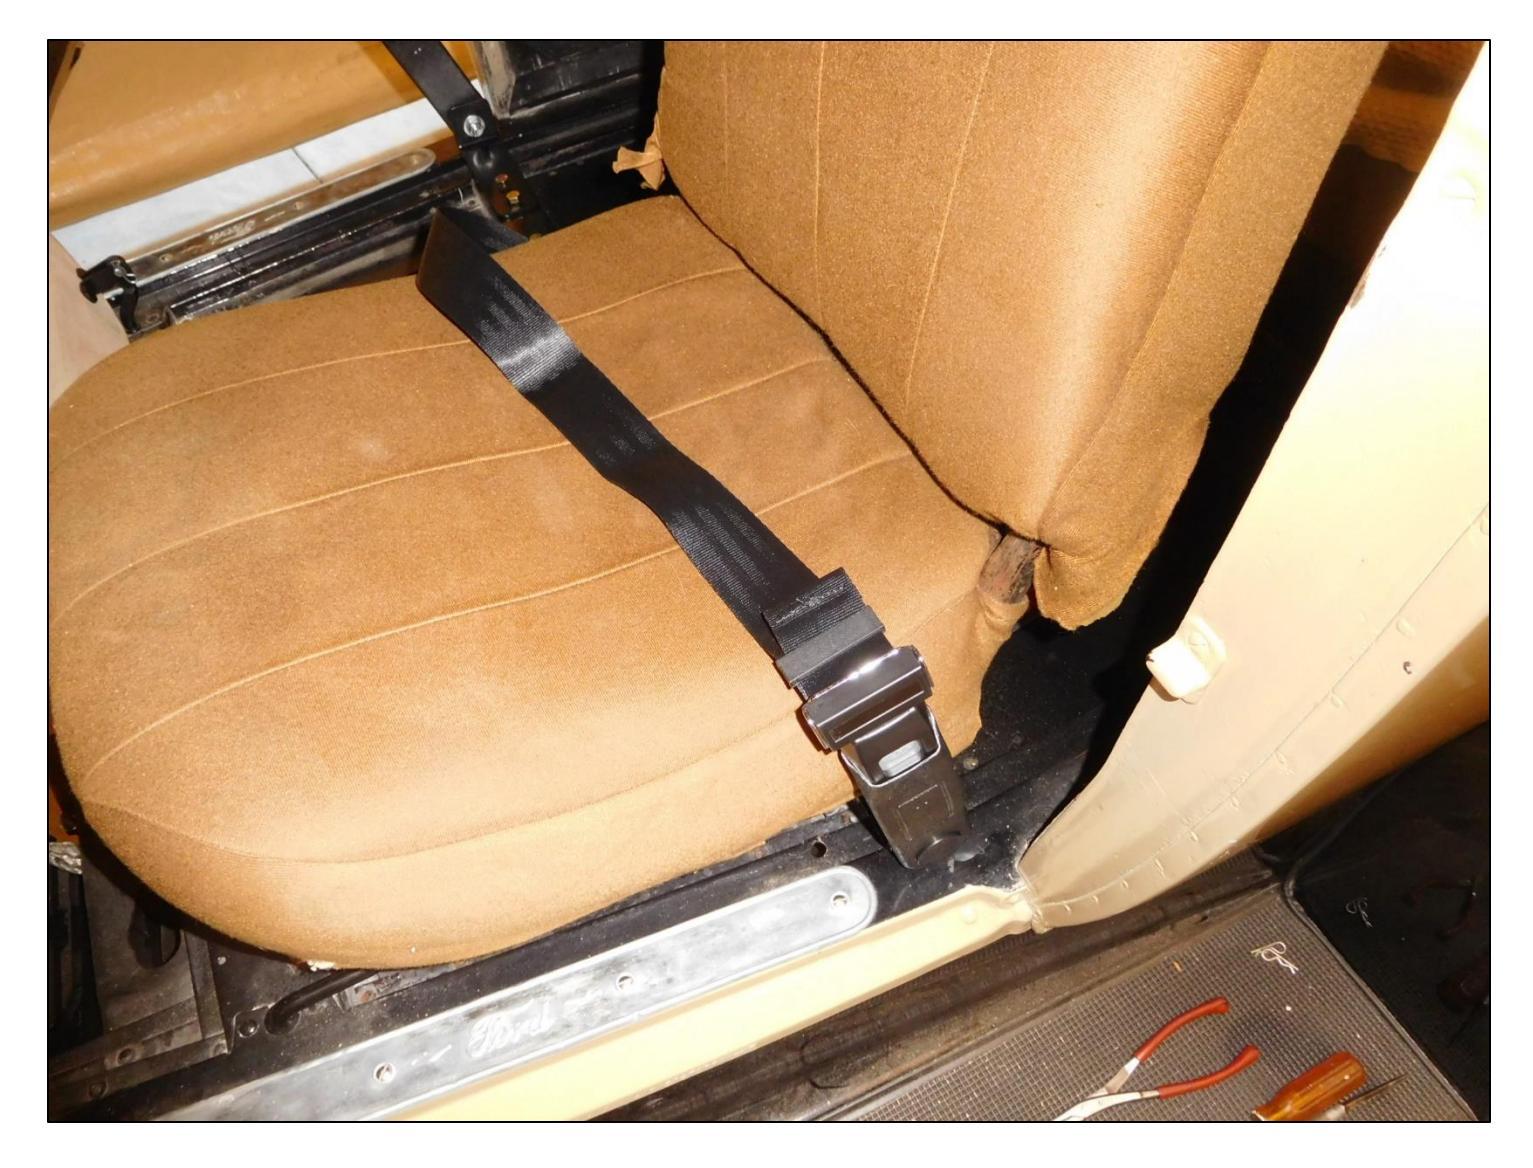
The front seat belts are safely secured to the car.
