# BELL HOUSING RESTORATION

by Tom Endy, Westminster, California

# DID THEY GET IT WRONG?

## EVEN THE PEDALS!

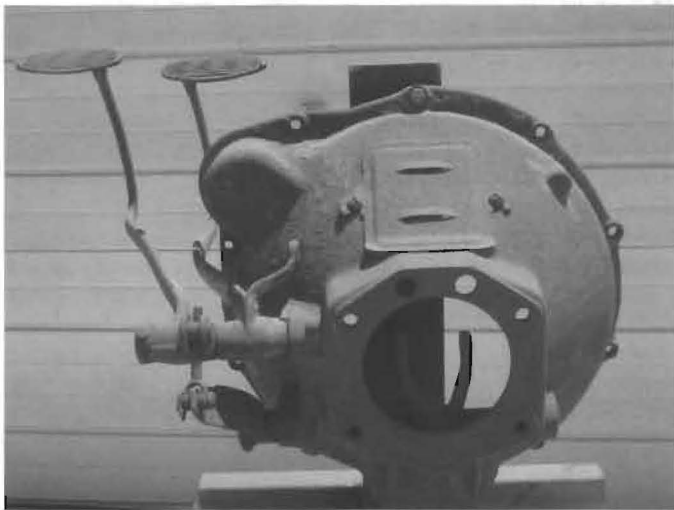
*A complete bell housing ready for disassembly.*

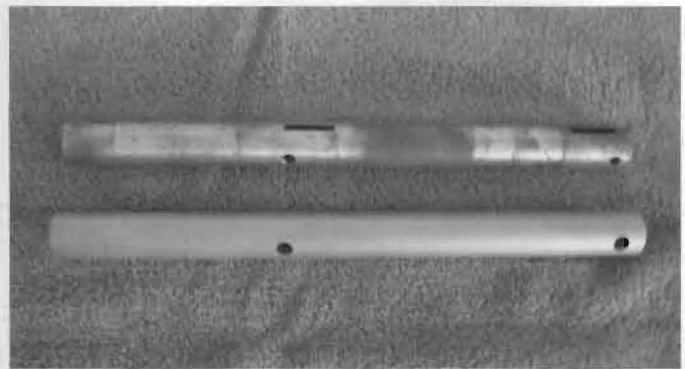
*Clutch release shafts. The shaft at the top of the photo is the early type using woodruff keys to lock the lever arm and yoke into place and using 3/16" locking pins. Note the wear on the left end of the shaft and about an inch in from the right end. The shaft at the bottom of the photo is the later type, using 5/16" locking pins. This shaft has only a slight amount of wear on it.*

Beware, there is an early and late version of the clutch release shaft, operating lever, and yoke. The early ones use a 3/16" locking pin and have a woodruff key in both the operating lever and the yoke that correspond to slots cut into both places on the release shaft. The later ones did not use the woodruff key method and had a 5/16" locking pin. Reproduction shafts and locking pins of both versions are available from Bratton's. There is a Ford service bulletin that addresses the change.

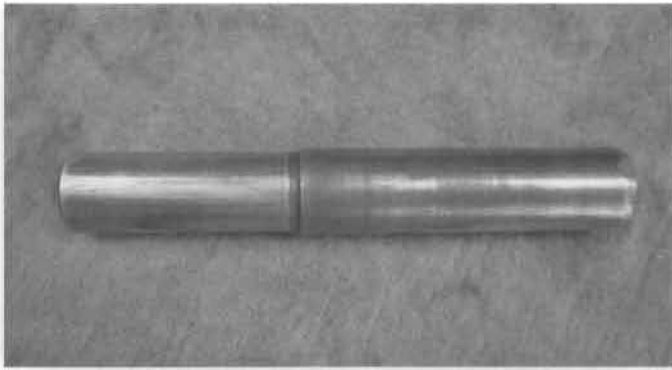
*Bushing removal and installation tool. The tool can be used for removal and installation of bushings in both the bell housing and the two pedals*

Once the clutch release shaft assembly has been removed from the bell housing, remove the two bushings. A stepped tool for removing and inserting bushings is the most desirable method. The tool is inserted into the bushing and driven out with a hammer. If one is not available, an alternate method is to split each bushing with a hack saw blade. Hammer or grind a common nail to a chisel point and tap it down alongside the split. Grip the protruding bushing with a pair of long nose pliers and curl it out. The pedal bushings in the two pedals are the same part number as the two in the bell housing and can be removed in the same manner.

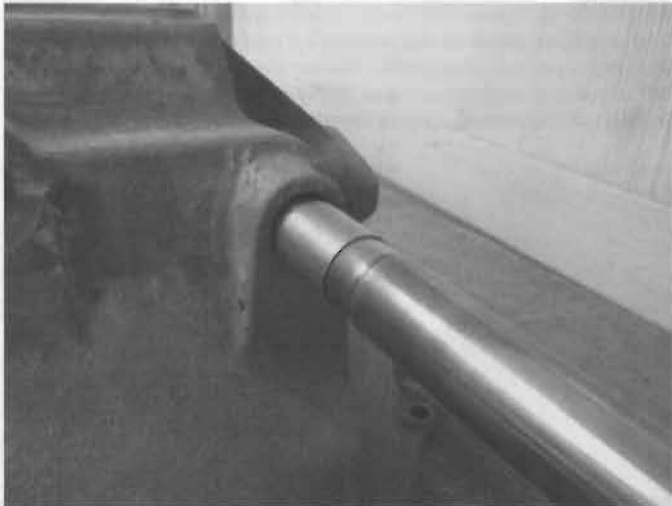
*The bushing tool can be used to drive the old bushings out and to drive the new bushings into place.*

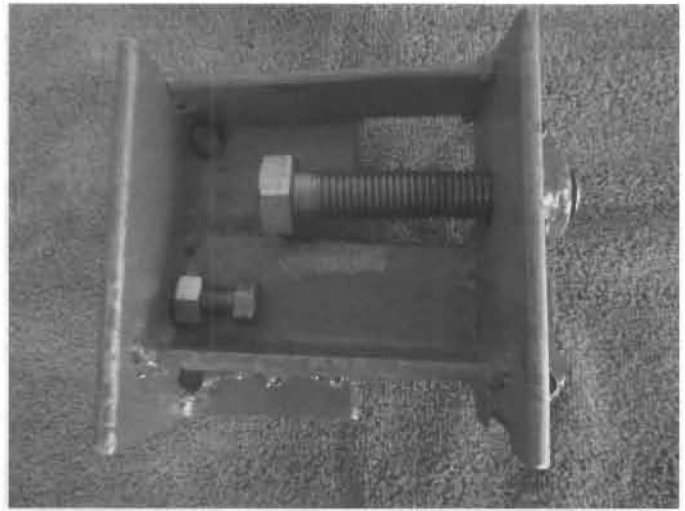
*Crude but effective tool used to push out a stubborn pedal shaft. The tool is bolted at the bottom to the four transmission mounting holes in the bell housing. The large bolt is turned with a wrench to push the shaft out.*

When the pin has been removed, the pedal shaft can be driven out from the inside with a long punch held at an angle, *sometimes!* Some pedal shafts are in there very tight and are difficult to get out. For the difficult ones I use a tool I made up that bolts to the transmission mounting holes. A large bolt is then turned and it forces the shaft out. An alternate method is to saw the shaft off close to the outside of the bell housing and drive out the remaining length toward the inside with a punch.

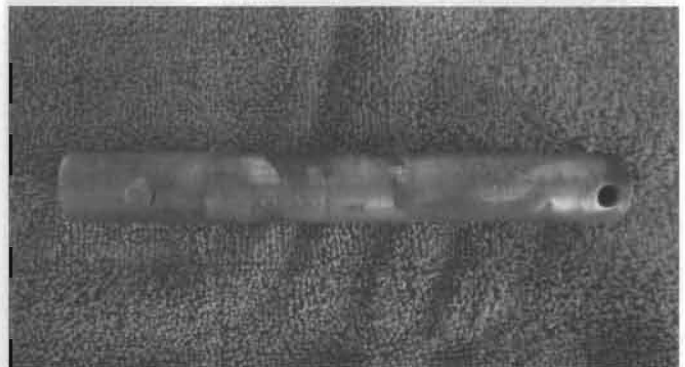
*Worn pedal shaft after removal from bell housing. Note the locking pin hole on the left end still has a portion of the pin in place. This stubborn pin had to be drilled out from each end, then sheared by driving out the pedal shaft.*

The last task in the disassembly process is to remove the pedal shaft, and this is not always easy. The pin that locks the shaft into place in the bell housing also comes in two versions. The earlier ones have a domed head, were driven in from the top, and had the end inside the bell housing mushroomed over. The later version had a soft tapered pin also driven in from the top. The tapered pins are fairly easy to get out. Both have to be driven out from the inside with a suitable punch. Before you can drive out the early ones with the dome-shaped head, you have to grind the mushroom off the end of the pin inside the bell housing. I used a small pneumatic grinder to do the job.

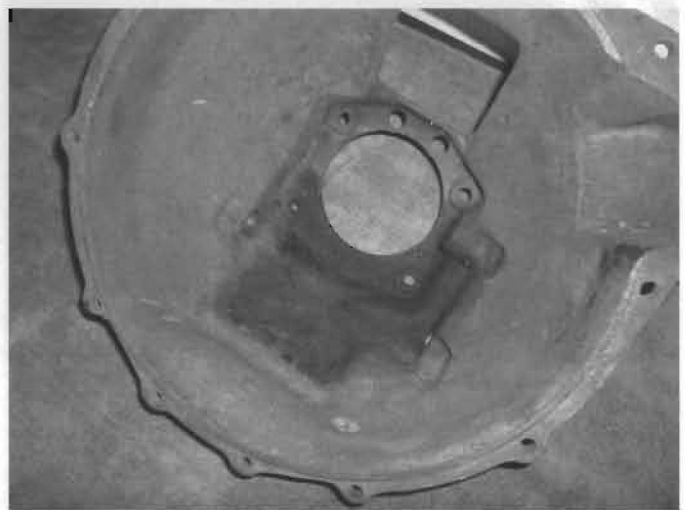
*The inside of a bell housing can be extremely cruddy. This one will have to be de-greased before it can be bead blasted.*

With the bell housing completely disassembled, a massive clean up project is the next task. After de-greasing, I bead blast them inside and out and paint the exterior with Ford green paint.

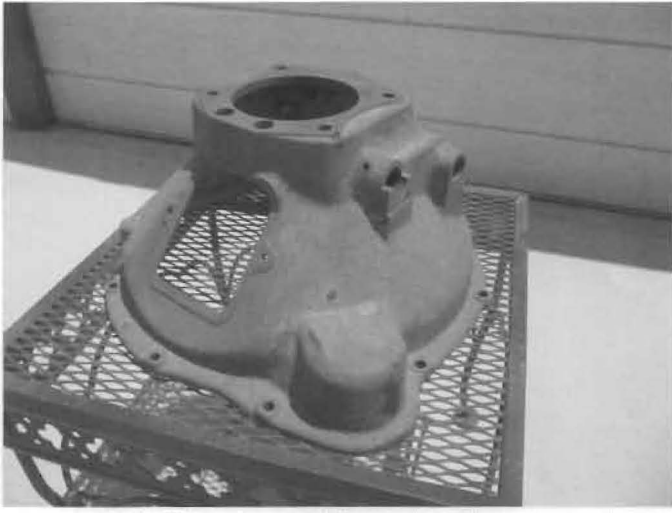
*Disassembled bell housing ready for bead blasting and painting.*

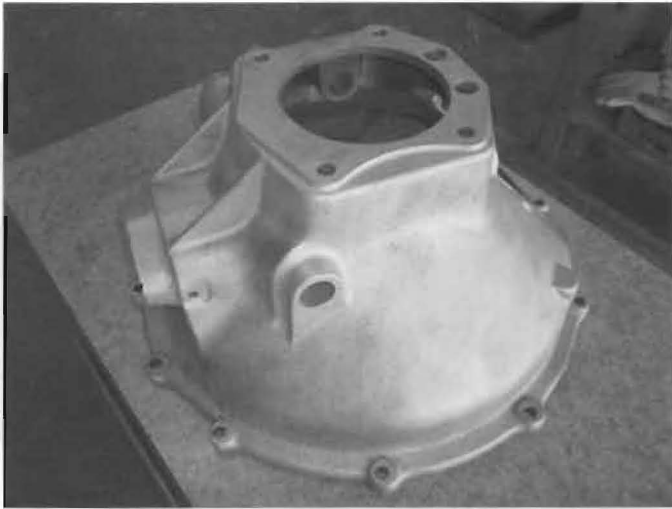
*The outside of the bell housing after it was de-greased and bead blasted.*

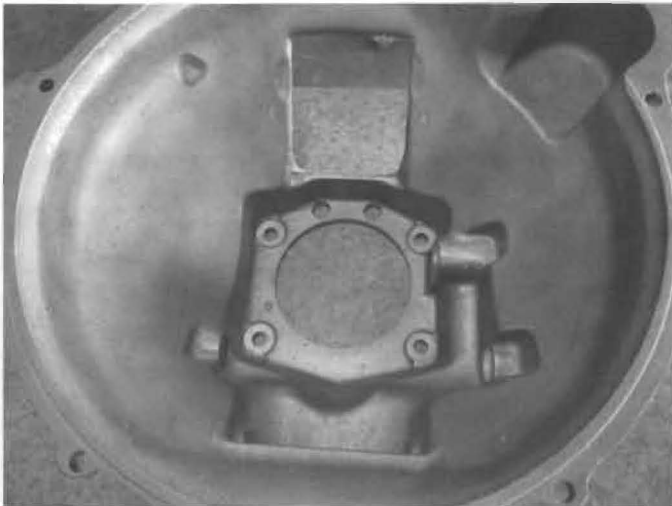
*The inside of the bell housing after it was de-greased and bead blasted.*

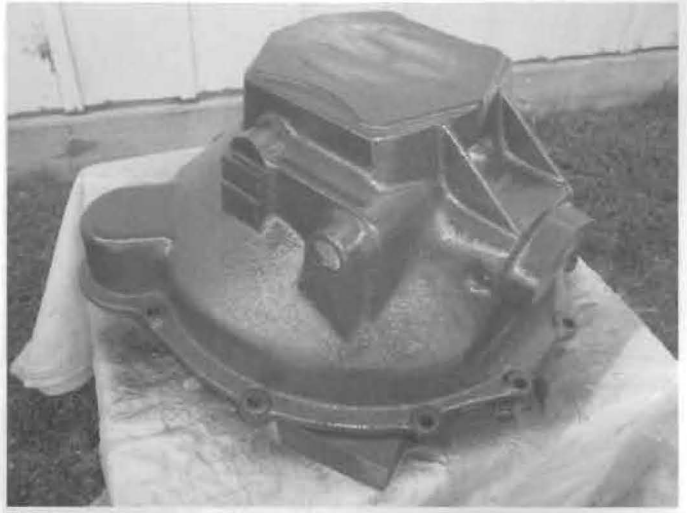
*The machined surfaces are masked off and the outside of the bell housing is painted Ford green. The inside of the bell housing is left unpainted and sprayed with WD-40 to prevent rusting. The unpainted machined surfaces are also coated with WD-40.*

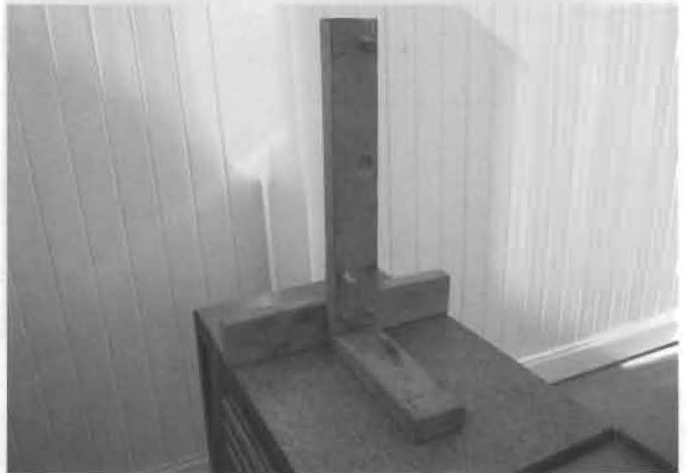
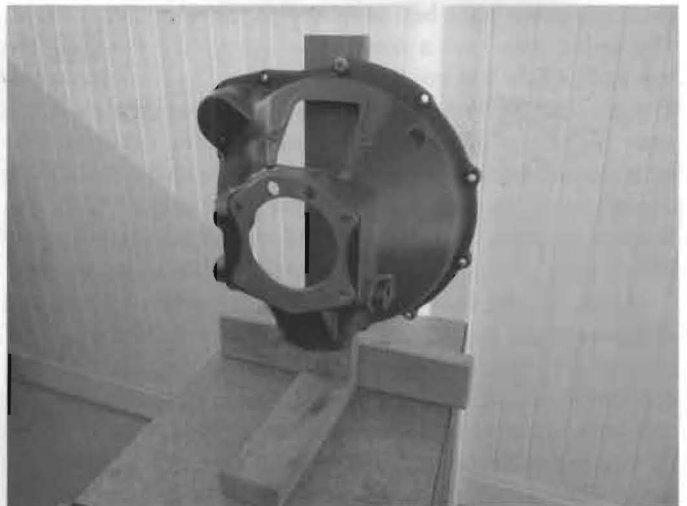
*A simple wooden stand makes the assembly process easy. It can also be used for disassembly.*

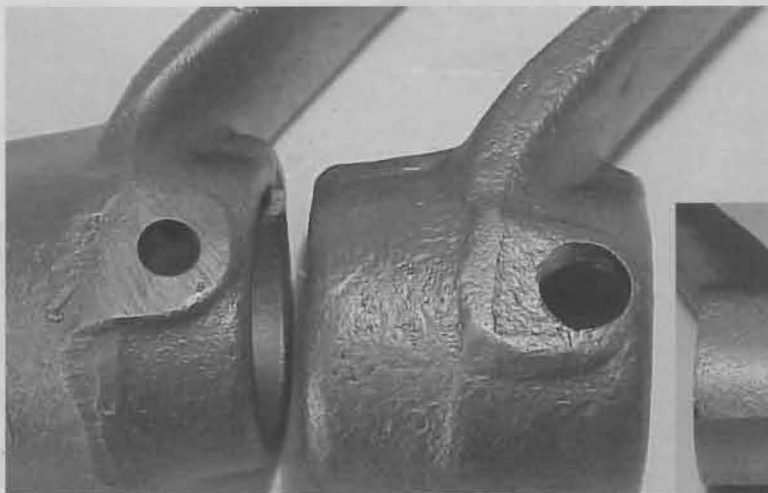
If you examine the old fork you will notice that there is ample material to accommodate a larger hole to allow use of the larger diameter pin. However, there is not ample material to allow the arm to be drilled out to accommodate the larger pin.

If the pin hole in the arm is enlarged the outer circumference of the new hole is almost to the edge of the arm and would certainly be prone to a crack at that point.

*The above photo shows two A7511-B arms. The arm on the left has the original 3/16" hole. The arm on the right has been drilled out to 5/16". Note how close to the edge the new hole is.*

I certainly would never drill out an old A7511-B release arm to accommodate a 5/16" locking pin, as it would be an invitation to failure of the arm.

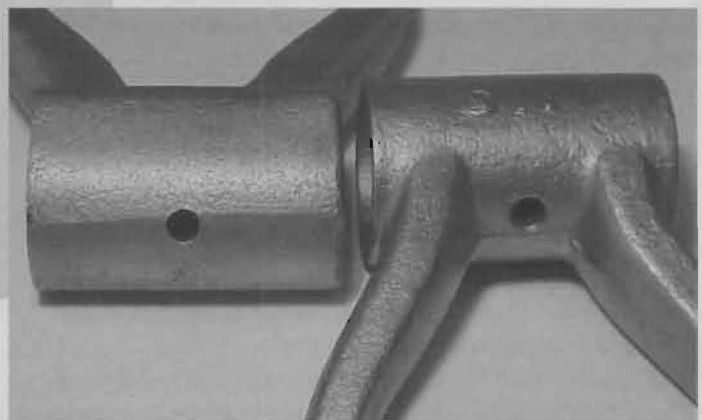
*The above photo shows two A7515-B forks with the original 3/16" holes. Note there is ample material to drill the holes out to 5/16".*

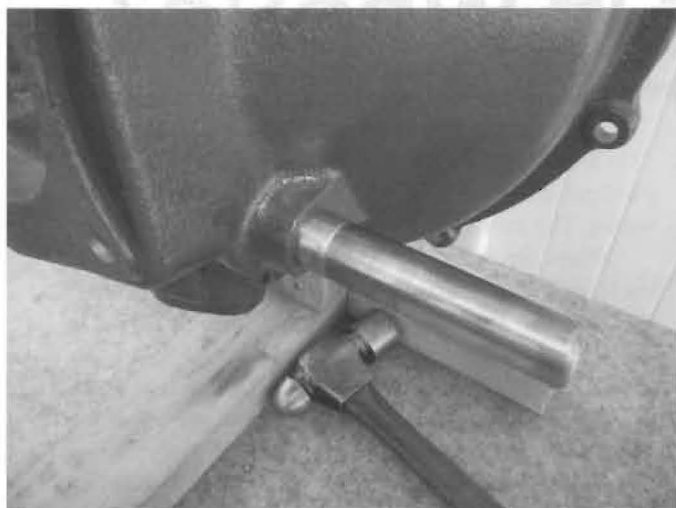
*New bushings are driven in with a bushing tool.*

stock. The tool should have a small collar on it that grips the edge of the bushing so it can be driven in without mushrooming the end.

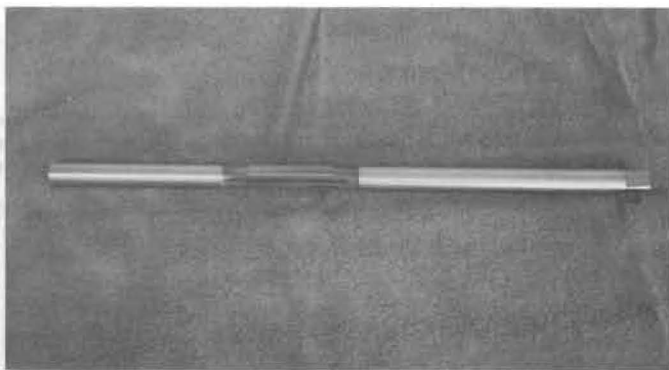
*Bushing reamer. This tool is long enough to ream both bell housing bushings in line. It is also used to ream the pedal bushings.*

The two bushings may need to be reamed to fit the new clutch release shaft. You will need a reamer long enough to be able to ream the two bushings so they will line up with each other. Honing is not a good idea in this case as you may be able to fit the shaft from either end, but they may not line up with each other and you will not be able to get the shaft through both bushings.

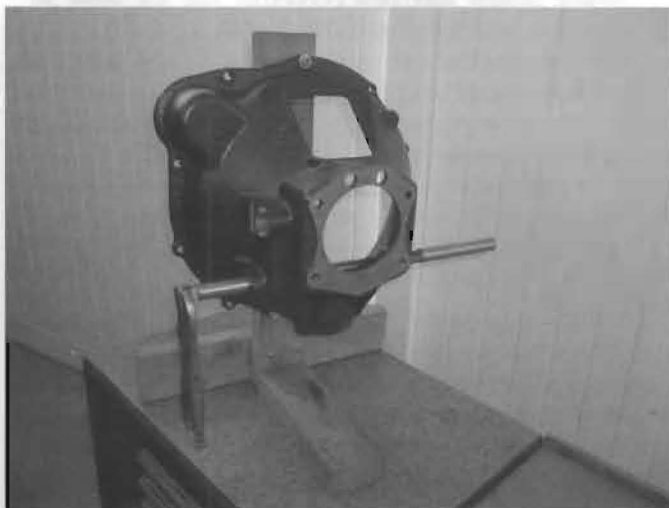
*This bushing reamer is long enough to fit through both bushings at the same time to ensure they will line up with each other.*

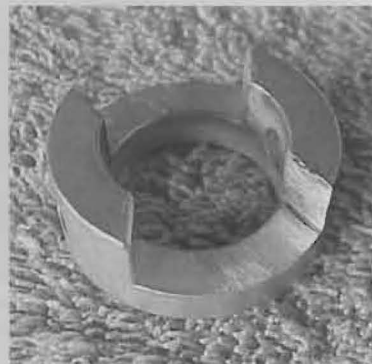
**I**t is quite common to find the brake pedal and the clutch pedal on a Model A Ford do not return to the upright position so they are even with one another. One pedal may sit lower than the other. This is caused by wear on the bell housing brake pedal stops, the clutch and brake pedal stops, and the clutch pedal collar stops.

*Clutch pedal collar with stops, p/n A7507-C*

Carefully note where the clutch pedal stops are sitting against the collar stops. With a marking pen mark the location of the two collar stops that are in contact with the

pedal stops. There are four stops on the collar, but you are only interested in the two you marked. Place the collar in a vice and carefully file material off both marked stops. Try to do it evenly. It is a trial and error fit process. As you remove material from the two collar stop positions, the clutch pedal will start to move

up even with the brake pedal. When the process is complete both pedals will be even regardless of the orientation of the clutch pedal collar. It can be installed on the pedal shaft two ways, but it won't make any difference in the pedal height.

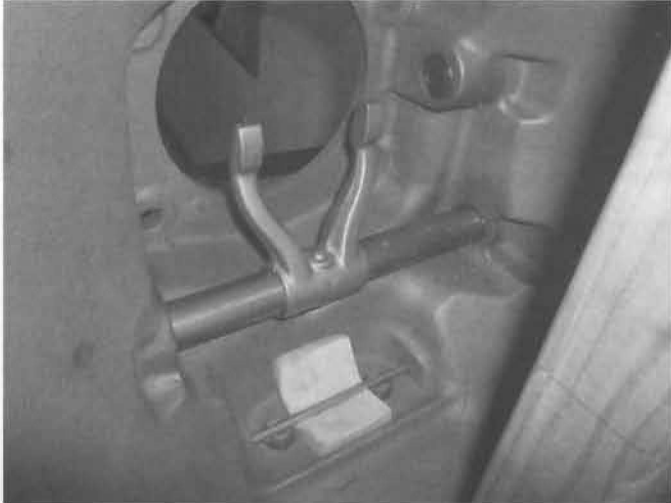
*Yoke oriented correctly on new clutch release shaft. Radius rod bolt heads and felt installed correctly and retained by the long pin.*

The yoke is then installed onto the release shaft as it is slid into the bell housing. Be certain to orient the yoke in the correct position to properly engage the throw-out bearing. With yoke in a vertical position the operating lever should be pointing to the rear. The yoke locking pin is driven in from the top.

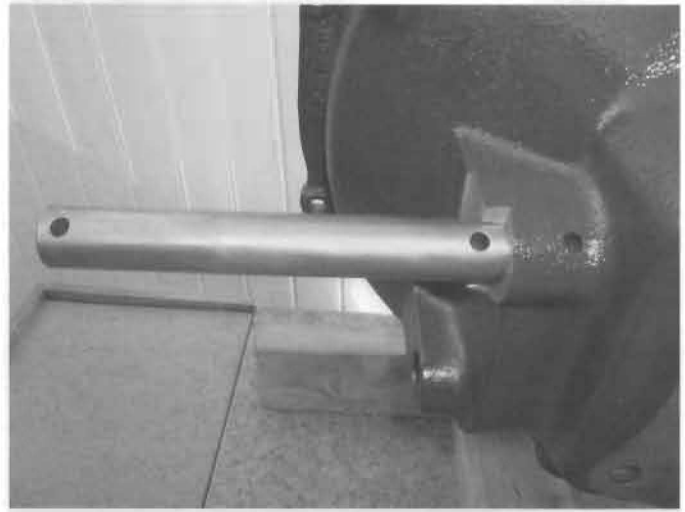
*The end of the pedal shaft with the pin hole about an inch from the end of the shaft goes into the bell housing. The other end of the shaft has the hole close to the end of the shaft. Accurately line up the hole in the shaft with the hole in the bell housing before driving it in.*

of the shaft into the bell housing. The end with the locking pin hole about an inch from the end of the shaft goes into the bell housing. (2) Be certain to line up the hole in the shaft accurately with the hole in the bell housing. (3) Do not pound on the end of the pedal shaft with a hammer as it will mushroom the shaft. Use a block of wood against the end of the shaft. Drive the shaft in until the two holes line up.

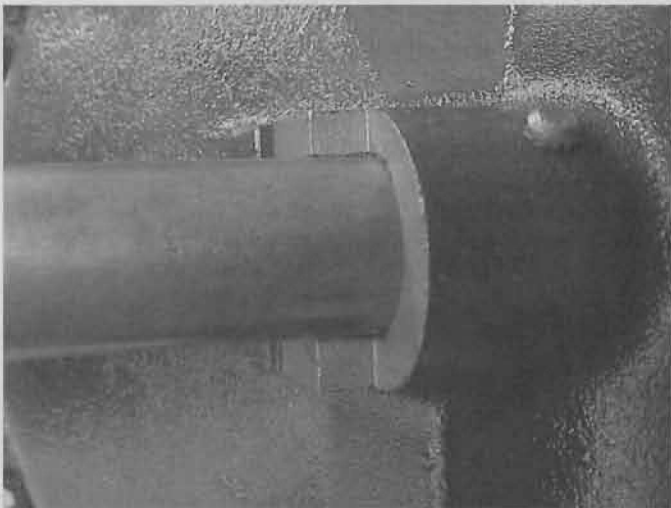
*Bell housing brake pedal stops*

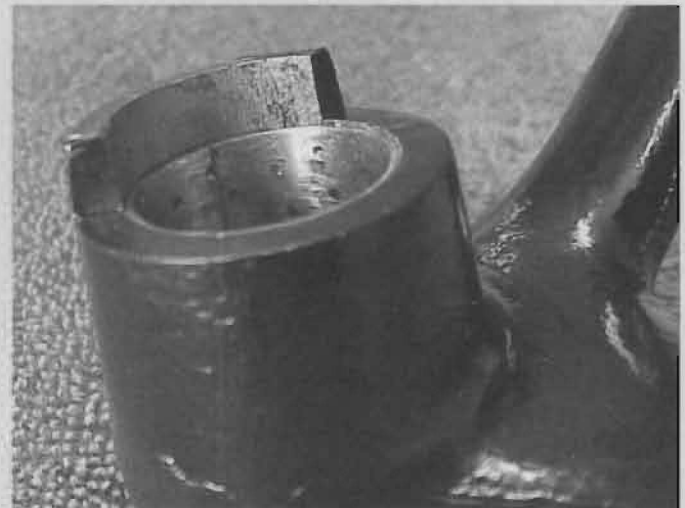
*Brake pedal stops*

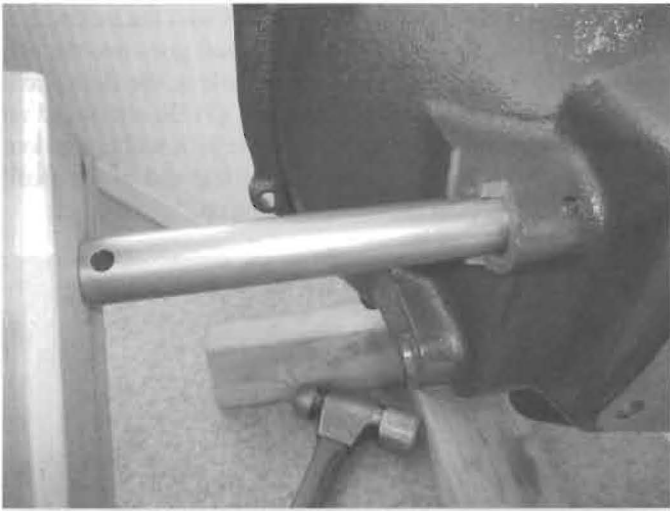
*Use a block of wood so as not to mushroom the end of the shaft with the hammer.*

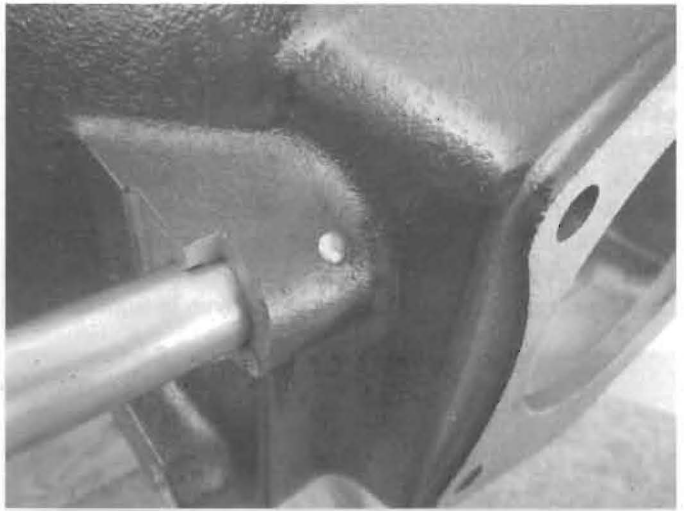
*Drive the pin in until it is flush with the housing.*

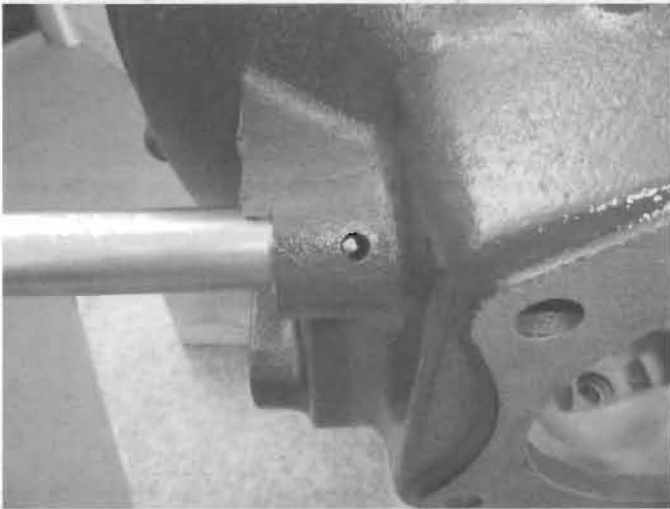
*Drive the pedal shaft in until the two holes line up.*

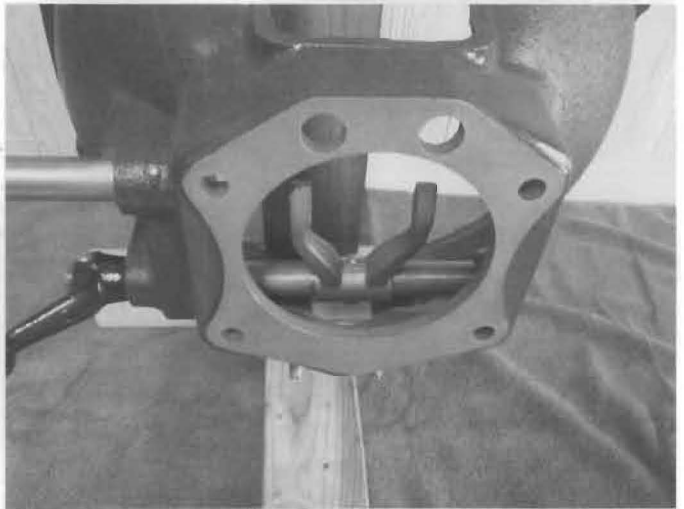
*New pedal and clutch release shafts installed. Note operating lever points to the rear when the yoke is standing vertical.*

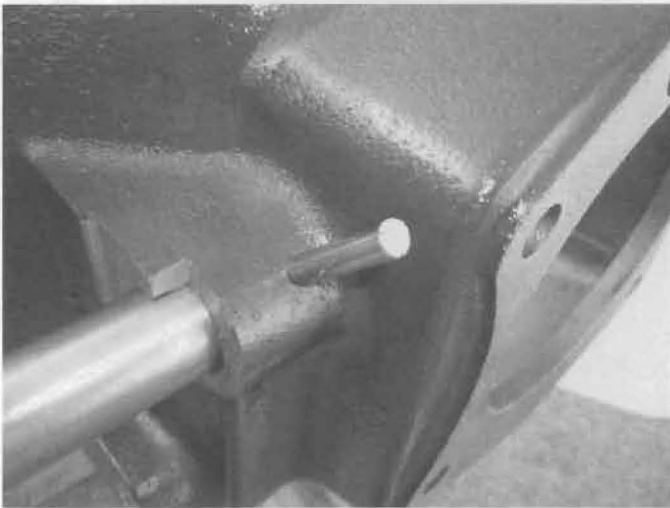
*A tapered pin is driven into the bell housing hole to lock the pedal shaft in place.*

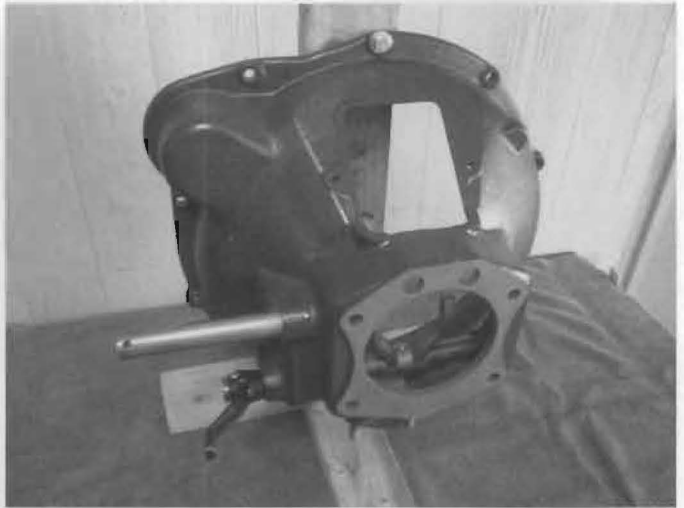
*Complete restored bell housing. New clutch release shaft, bushings, and pedal shaft have been installed. The bell housing is ready for installation in the car once the transmission has been attached.*
