# Rear Backing Plates

by Tom Endy

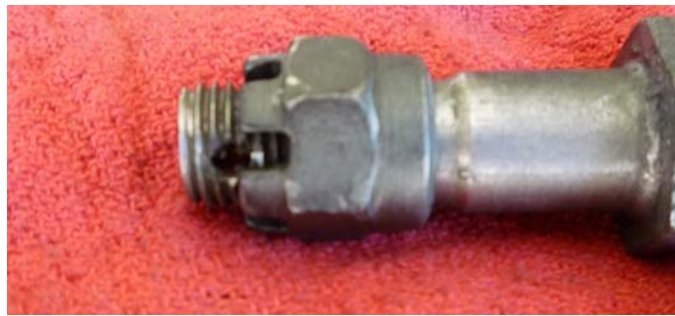
**Fig.1** Shows the castle nut run all the way up on one of the mounting bolts. The hole protrudes way past the end of the castle slot in the nut. This is often how the relationship of the bolt and nut ends up after the backing plate, emergency brake carrier, and grease baffle are installed.

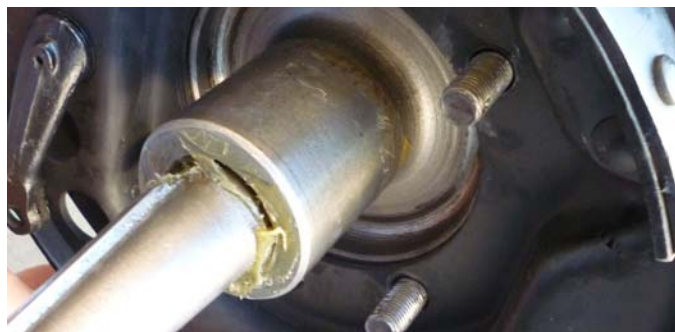
**Fig.2** This is how far the bolts protrude through the backing plate and the emergency brake carrier. The grease baffle, which is very thin, has not been installed yet.
