Technical tip:

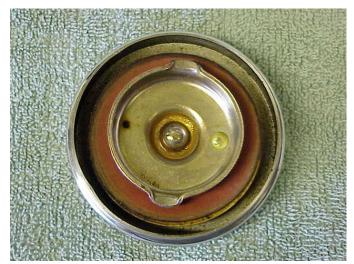
Reproduction gas caps have a quality issue that can cause you some amount of grief. A large single rivet in the center on the bottom of the cap holds the assembly together. The rivet goes through the bottom metal grabbing device, a red colored gasket, and a brass flat washer. Off to the side is drilled a vent hole through all three parts. Without a vent hole thank would experience a vacuum lock as the gas in the tank is depleted. Eventually it would stop the gravity flow of gas to the carburetor and the car would appear to run out of gas.

It is possible, and extremely likely, that as the cap is twisted on and off the tank numerous times, one or more of the three parts will rotate out of position on the center rivet. When this happens the vent hole will be blocked off and the vacuum thing will happen. When you remove the cap you are liable to hear a "Whoosh" sound as air rushes into the tank to equalize the vacuum.

Modified gas cap with a small rivet epoxyed into place opposite from the vent hole.

Before you allow the vent hole to become blocked it is a good idea to modify the cap. Drill a second hole through the three pieces. Be careful not to drill clear through the top of the cap, just the three pieces. Tap the hole for a 6-32 screw. Lock-tight or epoxy it in place so it won't fall out into the gas tank. The screw will prevent the three parts from rotating out of position and the vent hole will maintain alignment through the three separate parts.
