# Removing the Race

by Tom Endy

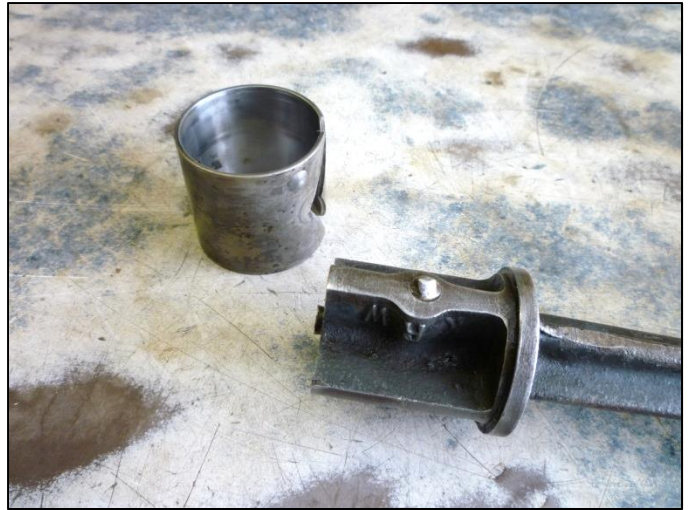
**The tool and a removed race: The split race is somewhat spring loaded and the spring tension holds it in place inside the torque tube. The dimple shown near the top edge of the race seats in a mating protrusion in the torque tube.**

The roller bearing race (sometimes called a sleeve) installed in the front of the torque tube can be difficult to remove unless you know the trick. The trick is to stand a drive shaft up vertical with the spline end up. Place a 1&1\16" six point socket over the spline. Slide the torque tube over it and bounce it a few times. Best to hold a rag over the top to catch the greasy race and seal that will exit.

K.R. Wilson made a removal tool for the purpose. It can also be used for installation. The tool is extremely rare, but some are still around.

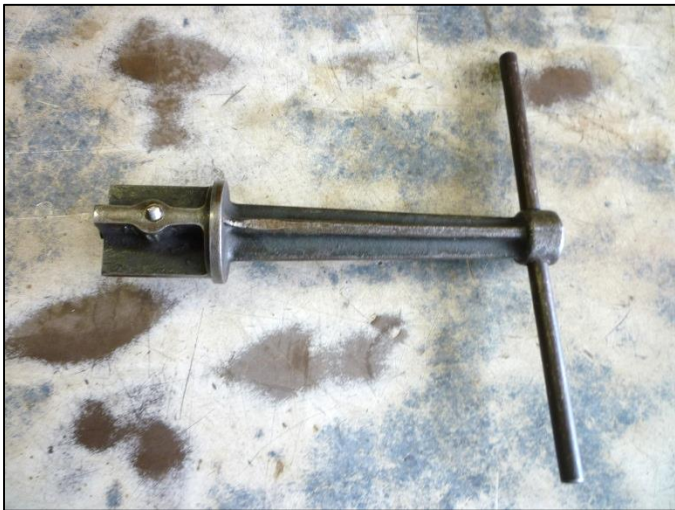
**KRW tool: Note the spring loaded button in the center at left. This button pops into the hole that is in the center of the race. A twisting pulling motion pulls it out of the torque tube.**

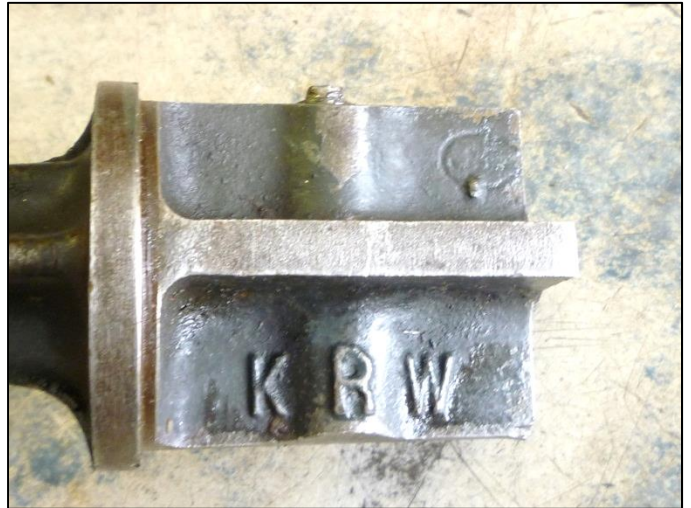
**Genuine vintage K. R. Wilson**

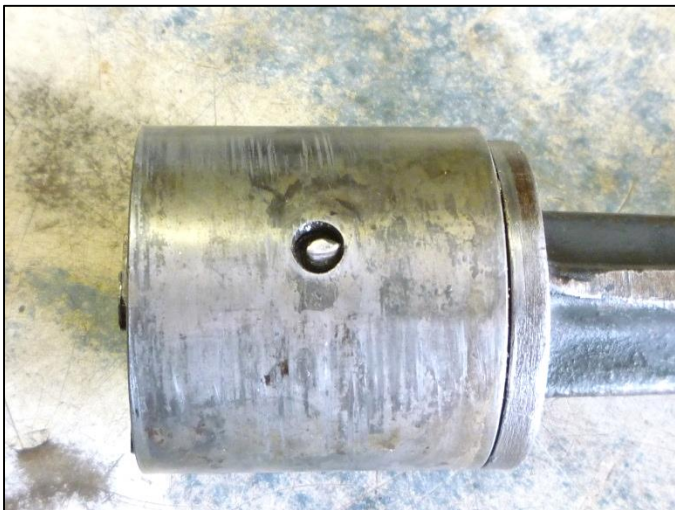
**A removed race is shown mounted to the tool with button protruding through the hole.**
