## **Pinion Gear Assembly Puller Tool Pictorial**

by Tom Endy 2018

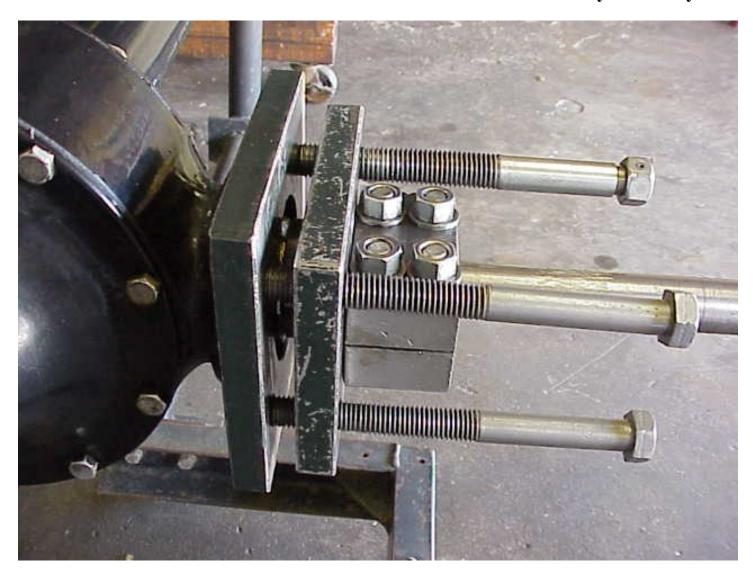
A number of people have contacted me inquiring if there is a drawing available for the pinion gear puller tool I use. There is no drawing. However, if someone wants to build a similar one, the photos shown here should provide enough information. The critical part is the block of steel that clamps to the drive shaft. It must clamp tight so that it does not slip.

The clamp was made from a solid block of steel. A hole was bored through it that is smaller than the diameter of the drive shaft. The four holes for the clamping bolts were also drilled. The block was then cut in half.

Using this type of a puller tool will not disturb the pre-load that is set on the pinion bearings. This is important if the task is to install an overdrive. The pinion gear assembly can be removed from the drive shaft and installed on the overdrive stub shaft without disturbing the pre-load.

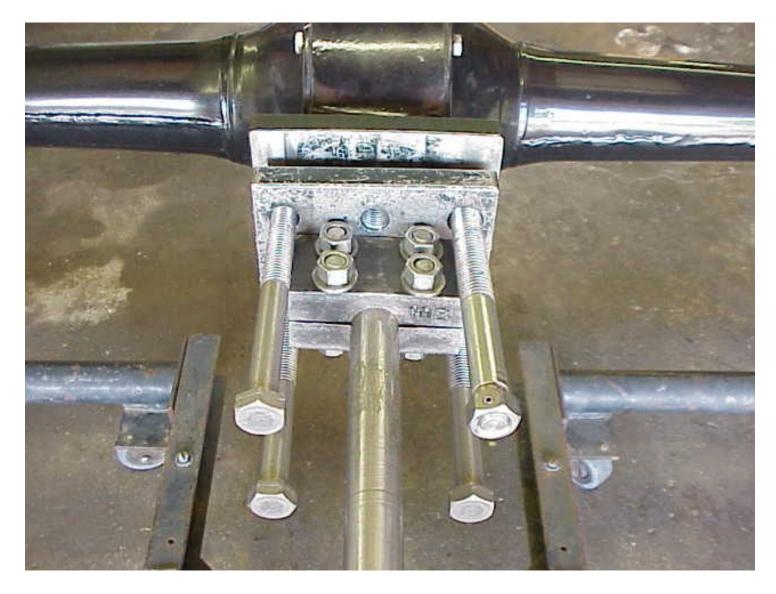
The puller tool is shown set up to pull a pinion gear assembly out of a banjo.

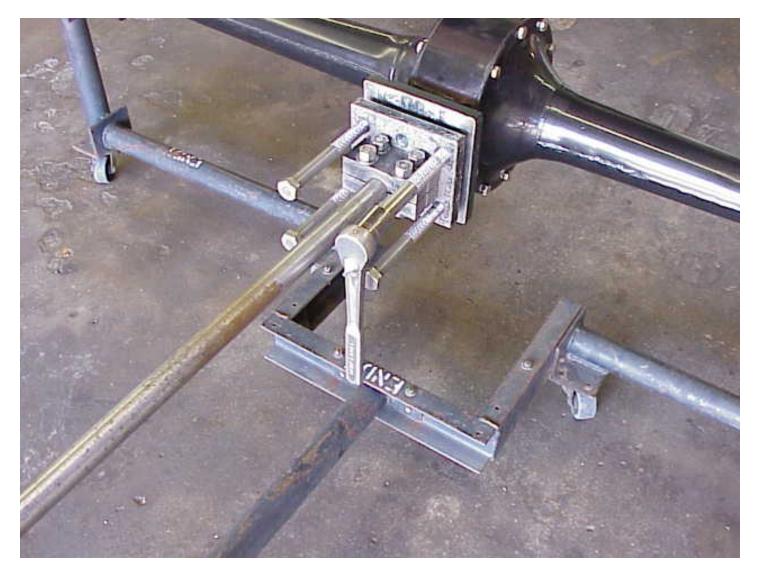
The puller tool is shown set up to pull a pinion gear assembly out of a banjo. By evenly tightening each of the four puller bolts the entire pinion assembly will be removed from the banjo.

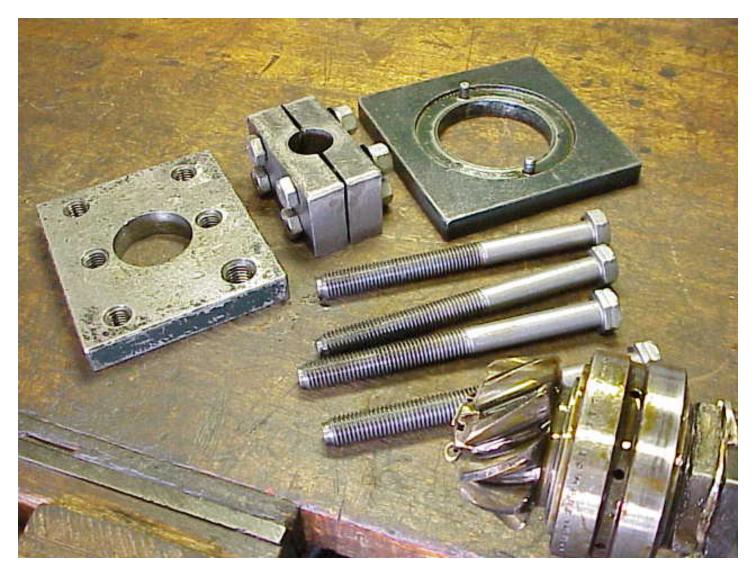
Photo shows the complete puller tool parts. The bolts have the ends tapered so the threaded ends do not dig in and become distorted. Should the ends become distorted they will damage the threads inside the plate as they are being removed.

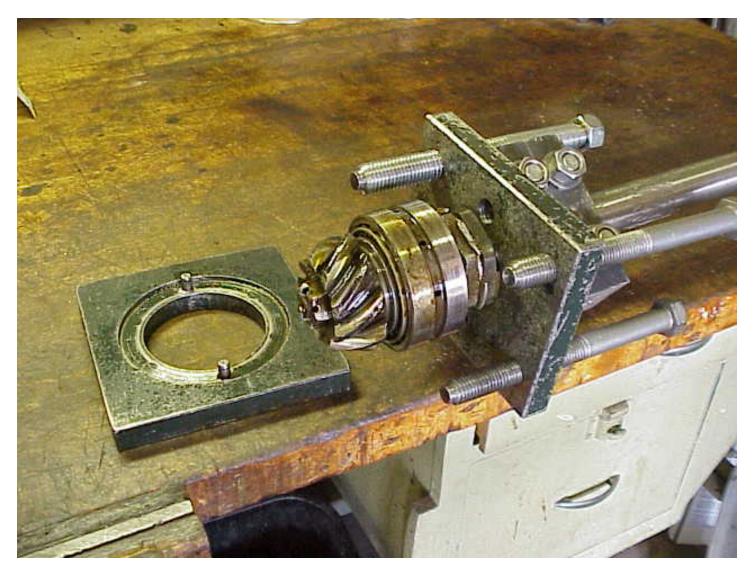
Photo show a pinion gear assembly pulled from a banjo using the puller tool.

Note in this photo that the entire pinion assembly has been removed from the banjo without disturbing the pre-load that is set on the pinion bearings. As long as the two large nuts are not disturbed the pre-load remains intact.

The pinion assembly can be removed from the drive shaft and installed on an overdrive stub shaft without disturbing the pre-load on the pinion bearings.

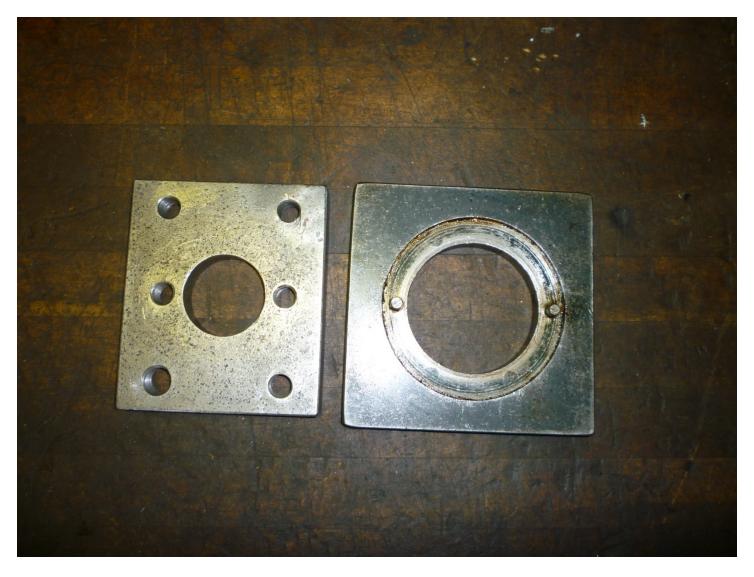
The plate on the right is mounted to the banjo flange with the two locating pins inserted top and bottom into the banjo flange bolt holes.

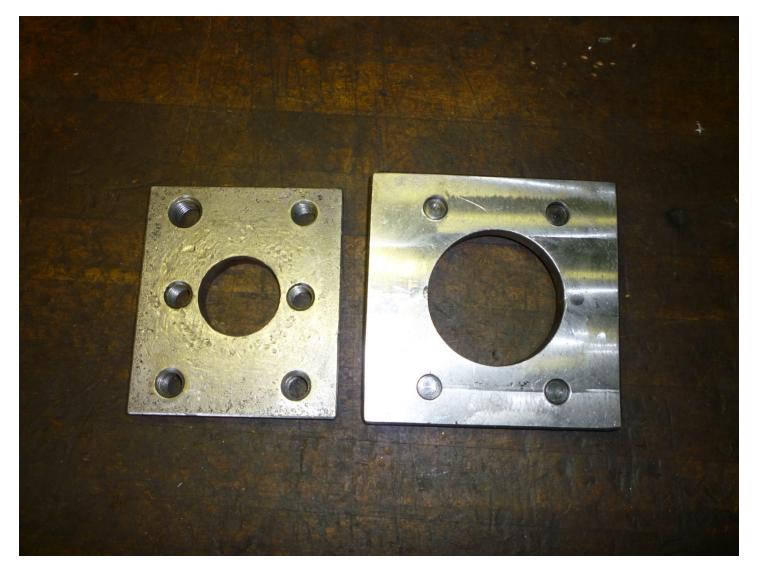
The plate on the right shows the front side of the plate that mounts to the banjo. The four cups are where the four puller bolts bottom out.

The plate on the left shows six puller thread holes. It was initially believed that it would require all six to pull a pinion. Actual use demonstrated that four are sufficient.

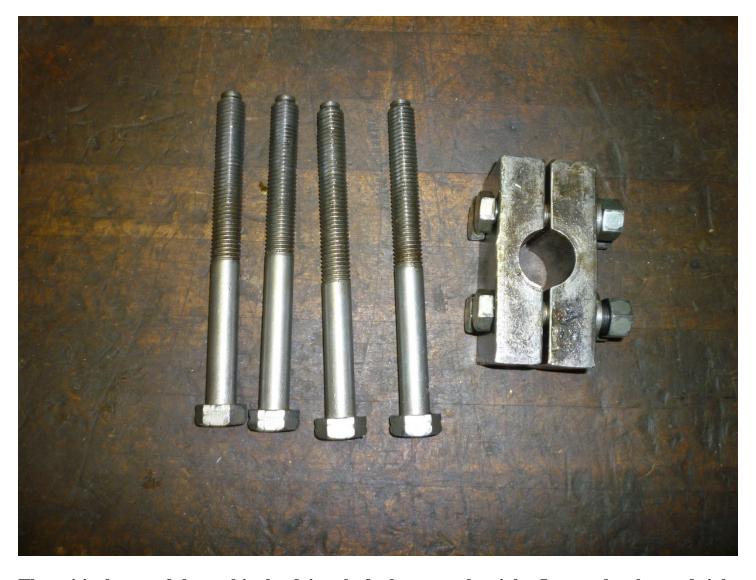
The critical part of the tool is the drive shaft clamp on the right. It must be clamped tight around the drive shaft so it does not slip.

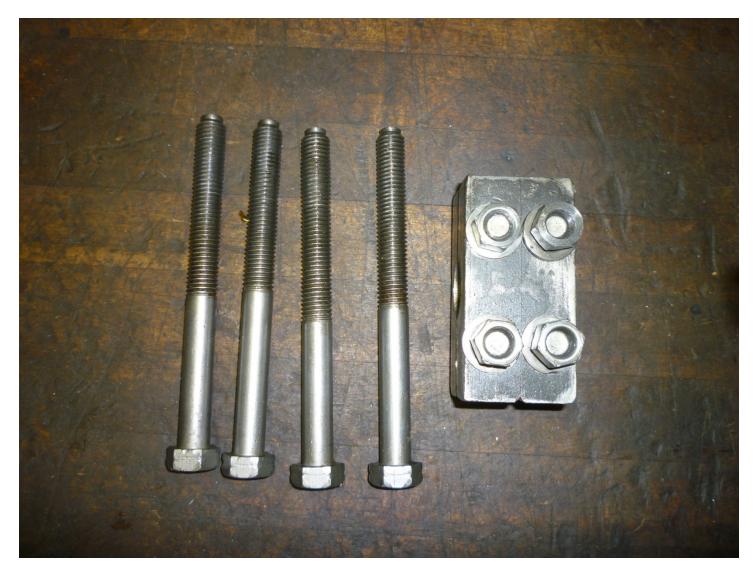
Photo shows the clamping block at a different angle.

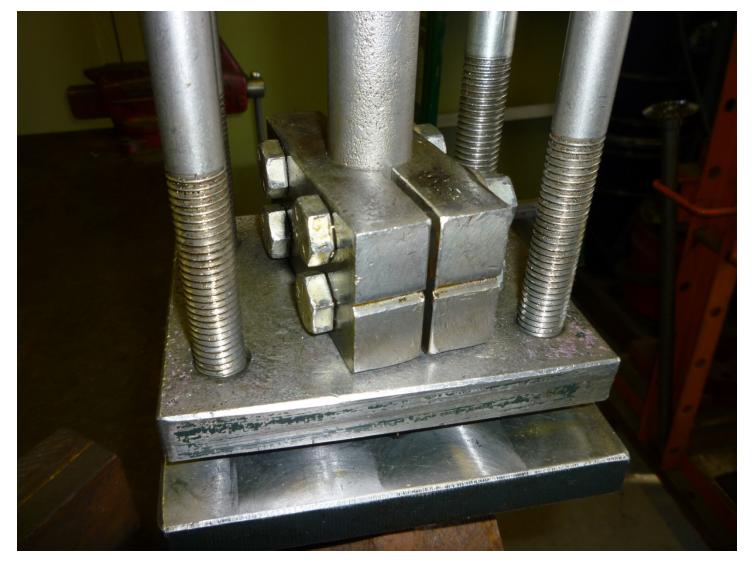
Photo shows the tool set up to pull a pinion gear assembly from a banjo.

When setting the tool up a liberal amount of oil should be applied to the threads of the puller bolts and into the four cups where the bolt ends bottom out.

A good idea is to put a chalk mark on the drive shaft just above the clamp. Monitor the chalk mark as the puller bolts are tightened to make sure the clamp is not slipping.

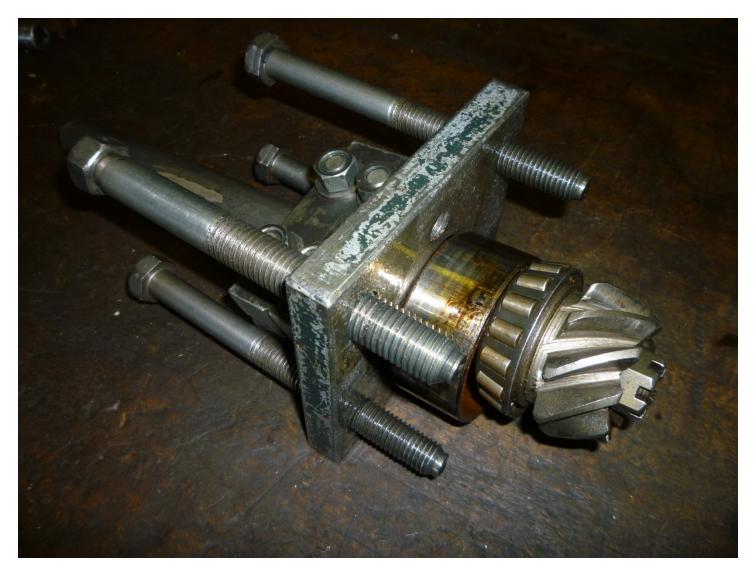
Photo shows a pinion gear assembly that has been pulled out of a banjo using the puller tool.

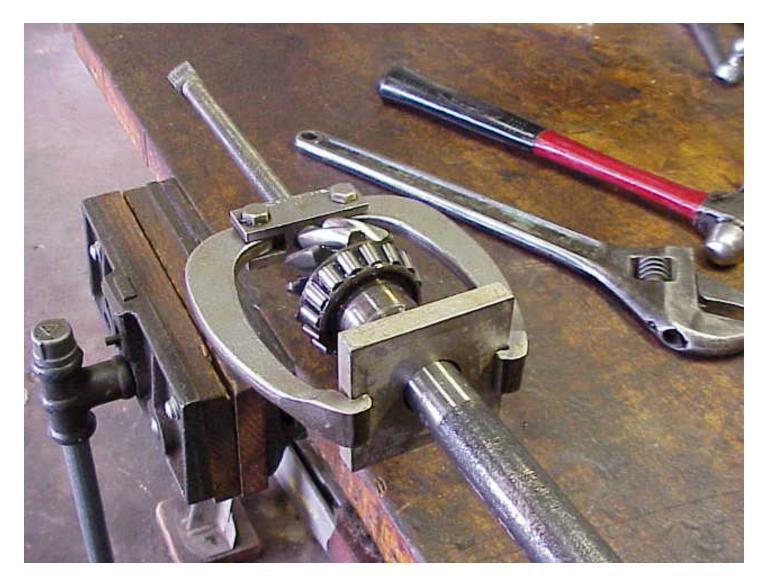
Once a pinion has been pulled from a banjo the next task is to remove the pinion gear from the end of the drive shaft. Care must be taken not to damage the threads on the end of the drive shaft, Do not hammer on the threaded end of the shaft. The gear is mounted to a taper on the end of the drive shaft and can be found extremely tight.

First remove the cotter pin and loosen the retaining nut. Back it off about 1/8", but do not remove the nut.

Place a steel plate with a hole in it behind the pinion gear. A bearing puller can also be used. Attach the gear puller so that the point is in the hole on the end of the drive shaft and the arms are around the steel plate. The gear puller shown was sold by Sears years ago to be used to pull the flywheel off Briggs & Stratton lawn mower engines. They are occasionally seen at swap meets.

Tighten the gear puller extremely tight. Smartly hammer the end of the gear puller about four times. If the gear does not pop loose, tighten the puller more and repeat the process until it comes loose. The reason the nut is left in place is so the gear does not fly across the room when it pops loose.
