Reproduction Gearshift Lever

by Tom Endy 2020

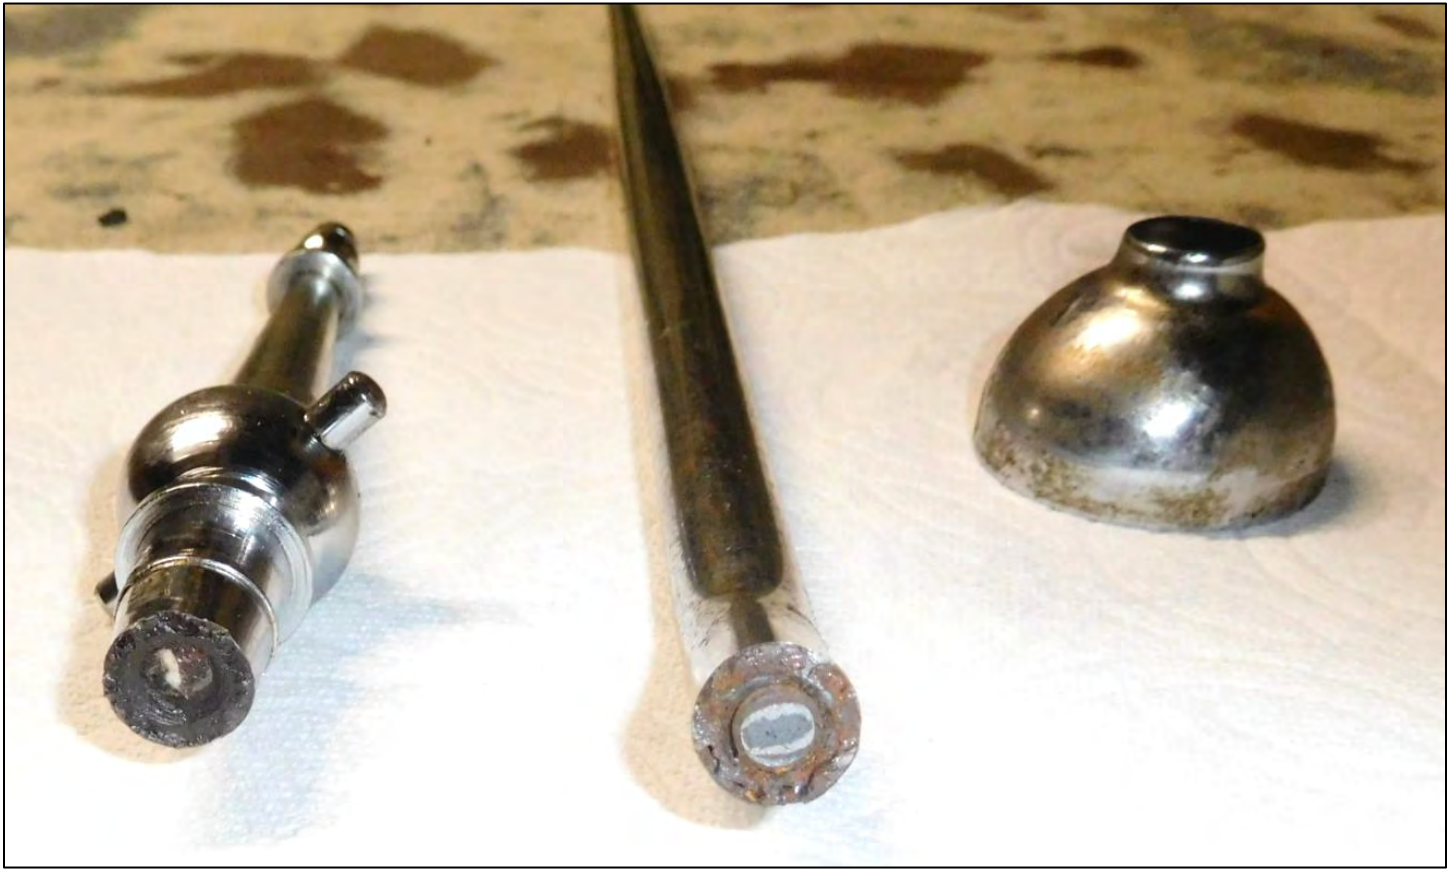
For a number of years the Model A Kingdom has been subjected to poor quality reproduction transmission gearshift levers. They are not made the same as the originals. The originals were all one piece and were bent at two different angles to accommodate 28-29 cars and 30-31 cars. The reproductions are bent to one size fits all, somewhere in between the required angles for 28-29 and 30-31. They are also made in two pieces and screwed together just below the angle bend. Many reproductions have experienced failure modes. The most significant is they tend to snap off right below the angle. The second failure mode is they can unthread where they are screwed together. The failed gearshift in the photo below failed as the owner was attempting to down shift from high to second. When the lever snapped off it fortunately left him in high gear so that he was able to coax the car home.

The best option is to always use an original gearshift lever, and one that is bent to the correct angle for your year car. The worn ball on the end of the lever can be welded up and ground down to fit the slots in the shifting forks. Quite often the issue is that the plating is shot and having something re-plated in the US is sometimes very difficult. The original gearshift levers were plated in what is known as a “Butler” finish, that had a dull appearance.
