# Model A Gas Cap

by Tom Endy

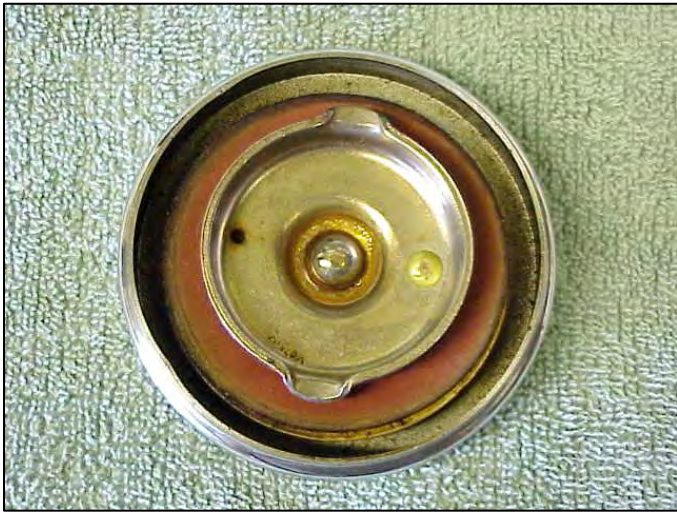
**30-31 modified gas cap with a 6-32 screw epoxied into place opposite from the vent hole.**

Reproduction 30-31 gas caps have a quality issue that can cause you some amount of grief. A large single rivet in the center on the bottom of the cap holds the assembly together. The rivet goes through the bottom metal grabbing device, a red colored gasket, and a brass flat washer. Off to the side of the rivet is drilled a vent hole that goes through all three parts. It vents to the outside edge of the cap. Without a vent hole the tank would experience a vacuum lock as the gas in the tank is depleted. Eventually it would stop the gravity flow of gas to the carburetor and the car would appear to run out of gas.

It is possible, and extremely likely, that as the cap is twisted on and off the tank numerous times, one or more of the three parts will rotate out of position on the center rivet. When this happens the vent hole will be blocked off and the vacuum thing will happen. When you remove the cap you are liable to hear a “Whoosh” sound as air rushes into the tank to equalize the vacuum.

Before you allow the vent hole to become blocked it is a good idea to modify the cap. Drill a second hole through the three pieces. Be careful not to drill clear through the top of the cap, just the three pieces. Tap the hole for a 6-32 screw. Lock-tight or epoxy it in place so it won't fall out into the gas tank. The screw will prevent the three parts from rotating out of position and the vent hole will maintain alignment through the three separate parts.

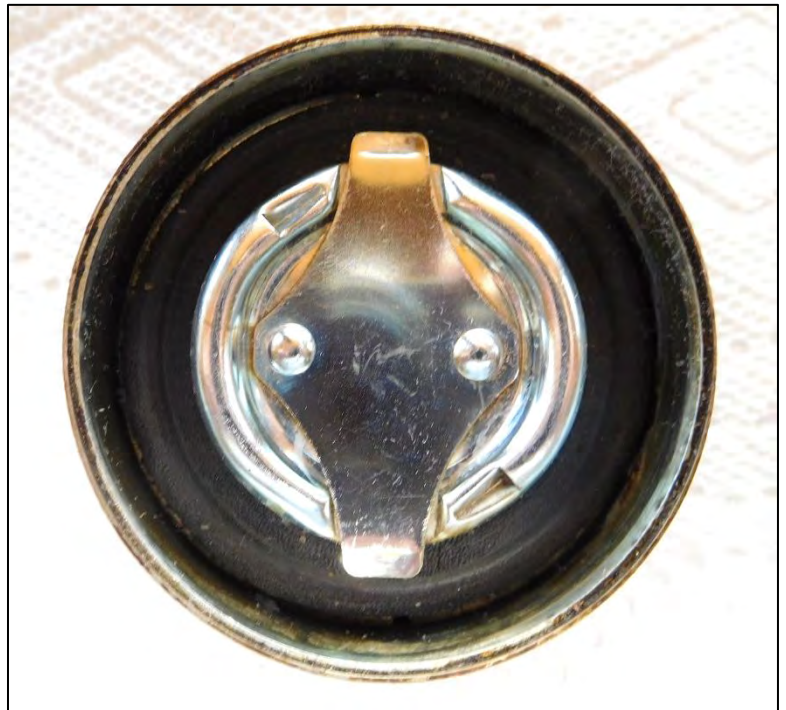
**30-31 Eaton style vented gas cap**

A better option is to procure a gas cap that is more like the original cap that Henry ordered. They are available from Snyders and are describe as an Eaton gas cap. The center section is secured with two rivets to prevent any of the parts from rotating out of position. There are two vent holes that are incorporated into the metal disk just above the rivets. One is located at the top to the left of the locking tab, the other is located at the bottom to the right of the locking tab.
