## Happiness Is a Clean Gas Tank in Your Model A

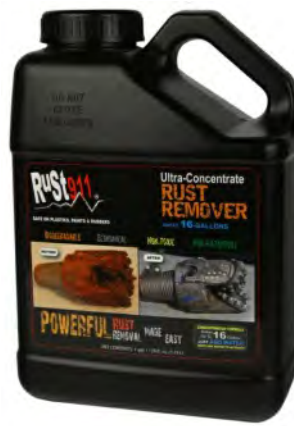
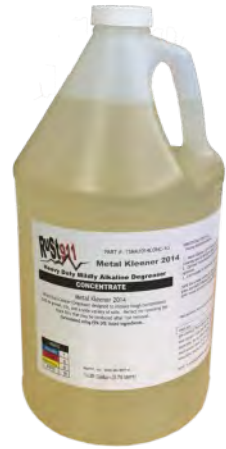
Today, there are alternatives that deal with the problems of rust and old varnish without removing the tank. Rust911 and Metal Kleener 2014 are 2 products, available thru "rust911.com" that I have used with very good success. Both are non-toxic, bio-degradable and come in concentrated form. If the tank is just dirty and has a lot of old varnish, it can be cleaned in place with Metal Kleener 2014. With the tank empty, just add one gallon of the concentrate and fill the rest of the way with water and let sit for several days. Periodically, rock the car from side to side to help dissolve the old deposits. Drain, flush out with water and leave the tank open for several days to dry. You should not allow Metal Kleener to come in contact with the paint but if you do, just immediately wash off with soap and water.

If the inside of the tank also has rust deposits, after using the Metal Kleener, fill with a mixture of 1 part Rust911 concentrate to 15 parts water, and let set for several days, occasionally rocking the car. Drain and flush with water and let the tank dry for several days. Again, if you get any Rust 911 on the paint, just immediately wash with soap and water. In order to get the best results, always clean the tank first with Metal Kleener 2014 before using Rust911.
