BLT Guys Mitchell Install – April 24, 2021

A Mitchell install was conducted by the BLT Guys organization on Saturday, April 24th 2021 at my house. The install was a double, a synchro transmission and an overdrive. The car is a 1931 Sports Coupe owned by Steve Miller, who lives in Garden Grove and has no Model A club affiliation. We started at 9 AM and the car was road tested at 3:30 PM. The installation fee was donated to the Model A Ford youth restoration program. There was a good turnout of BLT willing workers including a large contingent from the Santa Anita A's Model A club.

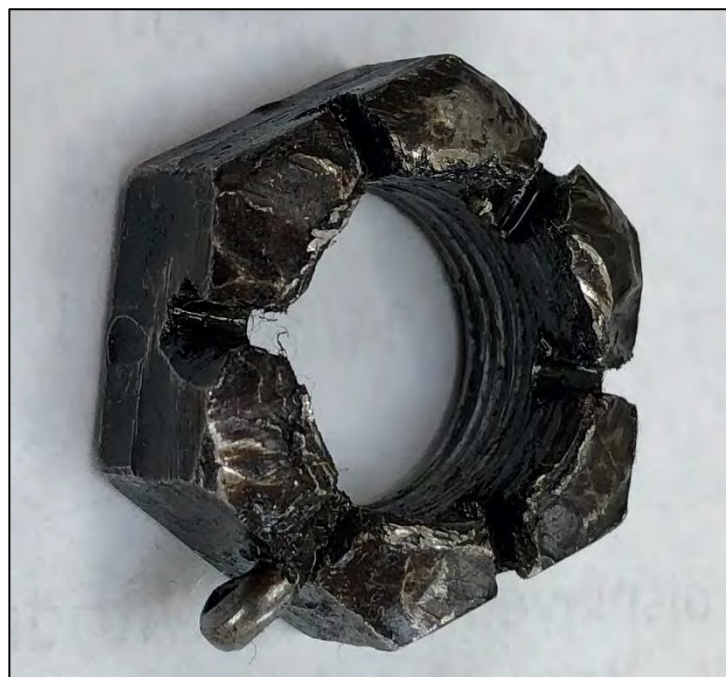
We almost had a show stopper. We removed the torque tube and attached my pinion puller to the drive shaft and expected to pull the whole pinion assembly out intact, instead the only thing that came out was the drive shaft. The threaded end of the shaft was butchered and the nut was missing. We were at an impasse on how to get the pinion assembly out. I did not have one of the pullers that you put behind the two large pinion nuts. However, the owner of the car had bought such a tool from Mitchell. He had to go home to get, but it saved the day. When we got the pinion assembly out we were able to fish the nut out of the banjo with a magnet. Fortunately there was no damage to the ring and pinion. I suspect what happened is that when the differential was last worked on the drive shaft nut had not been properly torqued and it came loose and backed off to the end of the shaft that allowed the nut and the end of the shaft to ride against the carrier grinding the nut and shaft down. Fortunately the nut remained captured between the end of the shaft and the carrier and did not fall into the banjo and destroy the ring and pinion. It appears a cotter pin had been installed at one time as there was a small portion of one remaining on one side of the nut. There were some metal particles in the differential oil, however, we were able to clean up the pinion bearings and re-set the preload. The oil in the banjo was changed. The overdrive was successfully installed.

The damaged drive shaft nut
