A Poor Man's Posi traction

by Tom Endy 2021

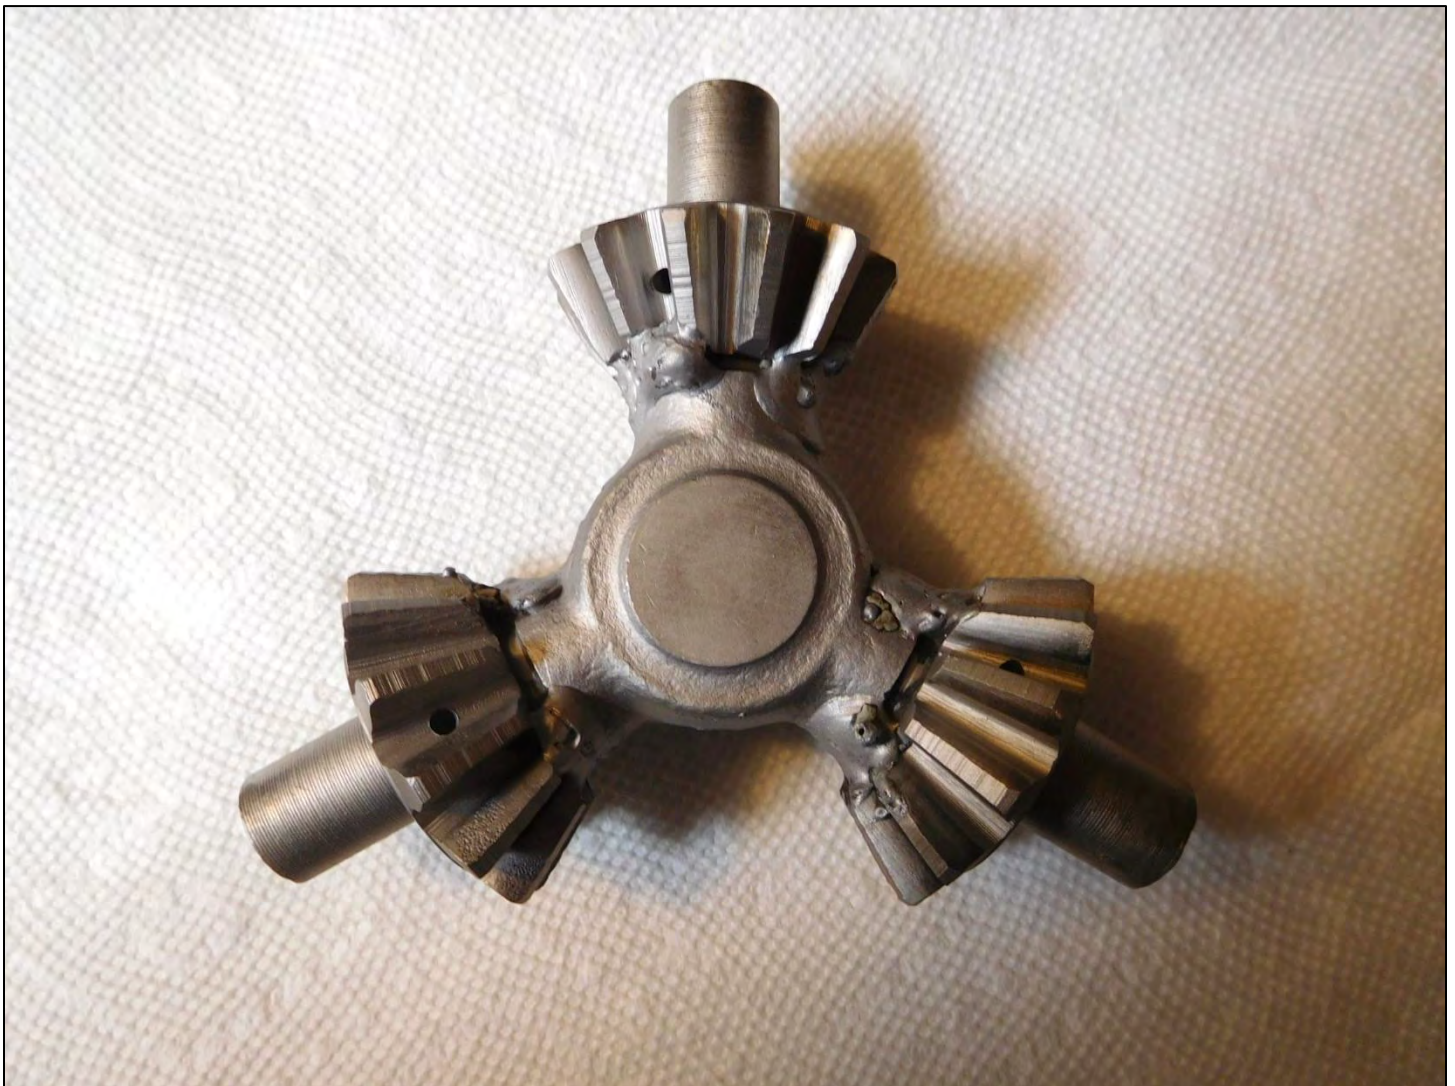
It is interesting to note that the rear axle assembly that the spider gear assembly came out of in the photo below also had a tooth missing from the ring gear.

The poor man's Posi traction that came out of Model A Ford that was one time owned in 1950 by a 17 year old kid with a duck tail haircut.

Every once in a while I disassemble a Model A rear axle assembly and find that someone has welded the three spider gears in the differential to their axle shafts so that they do not rotate. I envision some 17 year old kid with a duck-tail haircut back in 1950 doing this. In the day this was called a poor man's Posi traction. By welding the spider gears so that they do not rotate, there is essentially no differential gearing in the rear axle assembly. This allows Mr. Ducktail to take off from a signal and lay down a strip of rubber equally from both back wheels. The differential gearing in a rear axle assembly was developed by some ingenious mind. It allows a car to turn a corner with each rear wheel turning at a different rotation. The outboard wheel is turning faster than the inboard wheel. This allows the car to make a turn in either direction in a smooth continuous manner. Mr. Ducktail when making a turn would have his out board wheel skipping and making a chirping sound as the rubber tire skidded around the turn.
