# Too Tight!

by Tom Endy 2022

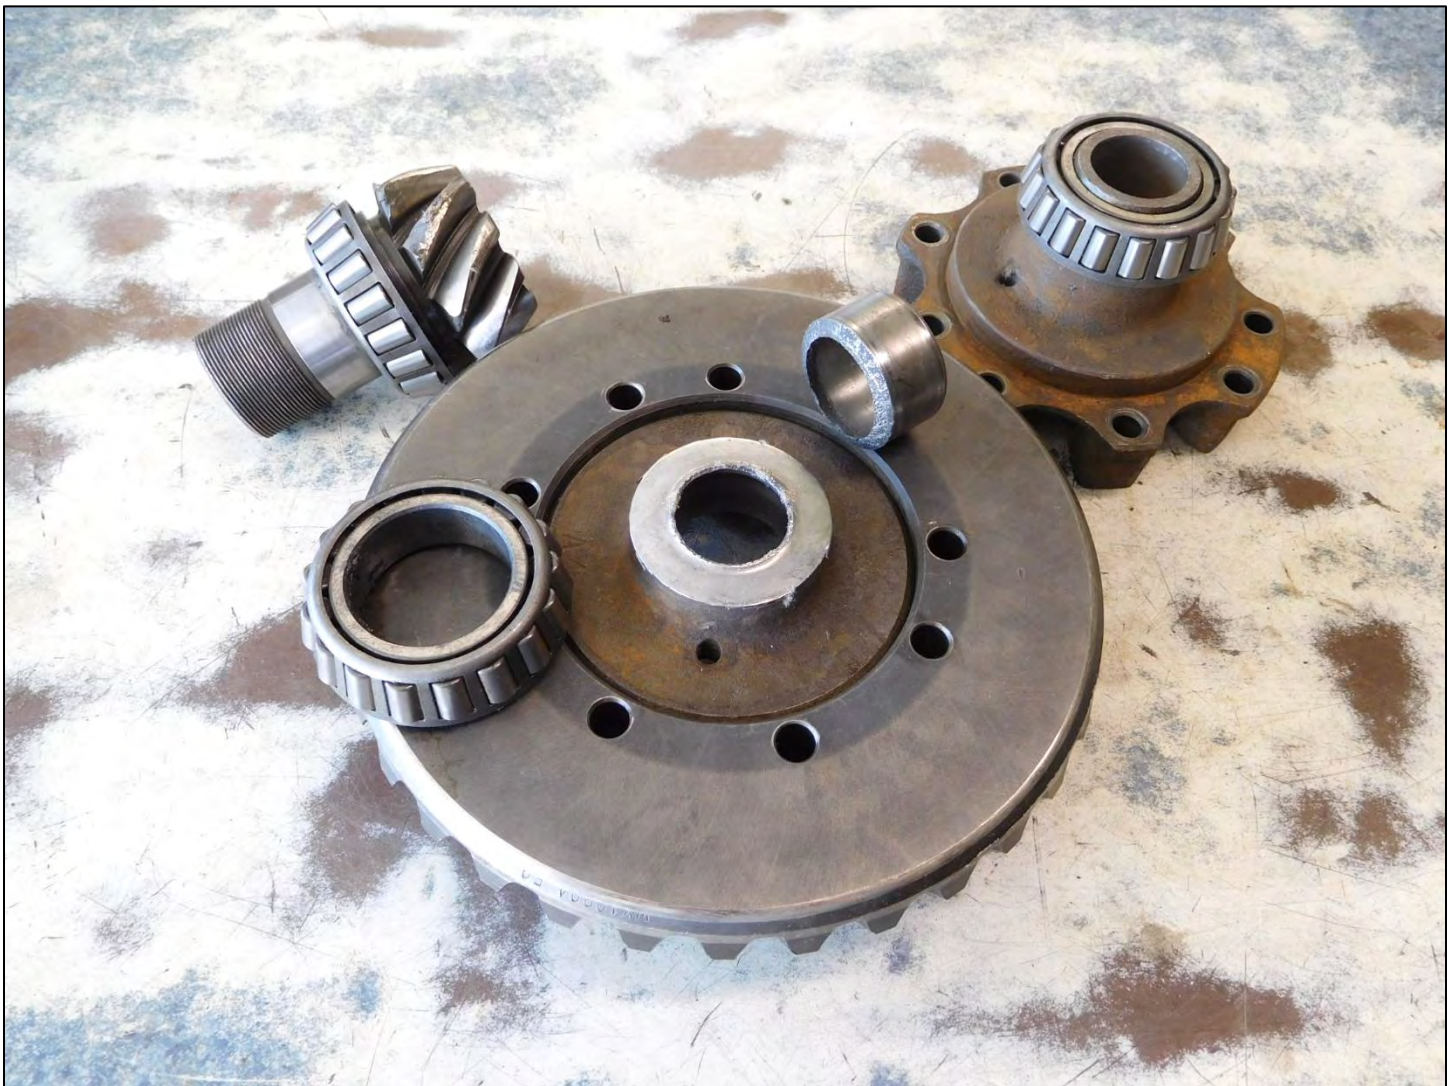
During the 35 years I have been rebuilding Model A Ford differentials I have seen just about every failure mode there is. On two occasions I have seen the bearing hub shear off the ring side of the carrier. The first time the car continued to run because the bearing and the sheared portion of the hub stayed pretty much together. This recent second failure was a different story. The differential locked up and the car could not go anywhere. The cause of this type of failure was set up when the differential was last overhauled, maybe years ago. The mechanic did not understand the need for proper carrier bearing pre-load setting, which resulted in the bearing being set too tight against the race. In most cases it causes the bearing to spin on the hub and does no further damage. However, if it is way too tight it can build up a lot of heat and eventually shear the hub off the carrier. The ring & pinion in this assembly took quite a beating and had to be replaced along with the carrier.

Carrier bearing pre-load is achieved by the selection of the quantity and thickness of banjo gaskets. The nominal pre-load requirement has been determined to be 20 inch pounds of torque as read on a dial indicator torque wrench.
