The Transmission Hook

by Tom Endy 2023

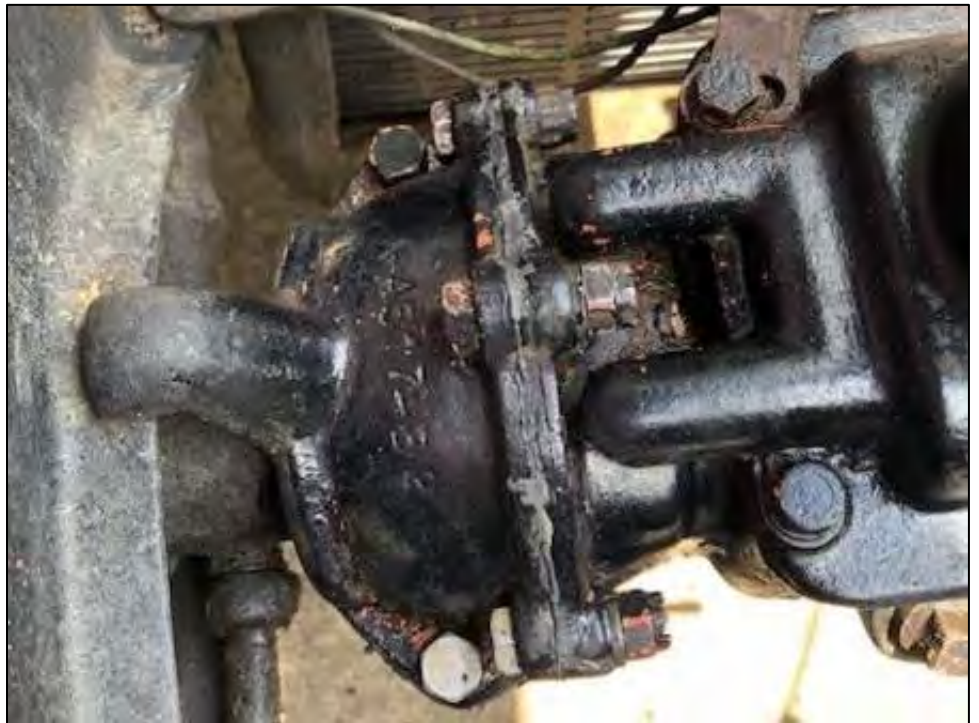
The early transmission hook.

The early Model A's had a U-joint housing design that incorporated a "hook" in the top clamshell casting. It was discontinued in March of 1929 for reasons unknown. The hook curves over the top of a cross section of the frame, but does not touch it, it sits a small distance above. Model A enthusiasts have debated its purpose ever since. Some believe it was to keep the drive train from bottoming out going over a bump, others believe its purpose was to allow the engine to be removed from the car at the bell housing and the hook would drop down and engage the frame section and keep the bell housing and transmission in position. Some even believe it stops the engine and transmission from bouncing up and down when you let the clutch out.

I have my own theory. I think old Henry did it for one reason only, to confuse and confound the next 100 years of Model A enthusiasts. The early U-joint housing with the hook has an off-set bolt pattern so they can only be bolted up to the transmission rear bearing retainer with the hook facing up. The early rear bearing retainer also has an off-set bolt pattern. When Henry discontinued the hook he made the bolt pattern symmetrical on both later components. This has caused confusion in the Model A kingdom ever since.
